**Federal Aviation
Administration**

ADVISORY CIRCULAR

AVIATION MAINTENANCE ALERTS

**ALERT
NUMBER
402**

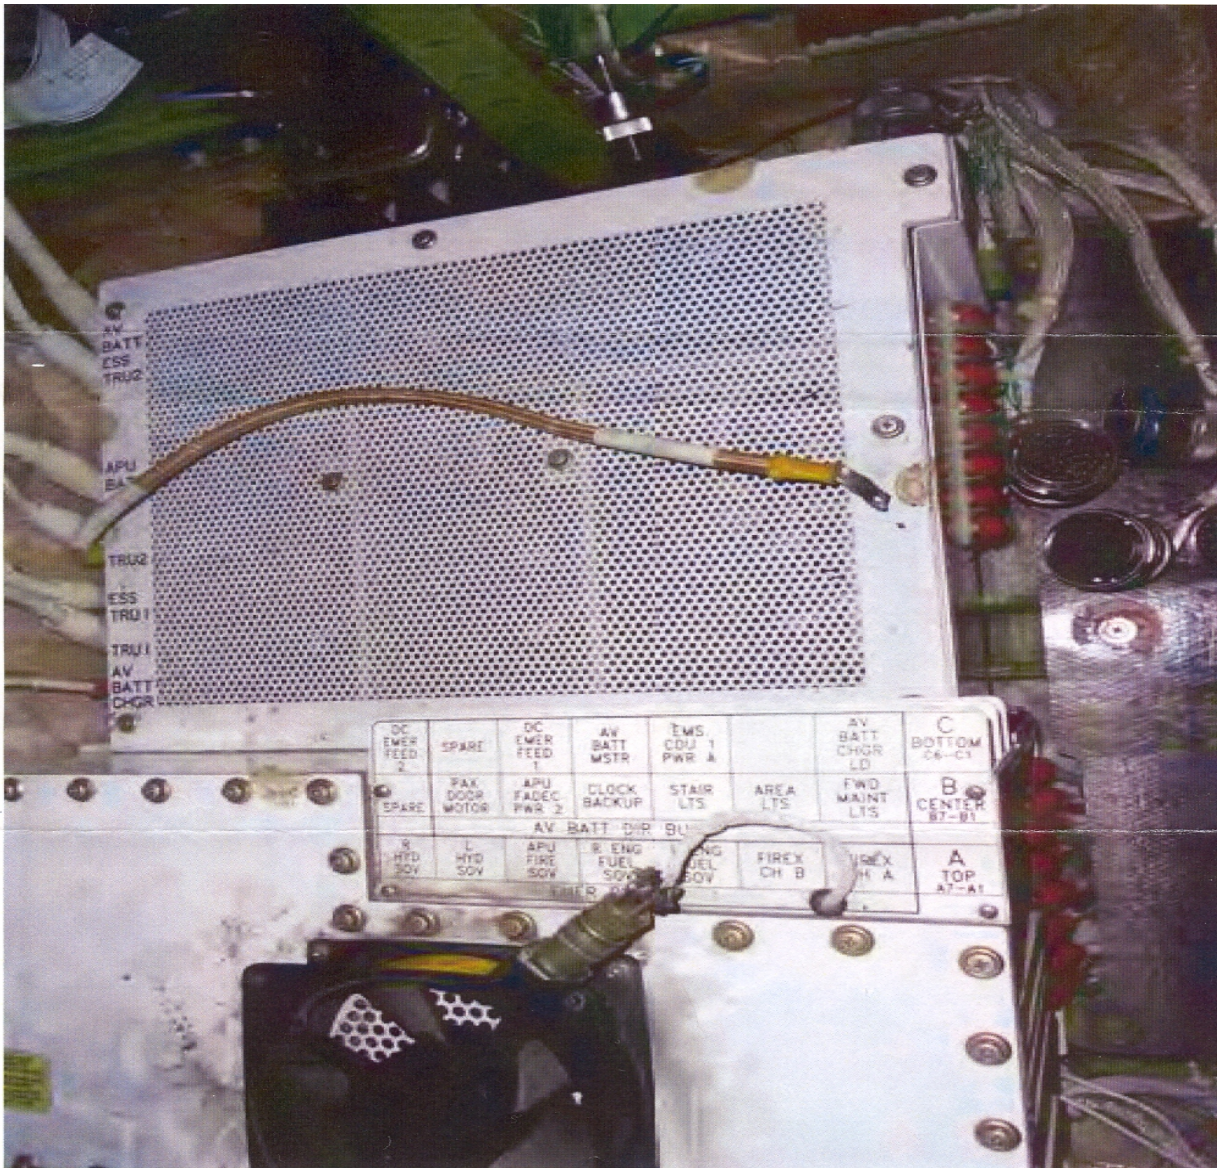
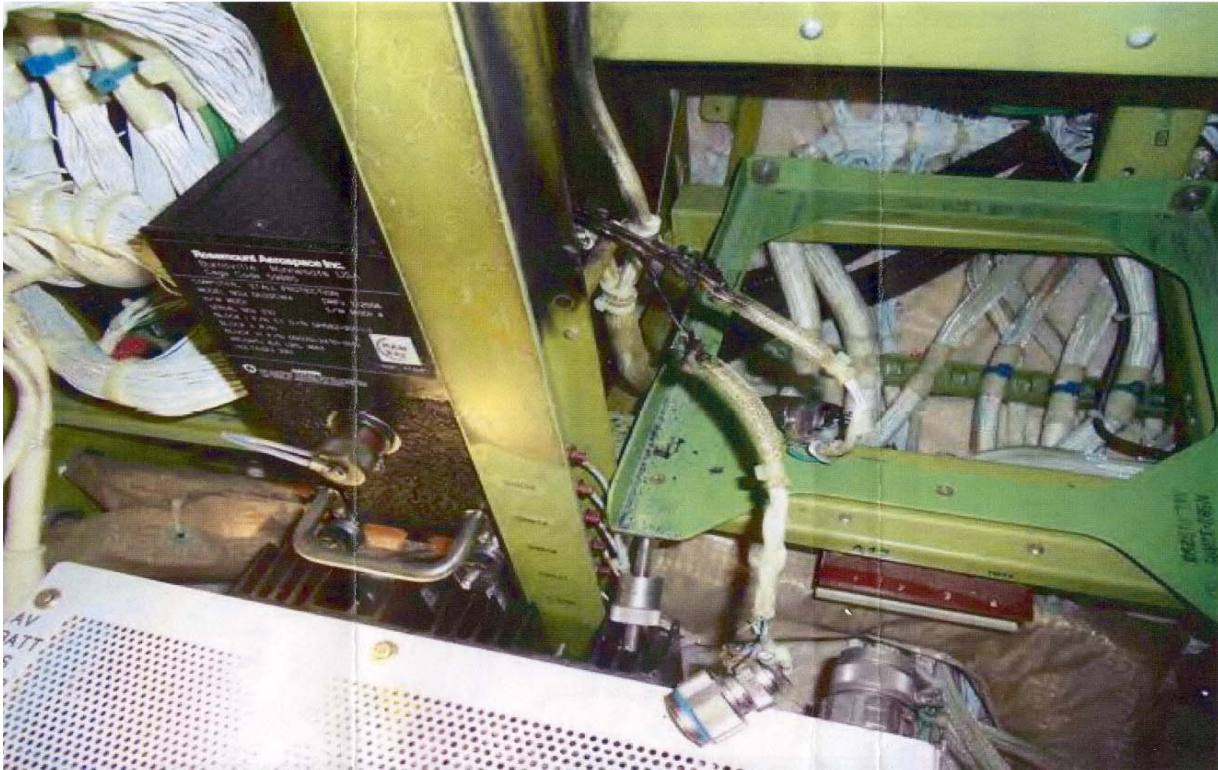
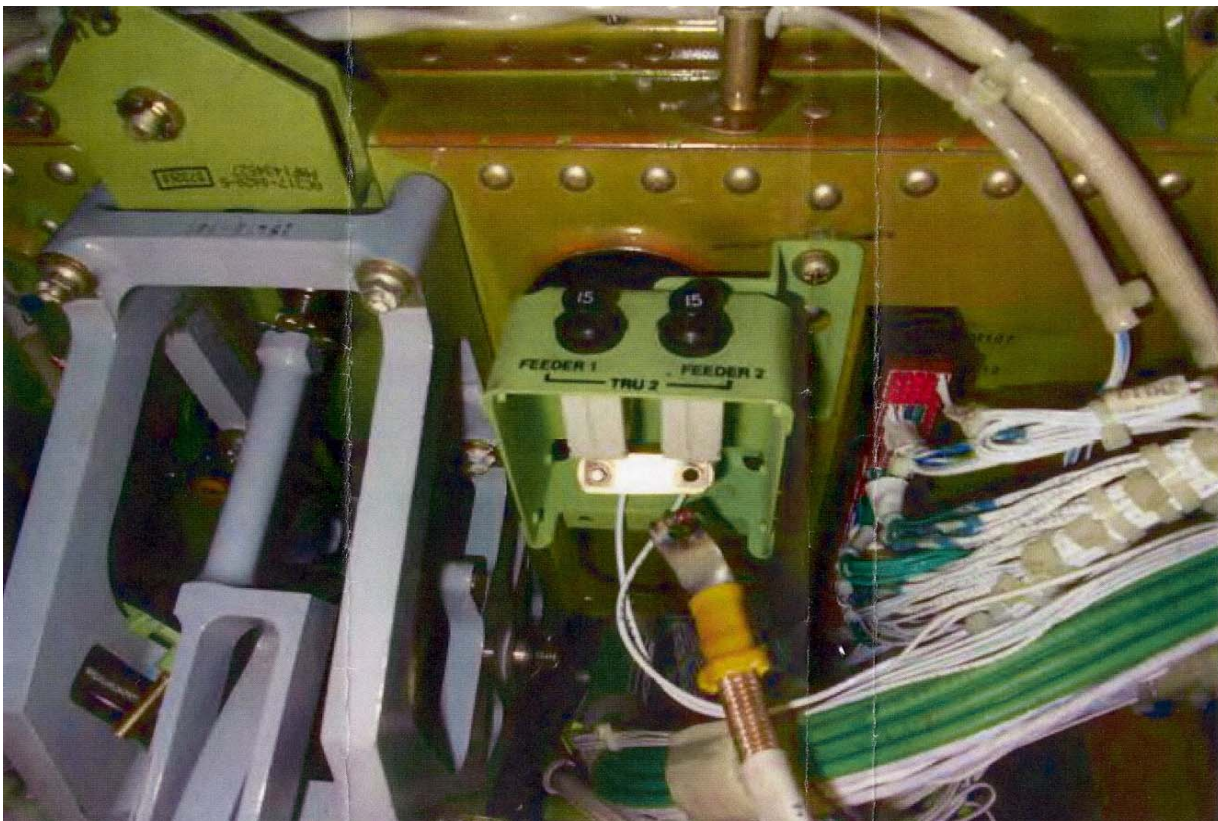
Bombardier: 700-1A10: Loose Power Cable; ATA 2497

A repair station technician states, "The customer noticed an amber 'electrical system fail' CAS message (*crew advisory system*). (*Inspection*) found a power cable for the number two TRU (*transformer/rectifier unit*) had come free. Also found were two charred wire harnesses at the number two SPDU (Secondary Power Distribution Unit)—and 'arcing marks' on the unit (*itself*). This arcing appears to have been caused by the loose power cable.

"The power cable P/N is 3PB189A4. It connects at one end to the TRU2 post on the forward side of the unit labeled 'DC Power Center'. This unit is located under the floorboard of the cockpit entry area. The other end connects to the bus bar of a unit (P/N 7274-11-15) which contains two fifteen amp circuit breakers. (*This too is found*) under the floorboards in the same area. The circuit breakers are marked 'Feeder 1' and 'Feeder 2'.

"The charred wire harnesses are P/N's A13P5/A13J5 F230 and A13P6/A13J6 F235. These two harnesses connect to cannon plugs on the SPDU assembly.

"No cause has been determined for the power cable coming loose. Bombardier technical representatives have been notified and (*they*) will evaluate *this issue*."

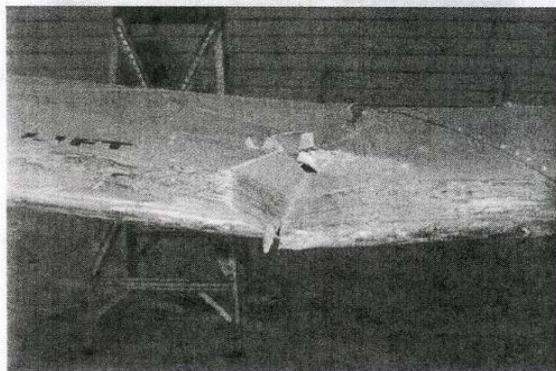
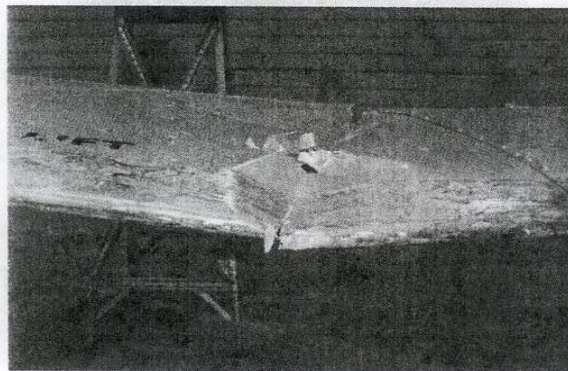
A damaged R/H Horizontal Stabilizer

Once the elevator jam cleared itself, the fractured rod end (still attached to the pushpull tube) began to thrash and flail about, causing significant damage to the tail section. The tailplane "flutter" (unstable oscillations) became so severe that both the front and rear spars of the R/H horizontal stabilizer completely fractured. Although, the R/H elevator assembly hinges were still attached, the R/H elevator and horizontal stabilizer assemblies were severely bent, twisted and buckled.

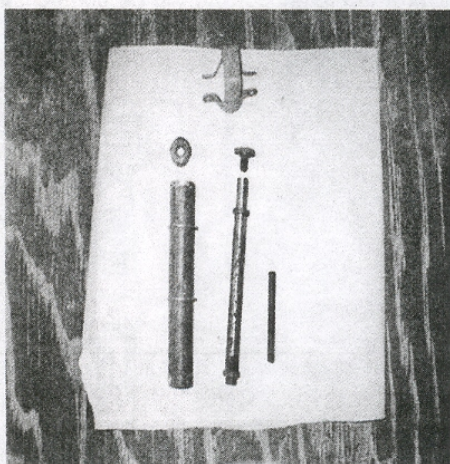
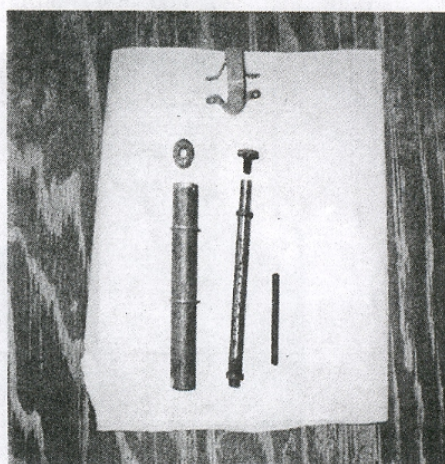
A follow-up investigation found that the threaded rod end (P/N 0310362-5) of the elevator trim tab actuator had completely fractured. The threaded rod end is mated into a long screw (tube) assembly (P/N 1260049-1) that fits inside the body of the actuator assembly (P/N 1260074-1). When the fracture occurred, the now failed trim rod managed to jam the R/H elevator to the down position. Considerable post-fracture damage such as pounding, rubbing and scratching was evident.

A disassembled R/H Elevator Trim Actuator Assembly

The Canadian Transportation Safety Board Engineering Report concluded that the threaded rod failed in reverse bending fatigue (high cycle – low stress) at the 1st or 2nd thread from the shank. The actuator was installed in the overhaul condition in August of 2003 at 7477.5 total airframe hours. The failure occurred at 10 303 total airframe hours; thus the trim tab actuator assembly was in service for 2825.5 flight hours since overhaul. During the period of 6 years, the actuator assembly was visually inspected and checked for freeplay every 50-flight hours in accordance with the operator's own specific requirements. There were no visible defects noted, nor any replacement recorded in the aircraft records.

The TSB Report also concludes that the chemical composition and thread dimensions of the trim tab actuator screw were in agreement with the manufacturers' specifications. Traces of corrosion were found on the threaded rod end and on the outer surface of the screw indicating moisture ingress. Multiple origin sites of reverse bending fatigue suggested that it was not a surface defect that caused the initial fatigue, but rather a general stress concentration in the thread root.

Cessna Aircraft Company agrees mostly with the TSB analysis and conclusions. Cessna stated that significant corrosion was found on the internal and external threaded screws and the grease showed evidence of old-age and water content. This raises the possibility of corrosion related fatigue having occurred in the initial stages of cracking on the elevator tab screw.

Transport Canada Civil Aviation (TCCA) recommends that owners, operators and other responsible agencies closely follow the manufacturers maintenance instructions.

Whenever actuator disassembly is required, maintenance personnel need to closely examine the threaded rod for damaged threads or dirt particles. It is also critical to closely examine the threaded rod and its mating screw for wobble/binding and corrosion and carry out the free play check. It is important to note that whenever it is necessary to install new bearings that maintainers carefully drill the bearing so the drill will emerge from the existing hole on the opposite side of the actuator housing. If these holes are drilled oversized, then misalignment/wobble of the threaded rod could induce stress and result in fracture of the threaded rod.

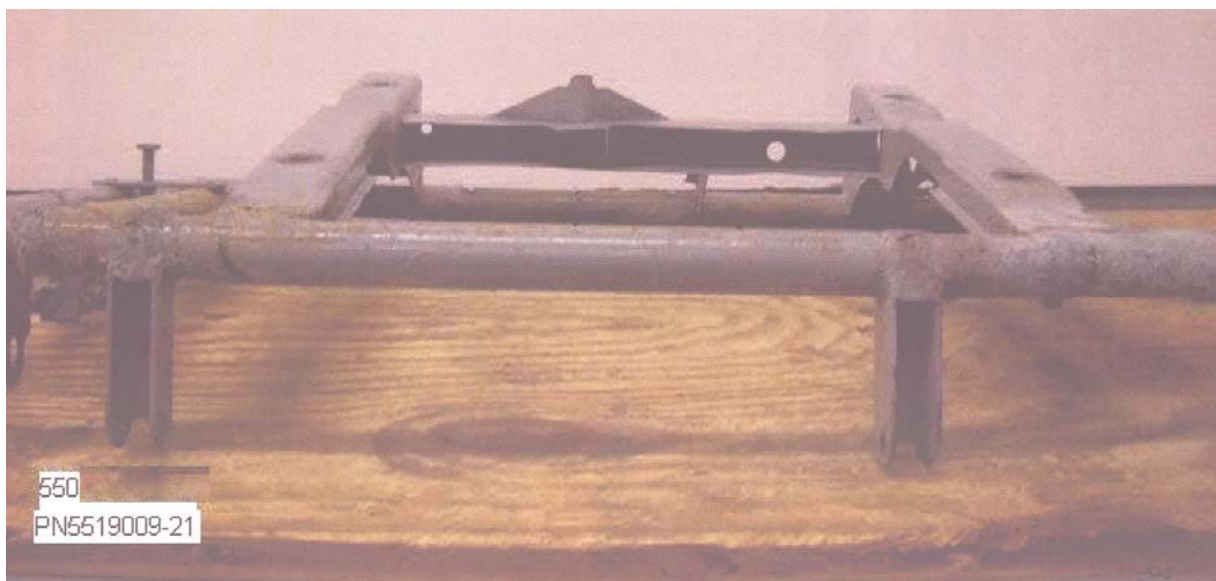
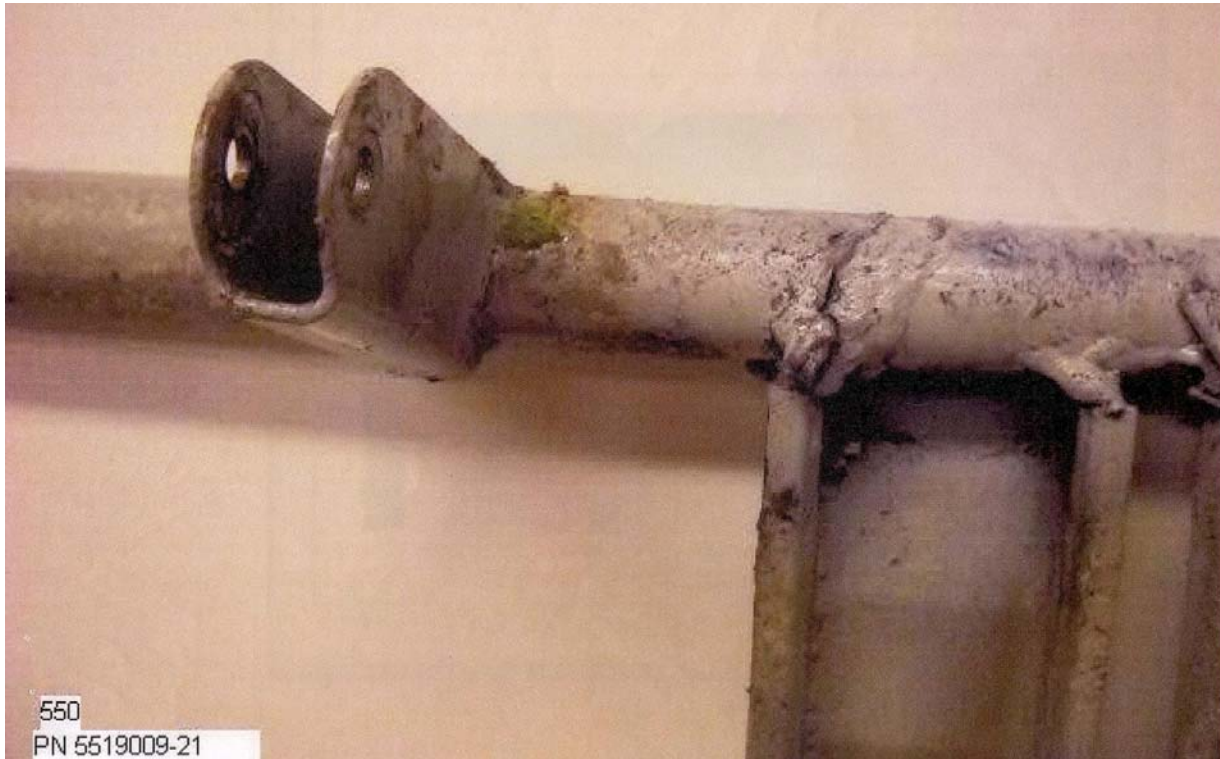
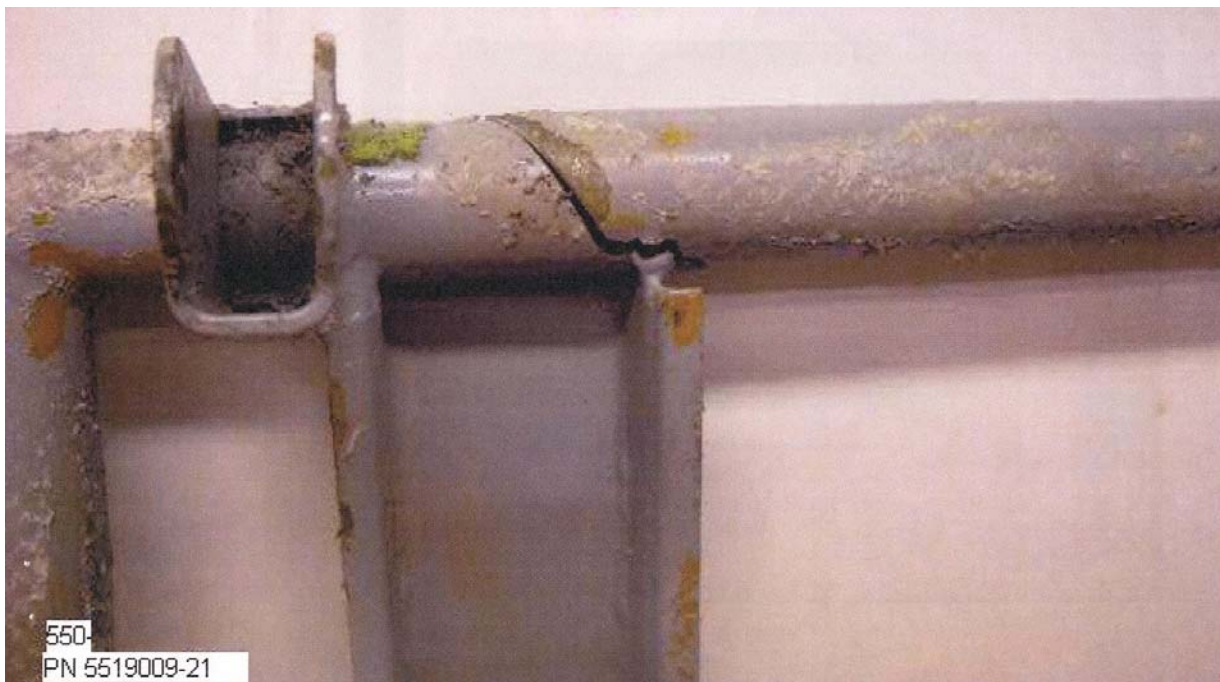
Cessna: 550; Cracked Seat Base Assembly; ATA 2510

"The upper Seat Base Assembly (P/N 5519015—15) was found cracked at the chair back attach points," states this repair station mechanic. "Stress on the chair back and metal fatigue are the probable cause. Also (*observed*) was a previous, inappropriate repair.

"This chair was repaired in accordance with STC ST01042WI." (*Seat base P/N: 5519009-21.*)

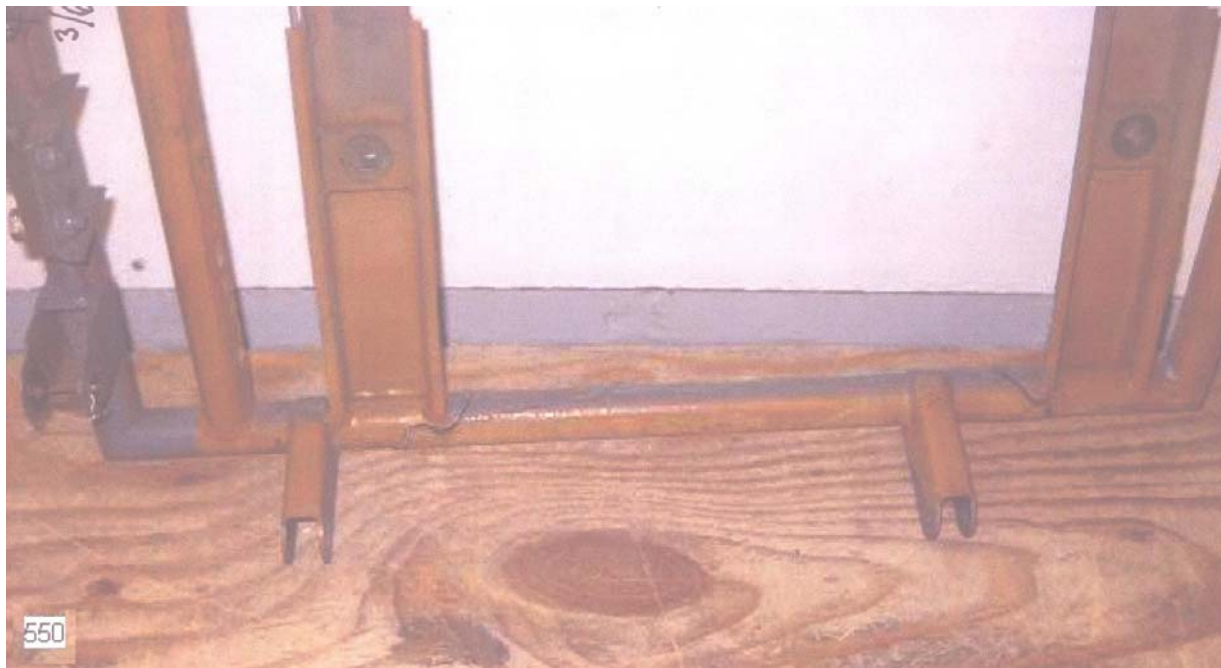
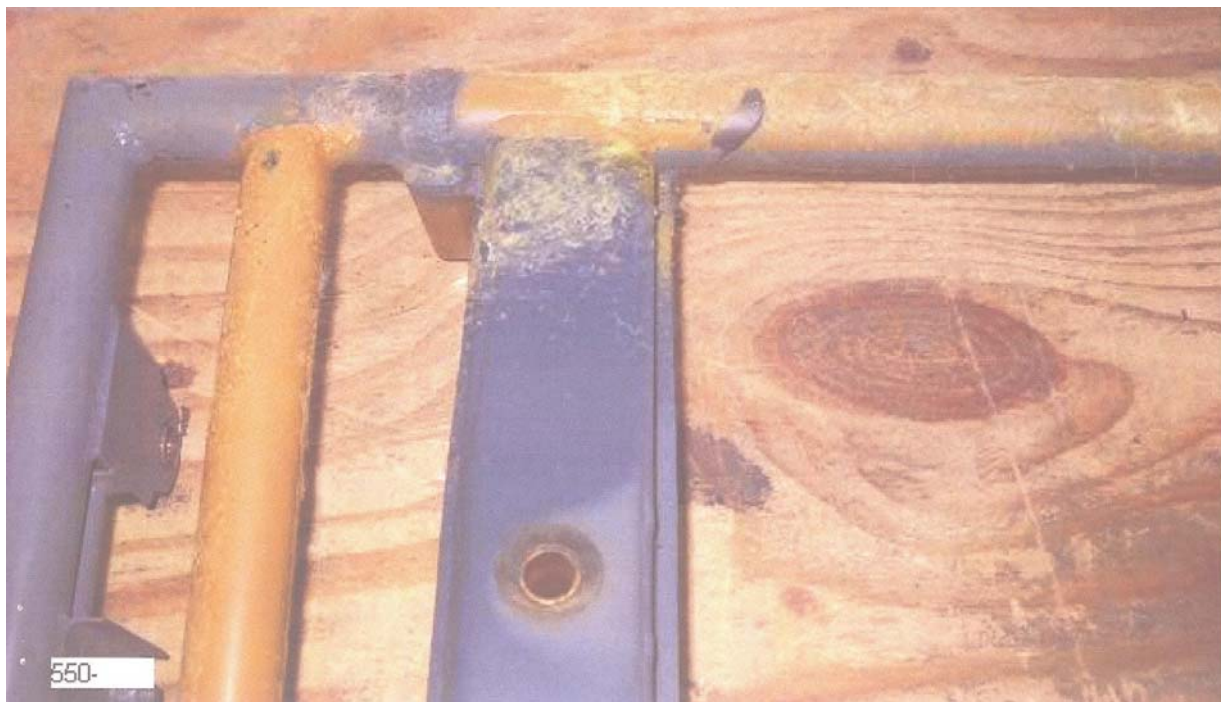
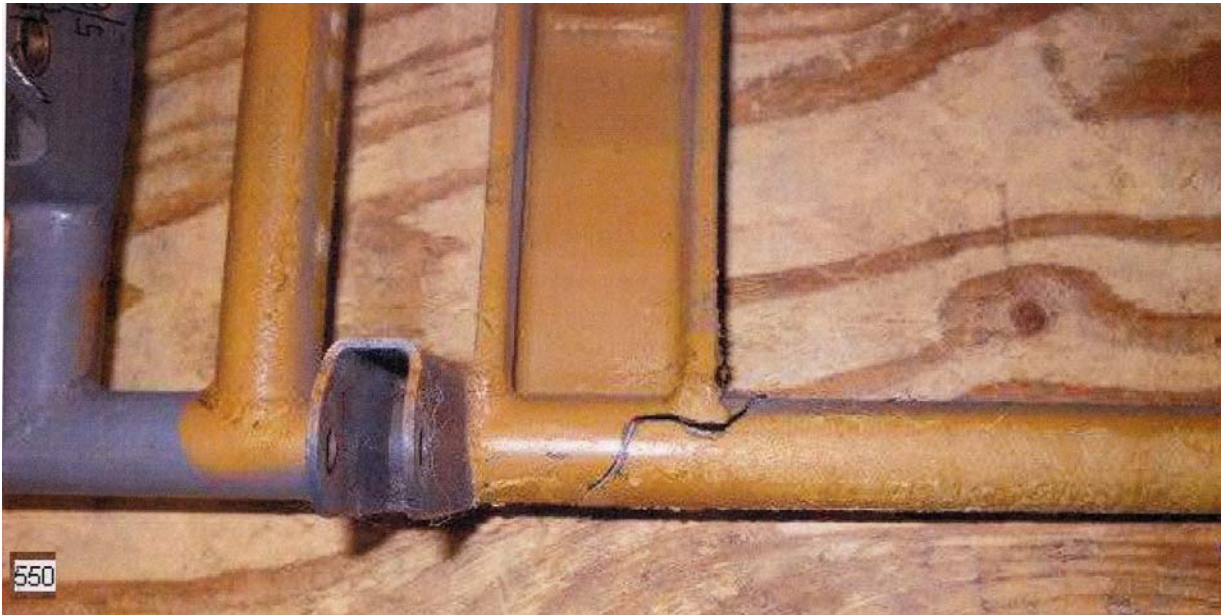
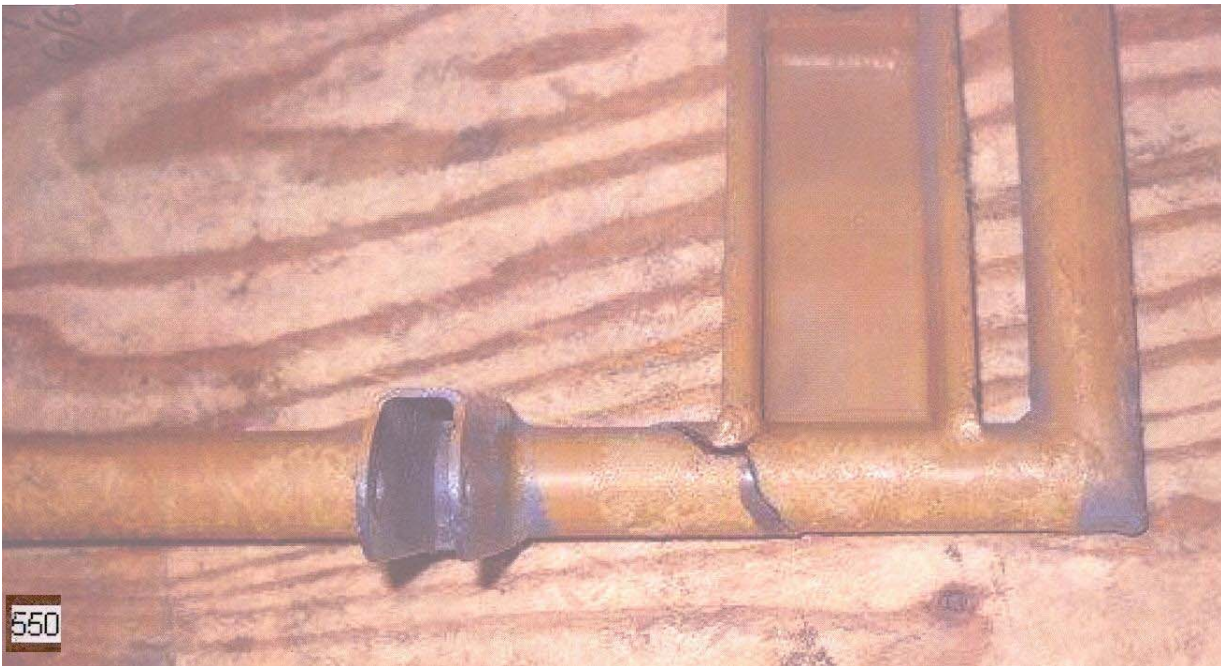
Cessna: 550; Cracked Seat Base Assembly; ATA 2510

The previous *Alerts* submitter provides another seat defect report from a different airplane. "The upper Seat base assembly (P/N 5519015-16) was found cracked at the chair back attach points (seat base P/N: 5519009-22). Metal fatigue and stress on the chair back is the probable cause. This chair was repaired in accordance with STC STO1042WI."

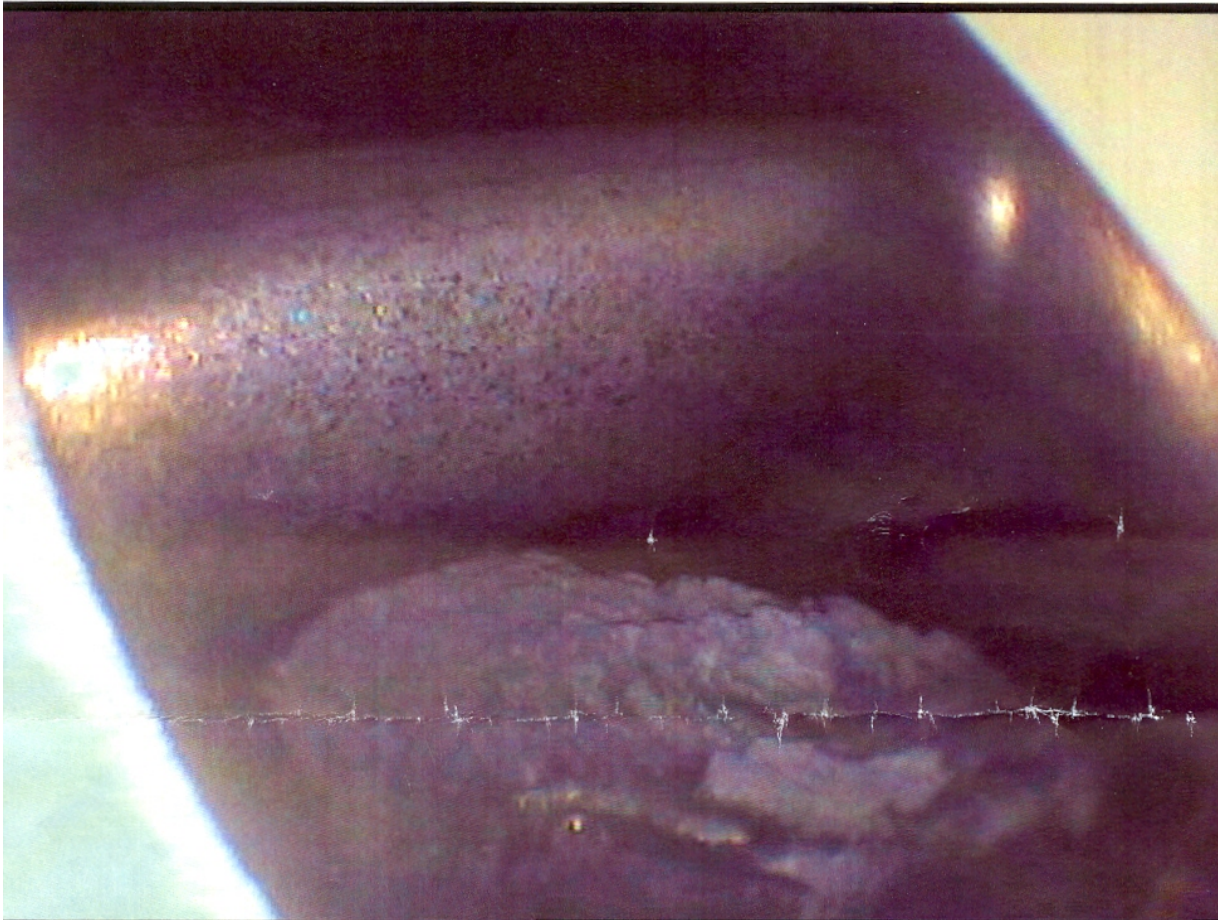
"Airworthiness Directive AD 2008-24-07 limits this aircraft to FL 370—higher altitudes cause this aircraft engine to quickly produce hard carbon buildup (coking)."

(Given the aircraft was operating within its altitude parameters, what caused the coking? Answer: Since this defect report submission early last year, AD 2008-24-07 has been superseded by AD 2011-06-06, lowering the maximum operating altitude to 30,000 feet. Reference:

Only one paper-scanned photo survived multiple e-mail transmissions sufficiently well to show some of the coke (carbon) buildup on what appears to be the turbine's rotor or stator—Ed.)

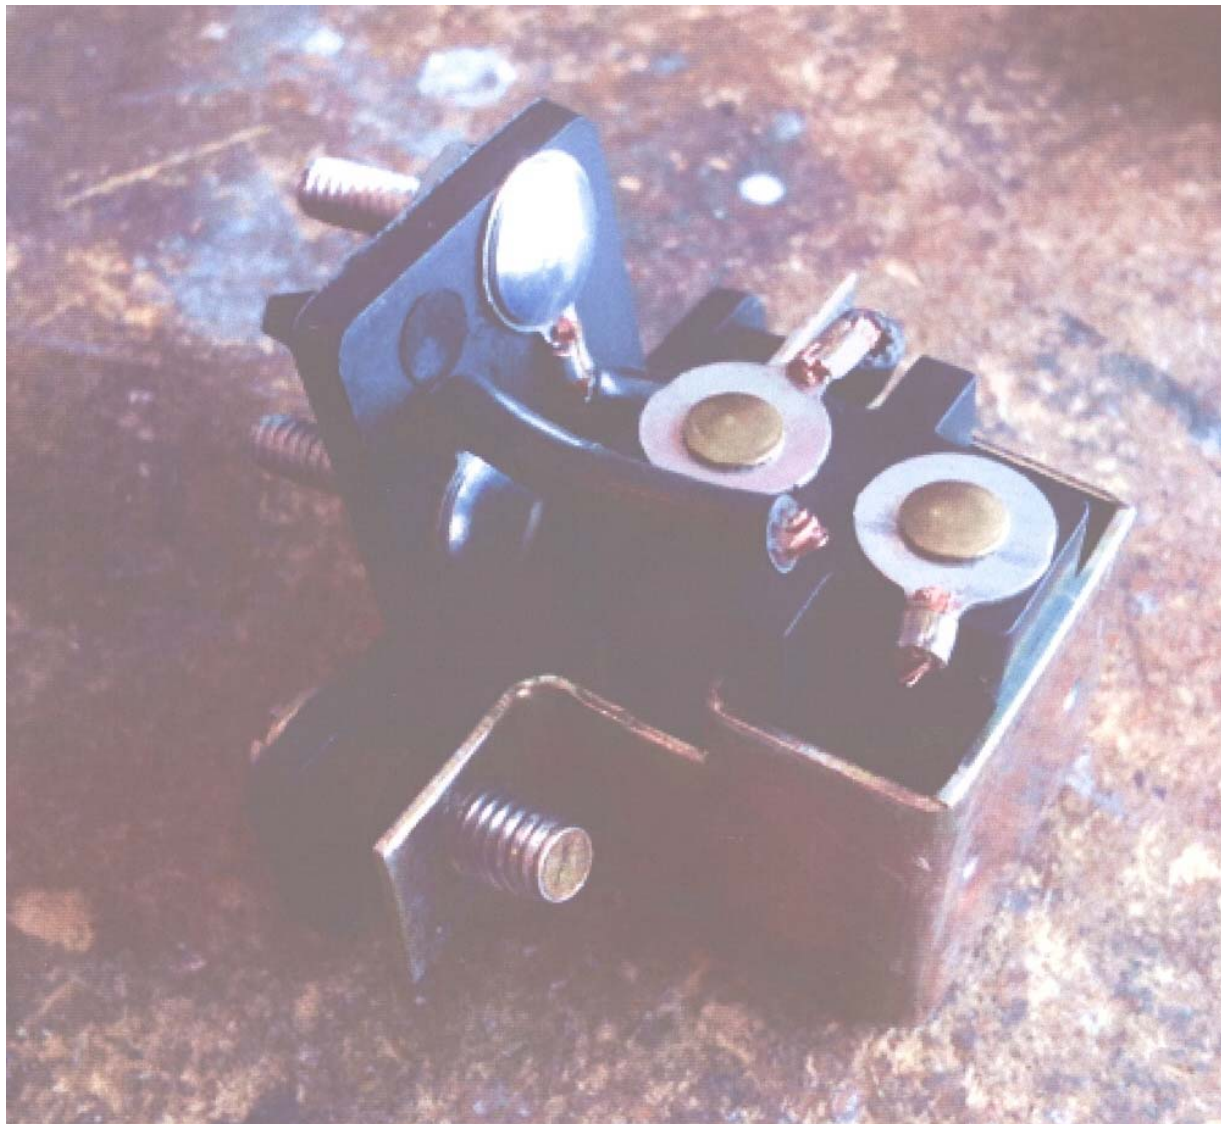
Kelly Alternator: ALU8521; Broken Brush-block Wire; ATA 2421

A repair station technician states, "This alternator failed in flight. (*I*) found the brush-block wire broken."
