## ADVISORY CIRCULAR

43-16A

# AVIATION MAINTENANCE ALERTS

**ALERT  
NUMBER  
404**

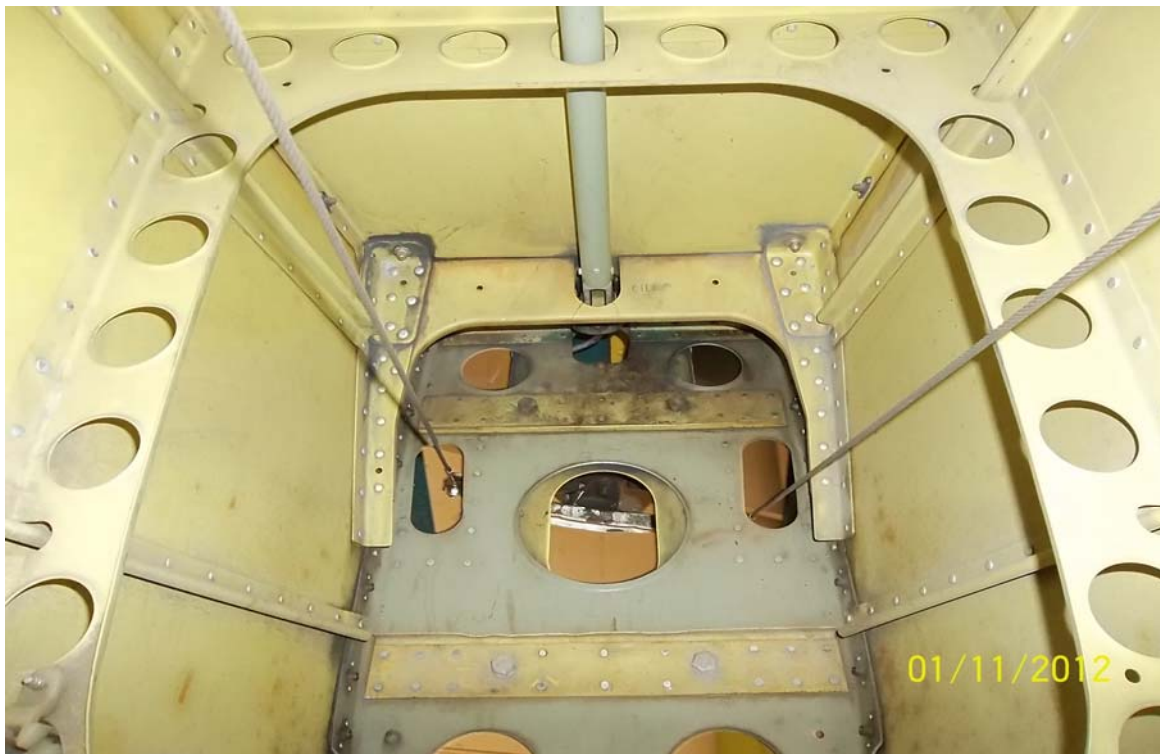
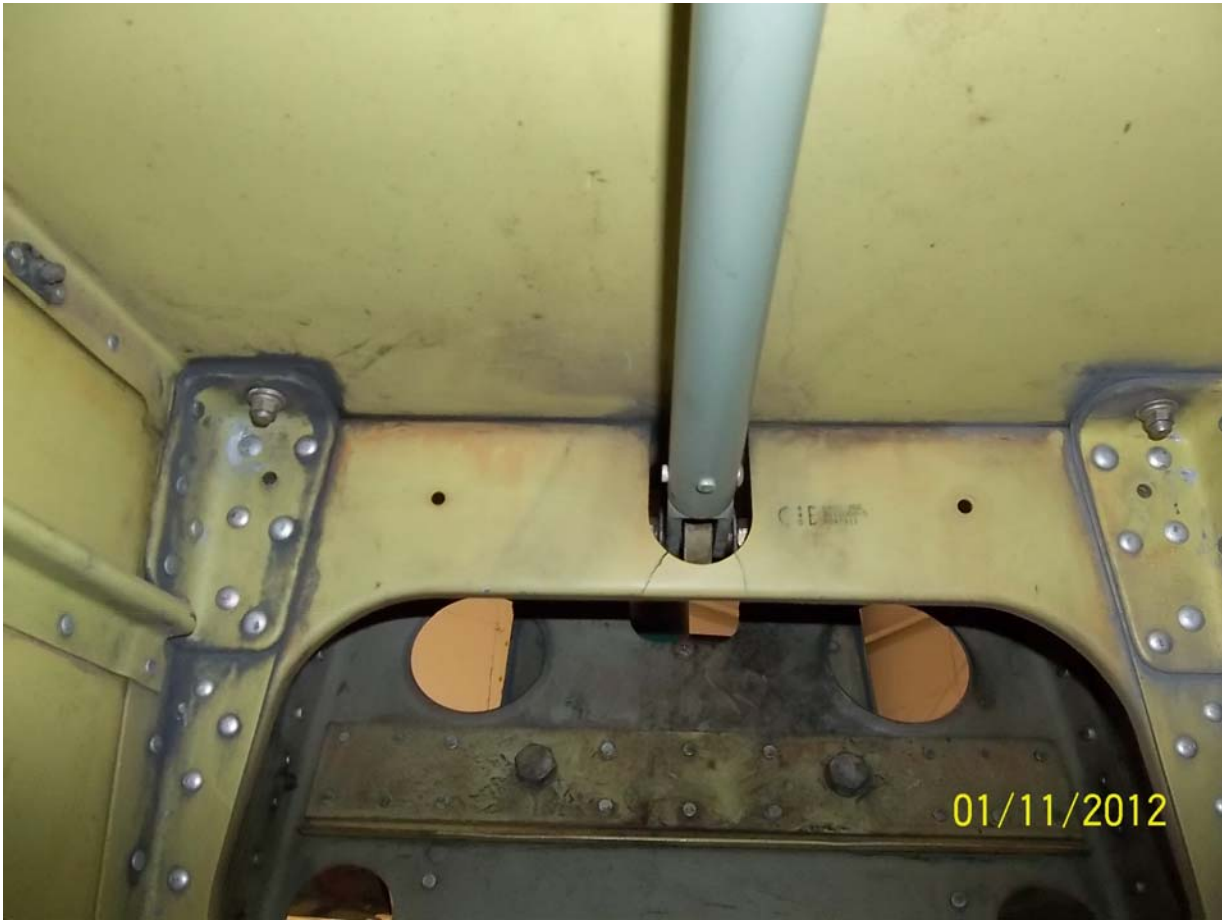
**Cessna: 208B; Cracked Bulkhead; ATA 5312**

This submitter states, "The aft canted bulkhead (P/N 2612060-5) at station 474.40 has two cracks, each approximately 1.5 inches in length. During removal of this part, other damage was found. Both vertical stabilizer webs (P/N's 2631021-15 and 2631022-2) were replaced because of significant fretting, (*so too*) the aft bulkhead assembly (P/N 2612059-1)."

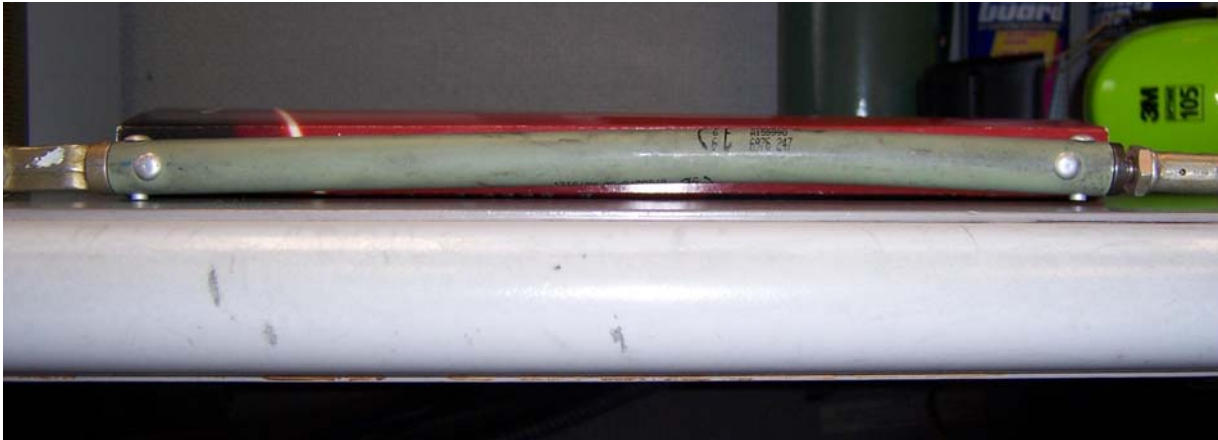
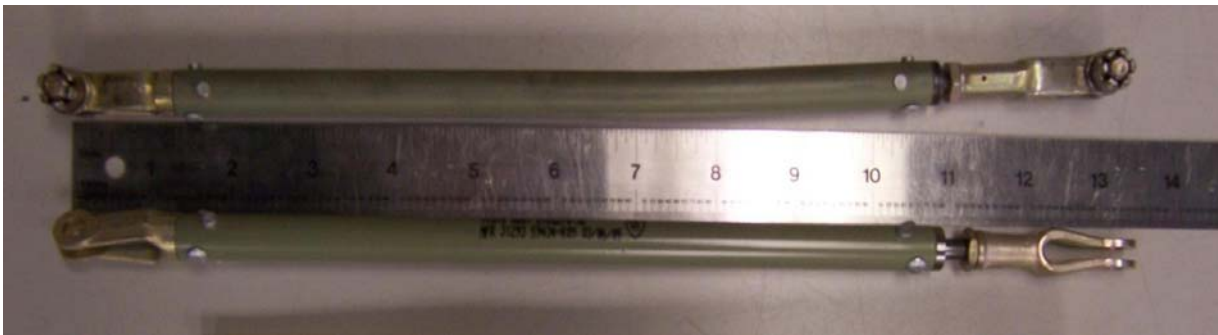
**Cessna: 750; Bent Speed Brake Push Pushrod; ATA 2701**

"When deploying speed brakes, the handle must be continuously held in position or the air load will stow the panels," says a corporate defect report. "A visual inspection revealed the speed brake pushrod to be installed upside down and bent—causing it to rub against the thrust reverser solenoid and preventing full travel of the speed brake handle. It was confirmed with Cessna Engineering that the pushrod should be installed with adjustable end up—and the rod should be straight, not bent. The pushrod was replaced with new (P/N 6760270-36). Operational checks were satisfactory."

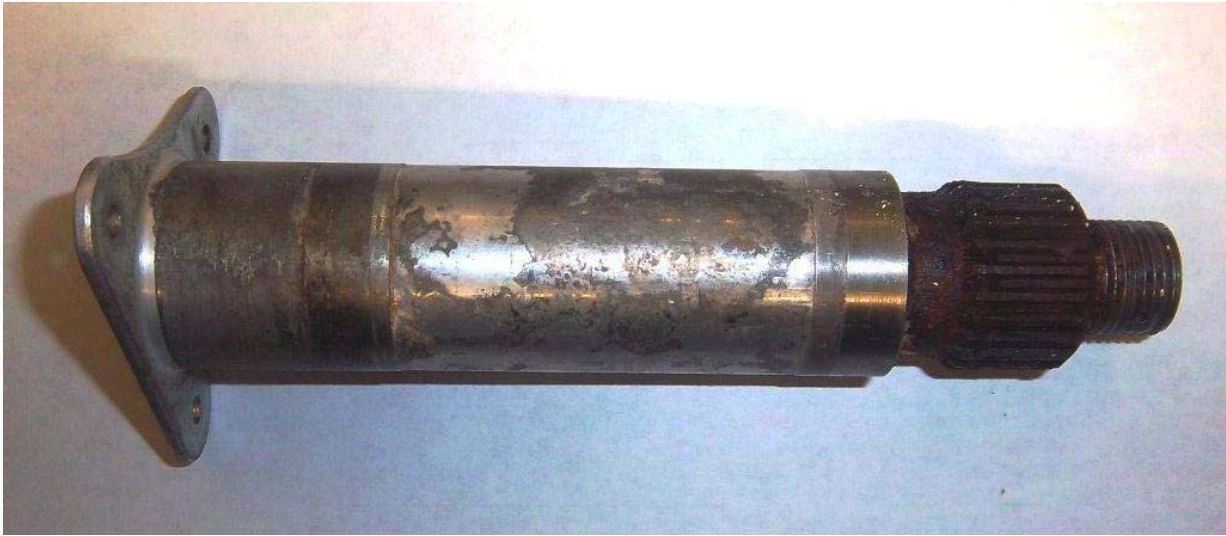
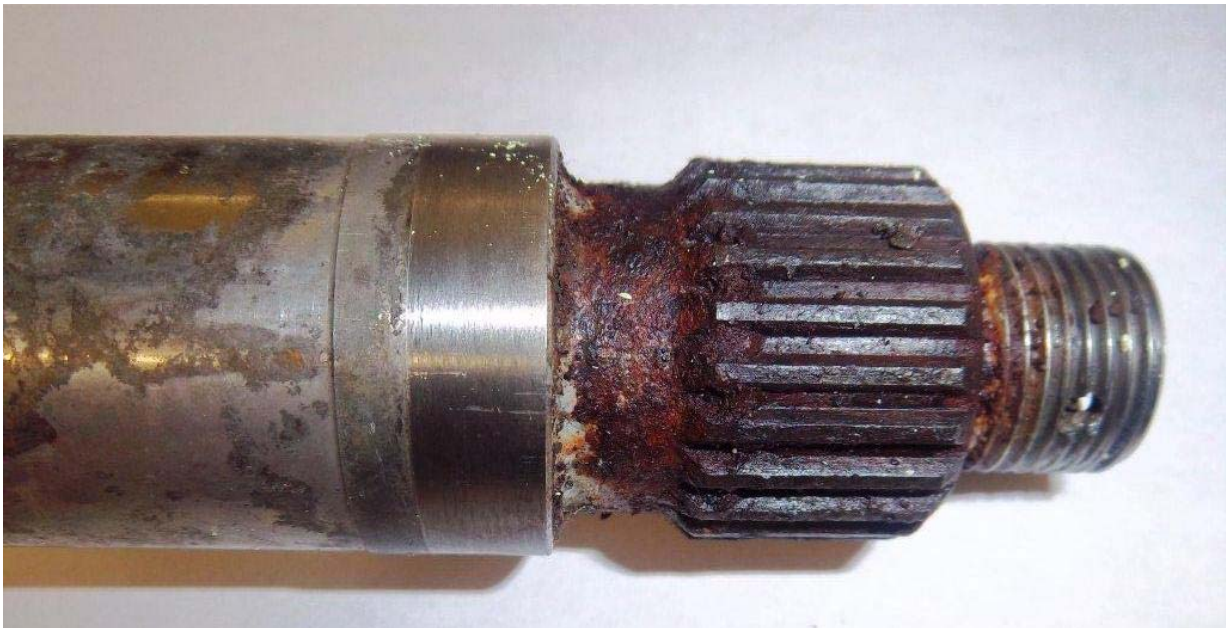
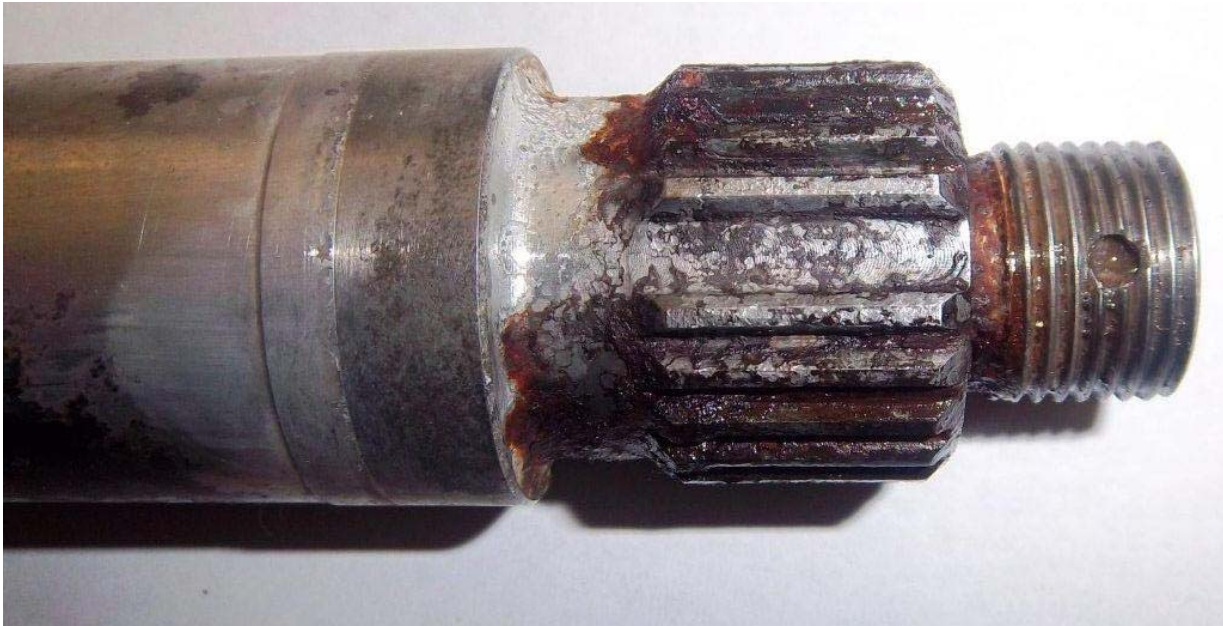
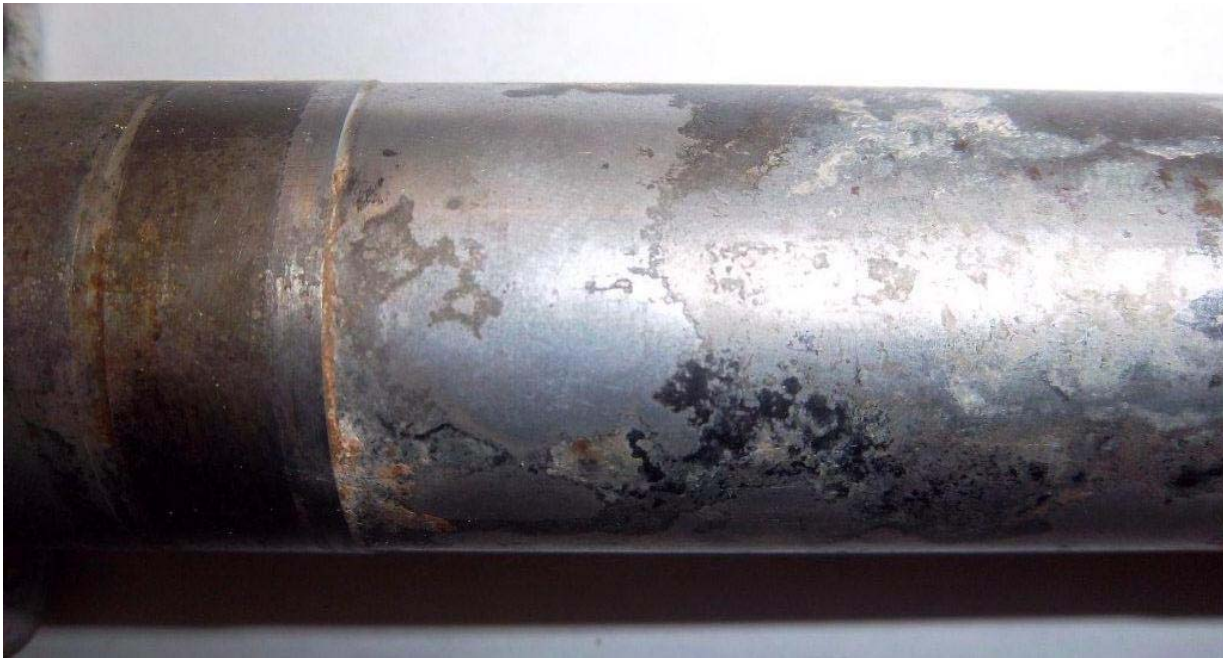
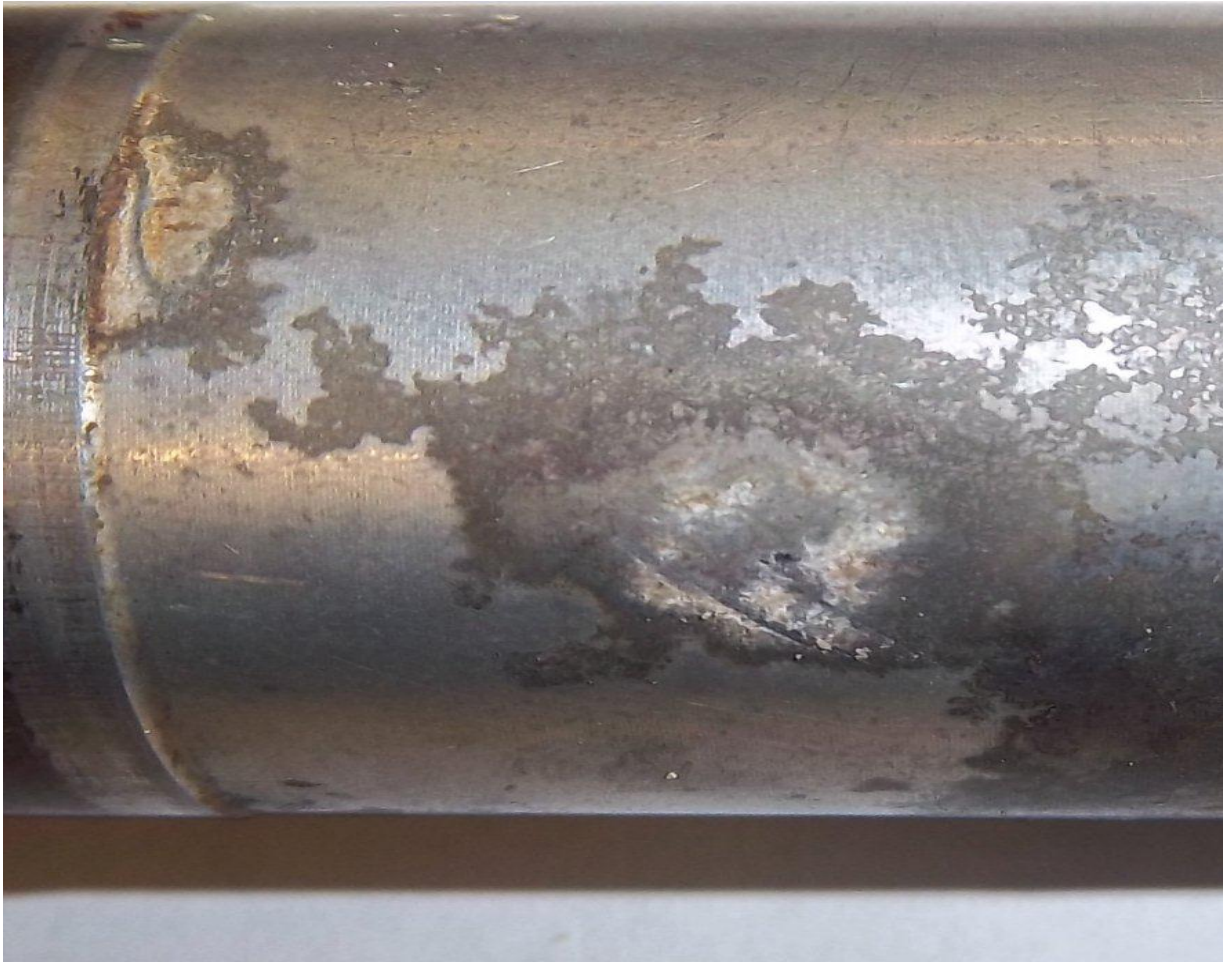
**de Havilland: DHC8103; Corroded Aileron Control Shaft; ATA 2710**

An air carrier operation writes, "Roll control was very stiff. (*We checked*) the tension of the aileron fuselage cables and lubricated the aileron quadrant bearings externally for (*initial*) troubleshooting." "We replaced the L/H and R/H bearings in the aileron quadrant IAW Mod Kit 8MK0930-001 instructions and the AMM 27-12-31. The control cable tensions (and their safeties) were not disturbed. The L/H aileron control shaft (P/N 82740083-101) was replaced due to corrosion."

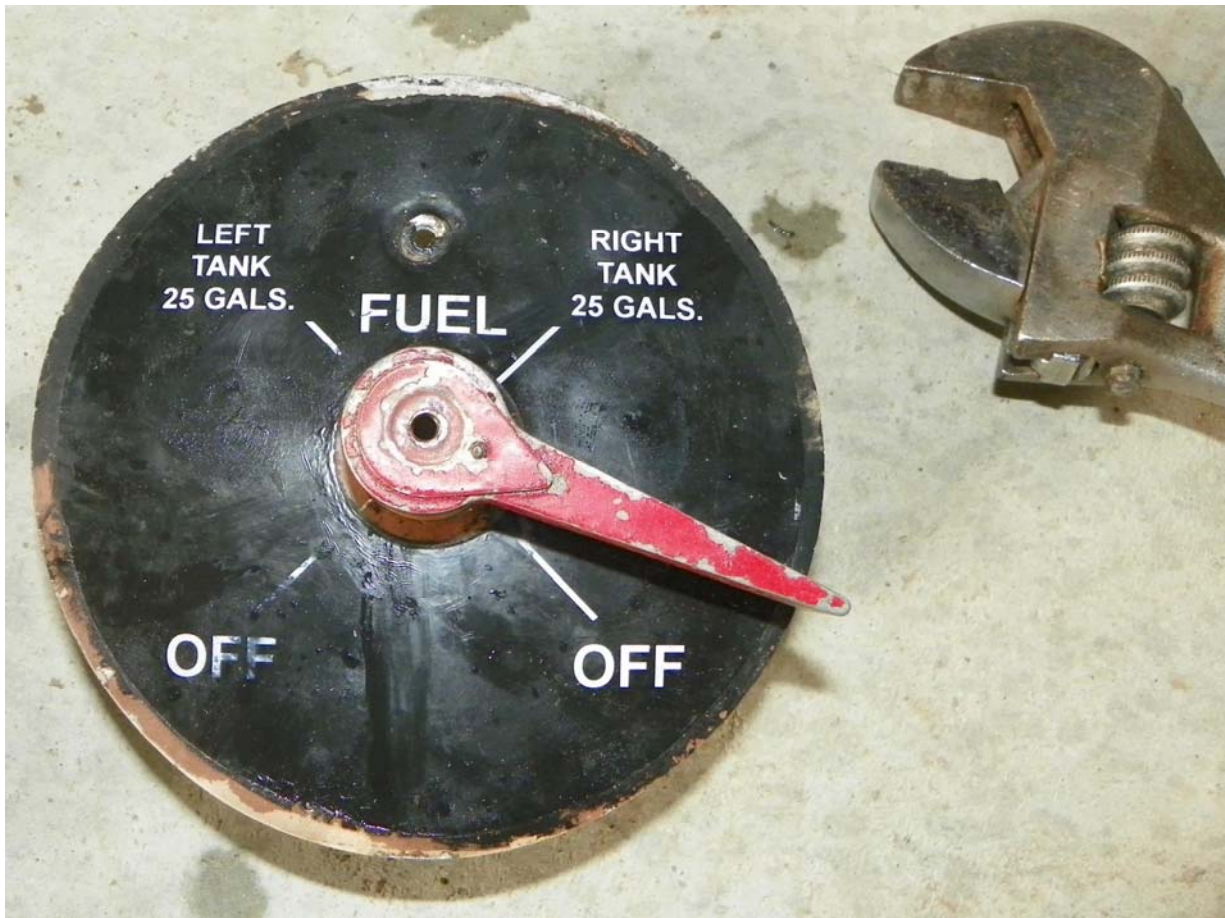
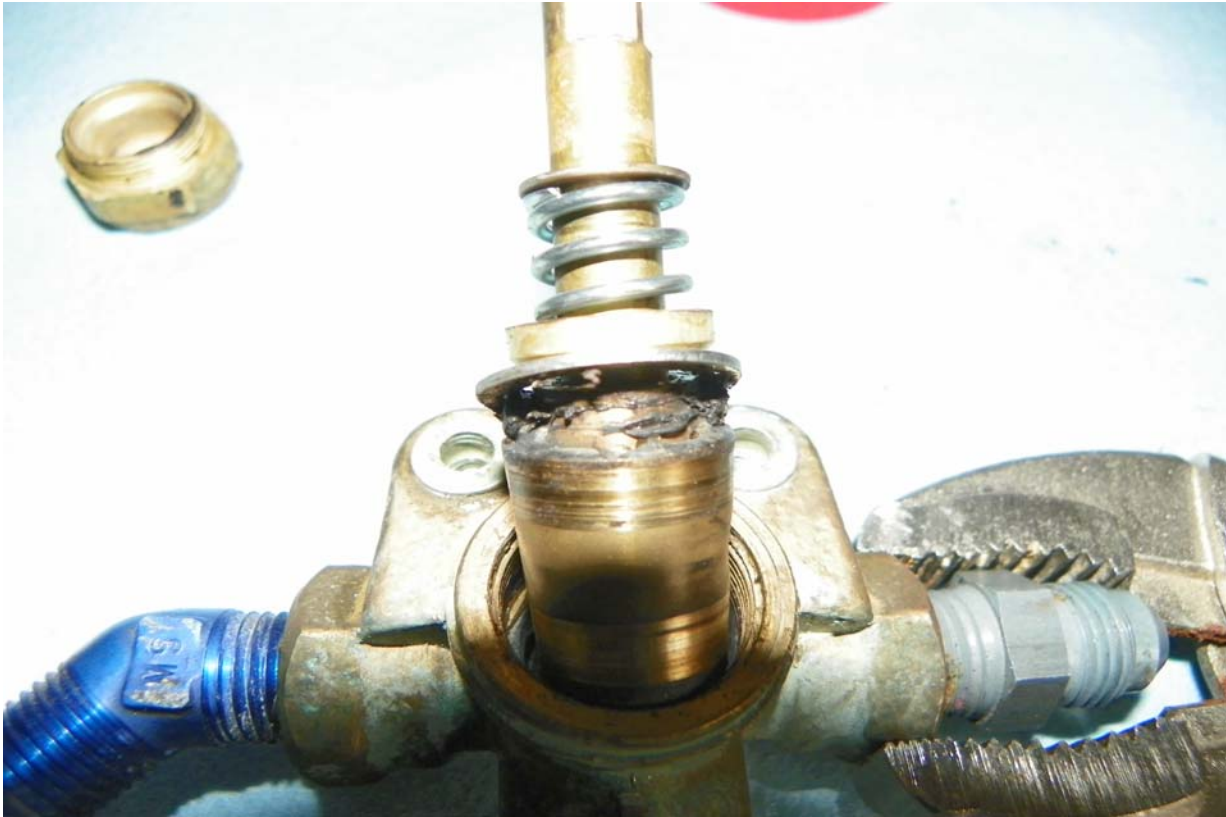
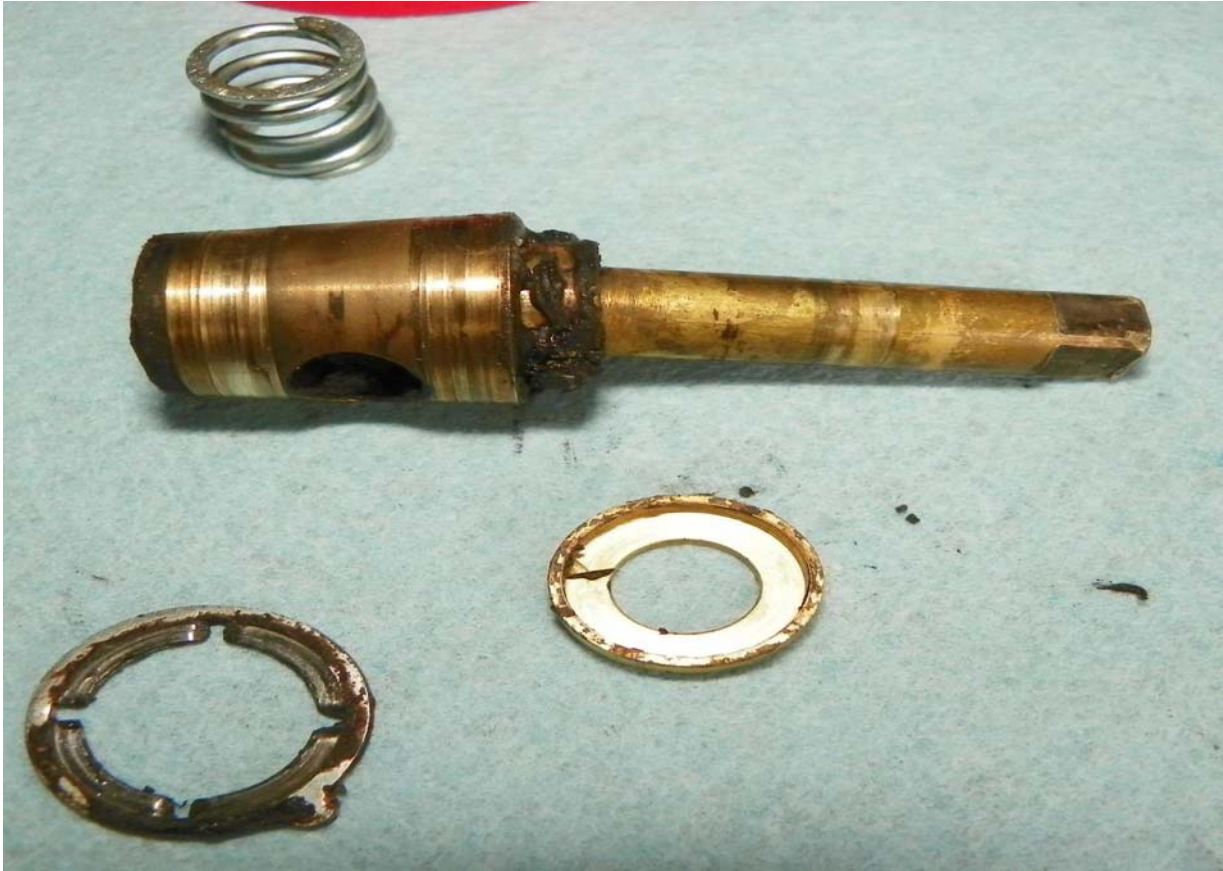
**Piper: PA28-180; Worn Fuel-select Valve; ATA 2823**

A general aviation mechanic writes, "When the fuel tank selector valve (*P/N 756645*) was rotated it was stiff to move, and the detents could not be felt at each position. A teardown showed the valve was very dirty inside, and the detent ring was worn. A review of Airworthiness Directives (AD's) and Service Bulletins (SB's) revealed two bulletins that directly involve problems with this valve. This defect (*worn and dirty*) led to improper fuel selection (*position*), greatly reducing fuel flow and causing stoppage of the engine.

"1. SB 0355: Fuel Selector Valve Lubrication. I was unable to locate a sign-off in the maintenance records of (*compliance*) with this bulletin.

"2. SB 0840: Fuel Selector Valve Cover Replacement. I was unable to locate a sign-off in the maintenance records of (*compliance*) with this bulletin. This bulletin deals directly with preventing the pilot from inadvertently moving the valve to the 'off' position. Piper considers this SB to be mandatory. No AD was found."

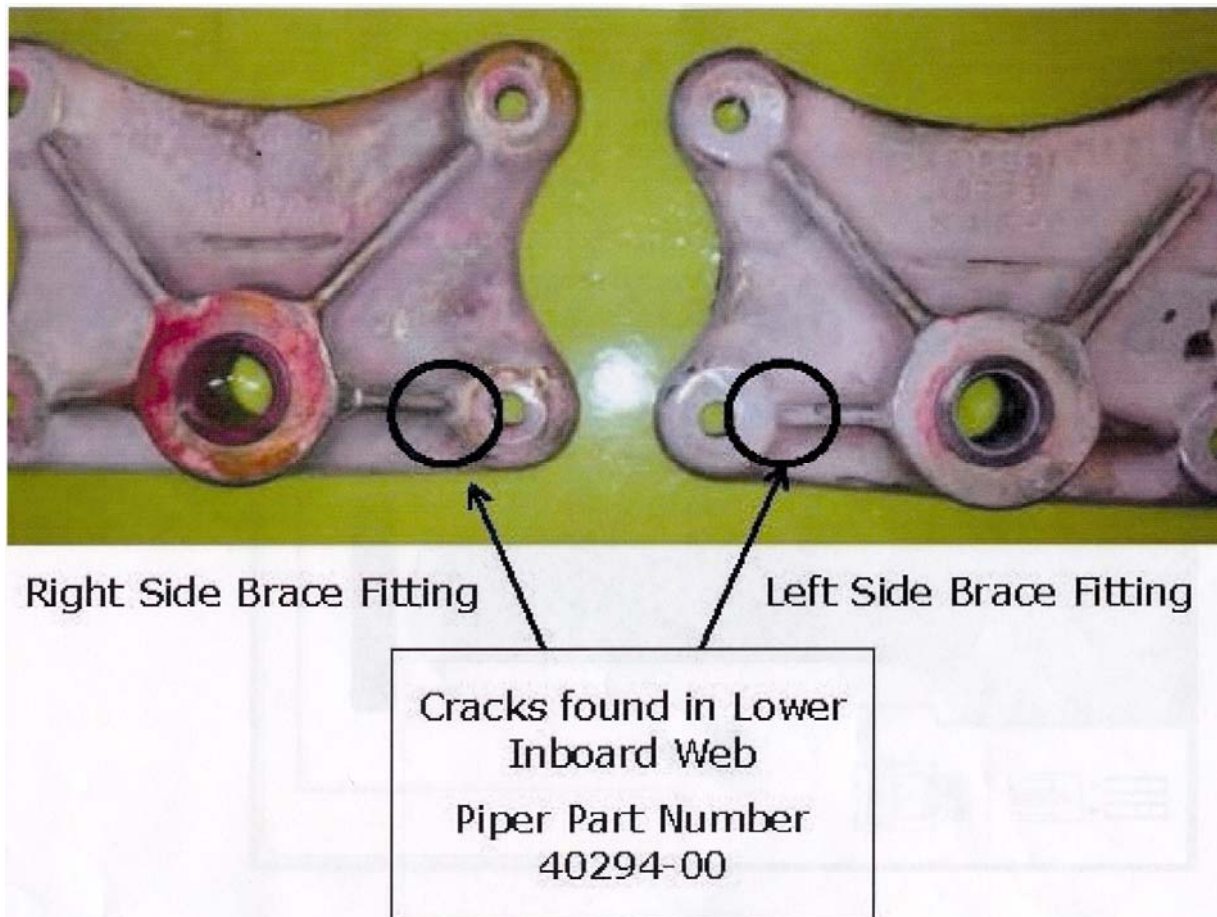
### **Piper: PA31-350; Cracked Main Gear Fittings; ATA 3211**

"(Topic:) Cracks in the Aft Main Gear Side Brace Fitting Assembly (P/N 40294-00). The Aging Aircraft Lab at the National Institute for Aviation Research (NIAR) in Wichita, Kansas recently produced a report titled, 'The Aging Airplane Study: Piper Navajo Chieftain.' Based on their findings, we initiated a dye penetrant inspection program on the forward and aft main gear Side Brace fitting assemblies on our Piper Chieftain Navajo fleet. The inspection of our aircraft revealed several of the aft fitting assemblies on both the left and right landing gear have cracks located in the lower inboard web of the Side Brace (Piper P/N 40294-00). As a result of finding these cracks, we have added a 1,000 hour Special Inspection to our PA31-350 AAIP (*Aging Airplane Inspection Program*) to monitor and replace any assemblies exhibiting the cracking found in the fitting assemblies. It is interesting to note these cracks have only been found in the aft assemblies on our aircraft."

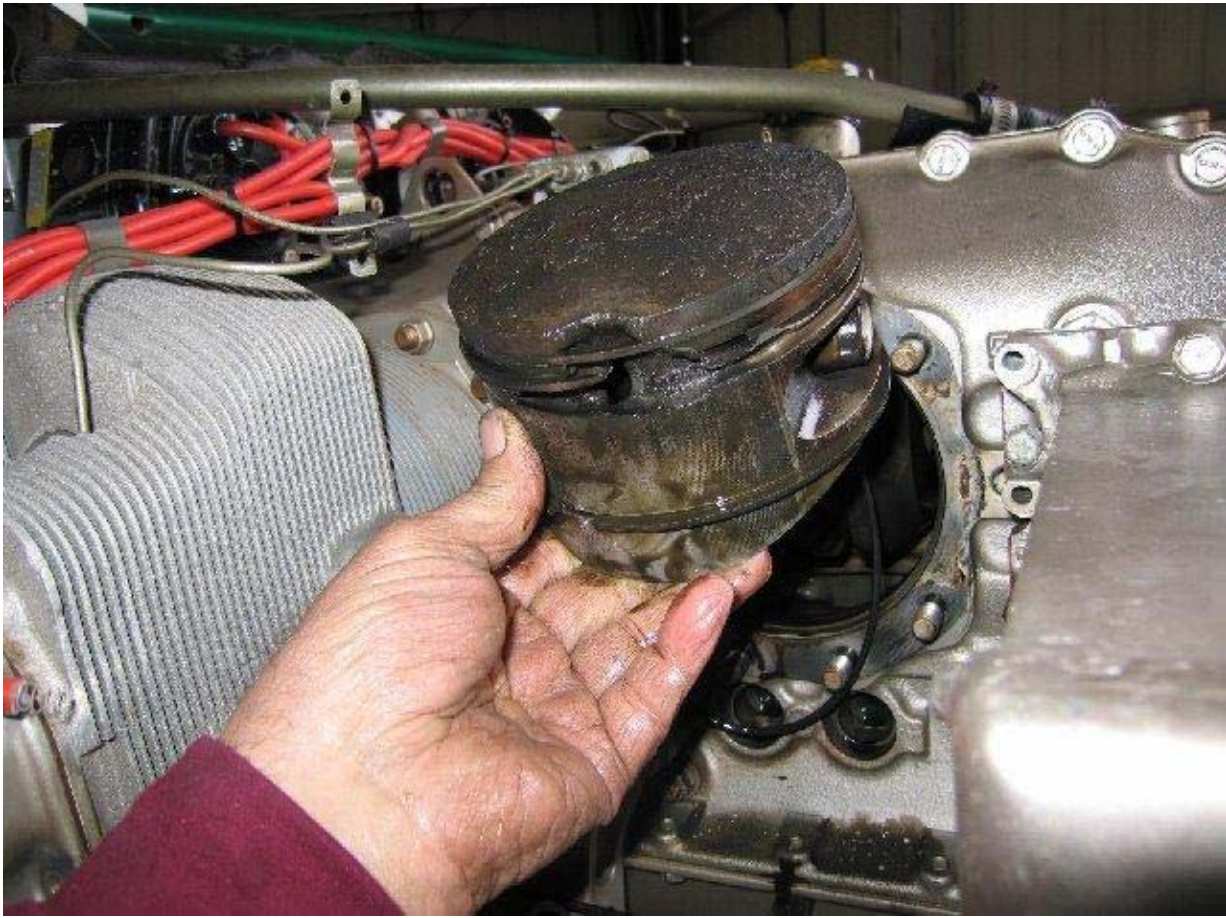
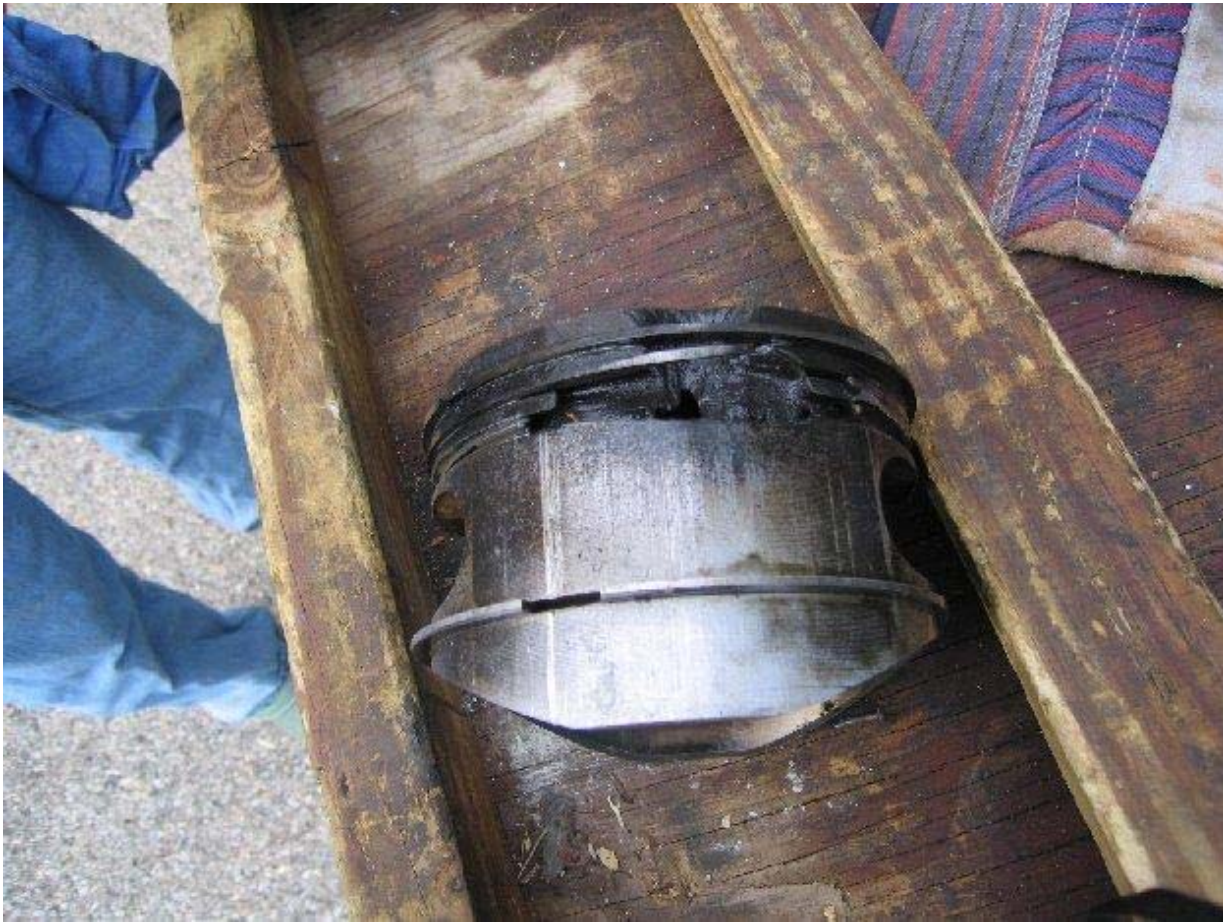
**AEC Piston: AEC646263; Blown Piston; ATA 8530**

An engine mechanic states, "(*After*) approximately 300 hours of (*operation*) the number five cylinder on this Continental O-470R engine experienced piston failure—appearing at first impression to be caused by detonation. However, (*I*) believe this piston (*P/N AEC646263*) to have failed due to a flaw in its manufacture—or (*it may have*) experienced damage (*such as a fall to the floor*) prior to installation in the engine. It is my belief this failure occurred over a period of several hours by combustion gasses slowly eroding the edge of the piston...."

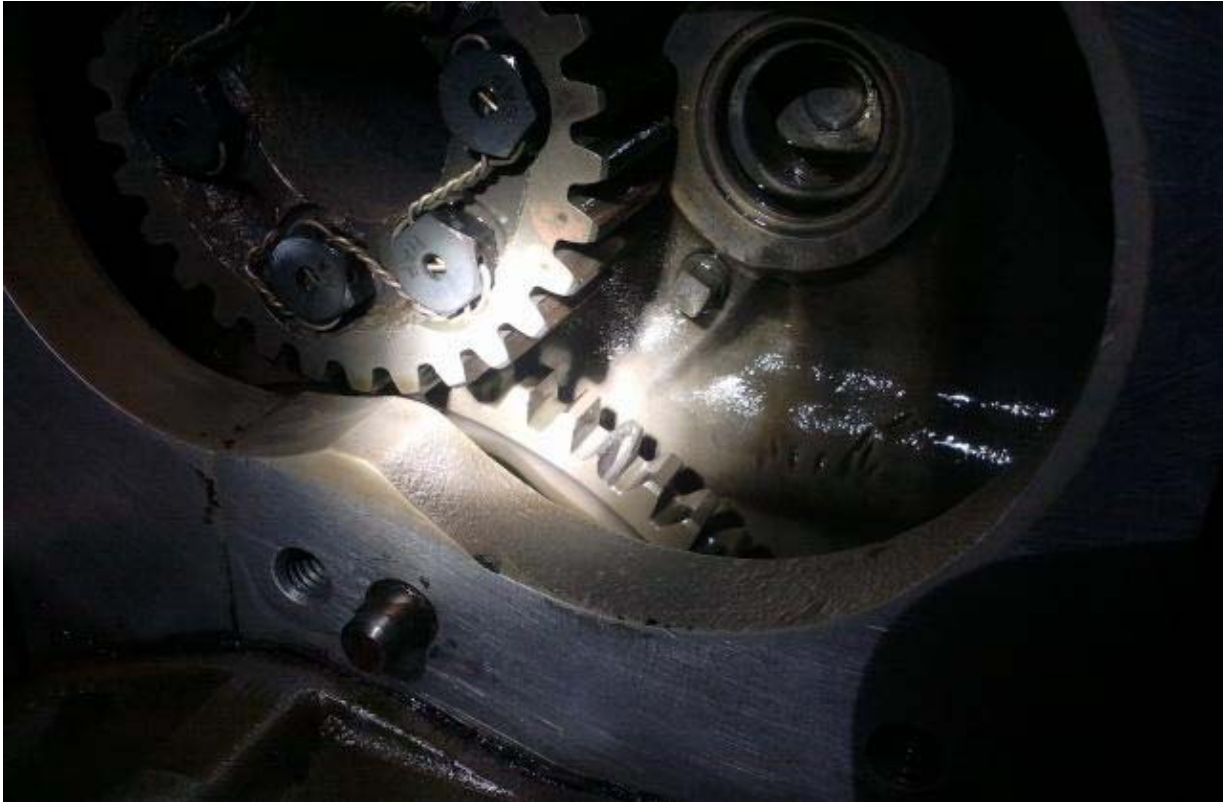
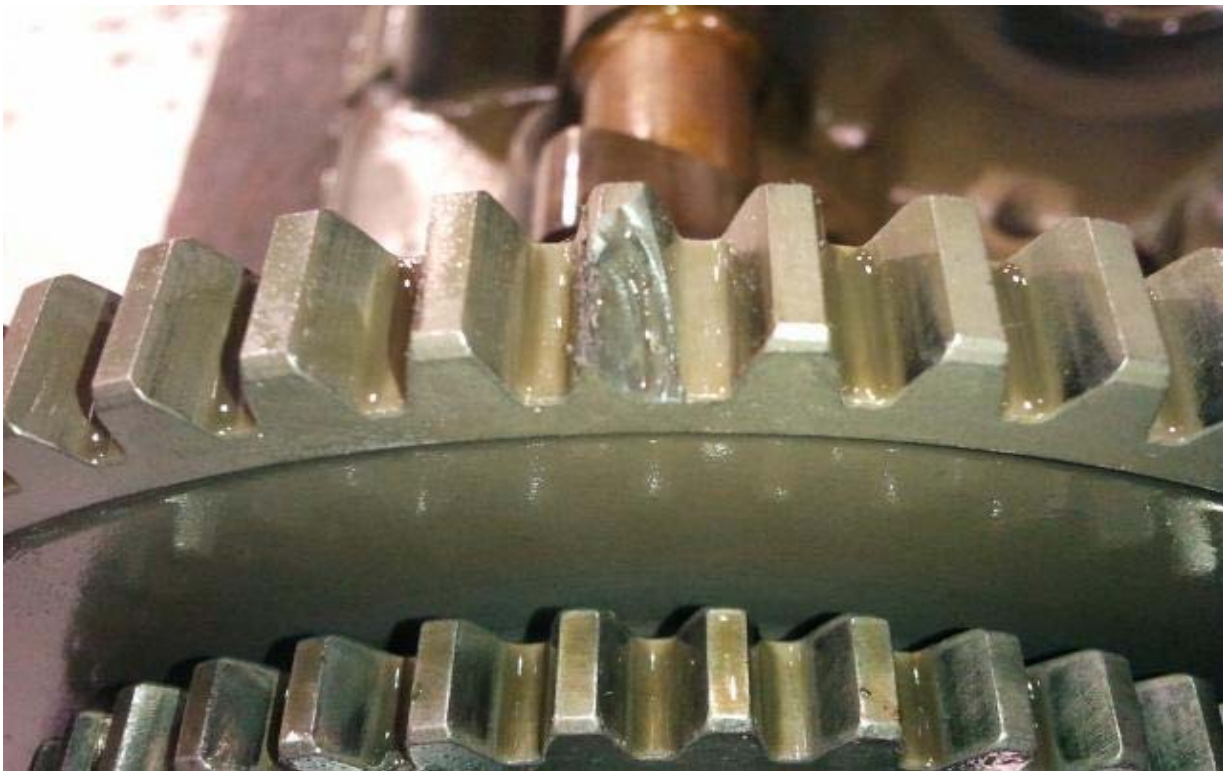
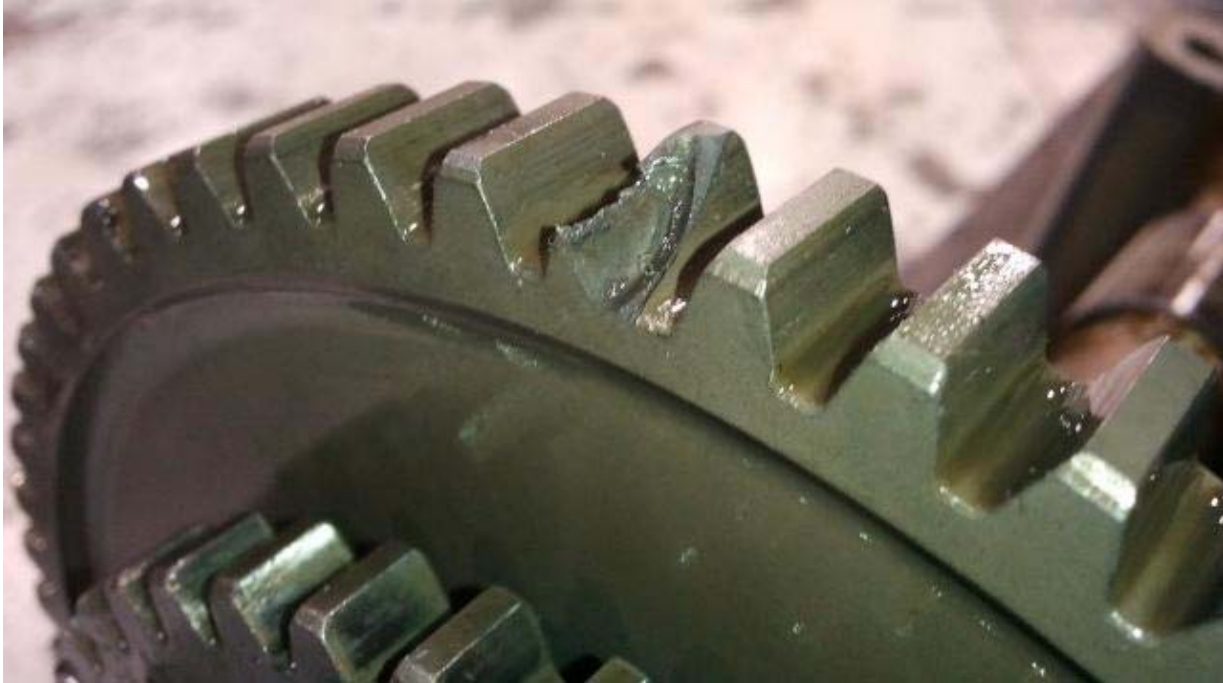
**Continental: GTSIO520L; Broken Camshaft Gear; ATA 8520**

"(I) was complying with AD 07-05-15 and performing an Annual Inspection," states this submitter, "when I found one broken tooth on the camshaft gear. No other indications were found of related defects or damage, internally or externally, after the engine was disassembled. And no metal (or the gear tooth) was found in the oil filter or internal to the engine. (Note:) The camshaft gear P/N 656914 supersedes P/N 537432."

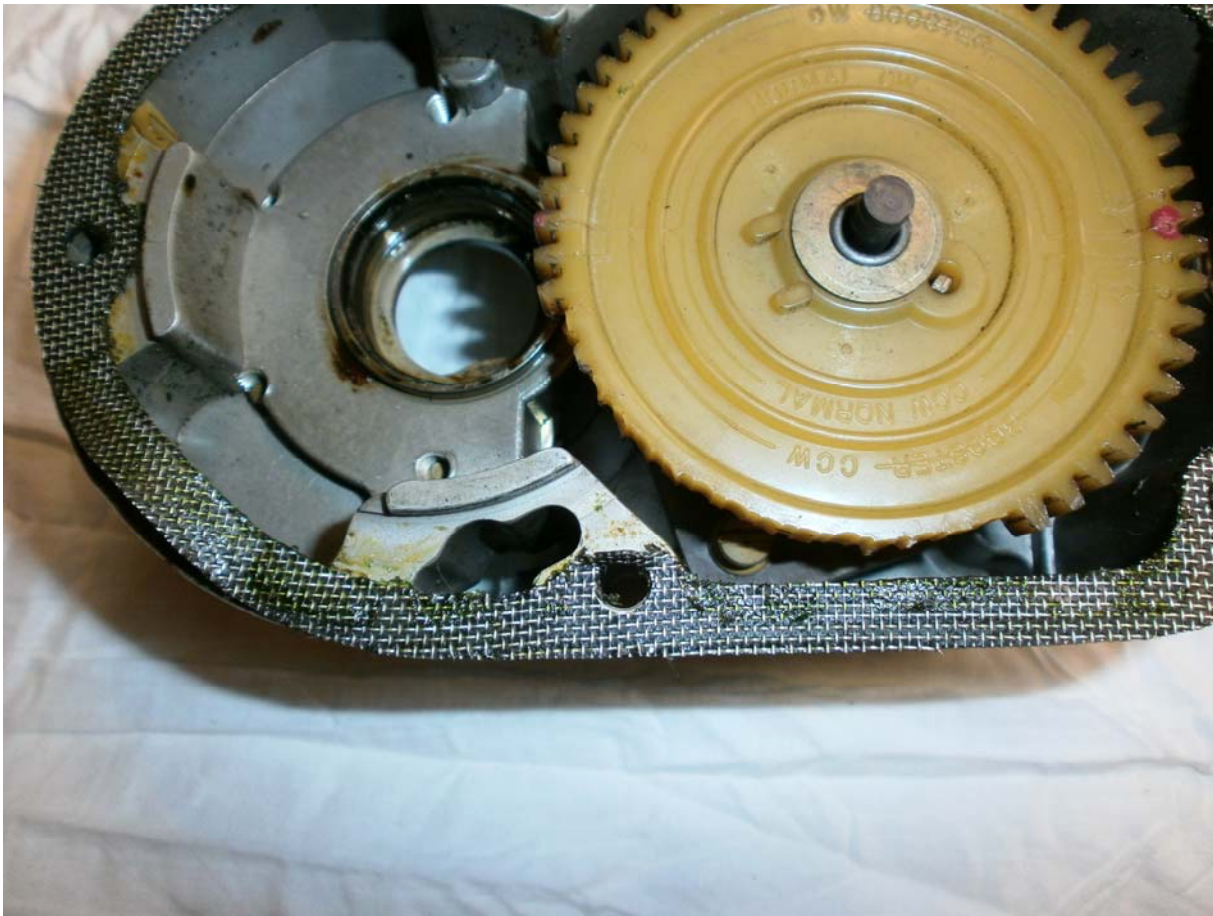
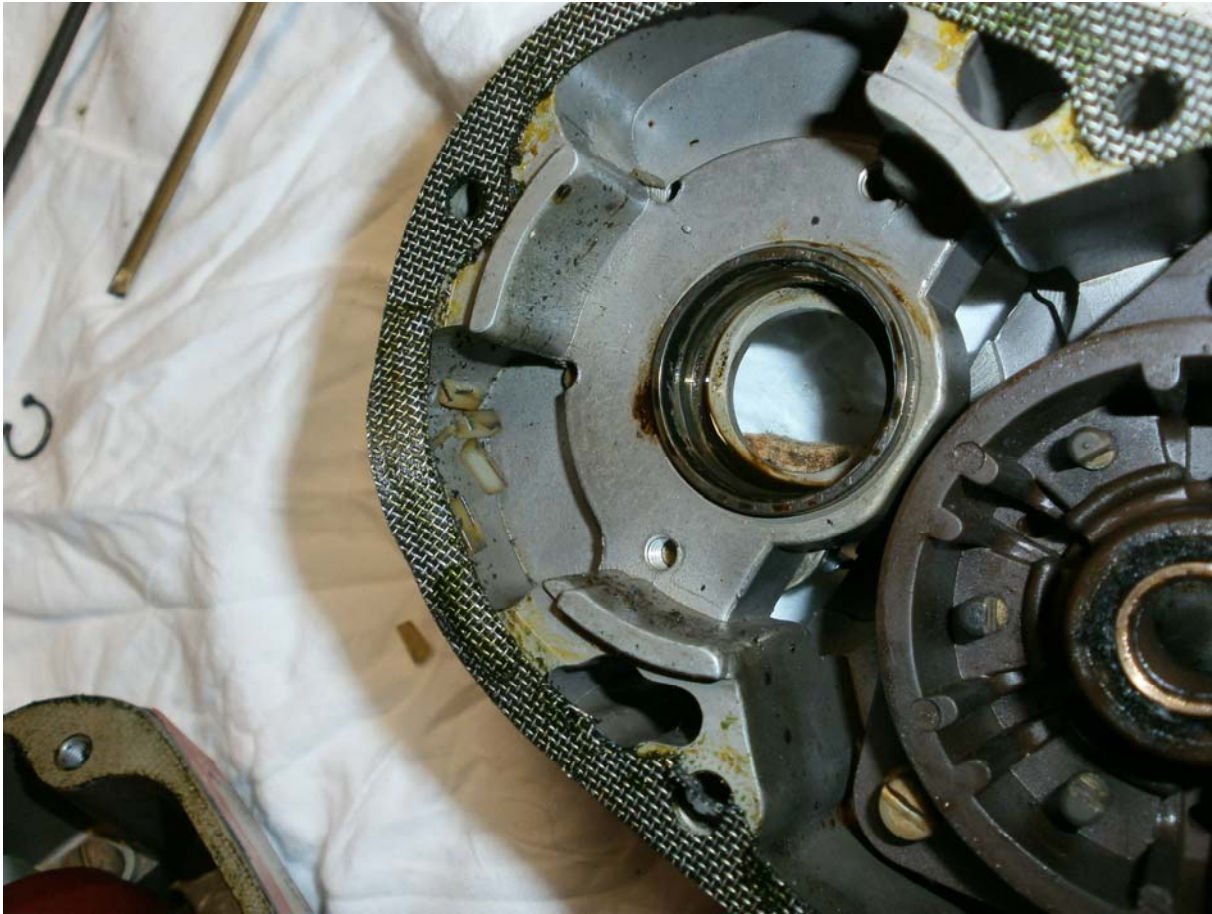
### **Continental Magneto: S6RSC-25P; Failed Distributor Gear; ATA 7414**

A mechanic writes, "The crew reported severe engine vibration and raised EGT (*exhaust gas temperature*) at the same time in cylinder number three. A quick inspection on the ground revealed the R/H magneto to be inoperative. The operator decided to replace the magneto (P/N 10-500556-101) with a brand new one. After replacement was accomplished, further investigations followed: cylinder differential compression check; spark plug check. During this additional (*inspection*) we also found the ceramic on the upper spark plug of number three cylinder to be broken. It was replaced, and a test flight conducted. We climbed to 18,000 feet—everything reported normal.

"During disassembly of the magneto, the distributor gear (*was found to have failed*). This (*defect*) might have caused an engine in-flight shut down that could lead to a loss of control. This magneto was replaced...."

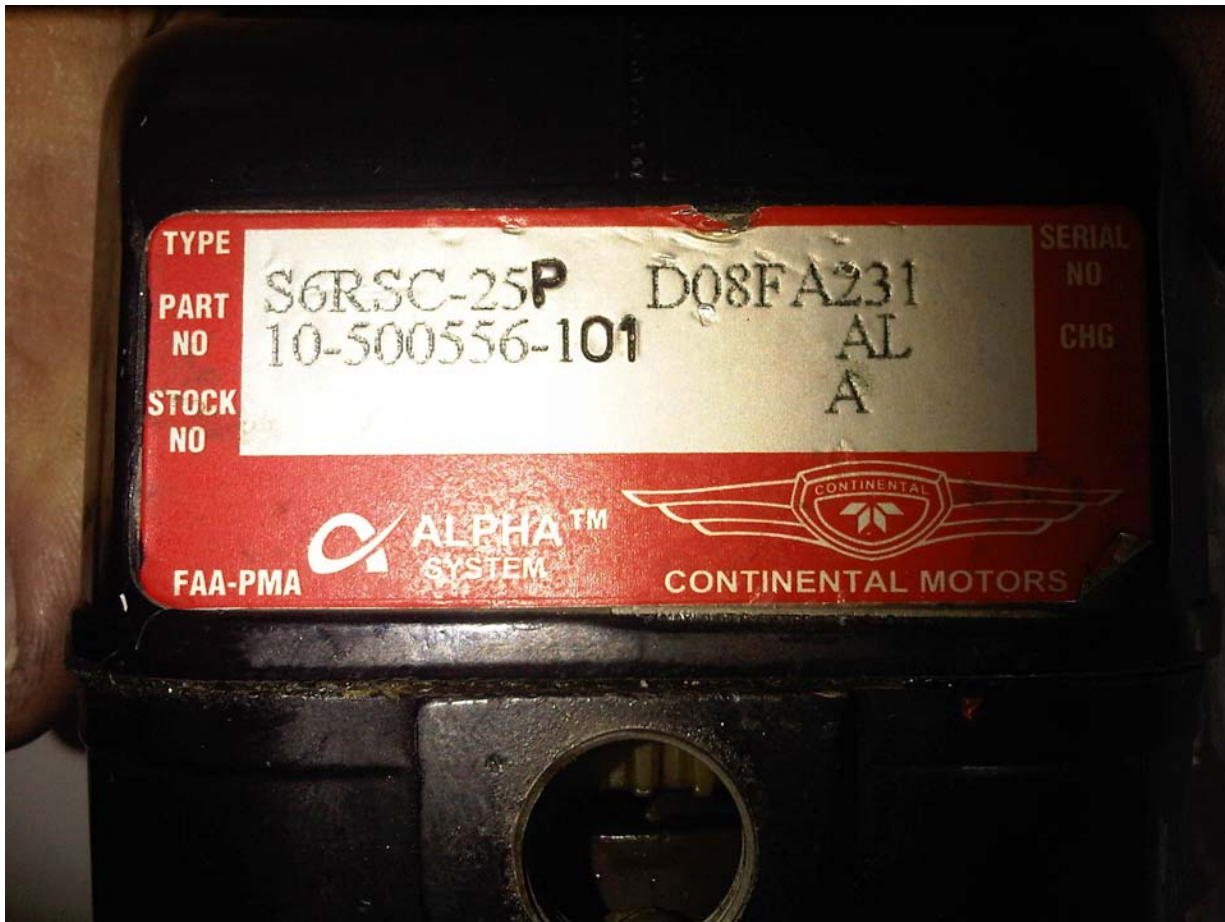
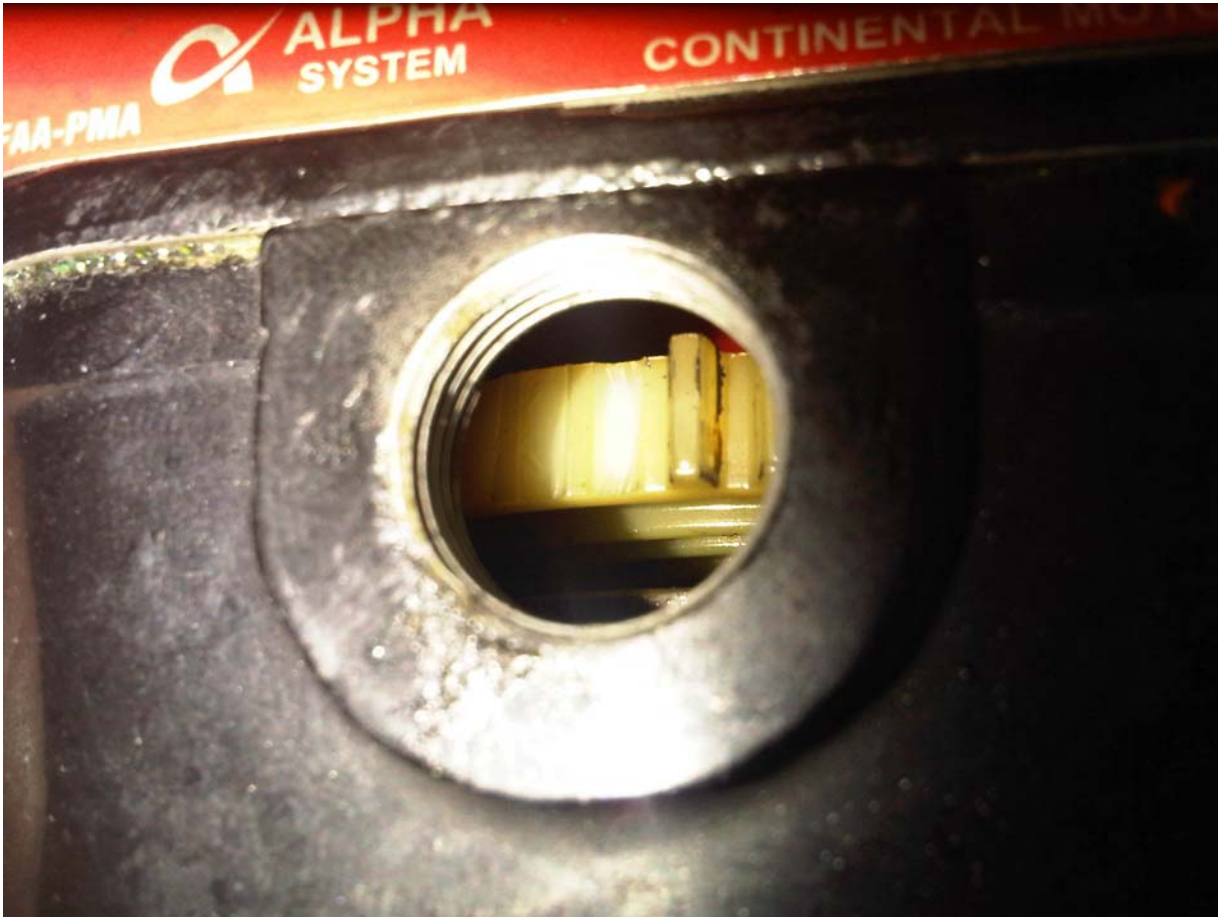
**Continental Magneto: S6RSC-25P; Failed Distributor Gear; ATA 7414**

Again our mechanic says, " The crew reported severe engine vibration during takeoff. Quick inspection on the ground revealed the L/H magneto was inoperative. *(As before...)* the operator decided to replace the magneto with a brand new one. Disassembly of the magneto *(P/N 10-500556-101)* found the distributor gear to have failed."

"We *(note)* the magneto overhaul manual does not include mandatory replacement of the distributor gear. We would highly recommend this *(suggestion)* to the manufacturer...."
