**Federal Aviation  
Administration**

## ADVISORY CIRCULAR

# AVIATION MAINTENANCE ALERTS

**ALERT  
NUMBER  
408**

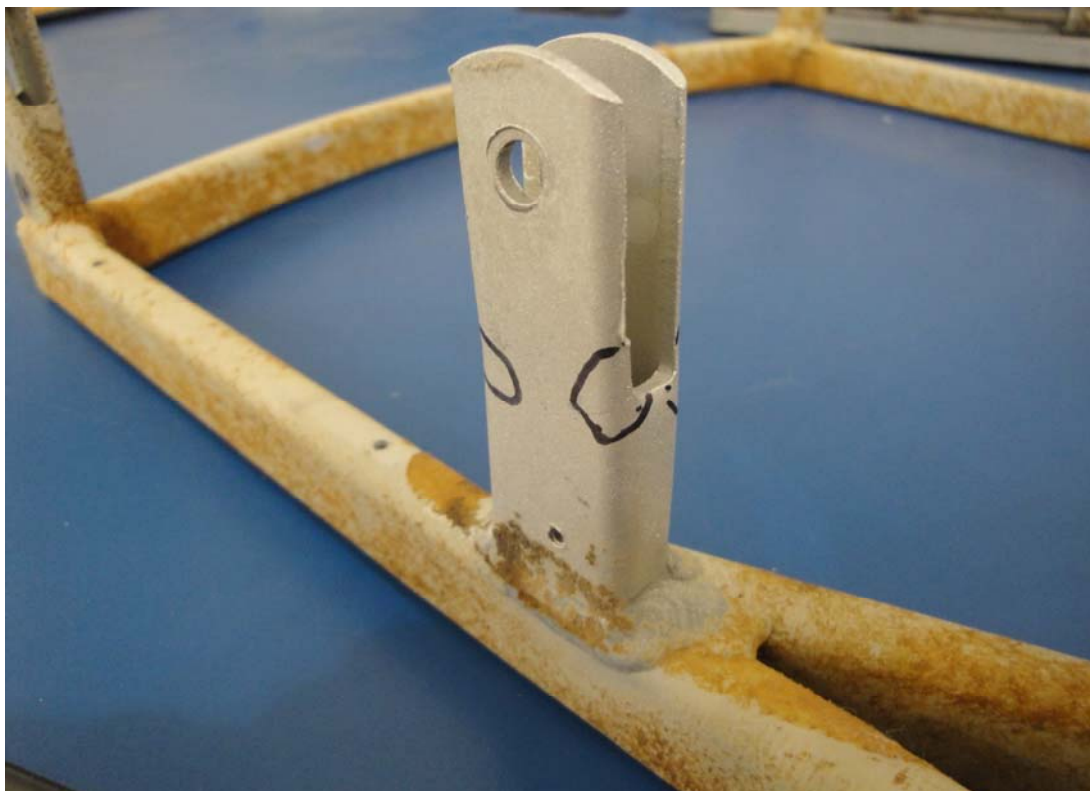
**Cessna: 172P; Cracked Seat Frame; ATA 2510**

A general aviation submitter writes, "The pilot's lower seat frame support legs cracked at the frame rail cut outs (where they attach to the seat height adjustment arms)." (*Seat frame P/N: 05142047.*)

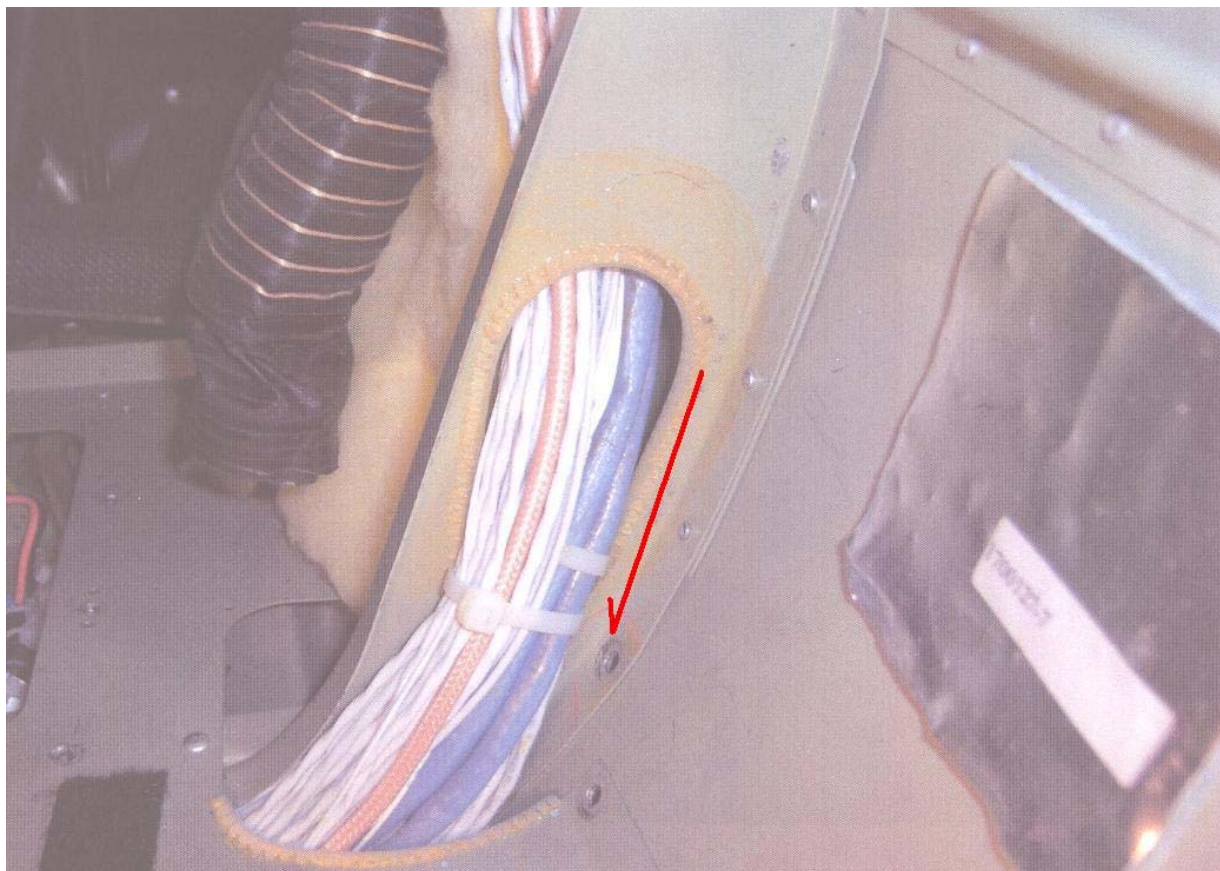
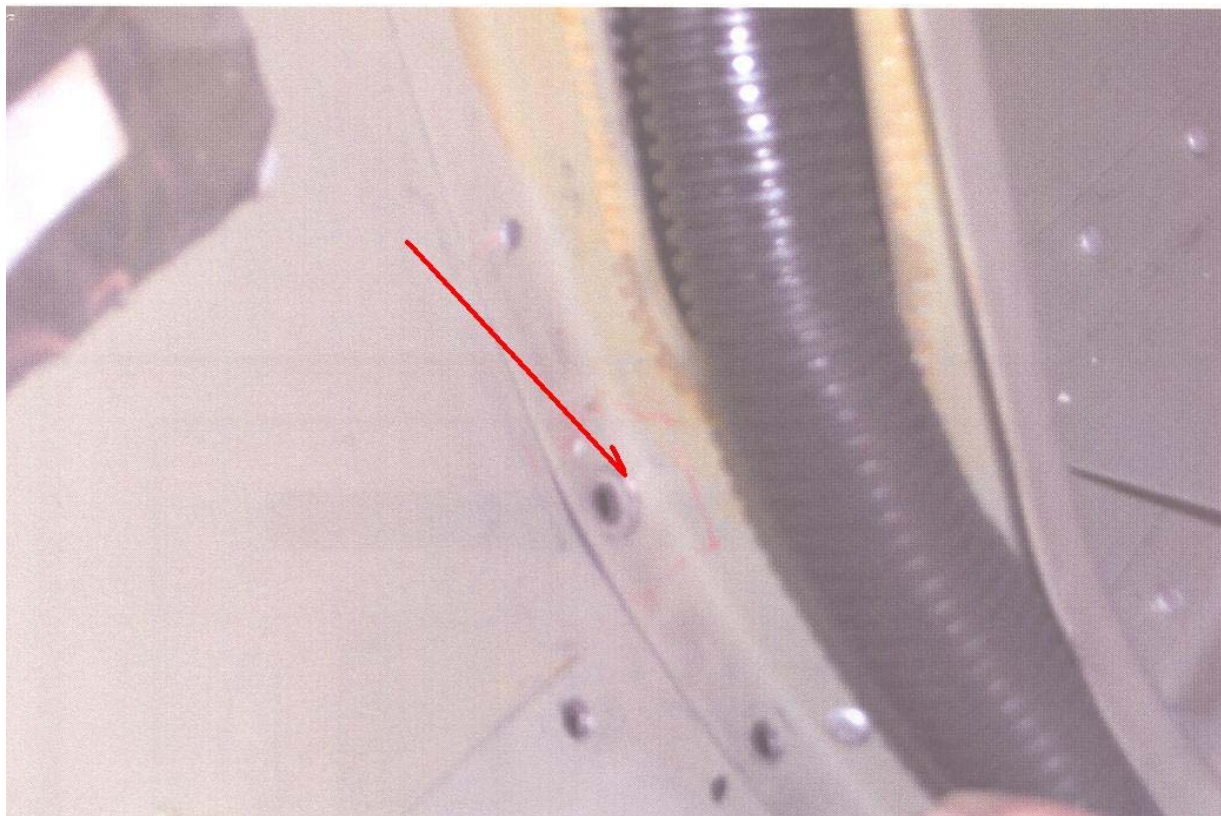
**Cessna: 182T; Cracked Fuselage Bulkhead Flanges; ATA 5312**

"Cracks were found in the flange of both the L/H and R/H fuselage bulkheads at station 17," says a repair station technician. "(These) cracks are radiating from the upper bolt hole where the fueling step attaches. The bolt hole(s) is too close to the bend radius of the bulkhead, causing distress when the bolt is tightened. This is the second instance (we have) found in 'Restart' aircraft (post 1996)." (Bulkhead P/N: 0713787110713787. Indicating arrows have been added—Ed.)

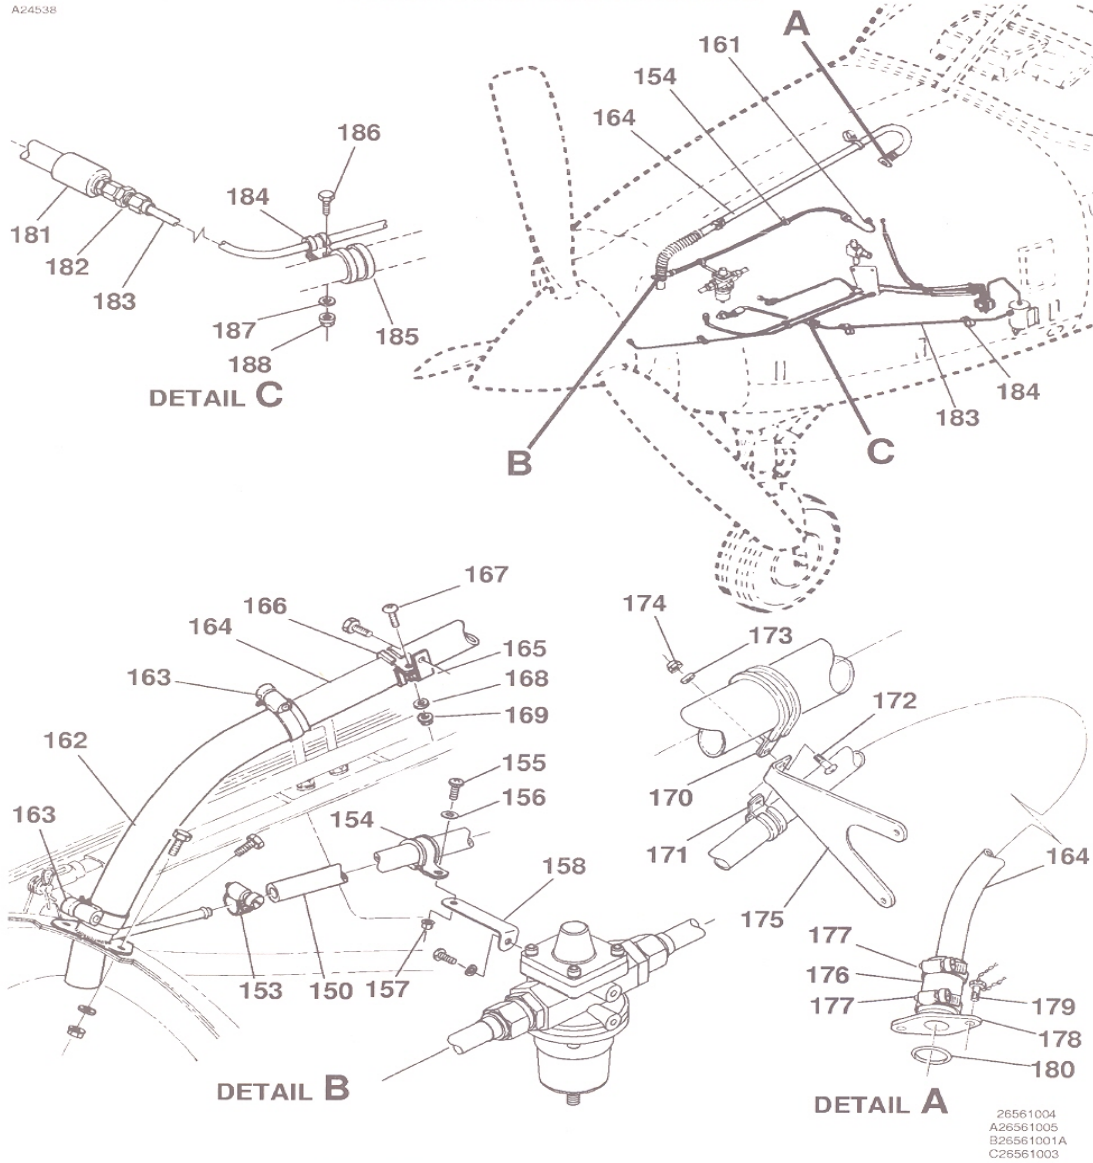
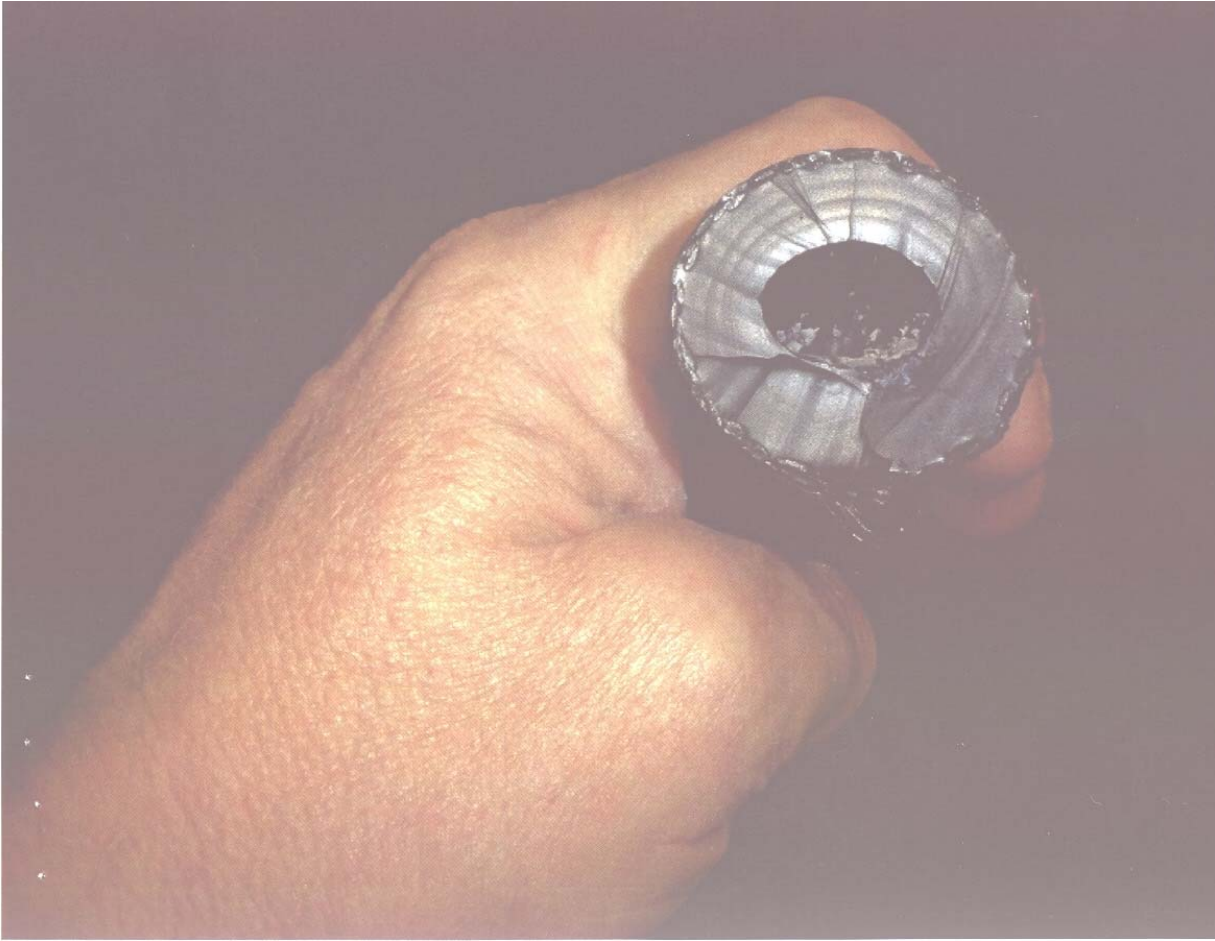
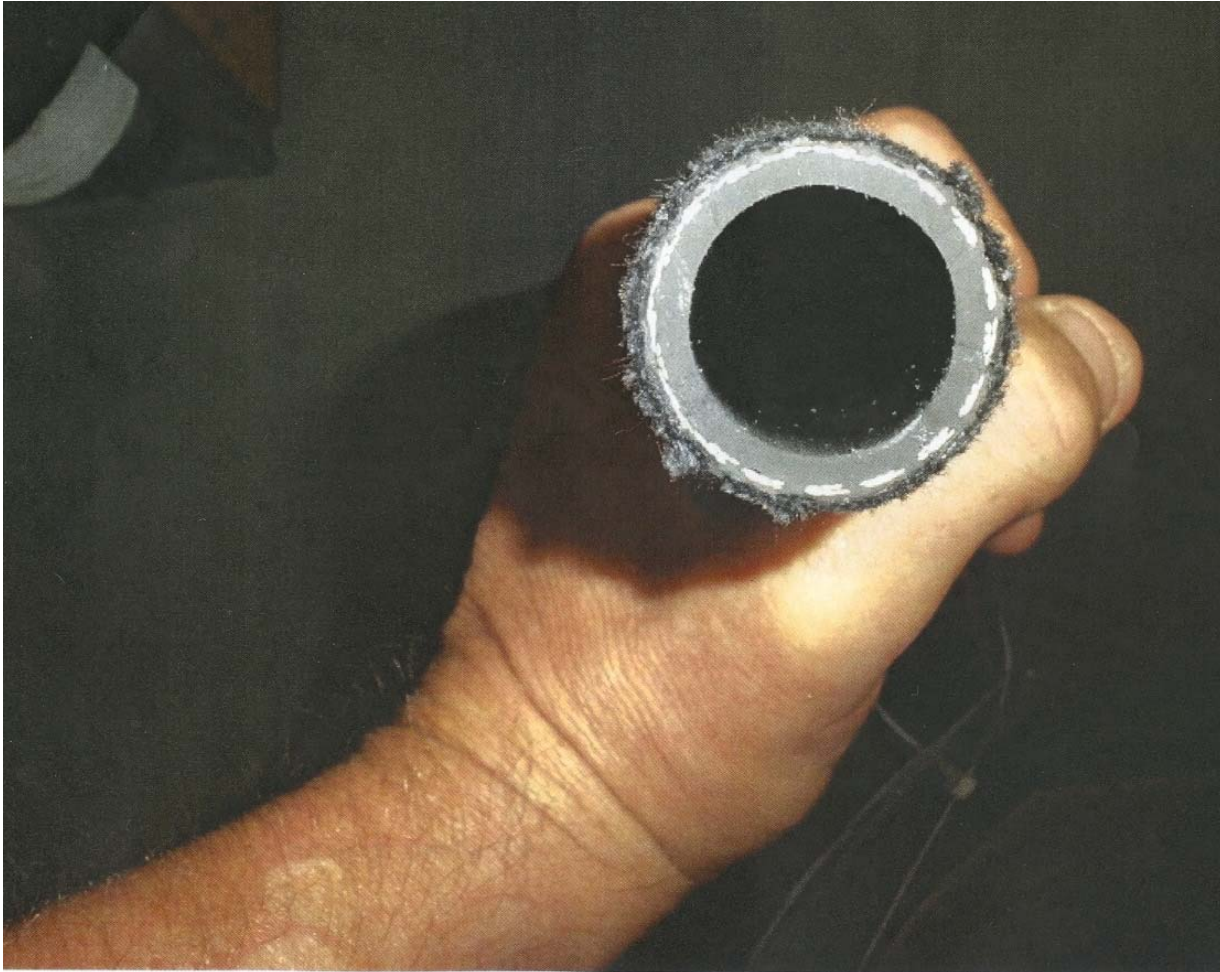
"The pilot reported an unusual amount of oil was being consumed," says a repair station mechanic. "And (*during*) his inbound flight (*he said*) the oil pressure gauge was fluctuating. There were no visible signs of an external oil leak. (*While performing*) a ground run maintenance noted the torque (*indication*) was (*also*) fluctuating. And when bleed air was turned on, a fine mist of oil was emitted from the heater vents. Subsequent troubleshooting found the engine vent line had collapsed, internally pressurizing the case and causing the oil to leak internally into the compressor."

(Hose P/N: S51-14.)

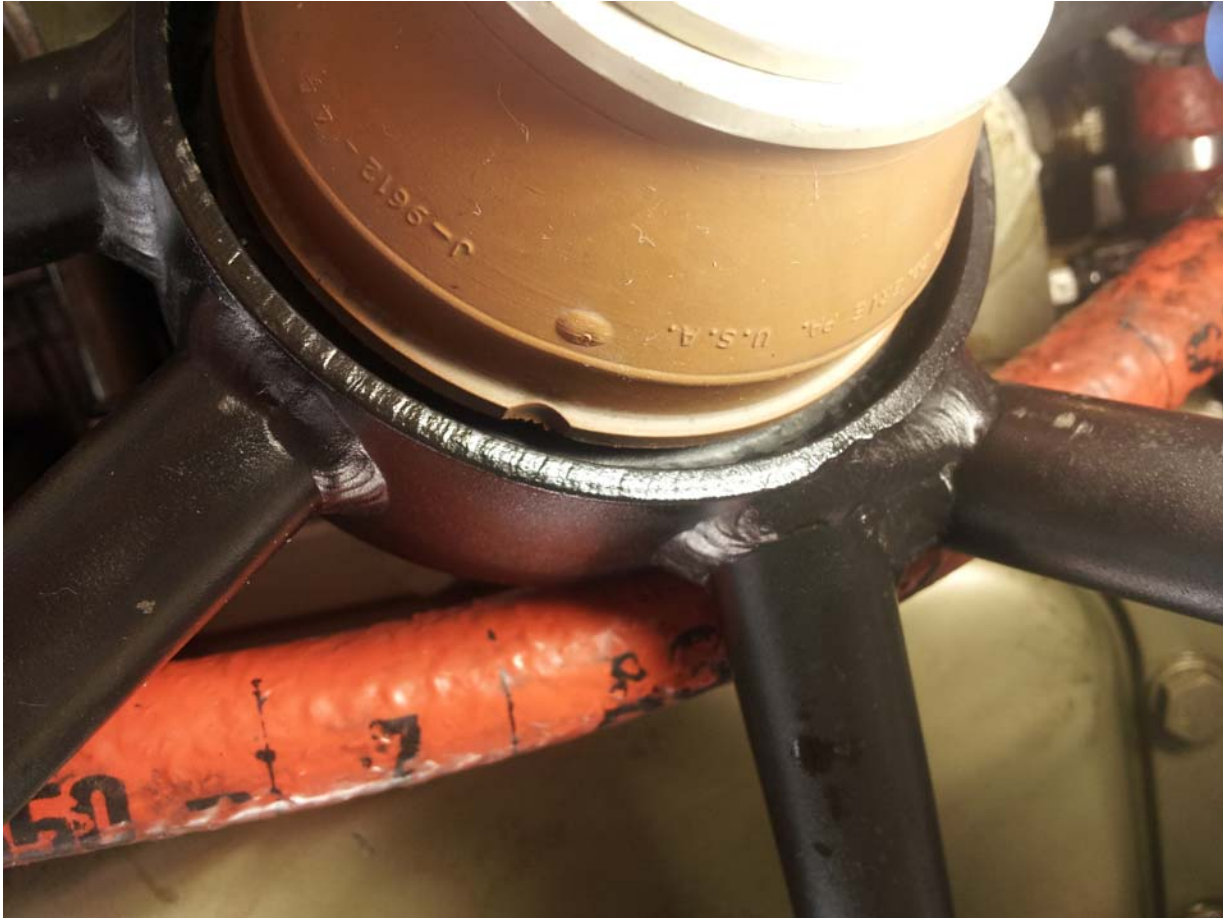
**Mooney: M20TN; Loose Engine Isolator Mount Bolts; ATA 7120**

"(I) discovered all four engine isolator mount bolts loose during a 100 hour inspection, noting *(these bolts)* do not have a safety wire or locking provision. I also found several areas of chafing related to the engine not being secured to the engine bed mount. All engine isolators were removed and inspected. I found metal shavings between the upper and lower isolators, and the left aft engine mount bracket thread insert pulled and cross threaded. Both rear engine mount brackets were replaced with new, and the front engine isolator mounts replaced with a new kit. I reinstalled the existing rear isolator mount kit IAW IPC and AMM *(parts catalog and maintenance manual)*.

"I found installing the isolator mounts and bolts very difficult. The engine mount brackets do not align with the engine bed mount focal rings. With all the isolators installed and the bolts torqued, the isolators are displaced from centerline and are laterally loaded. The isolators do not seat on the full circumference of the focal ring. I removed all the isolator mounts for further inspection of the bed mount, and contacted the aircraft manufacturer about the alignment issues. I measured the mount and found the engine bed mount focal ring centerlines are too narrow by 0.2500 inches on all four corners. No deformities of the bed mount were noted." *(Mount P/N: 590030501. A Continental TSIO550G sits in this airplane's engine mount.)*

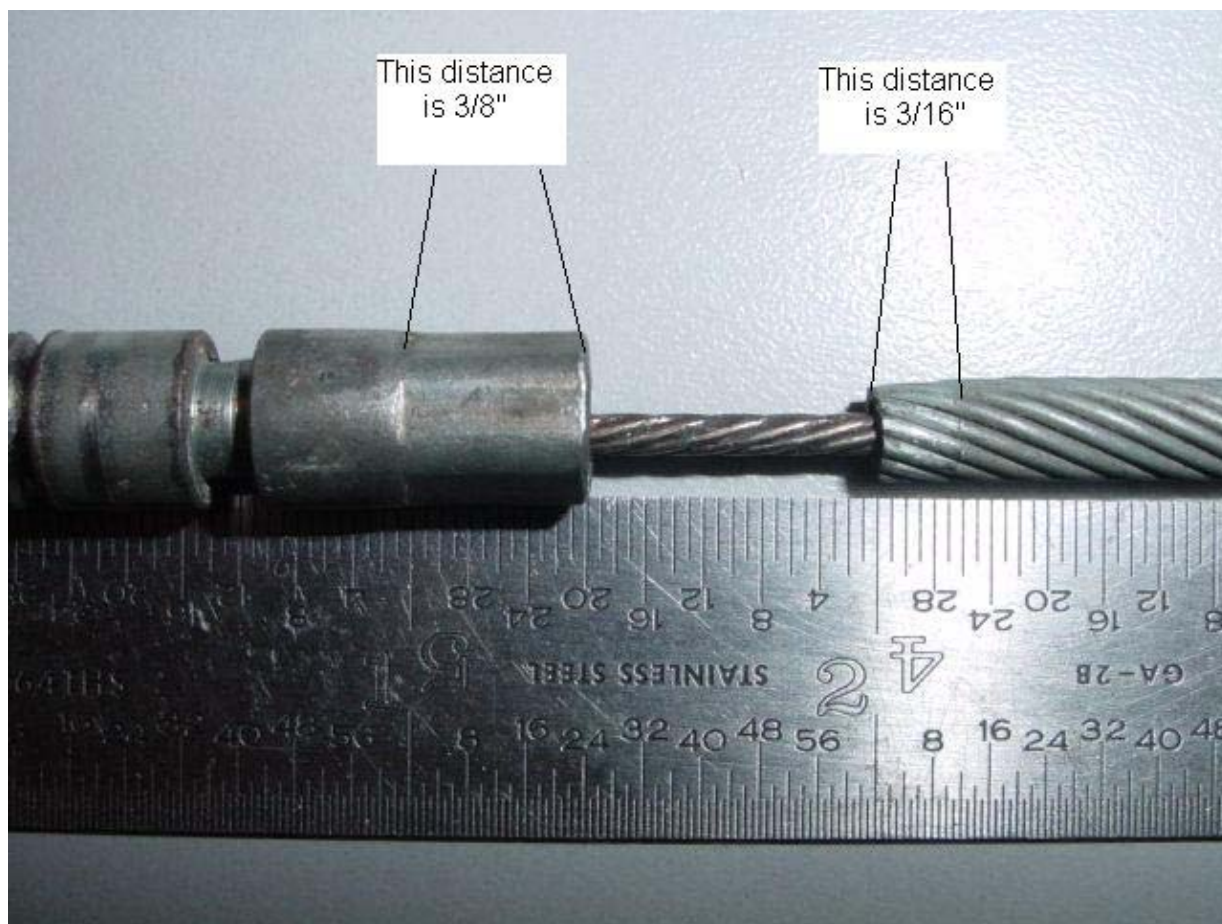
**Piper: PA44-180; Throttle Cable Separation; ATA 7603**

"During climb out and around 600-700 AGL (above ground level)," says this submitter, "the instructor pilot reduced the R/H throttle to idle to simulate engine failure. The student pilot simulated feathering the R/H propeller—and when attempting to set zero thrust, the instructor discovered there was no thrust available. The R/H engine was secured, and emergency declared, and an uneventful landing performed. Upon inspection of the R/H engine (*we found*) the engine end of the swaged portion of the throttle cable had failed, allowing only the cable housing to move when the throttle lever in the cockpit was (*actuated*). Further inspection of the failed swaged area leads me to conclude that during initial assembly of this particular throttle cable (*P/N 554528*) the cable housing had not been inserted into the cable end far enough before the end was swaged onto the cable housing."

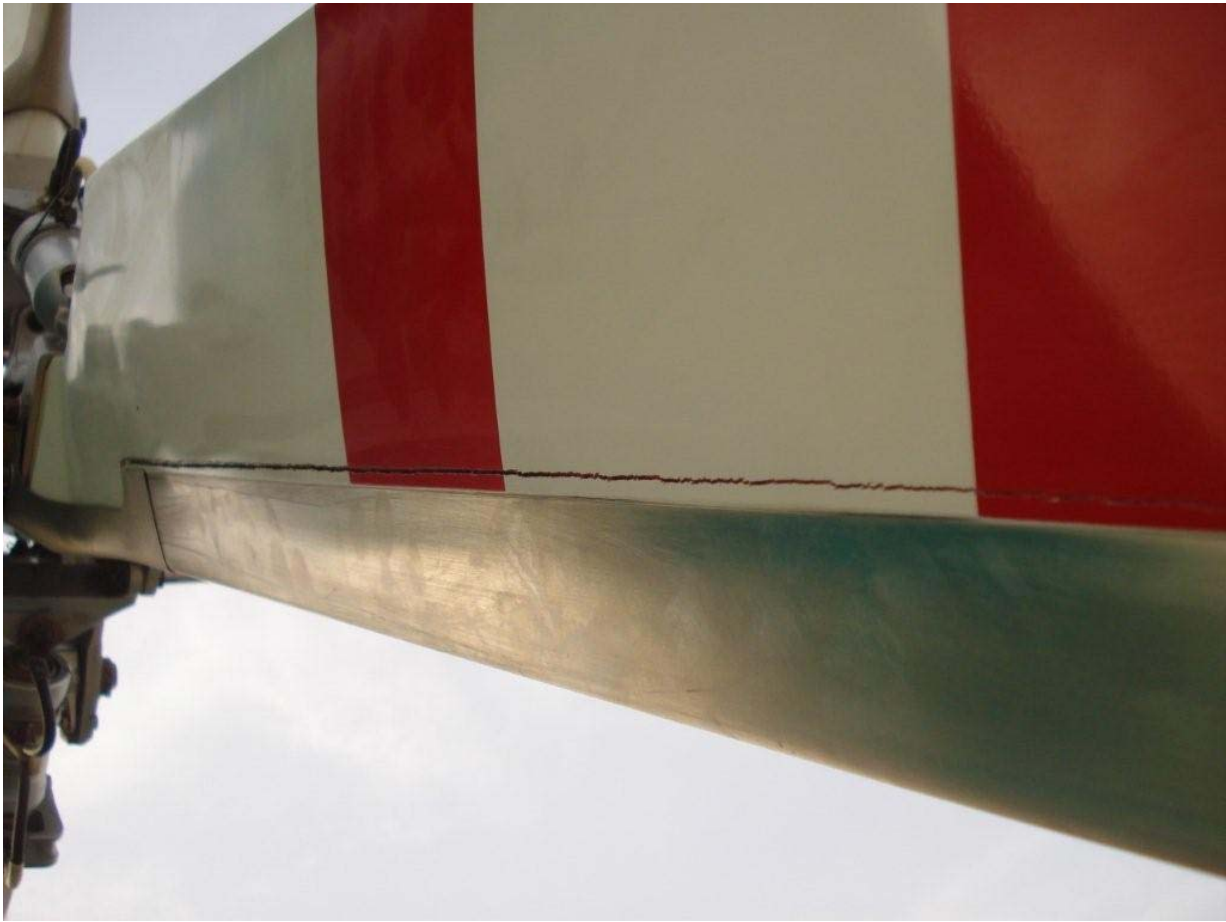
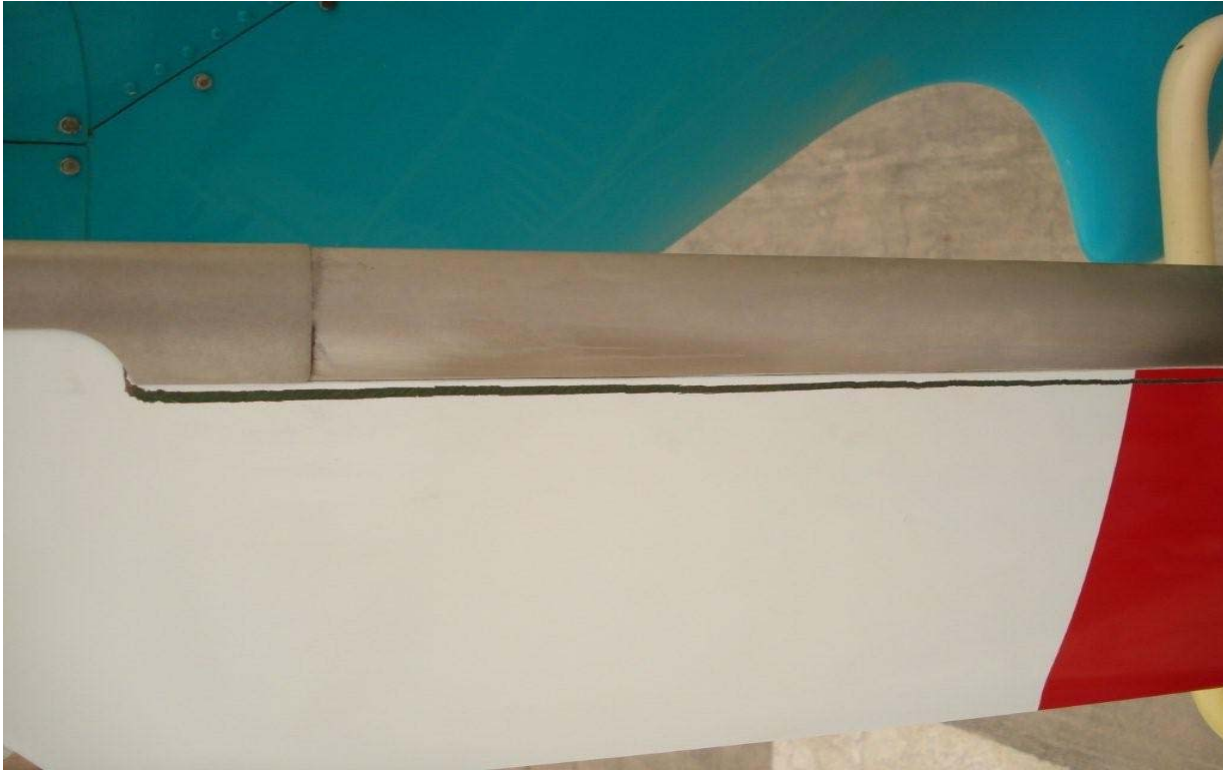
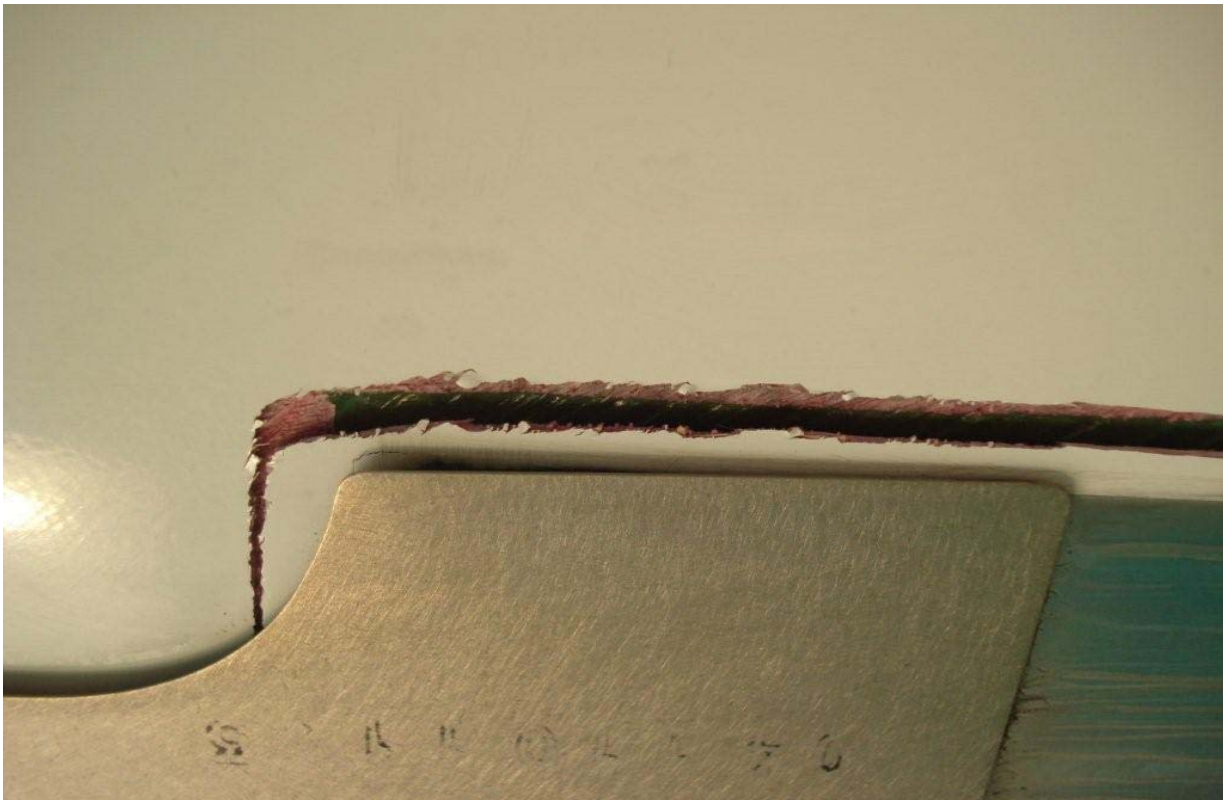
### **Agusta: AW139; Cracked Tail Rotor Blade; ATA 6410**

"During the daily check after flight," says this submitter, "the mechanic noticed a crack on one tail rotor blade just aft of the erosion shield, extending from the inboard end of the shield to within 8 inches of the outboard tip of the blade. The maximum opening of the crack is 0.1875 inches at the inboard end. The crack is evident on both upper and lower sides of the blade, indicating the leading edge plies are (*separating*). (Blade P/N: 3G6410A00131.)

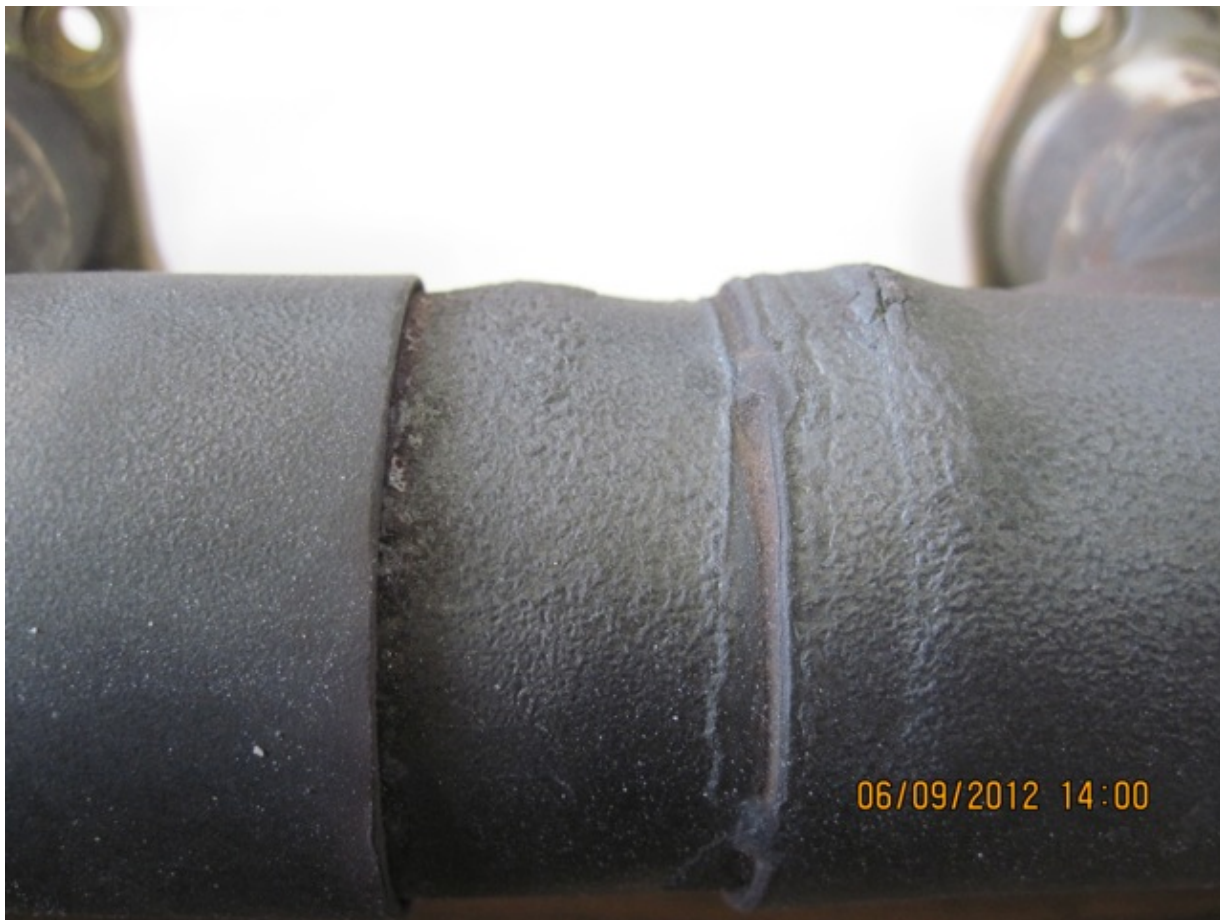
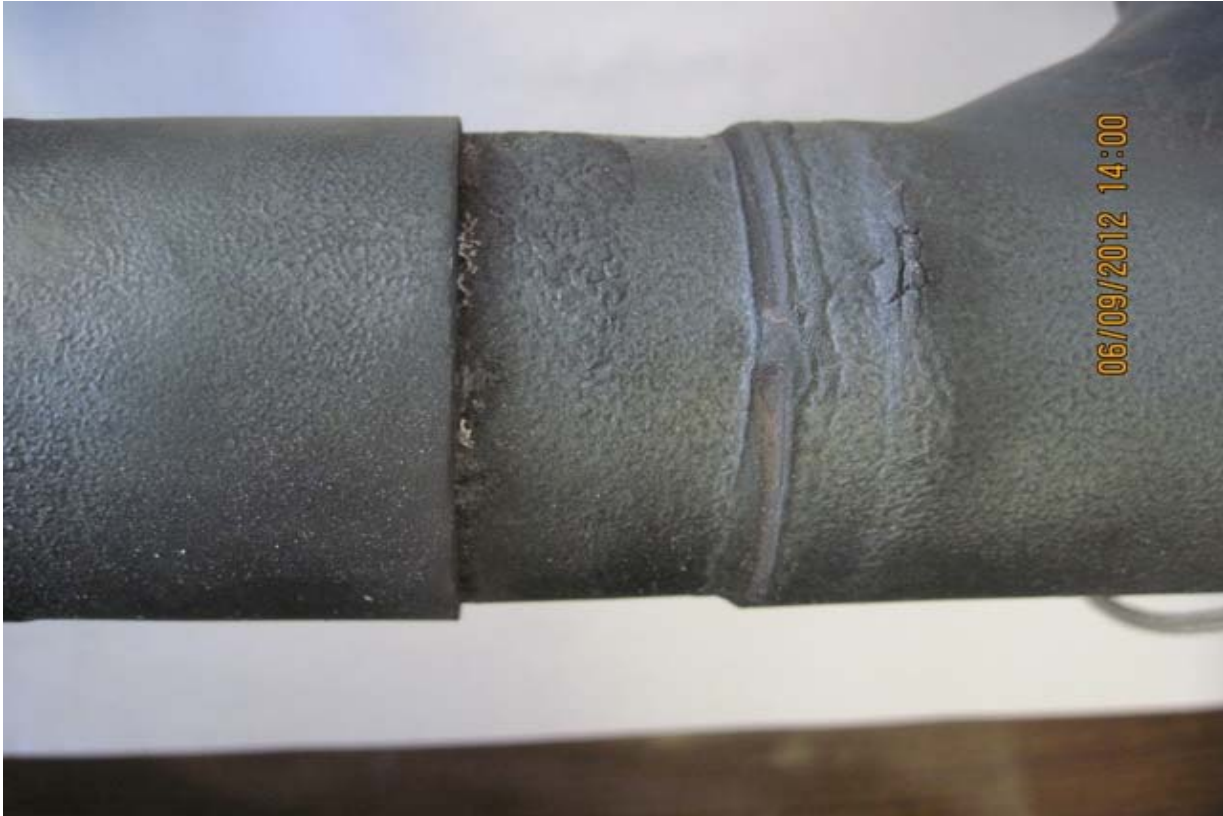
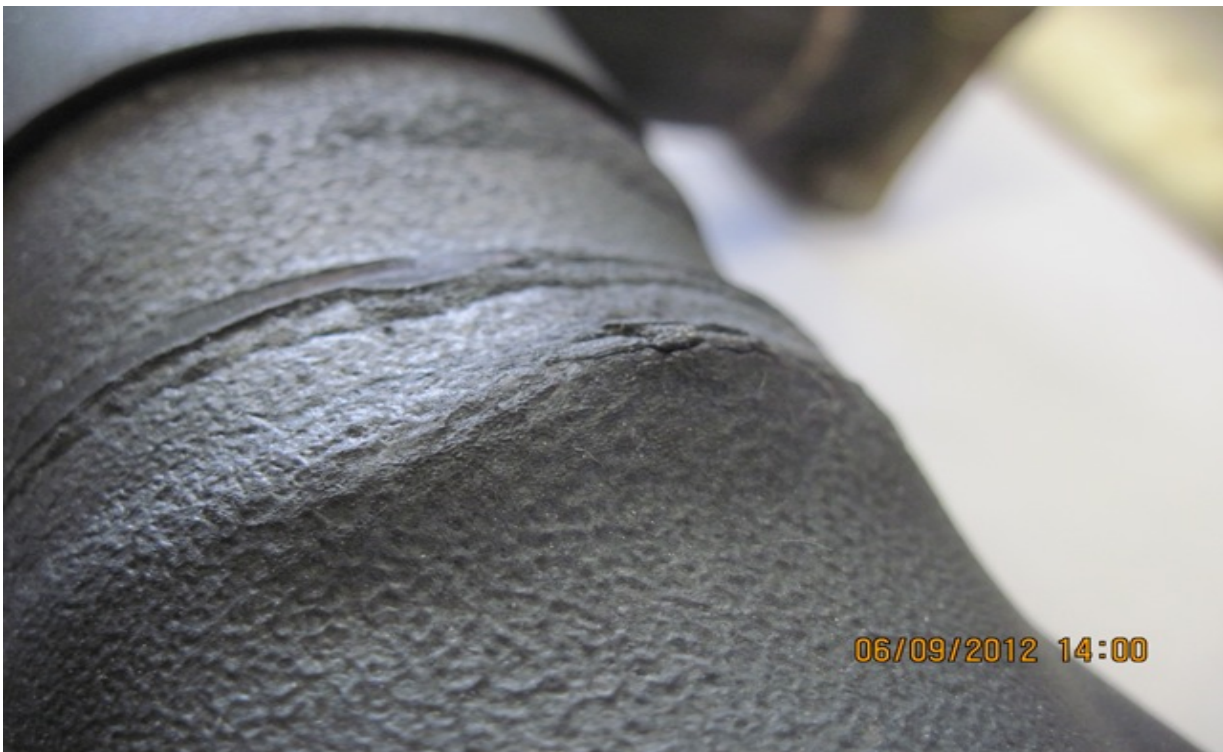
### **Continental: IO550N; Cracked Exhaust Manifold; ATA 7810**

A technician states, "*(I believe this exhaust manifold...)* is a common failure point on these aircraft having turbo-normalizing systems (installed under STC SA10588SC and SE10589SC). During a pre-buy inspection, *(I)* found the L/H exhaust manifold assembly was blistered and cracked in two places between cylinder numbers two and four. This happens because the slip joint becomes frozen due to lack of proper maintenance. Aggravating this condition is the installed heat shield covers this area from all but the most detailed inspections. The heat shield may also be reflecting heat back at the exhaust, causing the failure point to always occur beneath the shield. The manufacturer of the turbo-normalizing system has a service instruction (S/11-01) to address this issue. However, *(I)* have noted this inspection is not being performed on a routine basis on several aircraft *(serviced)* at this facility. This *(defect/report)* is only one of several aircraft having identical failures, including one which involved the exhaust pipe separating into two pieces. *(That failure resulted in...)* a 0.1250 inch gap, allowing exhaust gasses into the engine compartment.

"In my opinion, aircraft with this turbo-normalizing system installed should have an AD *(Airworthiness Directive)* with a 50 hour inspection requirement." *(Exhaust P/N: 226850002.)*

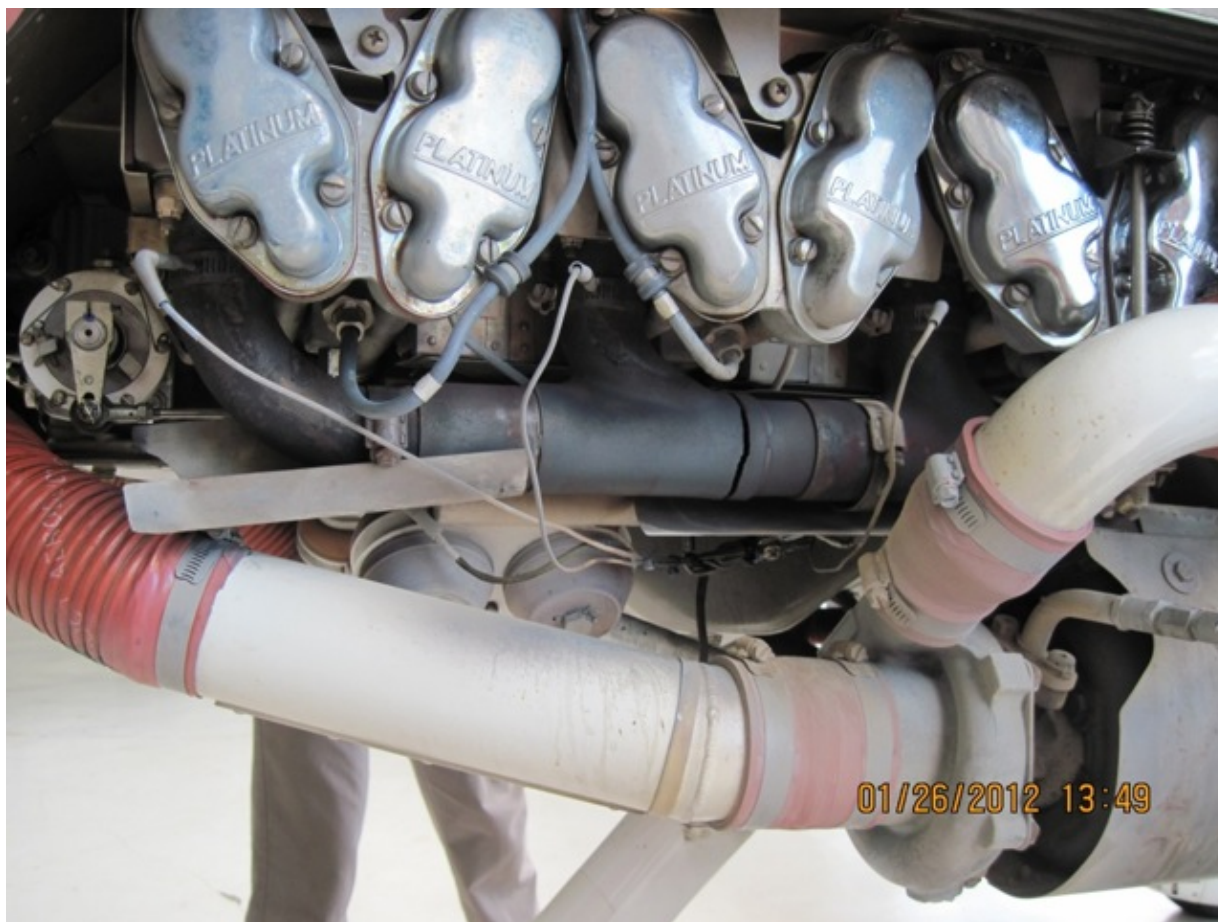
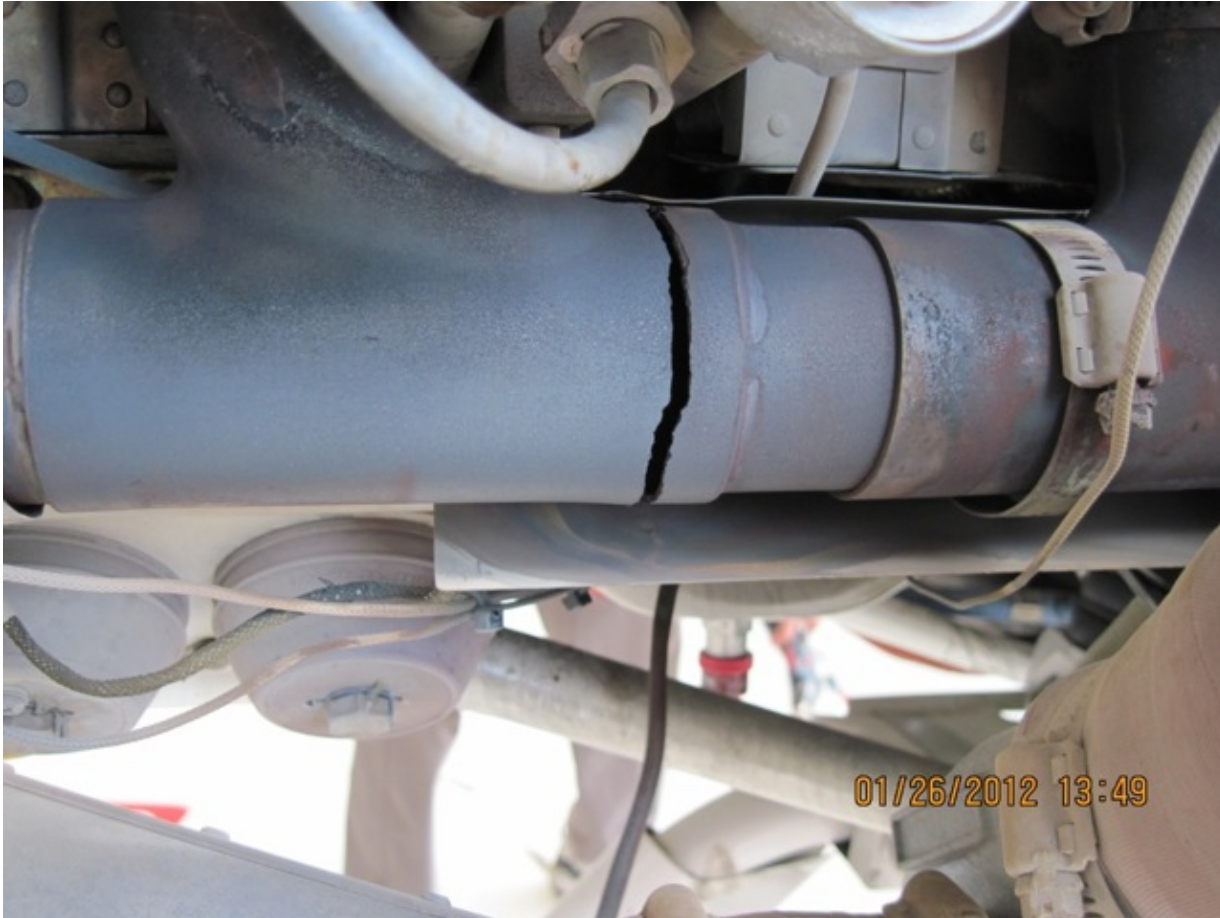
**Continental: IO550N; Cracked Exhaust Manifold; ATA 7810**

More thoroughly described in the previous report, the same submitter provides this second report and photos. "During routine maintenance, (we) found the L/H exhaust manifold had cracked into two pieces between cylinder numbers two and four." (Exhaust P/N: 226850002.)
