**Federal Aviation  
Administration**

## ADVISORY CIRCULAR

# AVIATION MAINTENANCE ALERTS

**ALERT  
NUMBER  
408**

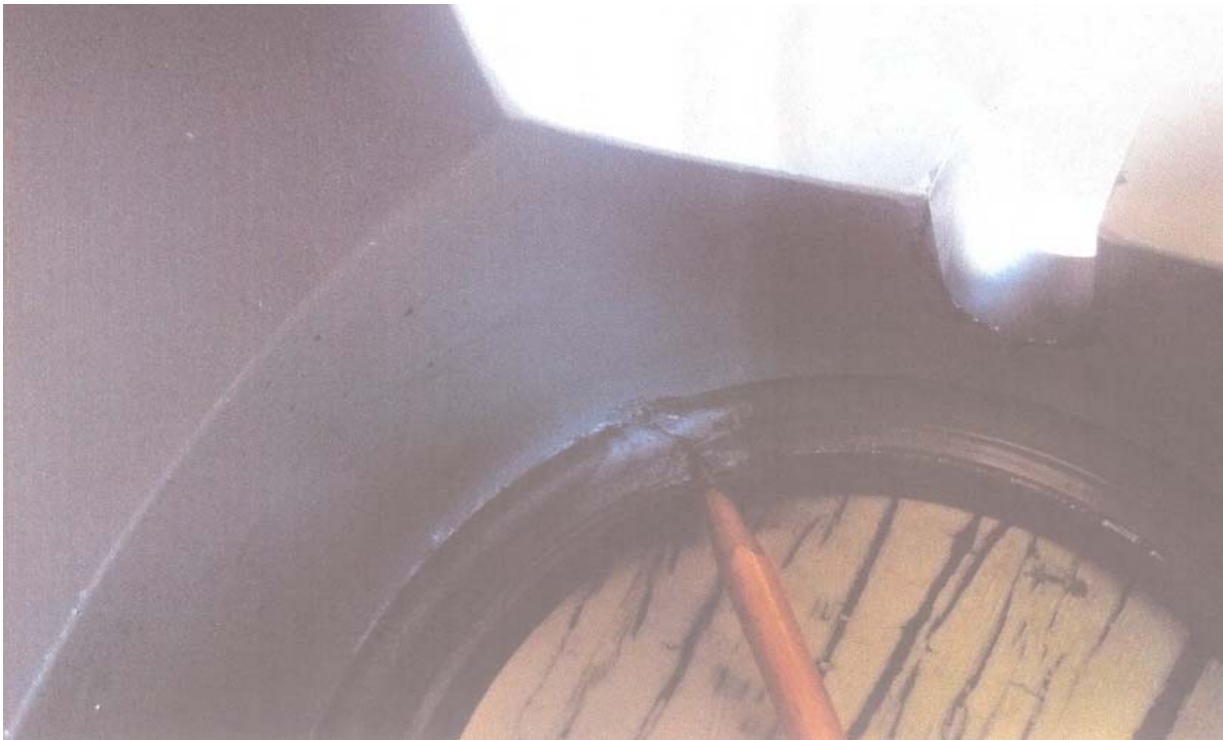
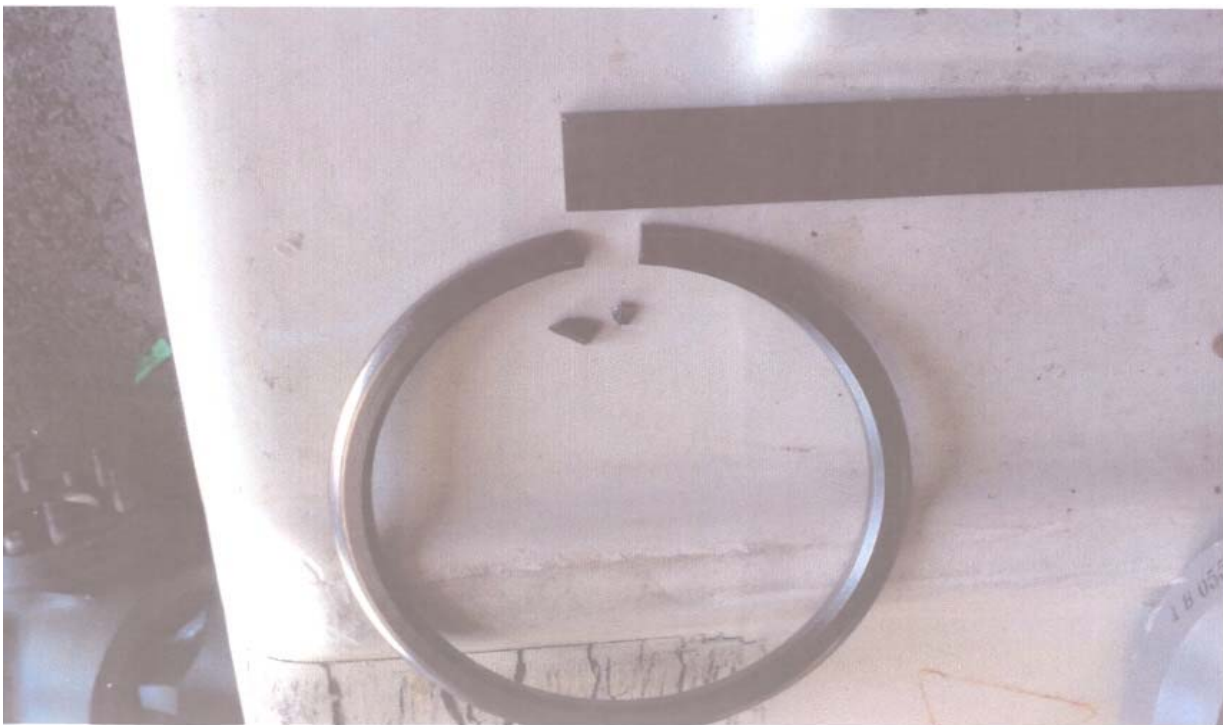
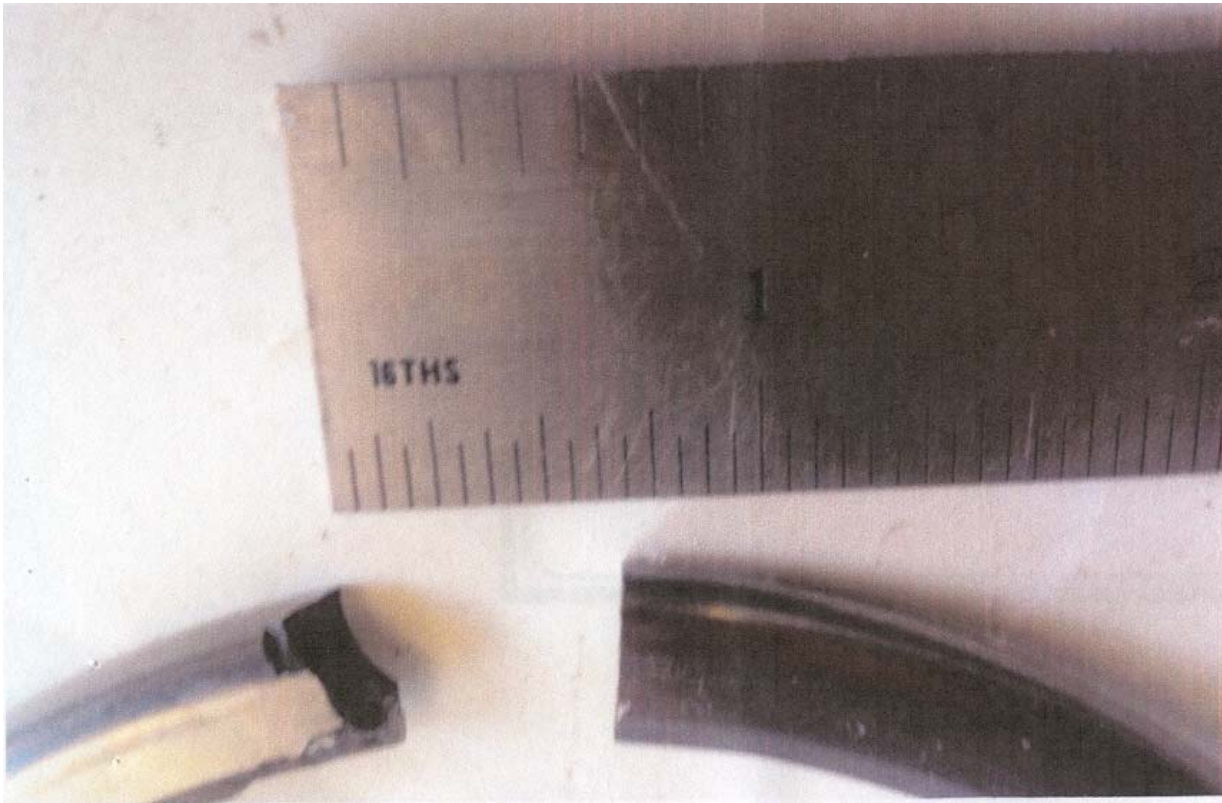
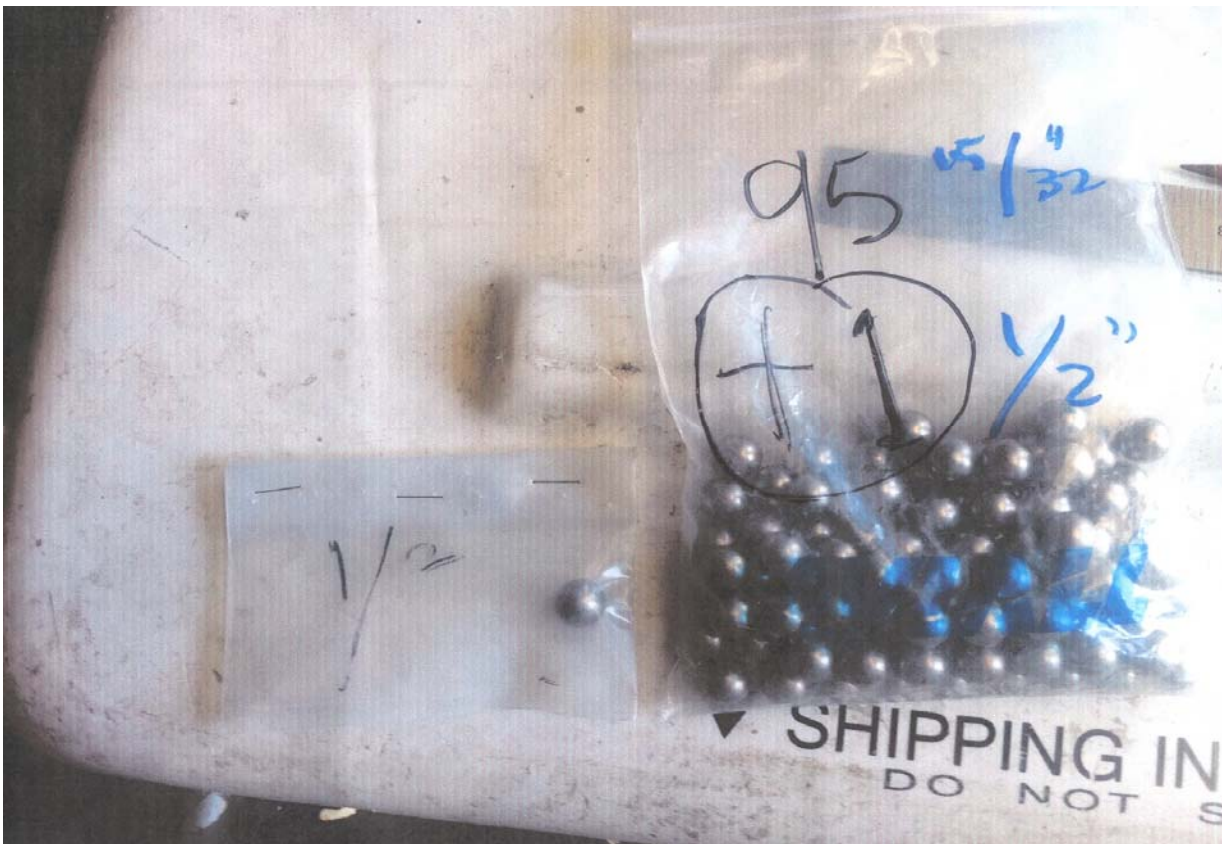
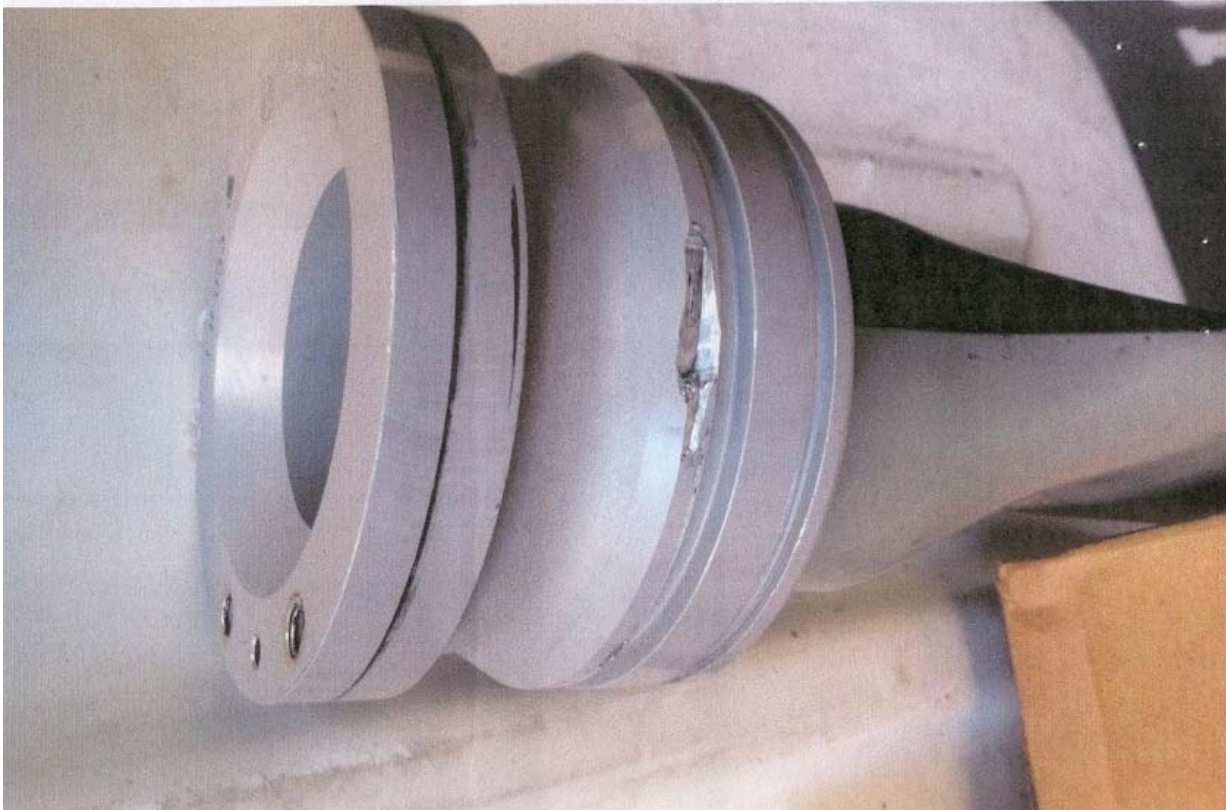
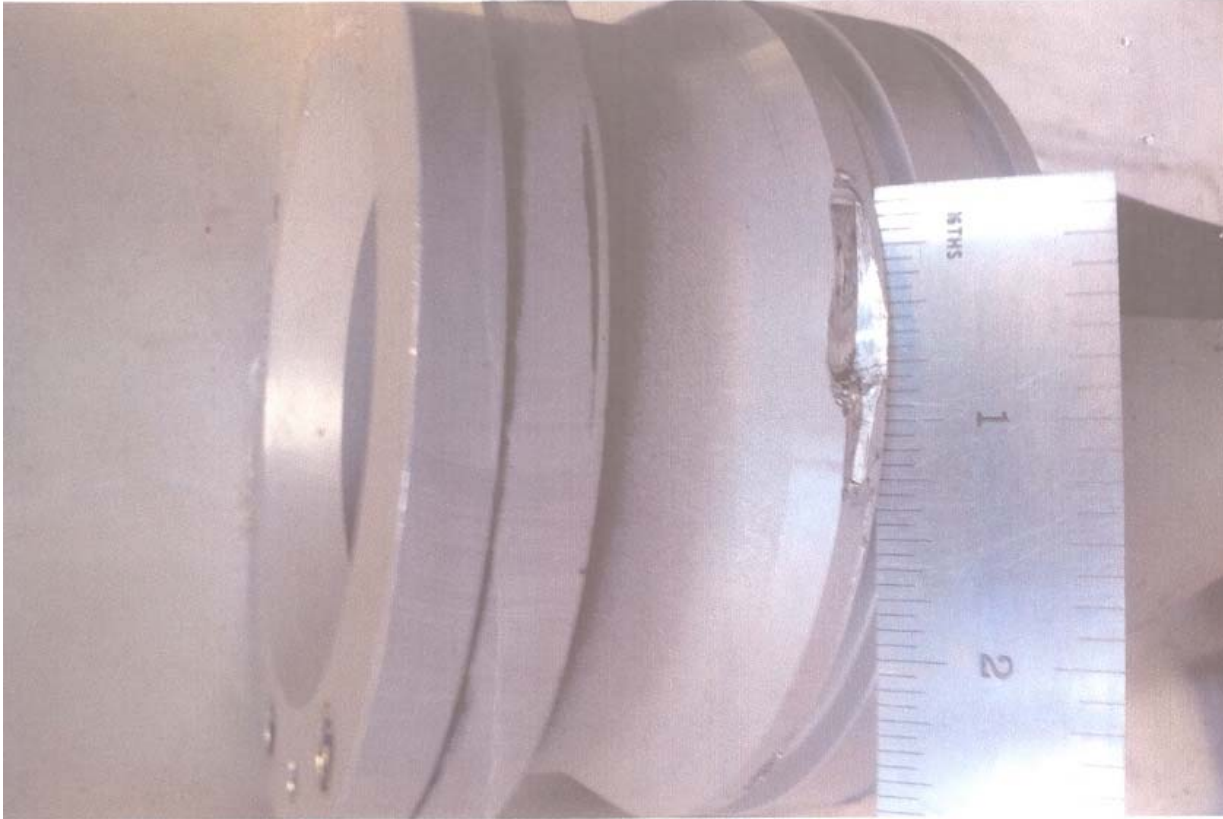
### **McCauley: D3A32C406-C; Broken Bearing Race; ATA 6111**

"The owner noticed a few specs of oil on the nose cowl," writes this mechanic. "The propeller was removed to replace the Crankshaft O-ring, but during removal (*I*) discovered the oil seepage was actually coming from a blade. The seepage was considered minor and the propeller operation appeared normal. However, the decision was made to have the propeller sent to a propeller shop and checked out. (*The repair shop*) recommended an overhaul due to the calendar time on the prop.

"During disassembly, the propeller shop discovered on blade was frozen. Further inspection found the bearing race broken, with approximately one inch (*of the race*) missing. Both the blade and the hub had a sizable gouge. Also, 95 of the ball bearings measured the proper size of 15/32 inches, but one bearing measured 16/32 inches.

"The blade and hub were not repairable. It appears the oversized bearing caused the damage. Complete failure of the propeller was imminent."
