Federal Lands Highway Post-Construction Safety Reviews

Final Report

January 2004

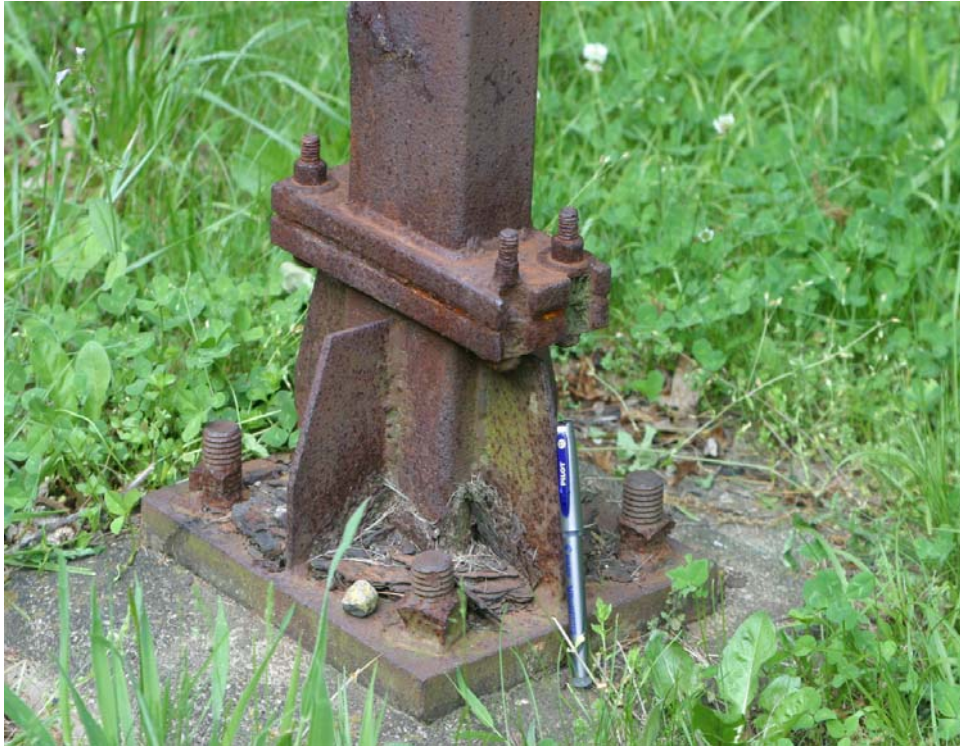
Severely rusted breakaway bond plate connection needs replacement. Also, the bond plate height is greater than 4-inches from the concrete footing.

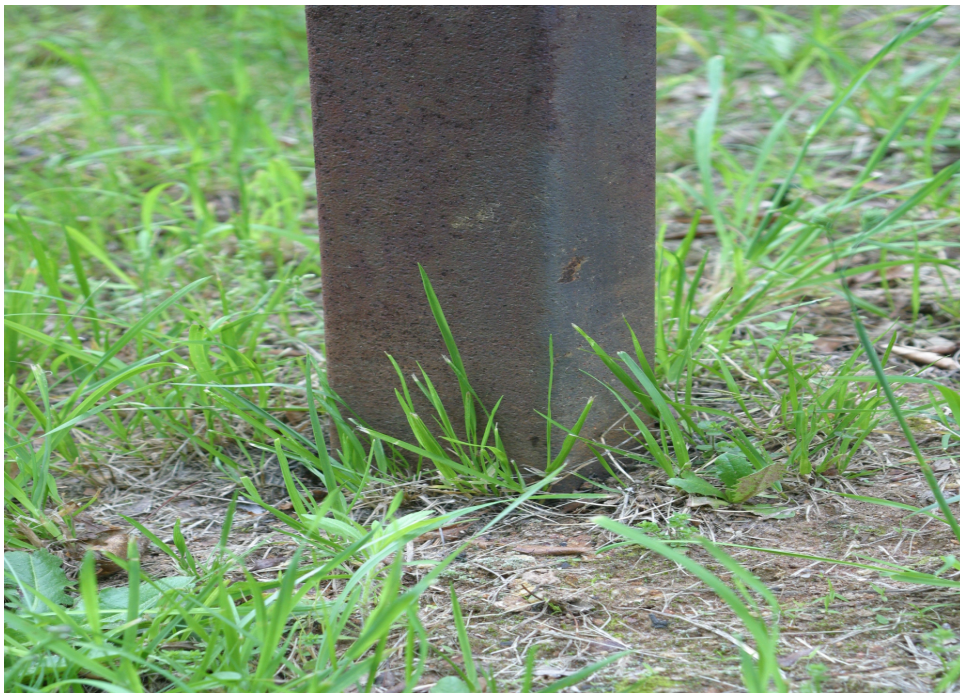
Weathering steel sign post installed without breakaway design.

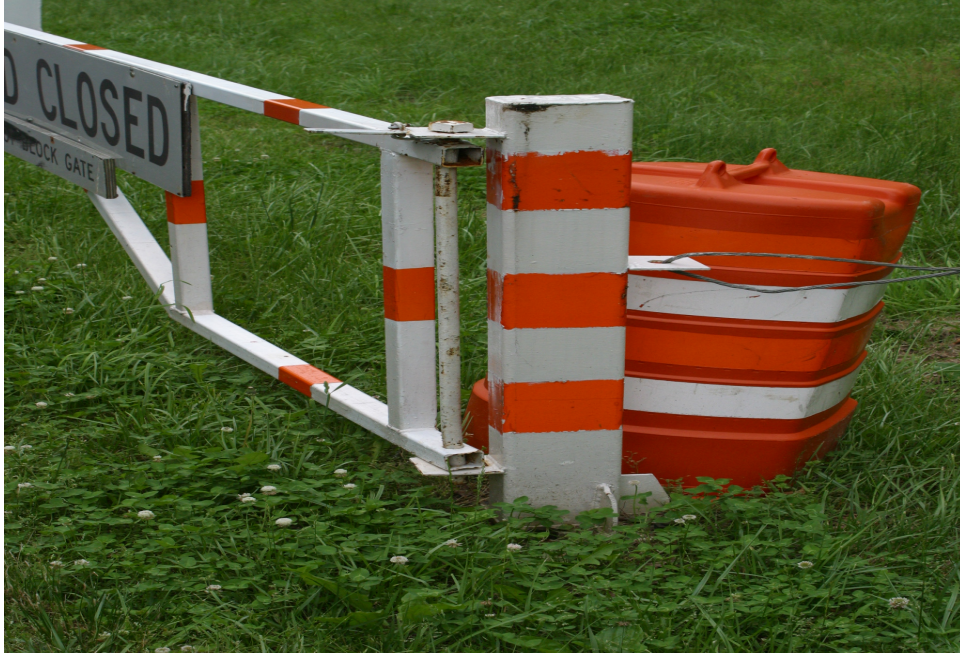
Entrance gate post within clear zone (approximately 2-feet from travel lane) is non-crashworthy

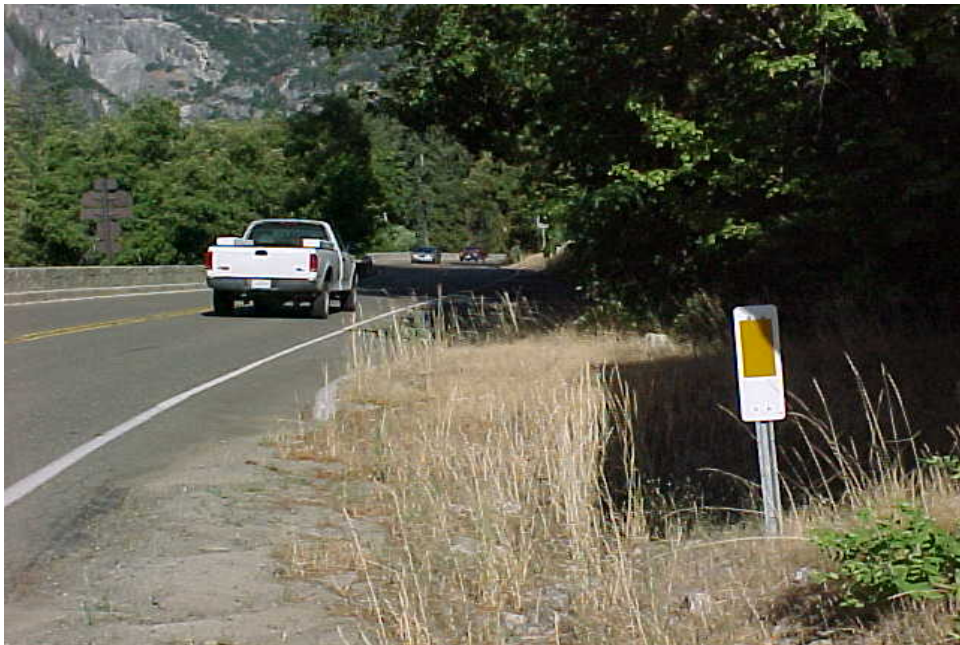
Incorrect placement of Object Marker.
Object Marker about 3 meters off shoulder.

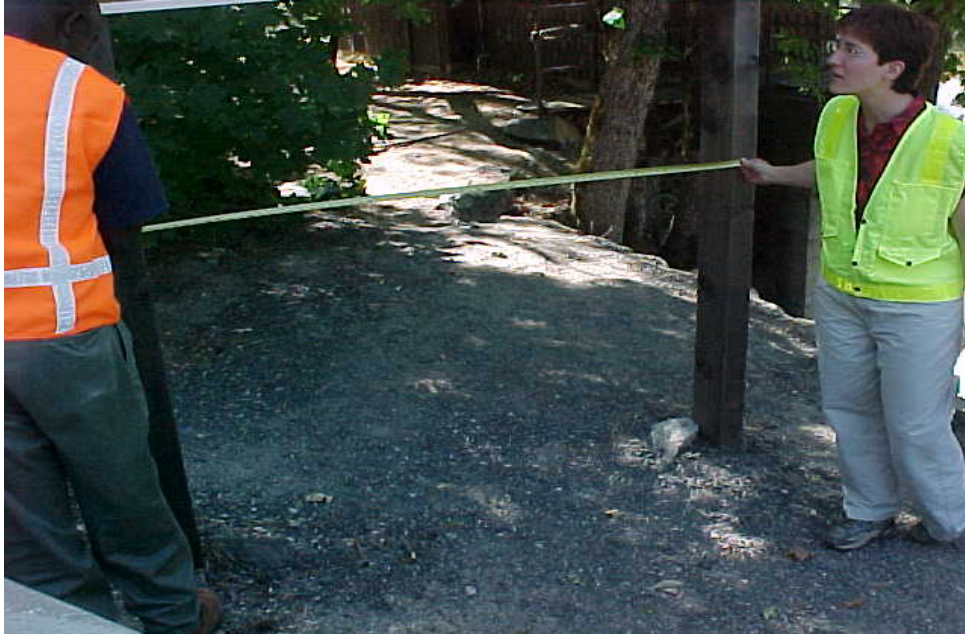
4" x 6" wood posts installed without breakaway holes in posts within the clear zone, and are not considered to be crashworthy.

- **Breakaway Sign Supports.** Standard drawings that shows the correct details for drilling breakaway holes in 4” x 6” and greater size wood supports as well as proper installation of

steel sign supports, should be developed. The drawings need to address the following: correct orientation of the breakaway assembly with the major direction of traffic or the use of multi-directional breakaway devices, and the use of hinges on signs with multiple support posts to allow the intended breakaway safety mechanism of the support system to function properly.

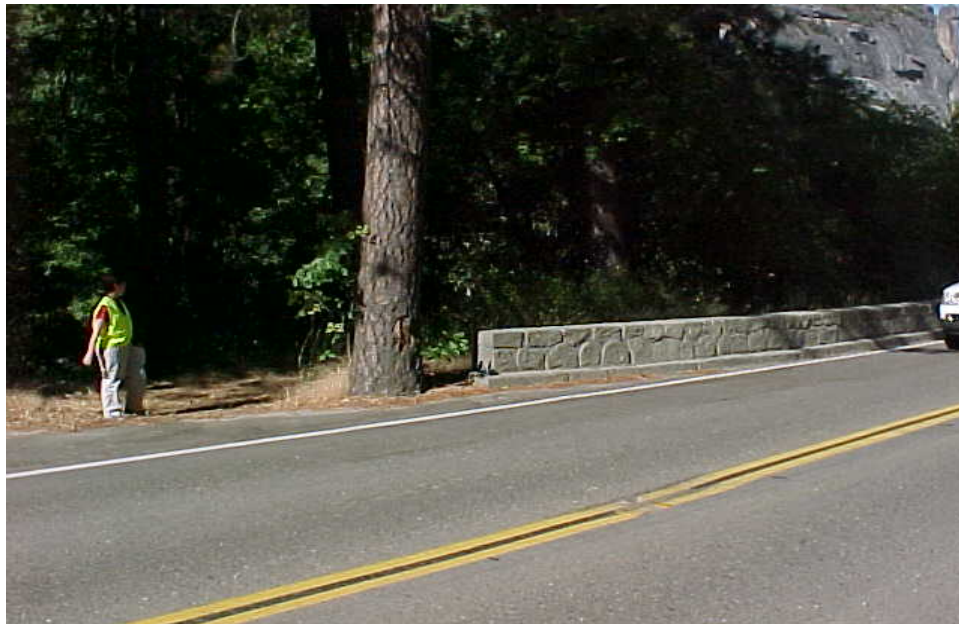
Guardwall terminating at a tree, within clear zone for opposing traffic.

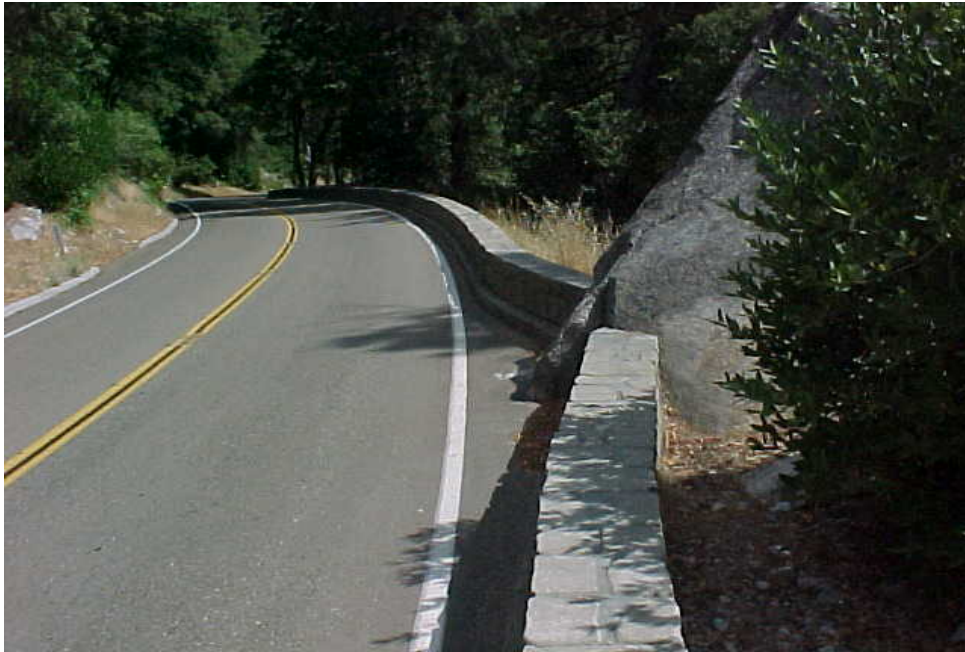
Rock protruding into the roadway. Guardwall ties into protruding rock.
Typical problem of environmental challenges
during project design and construction.

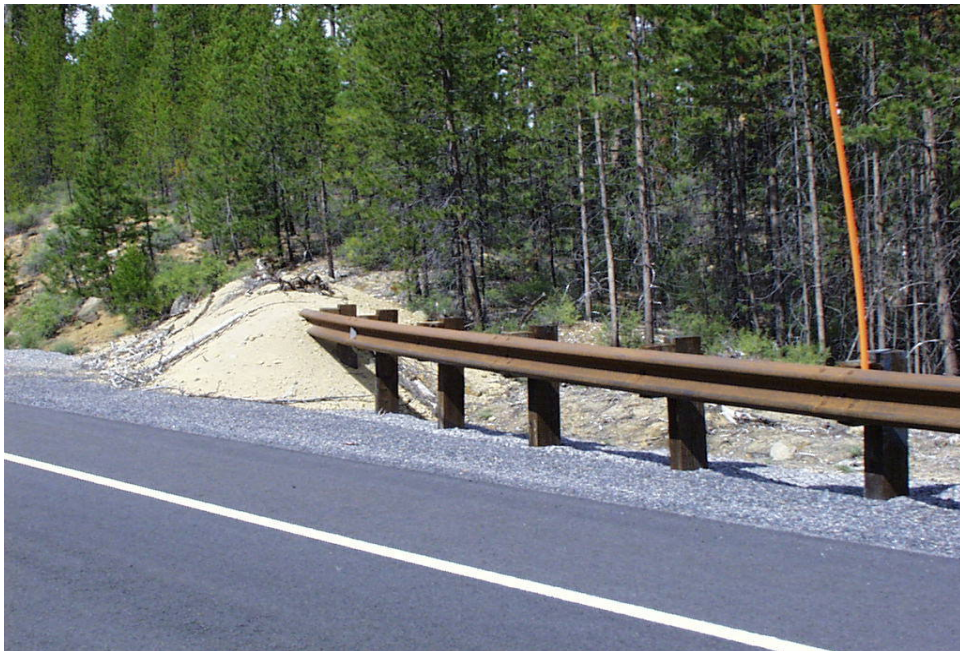
Terminating the barrier beyond the clear zone with earth berm is desirable
provided the roadway and terrain are suitable. Care should
be taken not to make the berm a hazard.

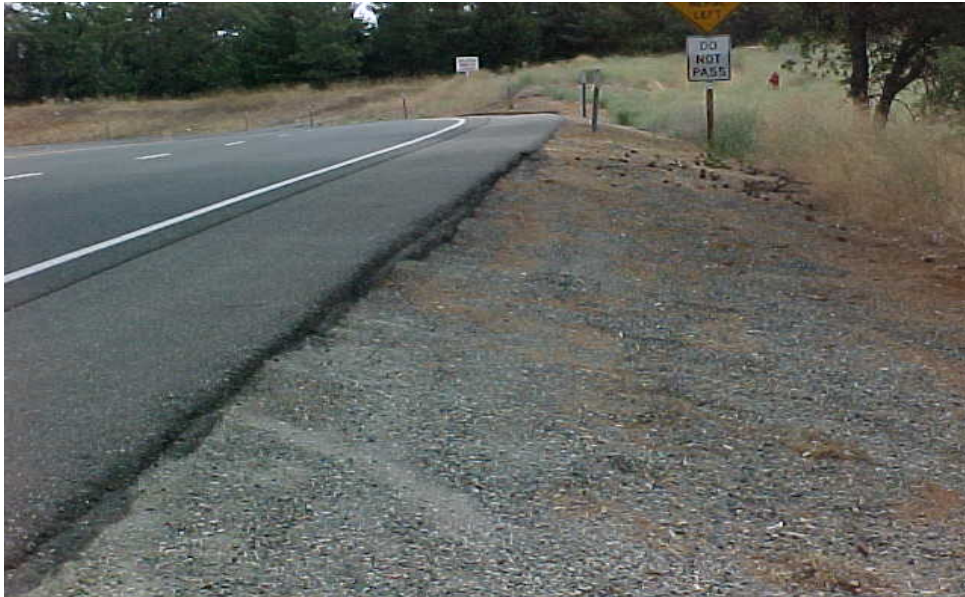
Example of improper signing as the warning sign is above a regulatory sign on the same Post. Also note the pavement drop-off is greater than 2 inches.

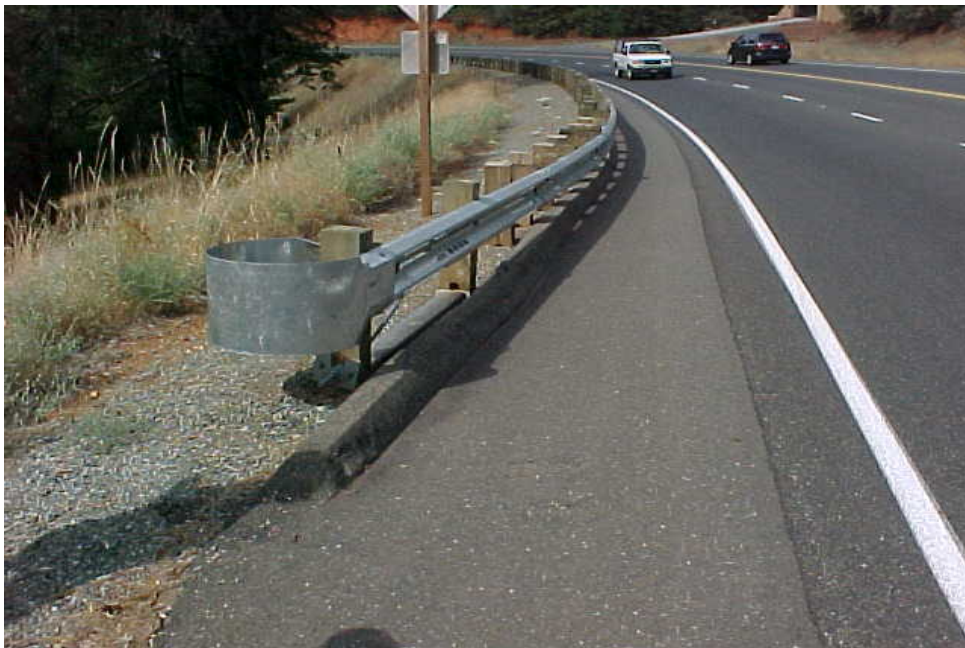
Curb in front of Slotted Rail Terminal (SRT) which negatively affects performance of the terminal section.

- **Curbs and Guardrails.** Typically, curbs are not desirable in combination with guardrail and, when used, curb height is limited to a maximum of 4 inches (100mm) and the face of the guardrail must be flush with the curb. For curbs higher than 4 inches (100mm), the guardrail system should be stiffened by adding another rail (nesting) or by adding a rubrail

underneath the normal rail. Curbs are particularly of concern in the terminal section of guardrail, including the CRT design where there is no block out. If the curb must be continued beyond the end of the guardrail, a special design is needed to relocate the curb away from the terminal. A new standard drawing to show this application is recommended.

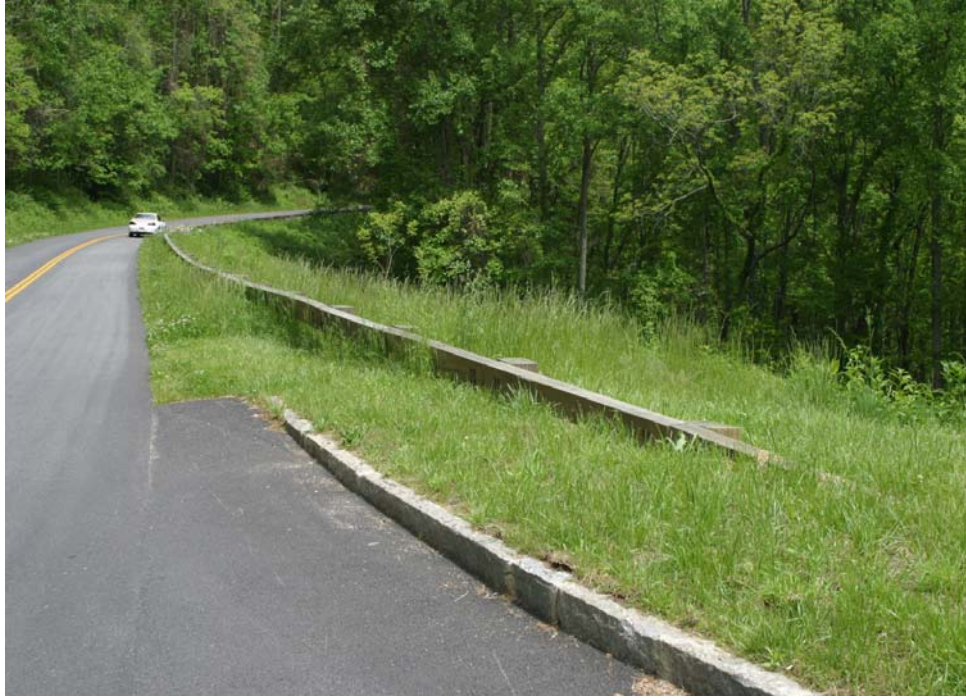
Timber guardrail standard height is not maintained up to the FAT-30 terminal section.

- **Guardrail Height.** There appears to be confusion related to the height of the G4 W Beam Guardrail for both steel and wood posts. The source of the confusion appears to be on standard drawing numbers 617-10 and 617-18, where the “TYPICAL GUARDRAIL CROSS SECTION” does not graphically show the “ALTERNATE HOLE ARRANGEMENT”, which indicates the post is installed 2-inches higher than the rail to accommodate future overlays. We recommend revising these standard drawings to clarify the appropriate height.

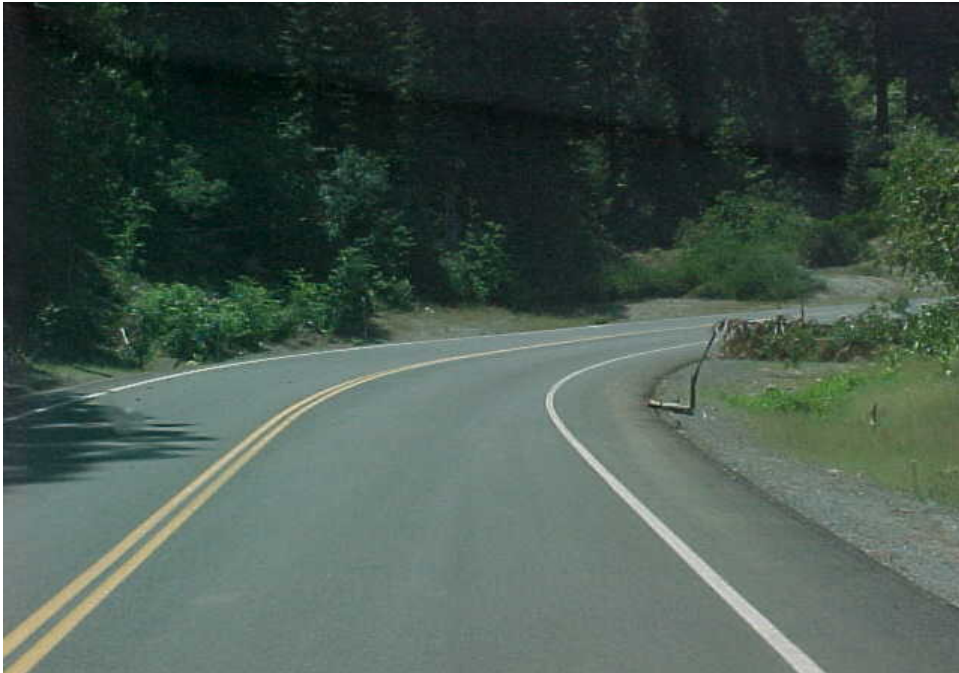
Incorrect striping at curve widening area. Place the centerline striping midway between the edges of the widened travel way. In other words, the distance from the edge of pavement to the edgeline should remain constant along the travel way.

- **Curve Widening.** On certain projects, striping was applied incorrectly in designed curve widening areas. It appears this was not a simple process for the striping equipment and that more data points are needed in the plans to apply centerline striping correctly. Therefore, it is recommended that a standard drawing be developed to adequately explain the proper striping for widened curves.

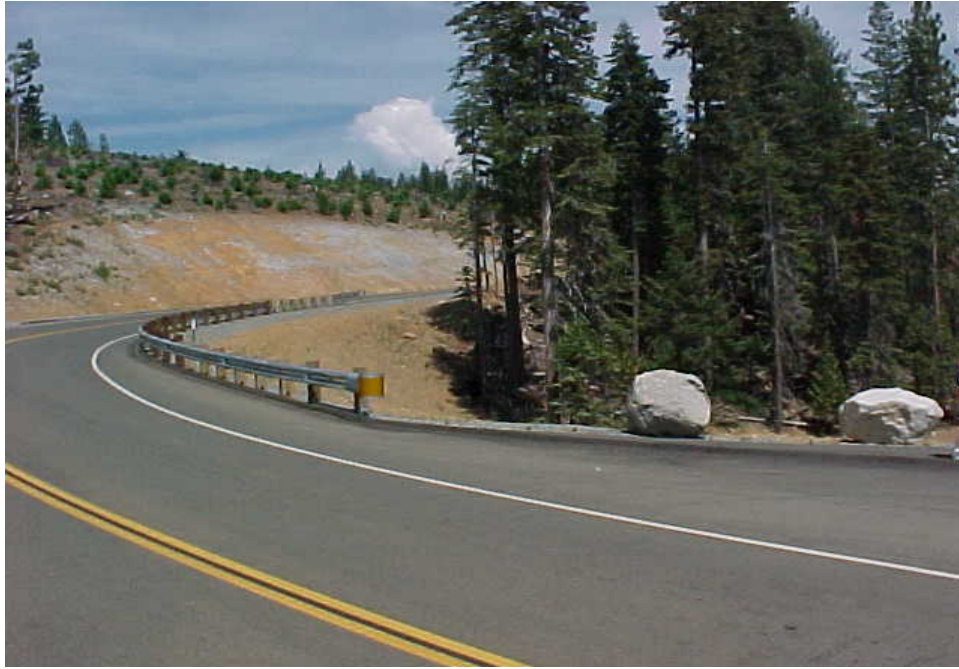
Guardrail improvements could have been made by extending the rail.

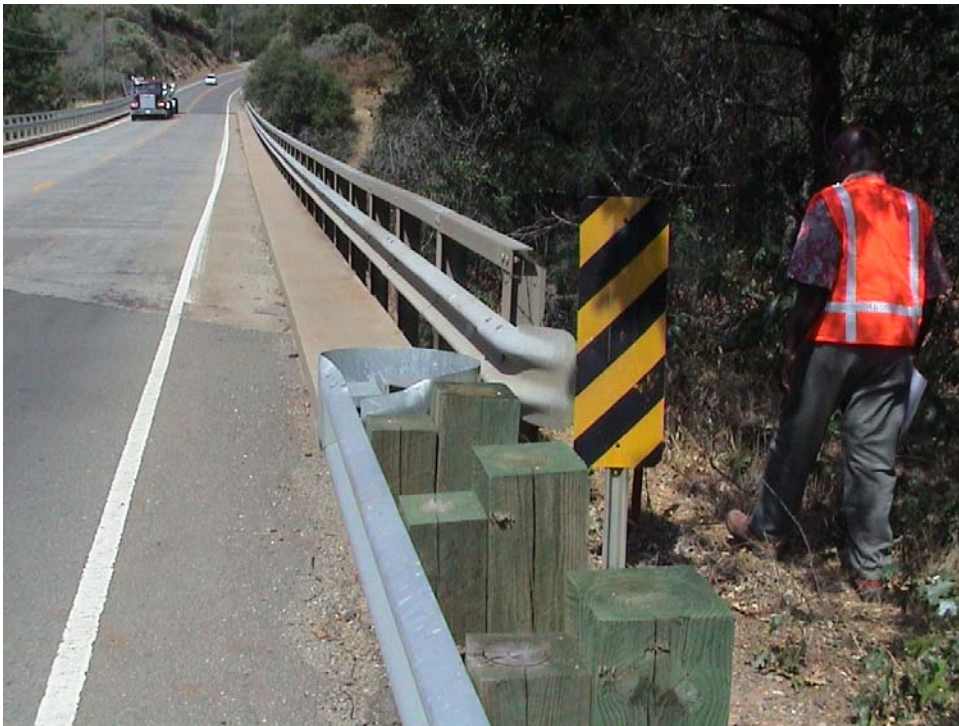
Guardrail approach transition to bridge railing is not crashworthy. Offset of guardrail in front of bridge is a potential hazard for opposing traffic.
