NATIONAL TRANSPORTATION SAFETY BOARD

PIPELINE ACCIDENT REPORT

TEXAS EASTERN GAS PIPELINE COMPANY
RUPTURES AND FIRES
AT BEAUMONT, KENTUCKY
ON APRIL 27, 1985 AND
LANCASTER, KENTUCKY
ON FEBRUARY 21, 1986

NTSB/PAR-87/01

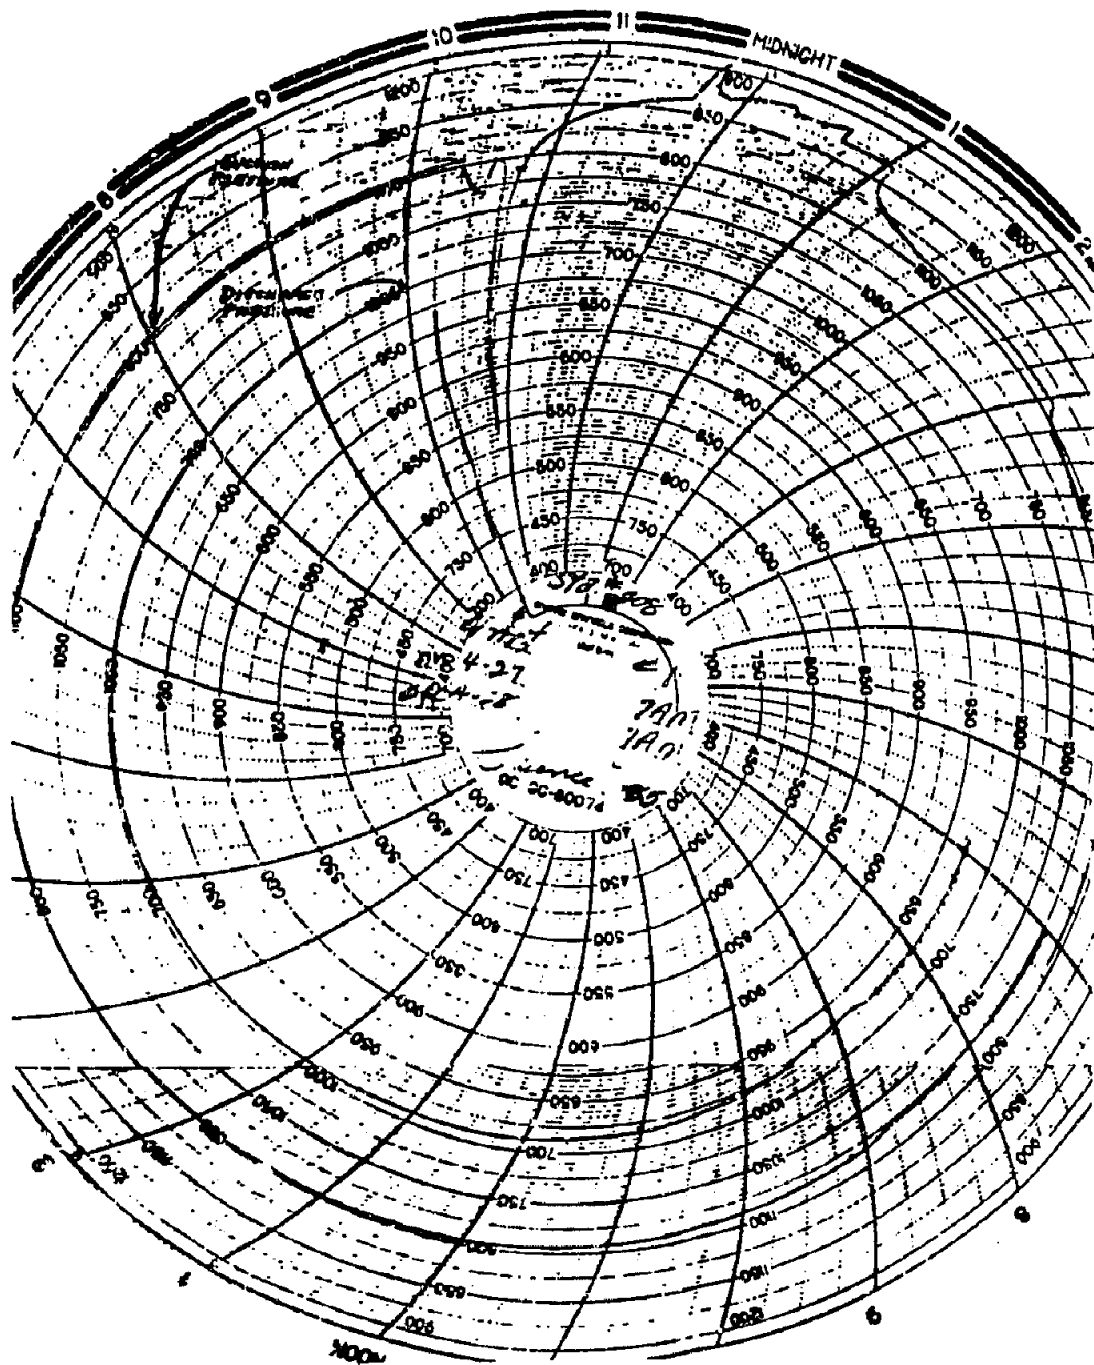
Figure 1.— Tompkinsville pressure recording chart.

telephoned his supervisor and advised him of the drop in pressure (see figure 1). The supervisor directed the station operator to shut down the No. 1 compressor which was compressing gas into the No. 10 pipeline and told the station operator that he would come to the compressor station and close the valve on the No. 10 pipeline in the compressor yard. The station operator ran toward the compressor to shut it down, and on the way he saw a large orange glow in the sky north of the compressor station indicating to him that the No. 10 pipeline had ruptured and that the escaping gas had ignited. The station operator shut down the No. 1 compressor at 9:15 p.m.

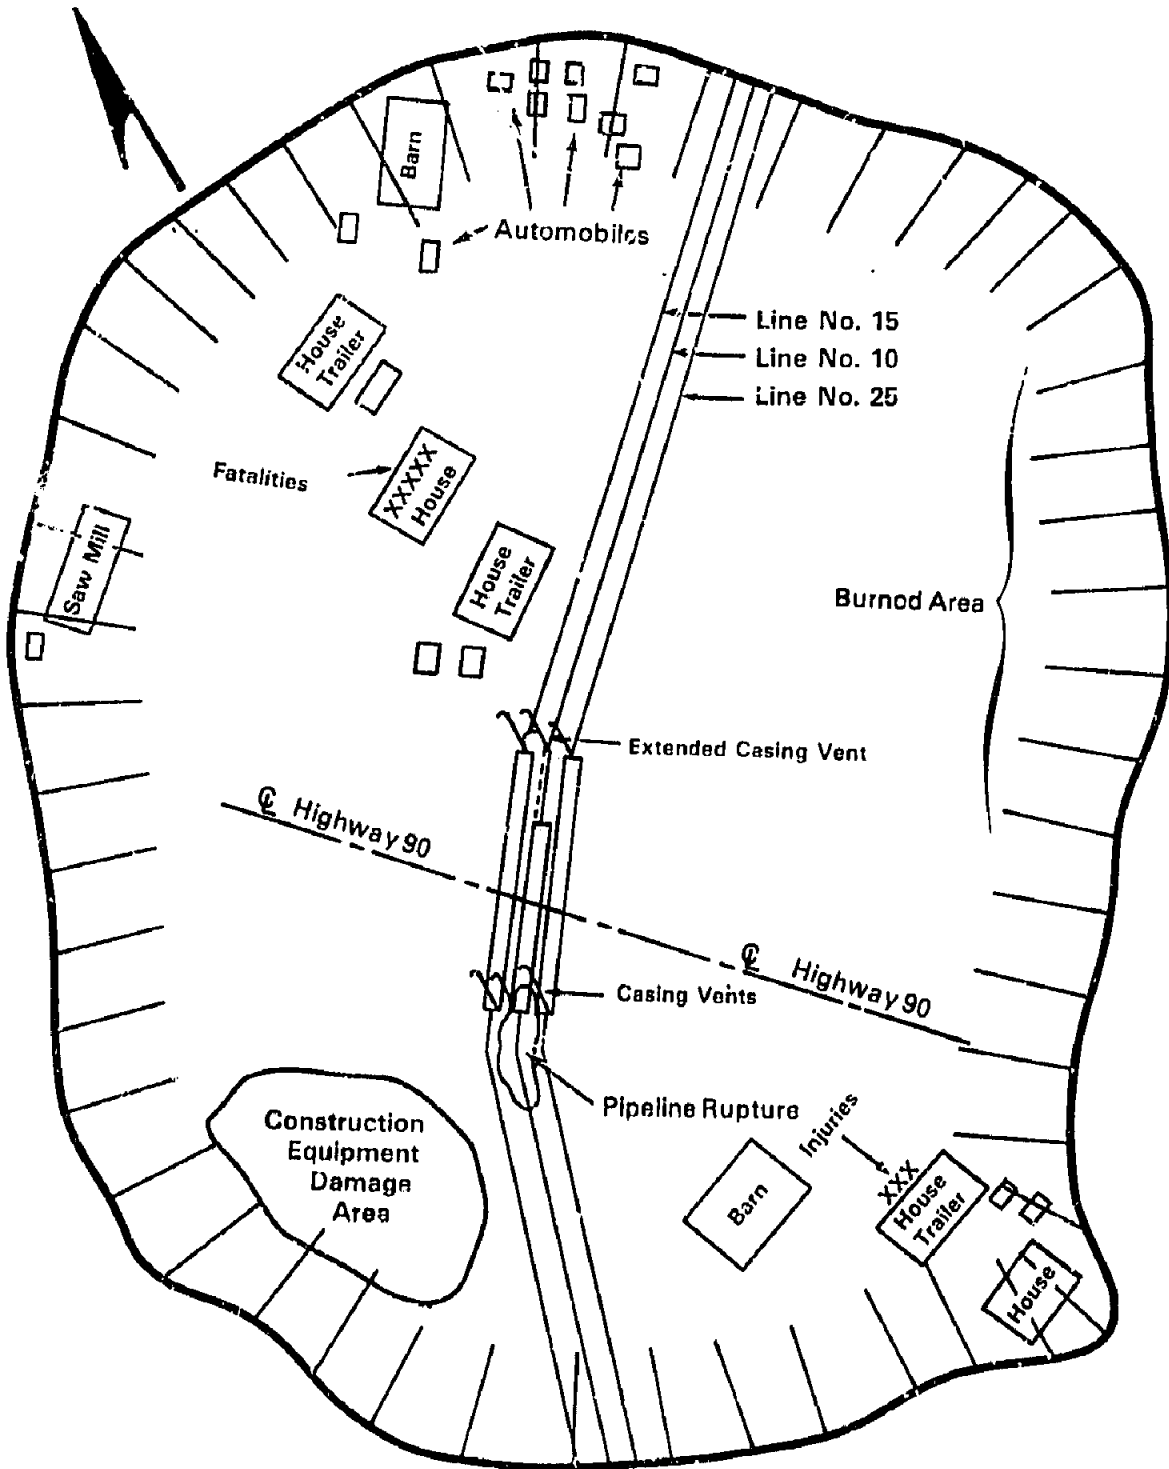
Figure 3.—Diagram of the accident site at Kentucky State highway 90.

Five persons in a house 318 feet north of the rupture were killed and three other persons were burned while fleeing from a house trailer 320 feet south of the rupture. The gas-fueled fire destroyed two houses, three house trailers, a sawmill, two barns, a school bus, numerous parked and abandoned automobiles, nine pieces of road construction equipment, and other items. (See figure 3.)

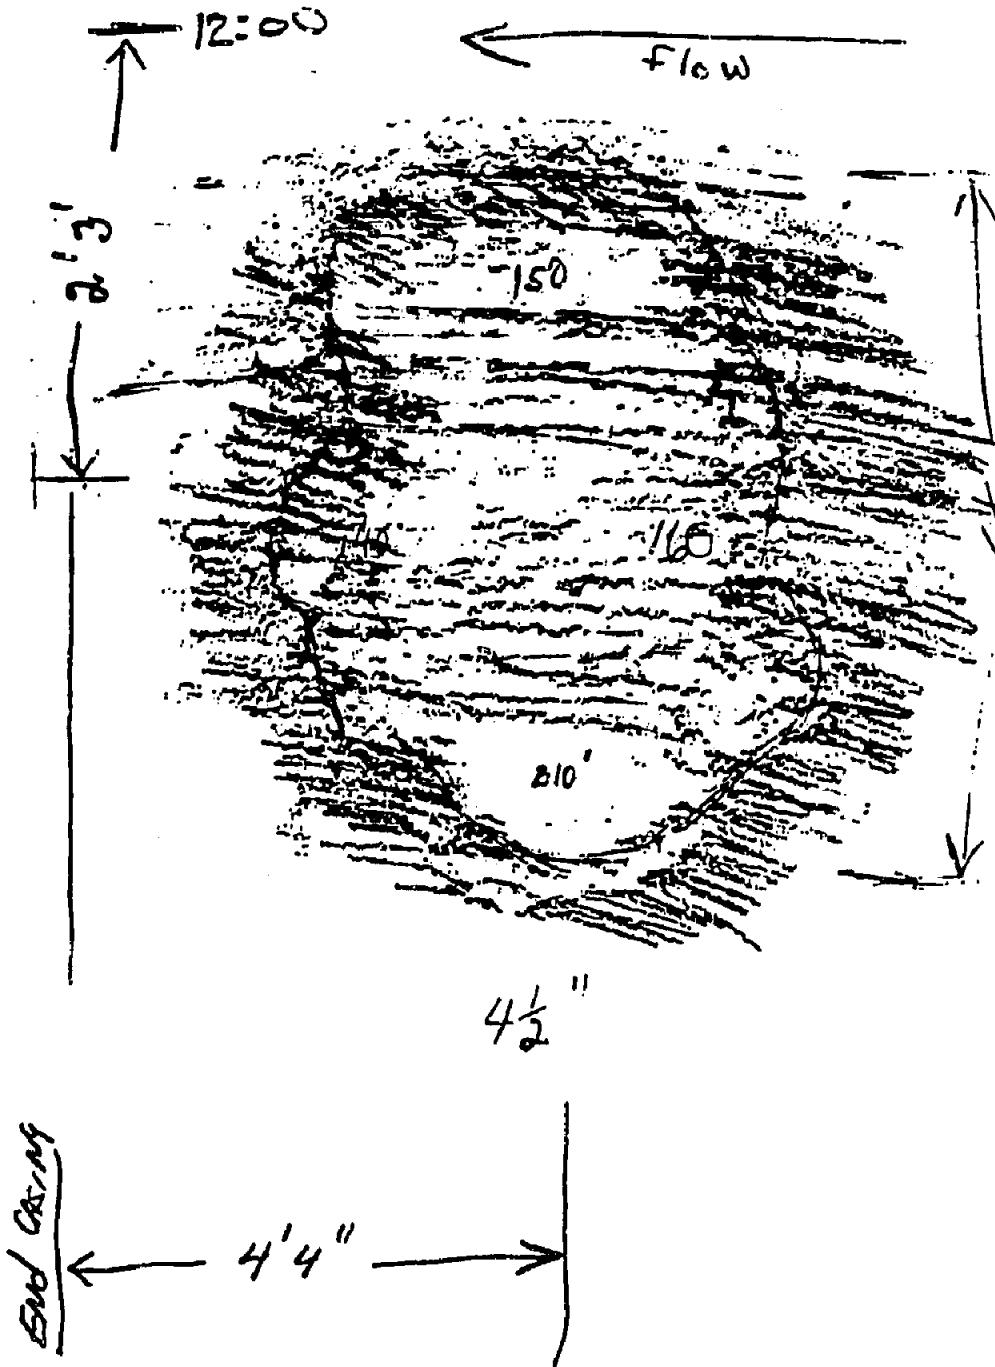
Figure 4b.—Tracing made of area and depth of corrosion at the south end of the casing under State highway 52.

The pipe could not be easily inspected completely because it was resting on a rock ledge. This prevented the gas company's personnel from determining whether the corrosion extended further along the underside of the pipe and it prevented their measuring the depths of pits close to the rock. The gas company personnel did make a notation on the "instrument verification" report that said "unable to gauge center, probably deeper than 190 mils." However, some information required to be entered on the report form used for the "instrument verification" was not provided, the report was not signed, and the company's personnel did not describe the condition of the pipe or the degree of corrosion. The corroded areas that were measured for depth and traced for area and configuration ranged from a 260 mil pit (55.4 percent of the 0.469 inch pipe wall thickness) at the girth weld joining the 0.469 inch wall thickness pipe to the 0.375 inch wall thickness pipe, to a 190 mil pit (50.7 percent of the 0.375 inch wall thickness pipe). In addition, a band of general corrosion on the bottom of the pipe about 5 feet in circumferential length and 1 foot in longitudinal length was located between the 260 mil and 190 mil pits.

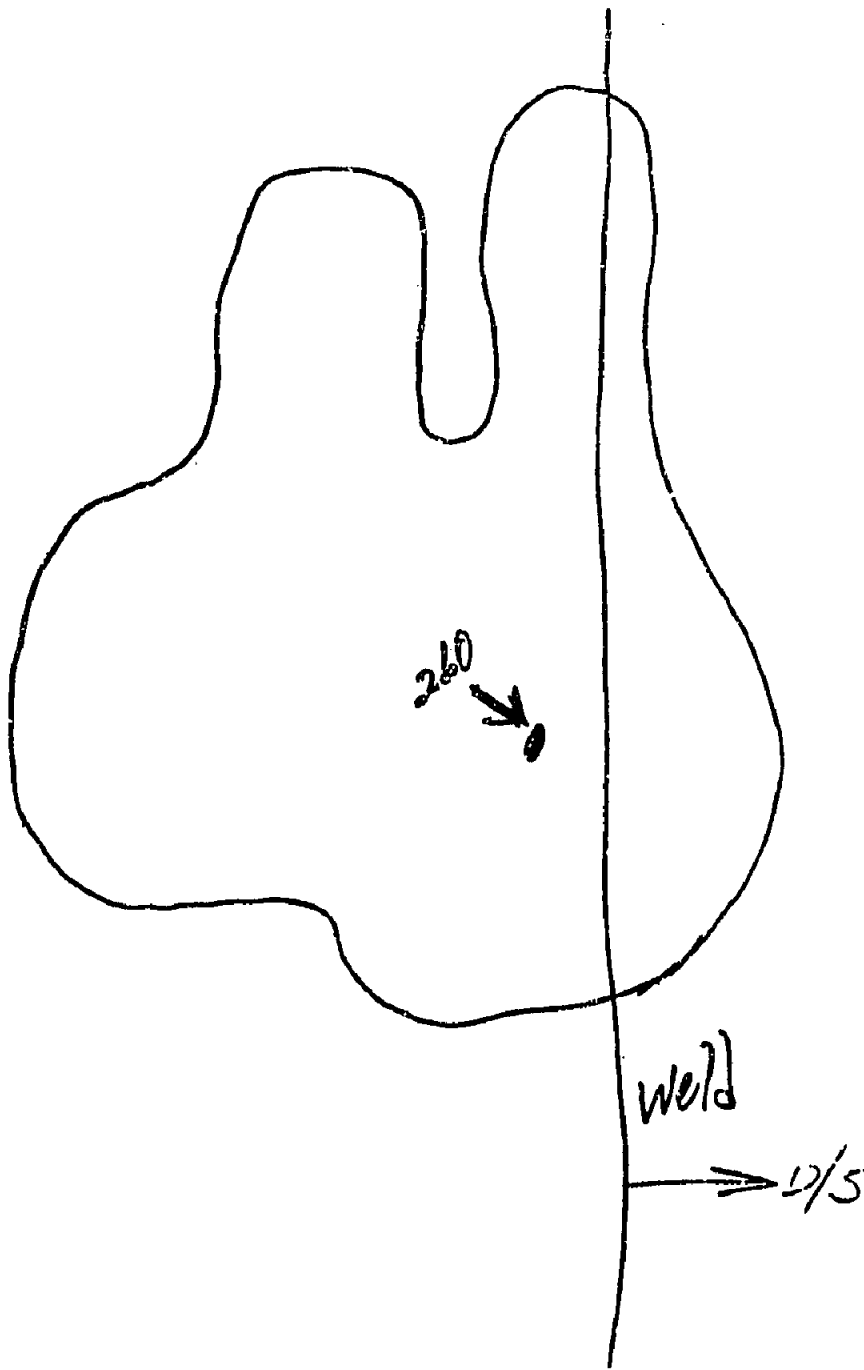
Figure 4c.—Drawing of area and deepest penetration of corrosion in No. 15 pipeline south of State highway 52.

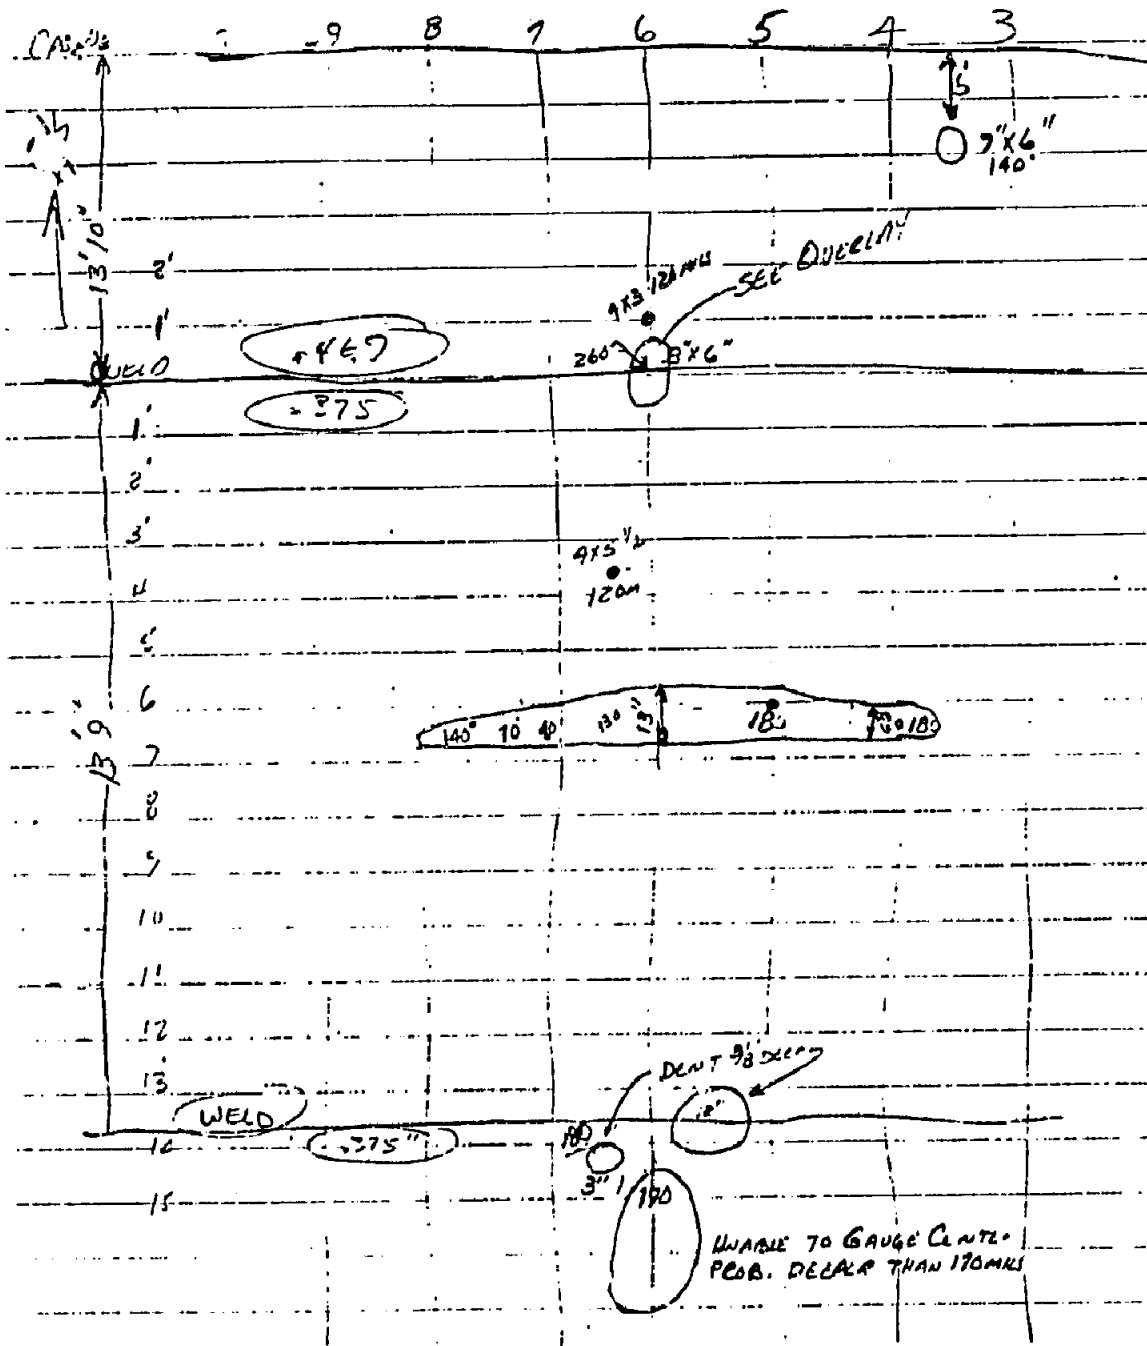
Figure 4d.—Drawing of overall corrosion areas and depths of penetration on No. 15 pipeline south of State highway 52.

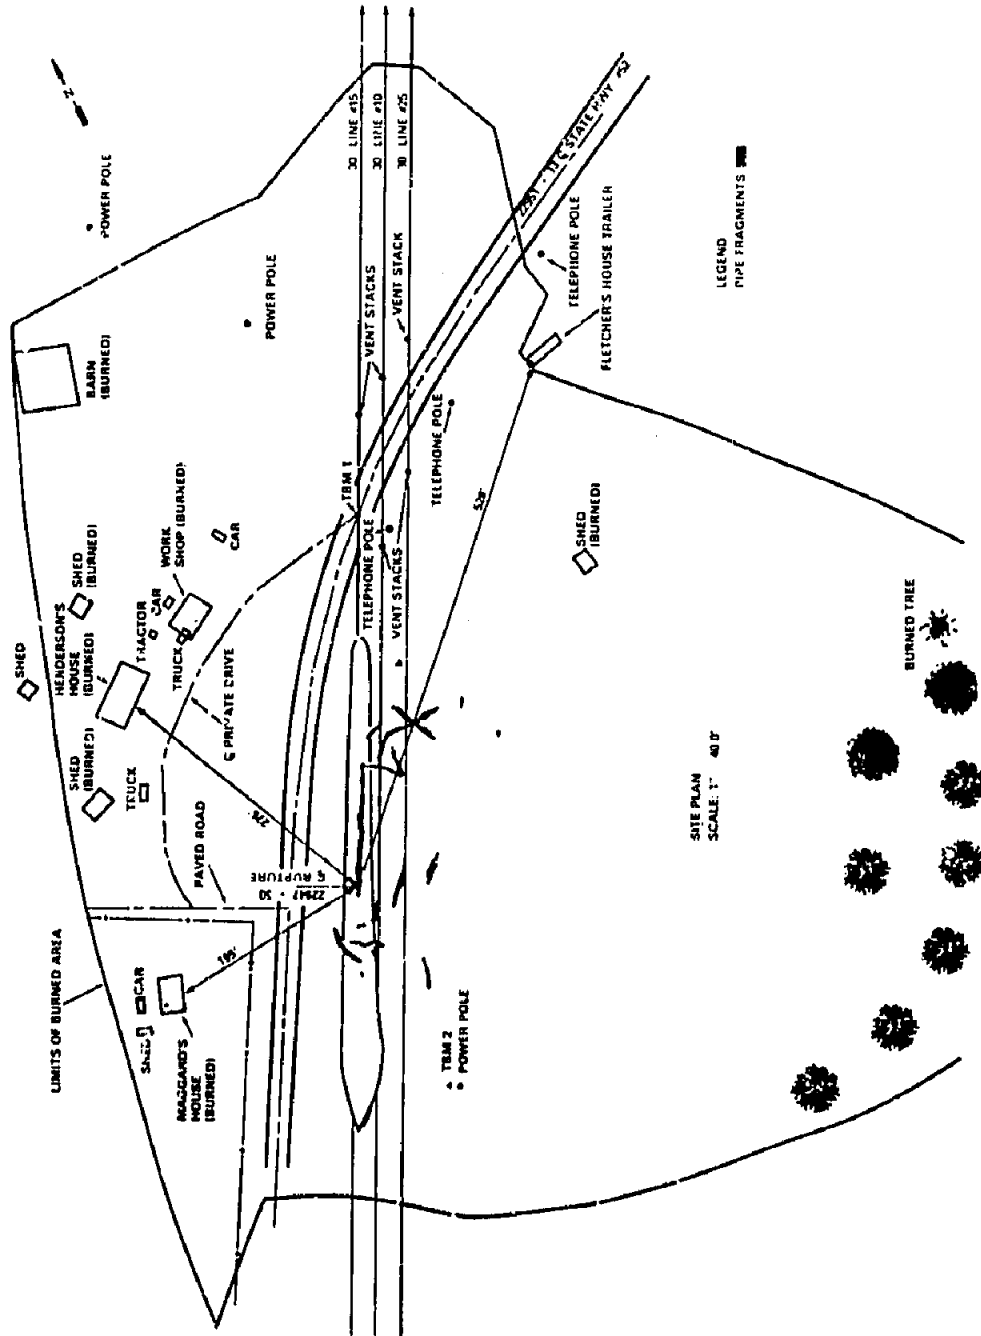
Figure 5.—Diagram of the accident site at Kentucky State highway 52.

The escaping natural gas ignited almost immediately and incinerated an area extending more than 900 feet north and south and 1,000 feet east and west. Three persons were burned as they escaped from their frame house located 280 feet west of the rupture and five other persons suffered minor injuries; two persons were burned as they ran from a trailer house located 525 feet north of the rupture and three persons were burned as they ran from a brick house located 200 feet southwest of the rupture. The two houses were destroyed by fire and the house trailer was damaged beyond repair due to the heat of the fire and by debris propelled by the force of the escaping gas. Two barns, several small buildings, and four automobiles were destroyed and about 15 acres of pasture and woodland were burned. Seventy-seven persons were initially evacuated from the area, but were allowed to return to their homes later the following day. (See figure 5.)
