# HIGHWAY ACCIDENT REPORT

MULTIPLE-VEHICLE COLLISION  
FOLLOWED BY PROPYLENE CARGO-TANK  
EXPLOSION, NEW JERSEY TURNPIKE, EXIT 8

SEPTEMBER 21, 1972

REPORT NUMBER: NTSB-HAR-73-4

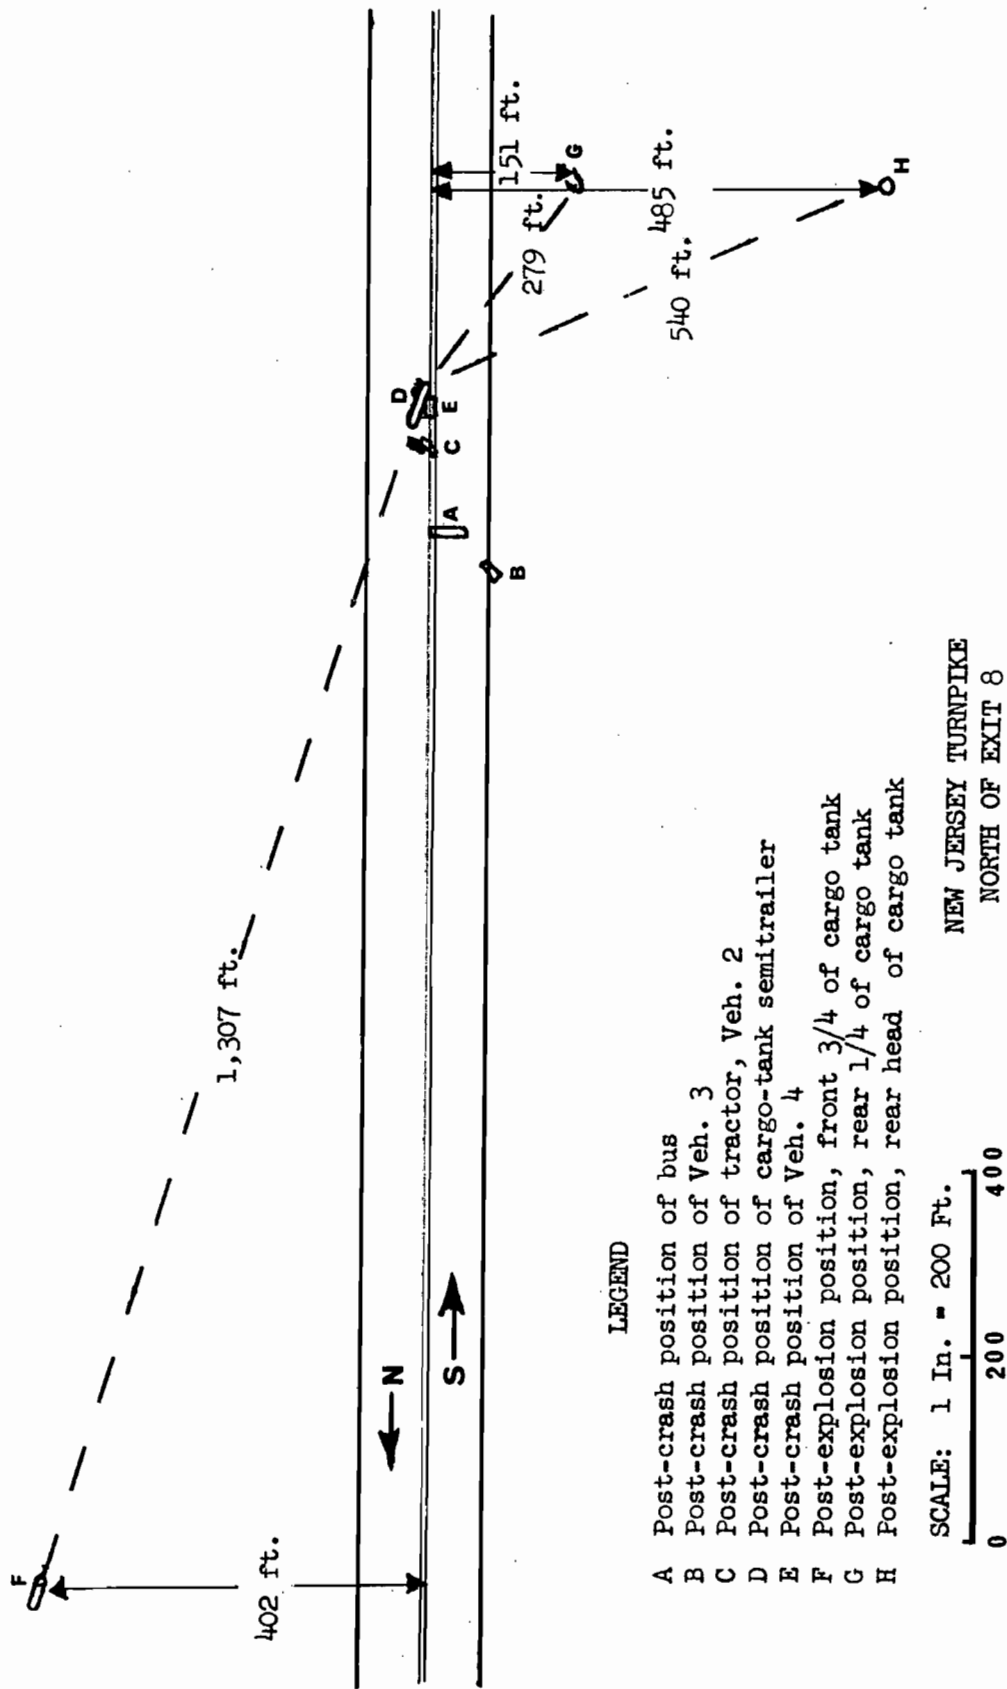
Figure 2. Distribution of cargo-tank segments after explosion.

About 20 or 25 minutes after the crash, the fire at the cargo tank momentarily subsided and then resumed with a loud hiss and roar. The tank exploded in a huge ball of fire which inflicted burns and other injuries to 28 persons, including 7 police officers and at least one bystander who was 600 feet south of the explosion. However, no one was killed or seriously injured in the explosion. (See Figure 2.)

The tank shell was recovered in three sections. The front section, about 27 feet long or three-quarters the length of the tank was found 1,307 feet northeast of the explosion point and 402 feet east of the highway center. The rear head was 540 feet southwest, and the rear one-quarter of the cylindrical section was 229 feet southwest of the explosion point. Parts of the trailer suspension and the two axles, with the tires burned off, were found along the eastern embankment of the turnpike. When first seen, the axles and wheels were glowing with heat. Other tank parts or components were found at various points along an 850-foot line generally southeast of the explosion point. The right-front pair of trailer wheels, with tires smudged but still useable, were found about 180 feet southeast of the explosion point. The wheels were attached to a 6-inch stub of box-section trailer axle.

The fact that the opposite sections of the tank did not travel in diametrically opposite directions resulted in part from the fact that the top of the tank was the last to fail and in part from the poor aerodynamic qualities of the two rear portions.

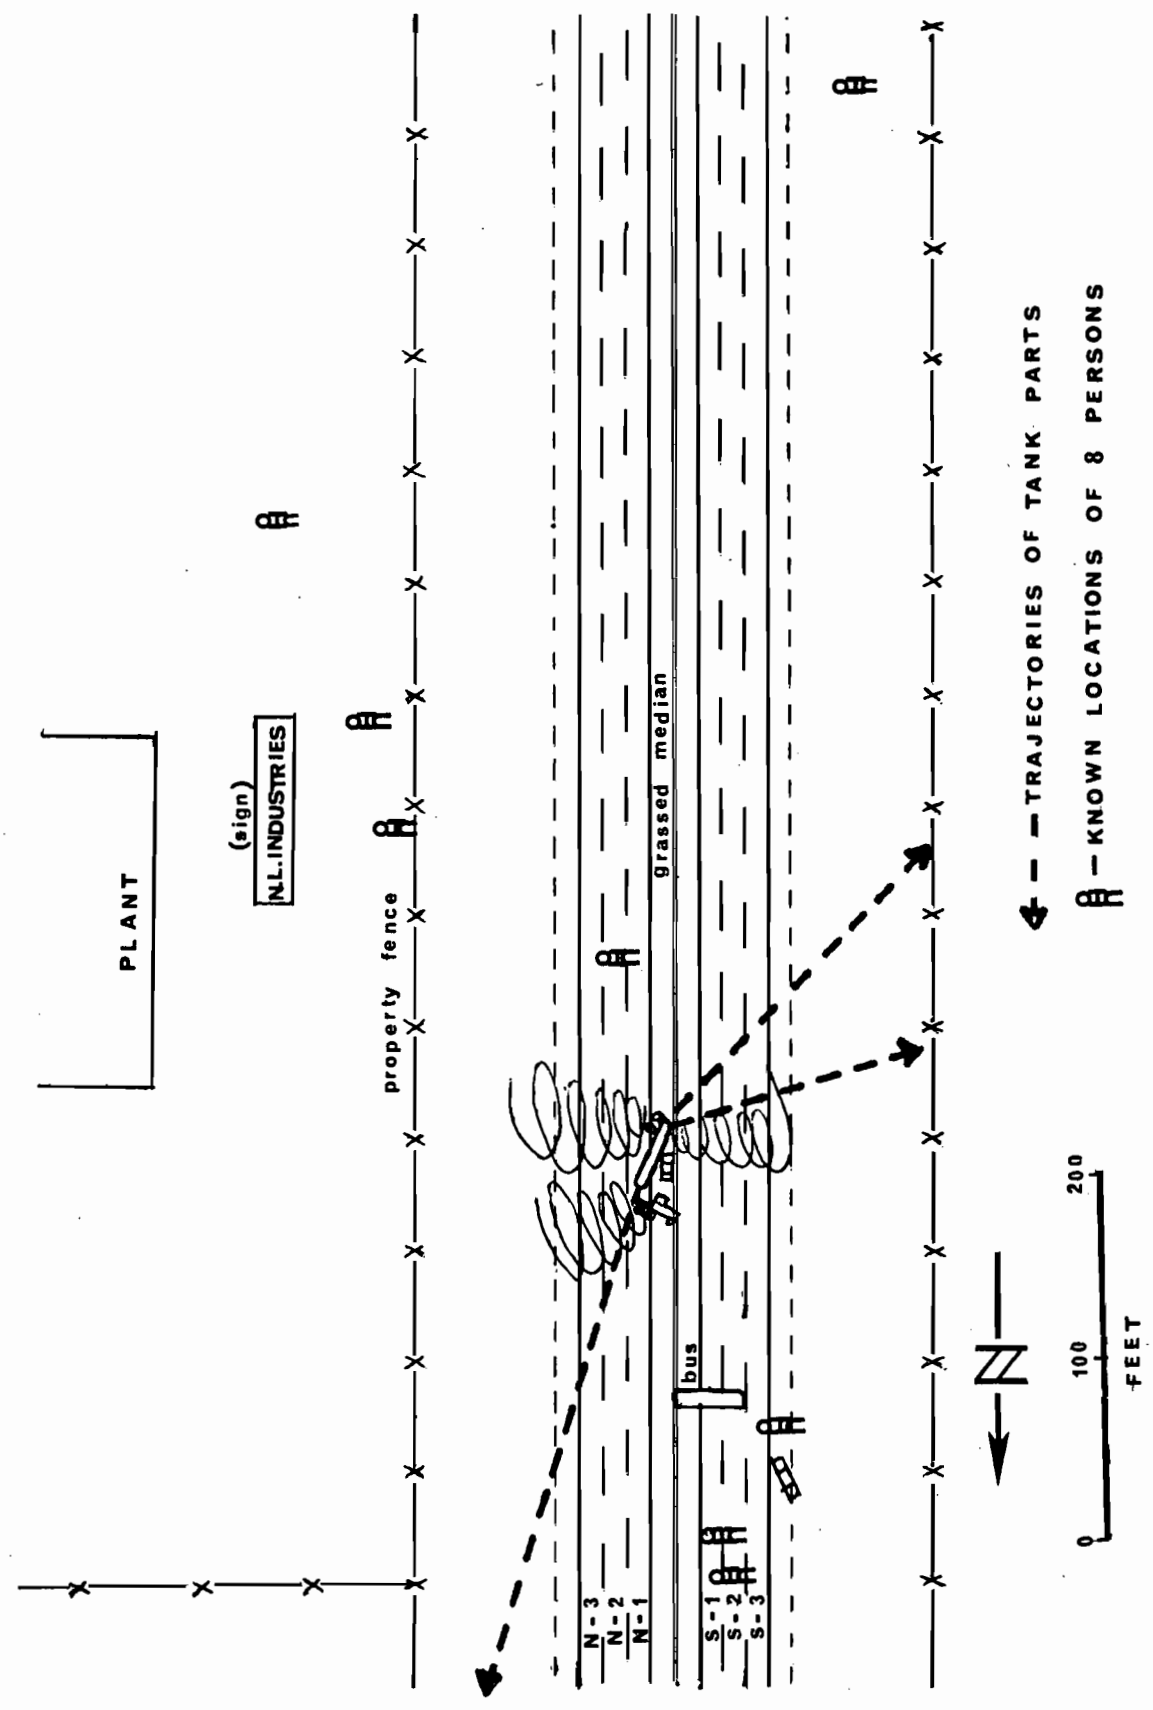
Figure 3. Distribution of persons injured in cargo-tank explosion.

The injury of seven of the eight police officers at the scene attests to their continuing efforts to control the crowd. However, their proximity to the burning cargo tank suggests a lack of awareness of the potential danger. How far the police could or should have gone in requiring evacuation of the area is a question which needs to be examined and resolved by the police profession. In metropolitan corridors like the New Jersey Turnpike, responsible police authorities might be expected to have a working knowledge of the risks, effects, and countermeasures associated with all potentially catastrophic types of highway accidents, so that important field decisions can be made and implemented with minimum delay.

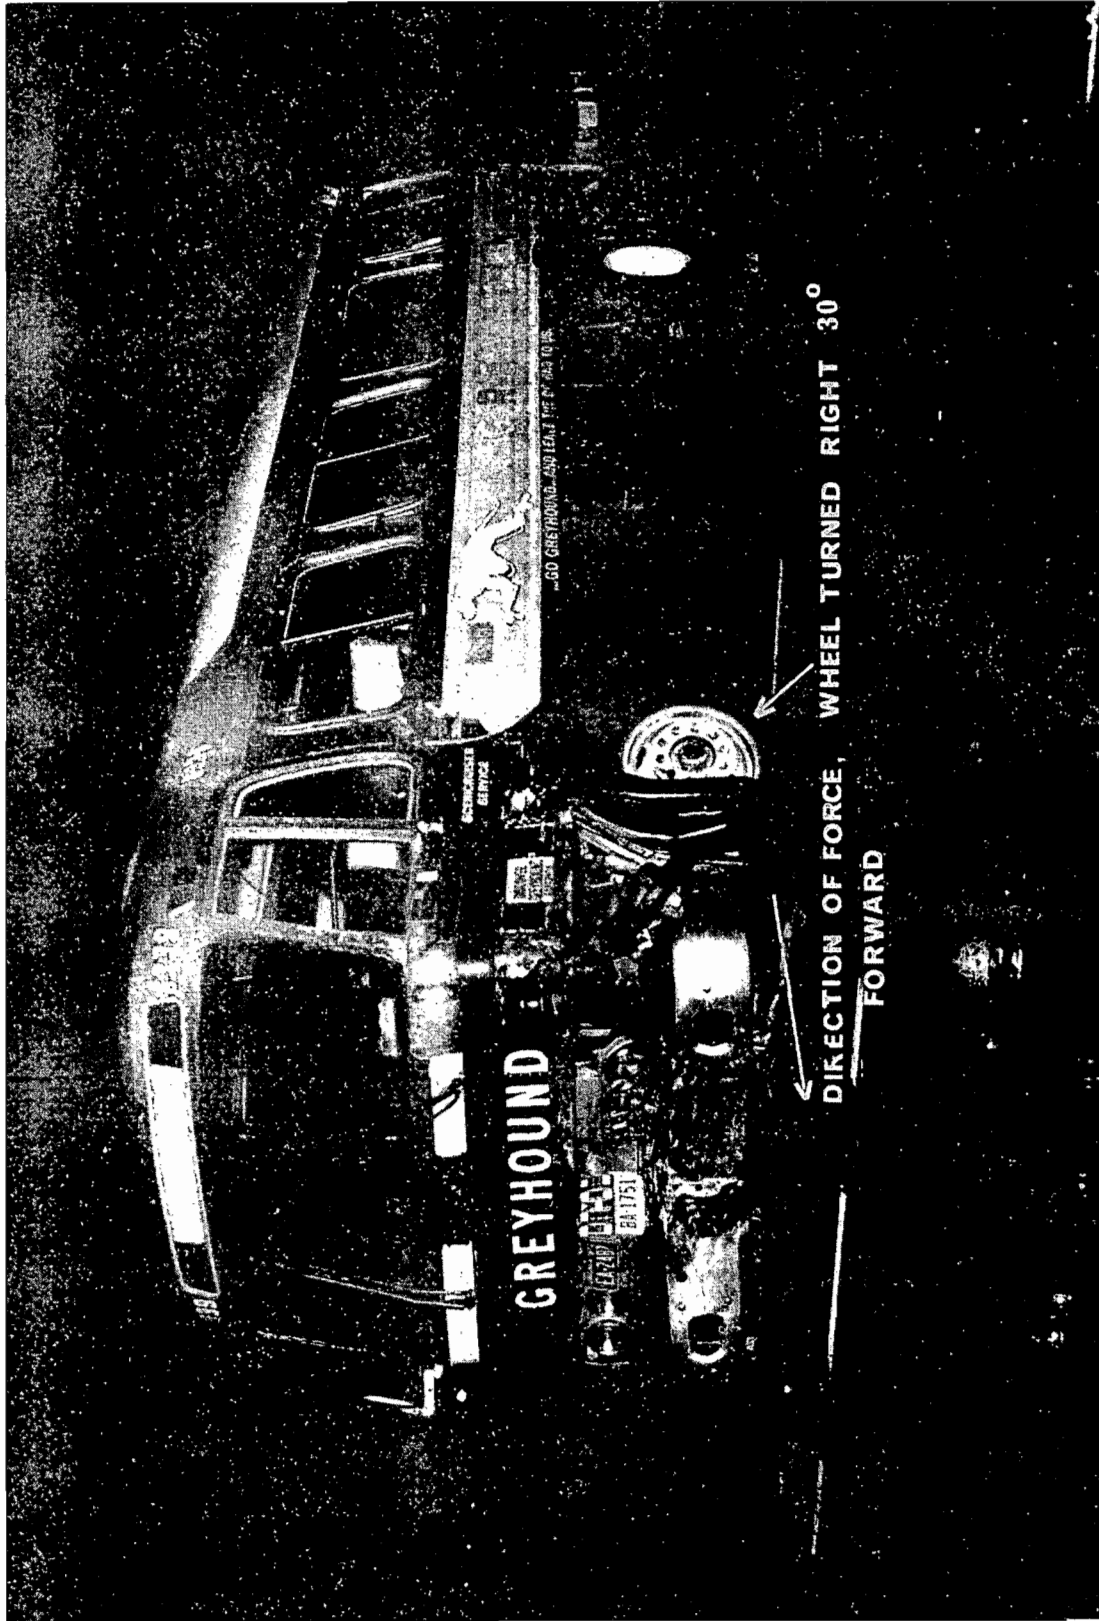
Figure 5. Left side of Greyhound bus.

Accident damage consisted of a dented front bumper and dented body panels, with a residue of white paint in these areas. The lower left-front body in front of the left-front wheel was torn away, with damage extending to air lines, hoses, and wiring. A shallow smudged indentation was on the side panel just behind the driver's window about 6 feet aboveground. The lower left rear of the bus behind the rear wheels was crushed inward. The windshield was loose in its mount but was not cracked; the left A-pillar was deformed about 1 inch away from the glass. At the extreme left-rear top of the bus was a 6-inch indentation, with about 2 inches of localized rightward distortion of the upper body. The driver's window glass was missing, as was the forward pane of the first left-side passenger window. All other left-side windows, except one, had random spiderweb cracks. The left-rear quarter window was missing,

but the rear window and right-rear quarter window were undamaged. There was no damage to the right side of the bus. (See Figure 5.)

The smudged indentation on the left body was said to have resulted from flying parts of the exploding cargo-tank, as were the indentation and rightward bending at the top rear. Cracking of side windows was believed to have been caused by the concussion of the explosion.

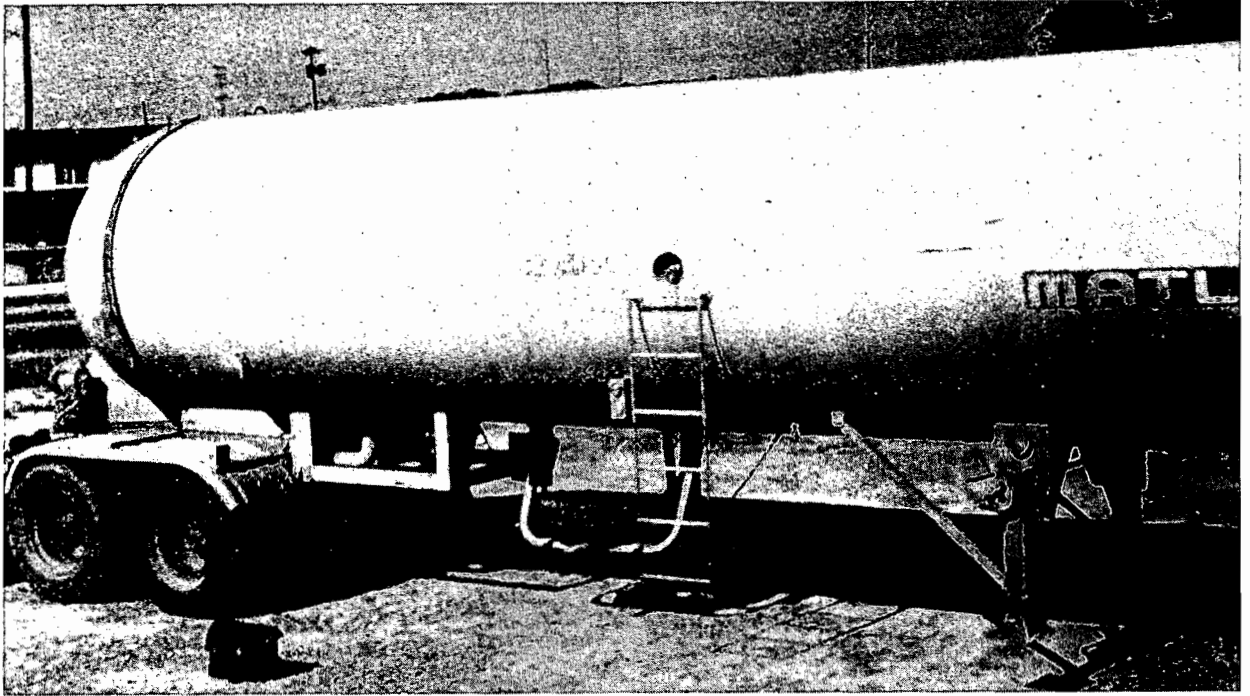
Figure 6. Sister vessel of the wrecked cargo-tank semitrailer.

Examination of wreckage. All recovered parts of the tractor-semi-trailer (and the other three vehicles) were taken to a turnpike maintenance yard adjacent to Exit 8, where they were examined in detail. A sister cargo-tank semitrailer (and, later, blueprints) was made available by the carrier and was used, together with the blueprints, to identify and locate various damaged components. (See Figure 6.)

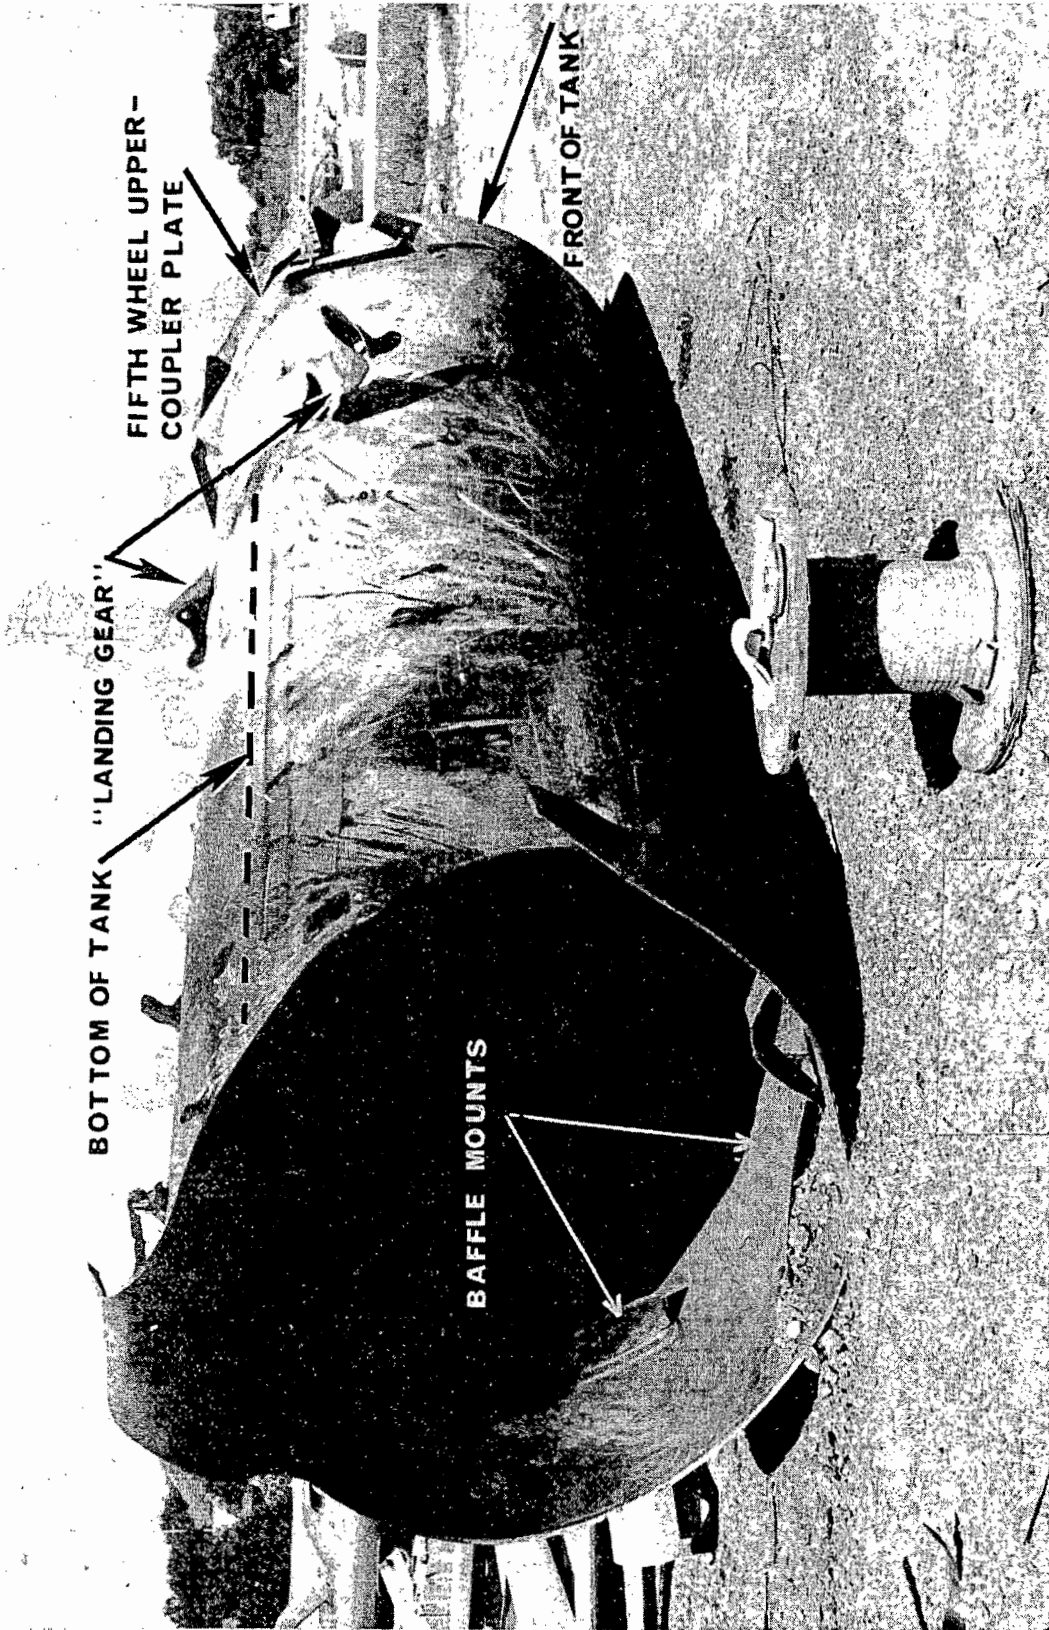
Figure 8. Front portion of the cargo tank.

Other than the fifth-wheel separation, no damage could be associated with the overturn of the tractor or semitrailer after the jackknifing. There were no lateral score marks on the cargo-tank body to indicate that it slid on its side, although there were numerous longitudinal and diagonal score marks. Only the mounting pads, with twisted and broken plates or brackets, remained attached to the outside of the tank shell. Three of the four baffle-plate mounts at the fractured open end of the largest tank section had been bent inward or sheared off; considerable loose earth was inside the tank shell. (See Figure 8.)

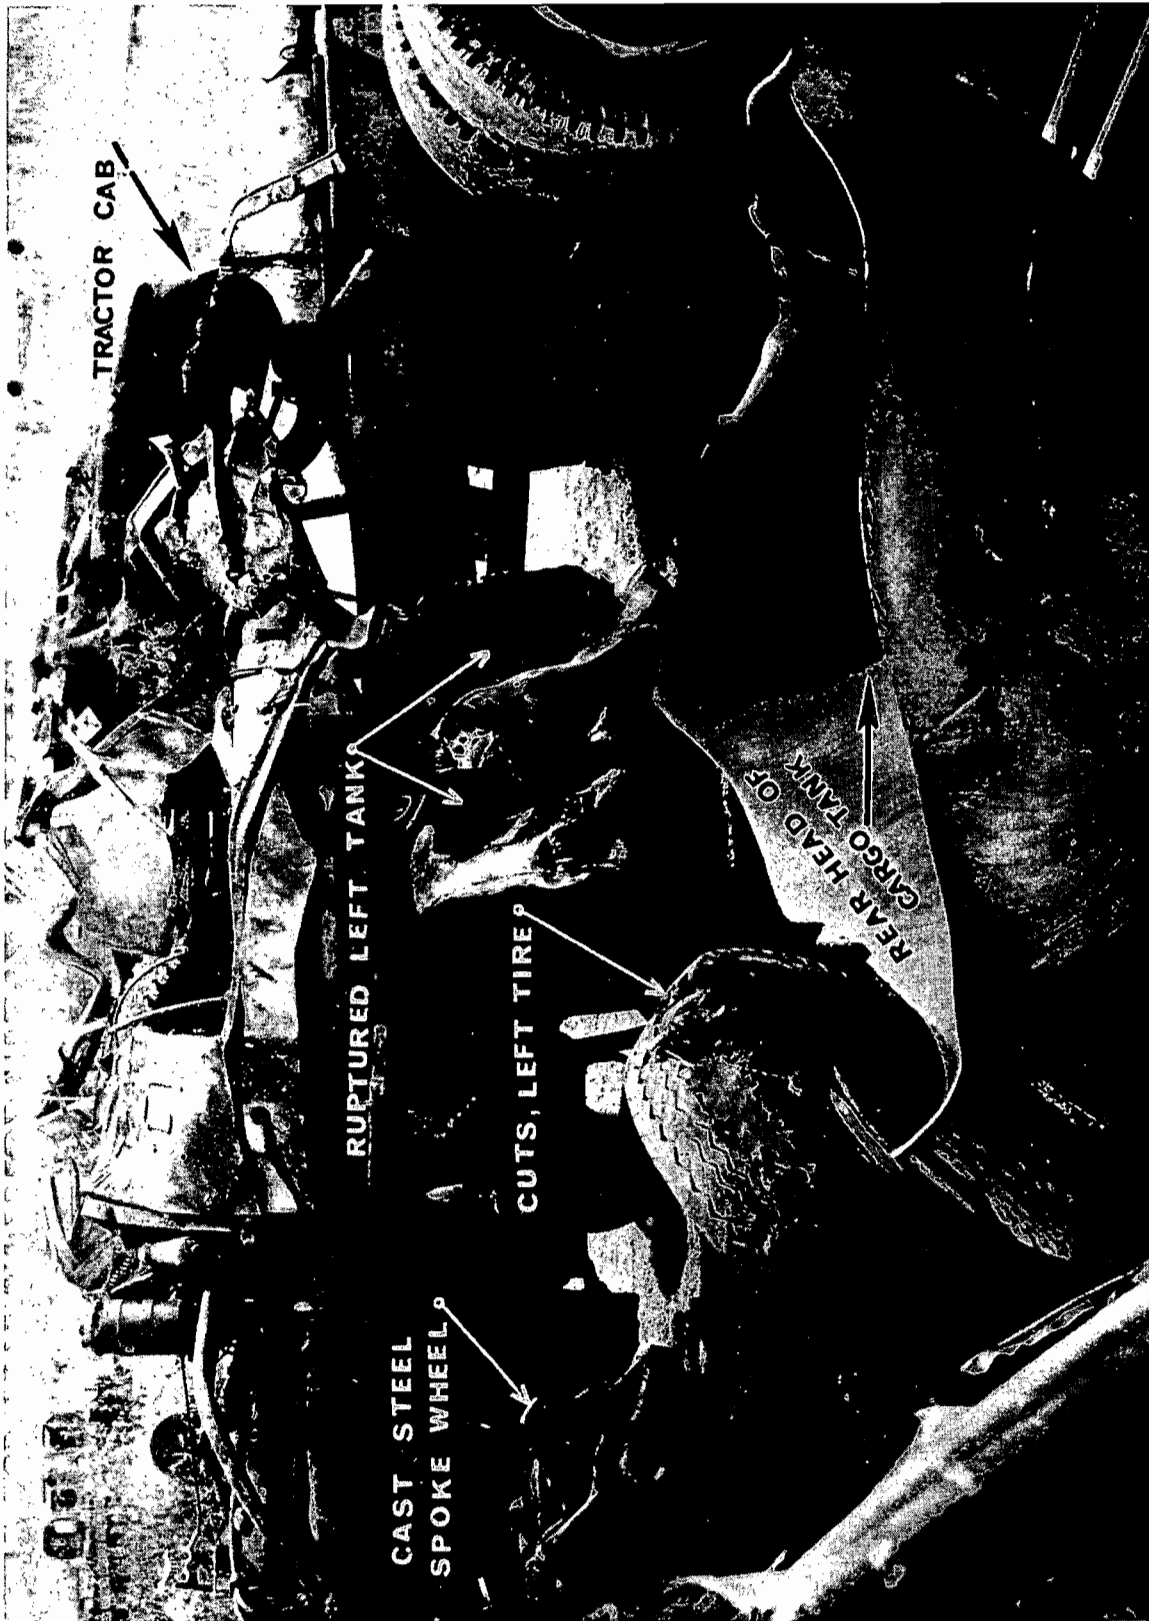
Figure 9. Tractor and rear head of cargo tank.

After the explosion, the tractor, demolished and lying on its top, was found 74 feet from the bus. Witnesses could not say whether the tractor had rotated three-quarters of a turn away from the explosion or one-quarter turn into it. The upper cab was crushed toward the right. Drippings of melted aluminum or pot metal, along with scorched paint and fire damage on the right-side fuel tank, indicated extensive burning while the tractor was in two positions, the first about 100° and the second 160° to the left of its upright position.

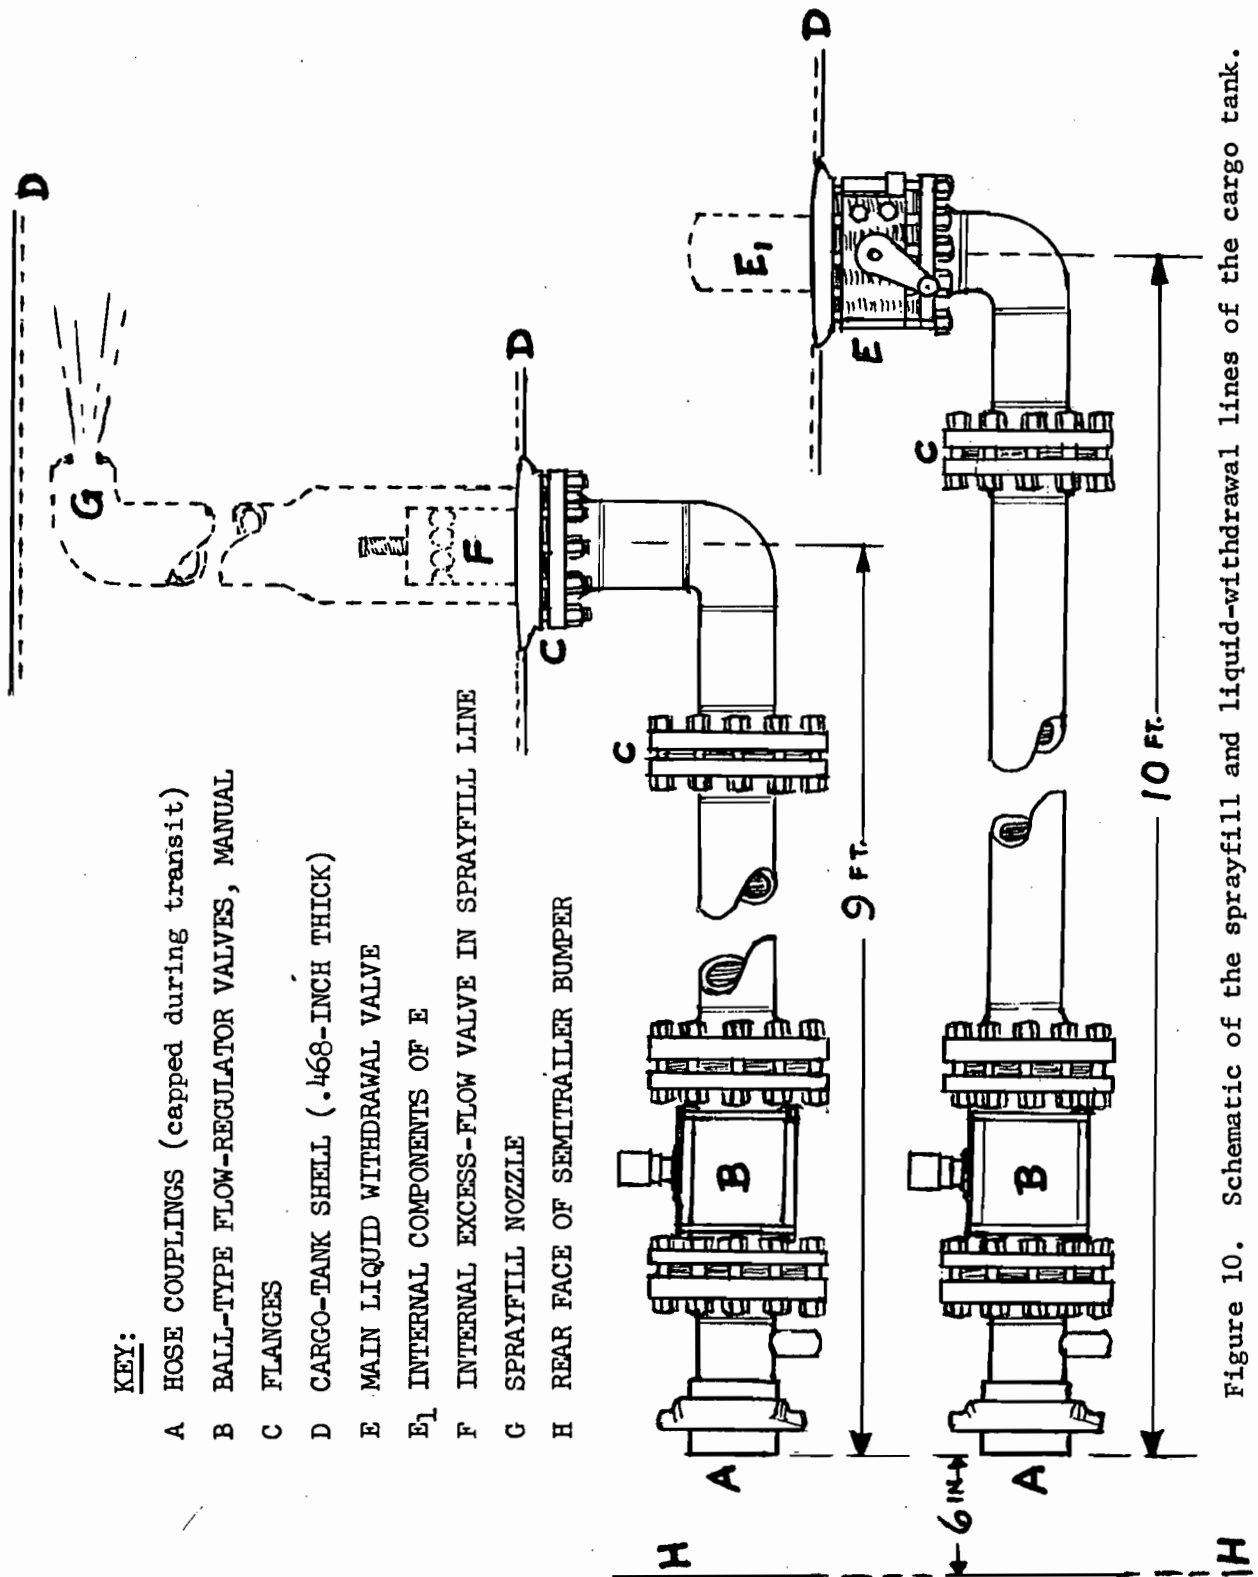
Figure 10. Schematic of the sprayfill and liquid-withdrawal lines of the cargo tank.

Cargo-tank plumbing. Both the external sprayfill line and the liquid withdrawal line were found in many segments. (See Figure 10 and Appendix D.) It was impossible to determine whether any fractures had occurred before the explosion. The withdrawal shutoff valve, mounted adjacent to the tank body, showed marked rotational distortion and horizontal separation. The aluminum valve body was also partially melted. There was no evidence found to indicate whether damage to the valve body had occurred in the explosion or in the pre-explosion crash, or in both.

When the tank-semitrailer rode down the median guardrail, and the front tires (and rims) of the tractor broke away, it was possible that loosened median rails or the loose tires either penetrated the plumbing guard or, coming up from below, placed severe rearward or vertical stresses on the plumbing. Furthermore, since the spare tire and hanger were probably raked loose by the median guardrail, the loose spare tire was probably tumbling free beneath the cargo tank. The trailer dual wheels, amputated from the trailer's front axle, could also have come up beneath the plumbing. The wedging of any of these items could have broken the plumbing without sufficient lateral force to separate completely the frangible flange bolts, which would have activated the cut-off feature of either the sprayfill or the liquid withdrawal systems.

Regulations regarding the plumbing guard (49 CFR 178.337-10) do not specify protection from potential impacts on the plumbing from below. In this accident, such an impact probably occurred with sufficient force to fracture the plumbing but without necessarily damaging the plumbing guard.

Because of its design, the external sprayfill pipe contains liquid during transport. A fracture in the external pipe can permit the escape of liquid propylene without necessarily activating the excess-flow valve. The excess-flow valve spring, balanced to hold the valve in an open position when the tank is upright, is no longer in balance when the tank is on its side. Without gravity to assist in closing the valve, a considerably greater outflow is permitted before the valve shuts than would be permitted with the tank upright. This differential in flow was not calculated in this accident because of the absence of pertinent data. It is evident, however, that a flow-check valve, with its spring balanced to hold the valve shut, would work equally effectively with the tank in any position, and would have stopped any outflow from even a minor fracture in the pipe.

The automatic shut-off feature of the liquid withdrawal valve (Fisher C-302A-43) used on the cargo tank would not activate unless there was full breakaway of the external valve body. Thus, a substantial leak could have been caused in the valve body without concurrent fracture of the frangible bolts; as previously stated, a vertical force imposed from below would have permitted this.
