**PROPANE TRUCK COLLISION WITH
BRIDGE COLUMN AND FIRE
WHITE PLAINS, NEW YORK
JULY 27, 1994**

HIGHWAY ACCIDENT REPORT

**Adopted: November 14, 1995
Notation 6479A**

**NATIONAL
TRANSPORTATION
SAFETY BOARD**

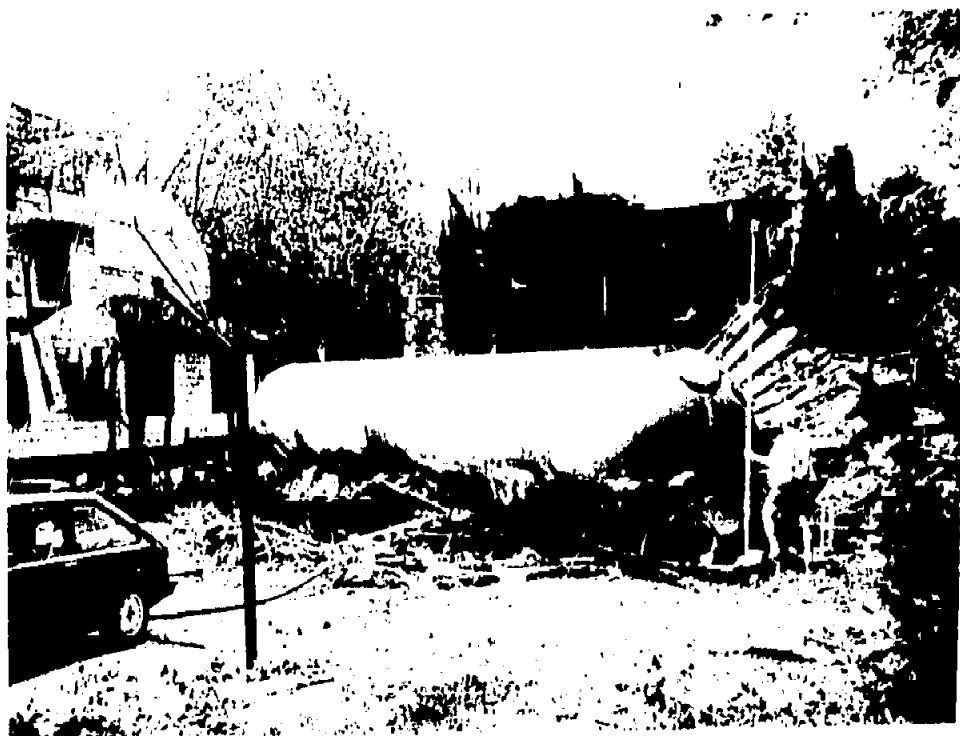
Tank -- The amount of crush in the front head was about 21 inches. The separation was between the 9 and 2 o'clock position, looking aft (where the 12 o'clock position is defined as the top of the cylinder) along the heat-affected zone of the weld. The fracture then left the circumferential path and extended forward in the cylinder head and returned to the 9 o'clock position. (See figure 9.)

Figure 9. – Front and rear views of tank at rest at 103 Clinton Street
(top photo by Mike Horn; bottom photo by Chas. H. Sells, Inc.)

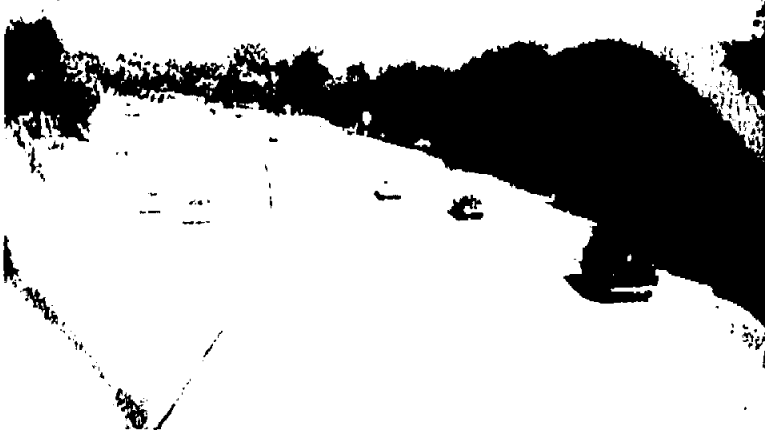
A -- Looking west from Grant Avenue overpass at box beam guardrail

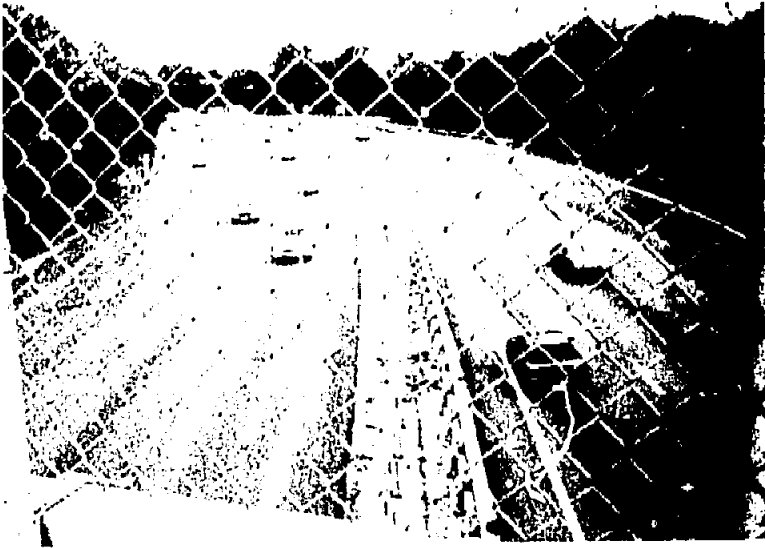
B -- Looking west from Grant Avenue overpass at strong post block-out guardrail

The blocked-out W-beam (strong post) barrier system in place at the time of the accident was a standard design that had been used by the NYSDOT since 1979. After the accident, the guardrail was replaced with another guardrail of the same design. This system is the most common barrier system in use today, but it was designed primarily to protect passenger cars by redirecting them from roadside obstacles. It is classified as an operational semi-rigid system by the AASHTO *Roadside Design Guide*, which means that it has demonstrated satisfactory field performance in terms of construction and has been successfully crash tested for automobiles.³⁴ In crash tests, this barrier was marginally successful in redirecting two pickup trucks weighing 3,260 and 4,179 pounds, respectively.

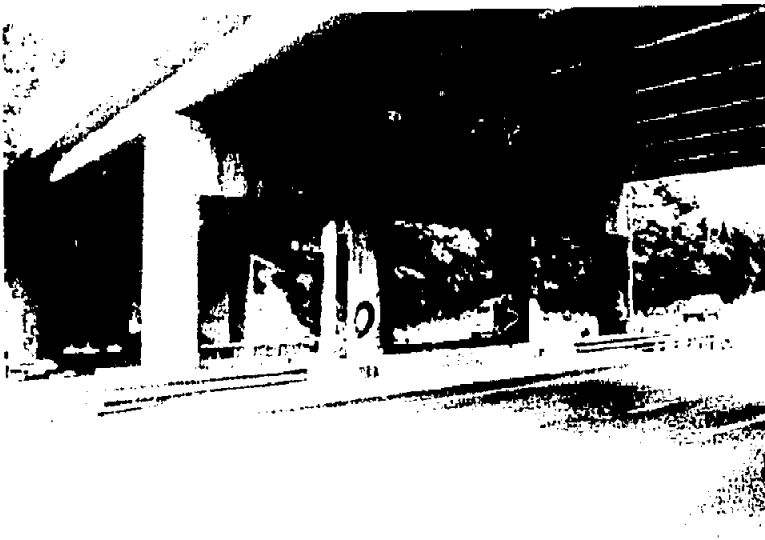
Figure 12.

C -- Attachment of W-beam guardrail to concrete barrier

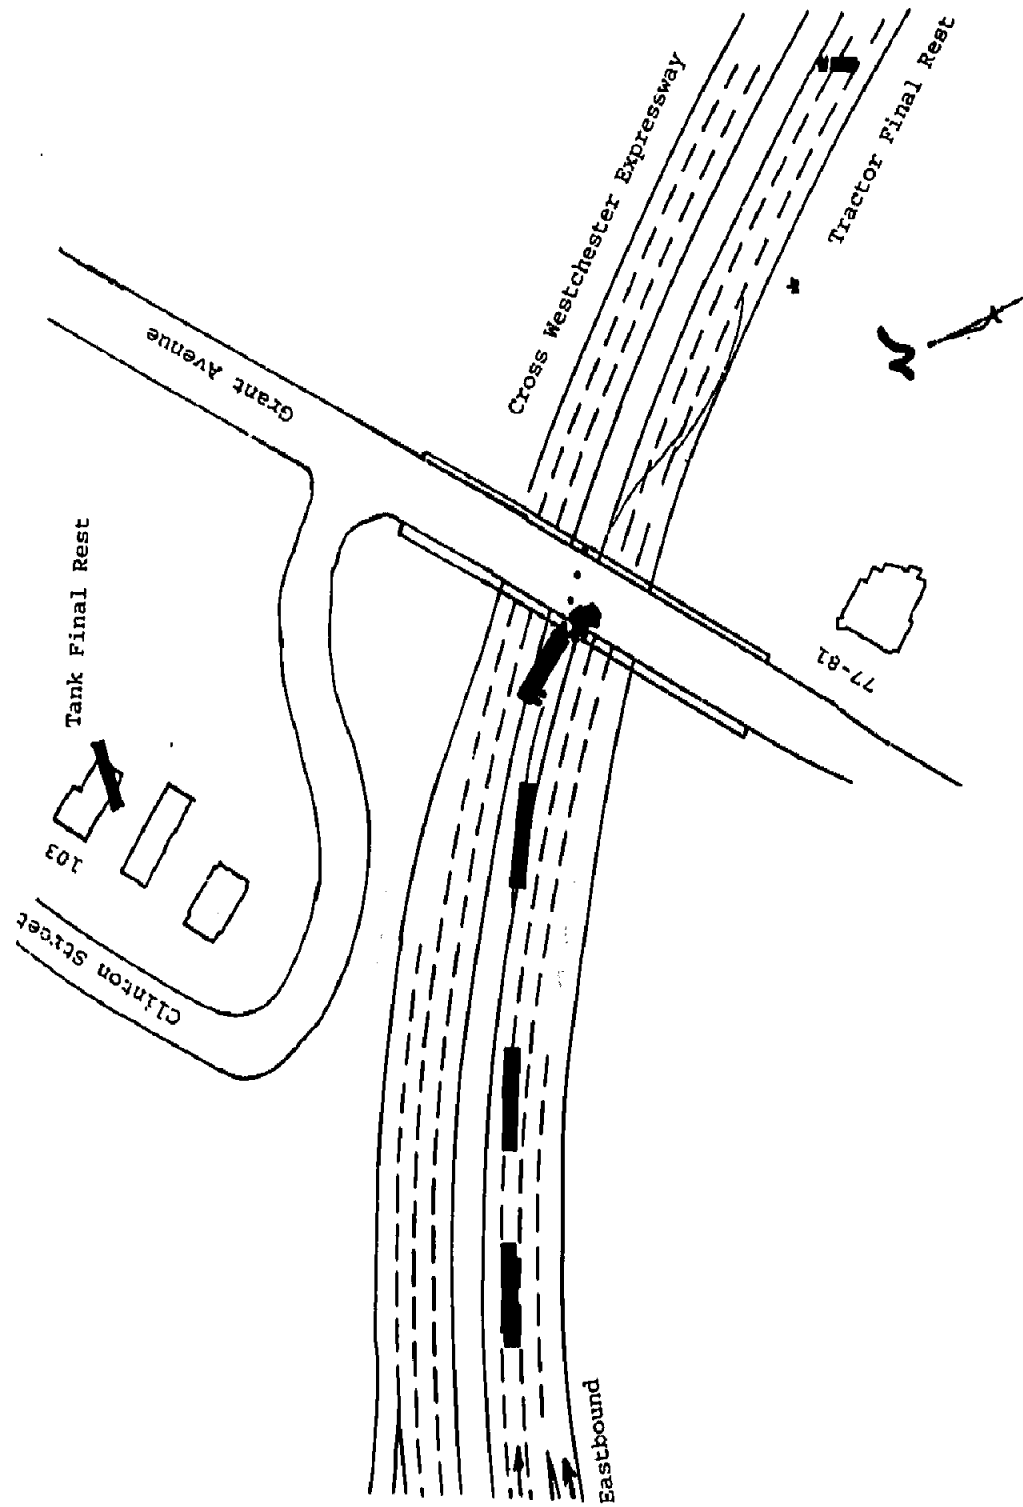
In the collision, the tank sheared the bridge column off. The force of the impact caused a catastrophic failure of the tank.

Figure 15. - Rollover sequence
