NATIONAL TRANSPORTATION SAFETY BOARD

HIGHWAY ACCIDENT REPORT

**MULTIPLE VEHICLE CROSSOVER ACCIDENT
SLINGER, WISCONSIN
FEBRUARY 12, 1997**

**Adopted: July 24, 1998
Notation 6832B**

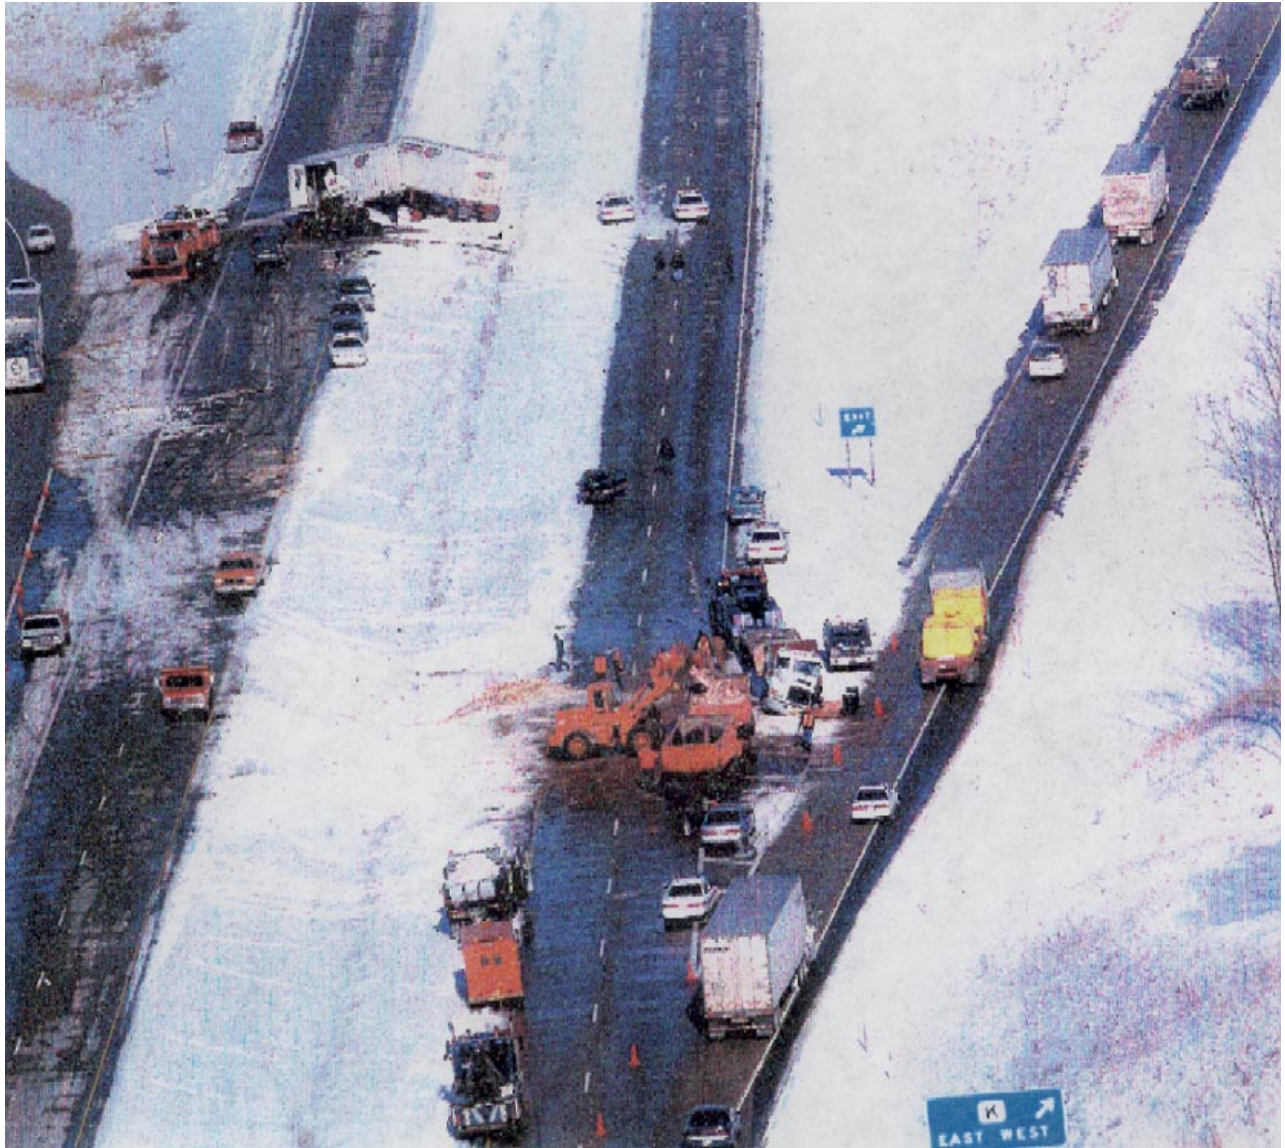
Figure 2 -- Aftermath of the accident

The doubles truck tractor was a total loss. The front of the doubles lead trailer and the top of the rear trailer both had moderate damage. The single-axle converter dolly was not damaged. The flatbed truck tractor was also a total loss, and the semitrailer sustained major damage. The passenger van was a total loss. It sustained major damage to the front, with intrusion into the driver's and front passenger's spaces. Damage to the refrigerator truck was limited to the front bumper grille and hood assembly.

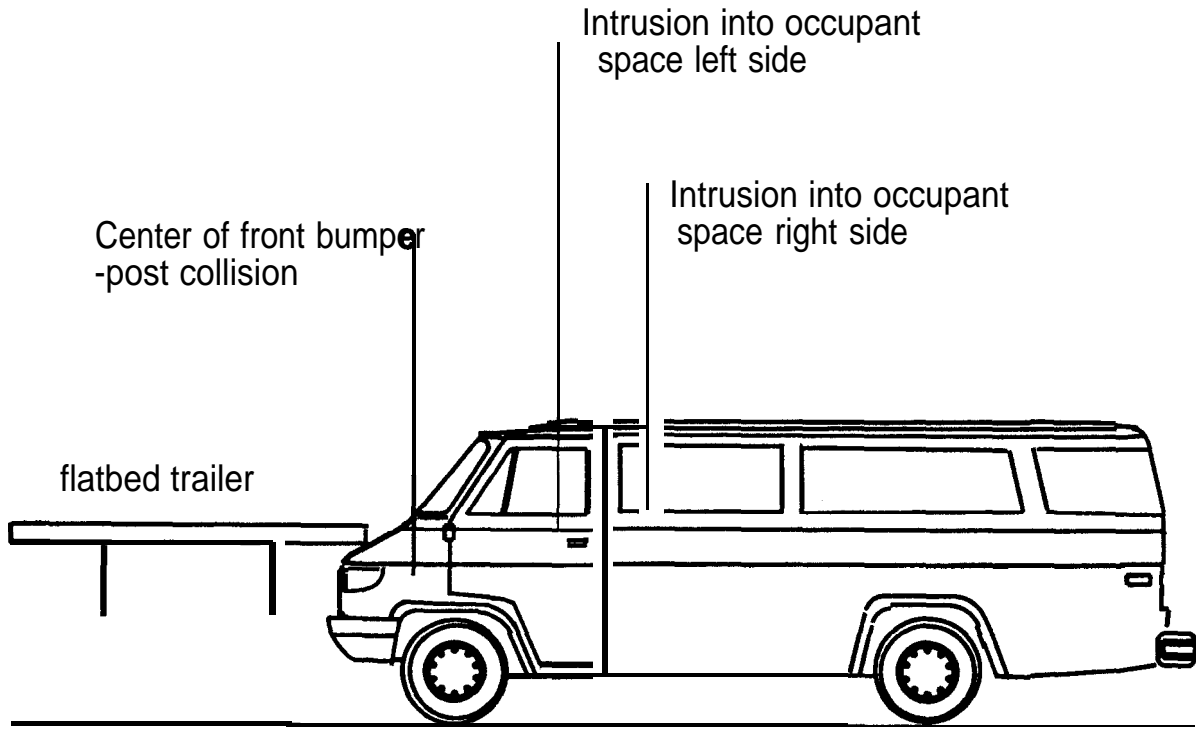
Figure 7-- Van and flatbed intrusion profile

The front bumper was pushed up and aft and showed evidence of direct contact with a rear wheel of the tractor and the landing gear of the trailer. The front wheels were displaced rearward. The grille, hood, headlamp area, radiator, and engine front had major impact damage and red paint transfers. Shearing-type impact damage affected the entire upper area of the van from across the top of the cowl/dash at the windshield opening to each A-pillar and from the front doors and the roof panel extending rearward to the driver area and the passenger seatbacks.

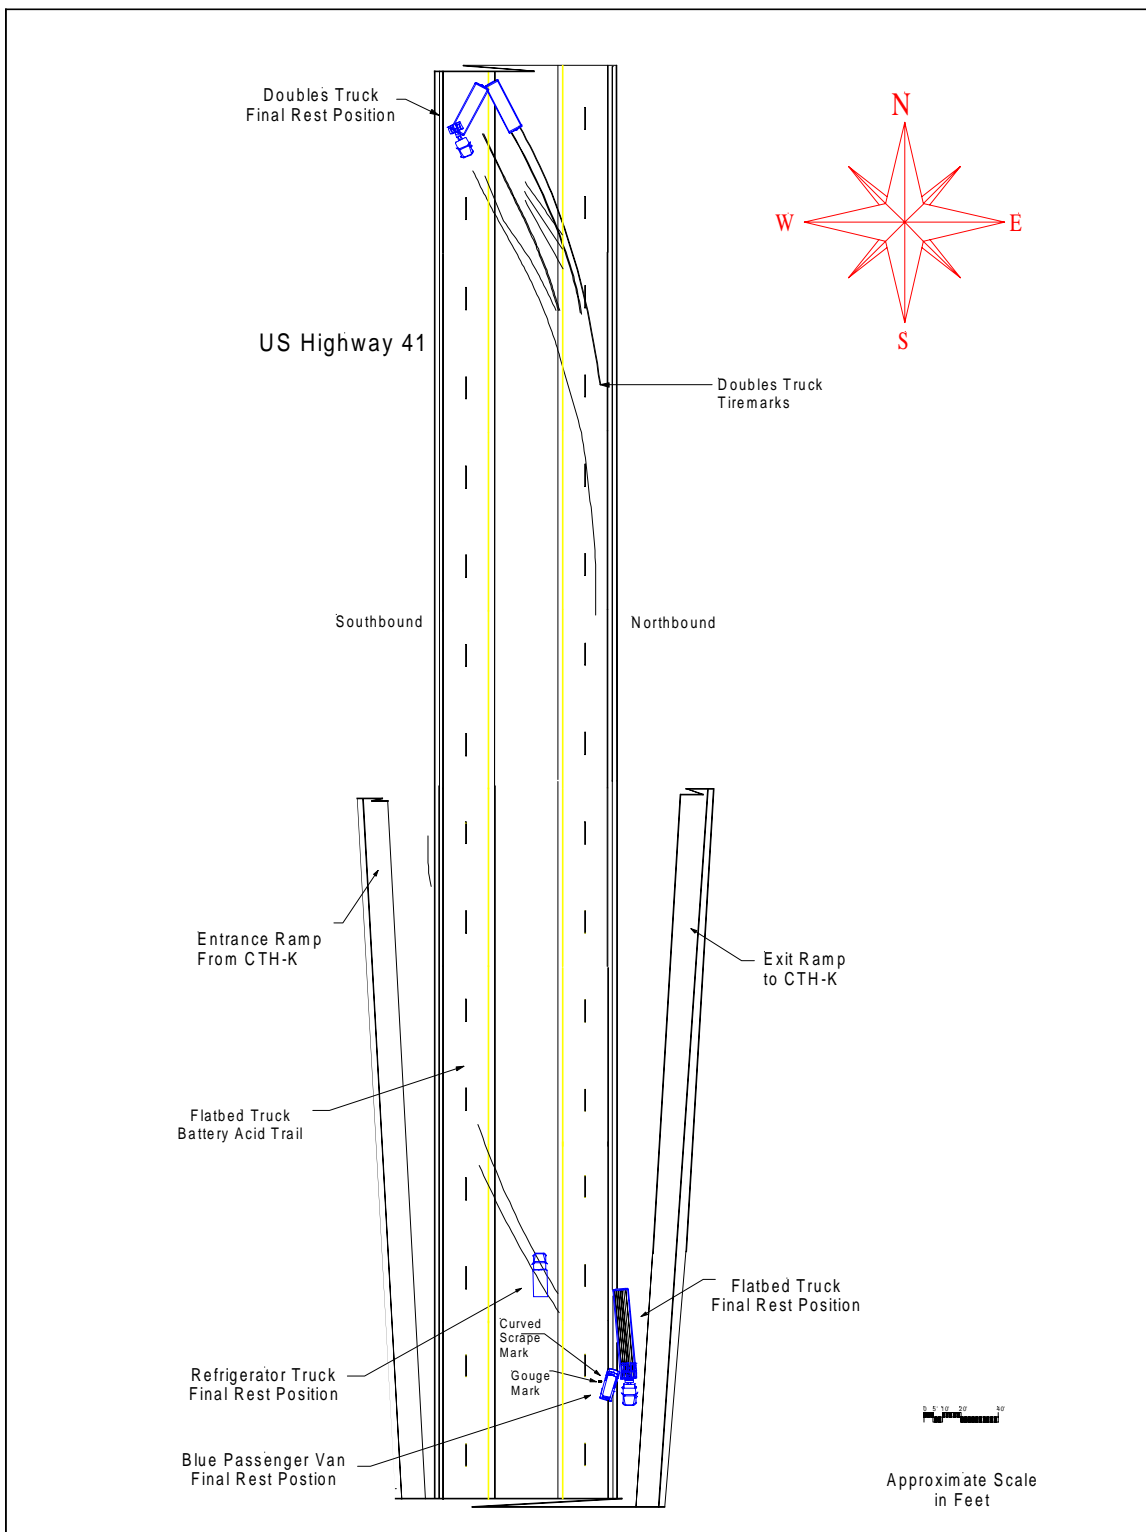
Figure 8 -- Diagram highlighting the physical evidence

The doubles truck tractor was found facing southeast in the southbound left lane; its semitrailer was facing southwest, also in the southbound left lane, and the full trailer was facing northwest in the median. Tire marks in the northbound lanes started approximately 1,260 feet south of the CTH K overpass. The 127-foot-long tire marks on the pavement began in the right lane and continued across the left lane into the median. They were clean scrub marks that started out faint and became more distinct and uniform. The 145-foot-long plow marks in the median led to the point-of-rest for the doubles truck.

The tire marks and subsequent position of the tractor and trailers as they entered the median indicate that the tractor began to jackknife toward the left. The curved tire mark that begins in the right lane leading toward the median was made by the left front (steering) axle tire and confirms that the driver tried to countersteer.

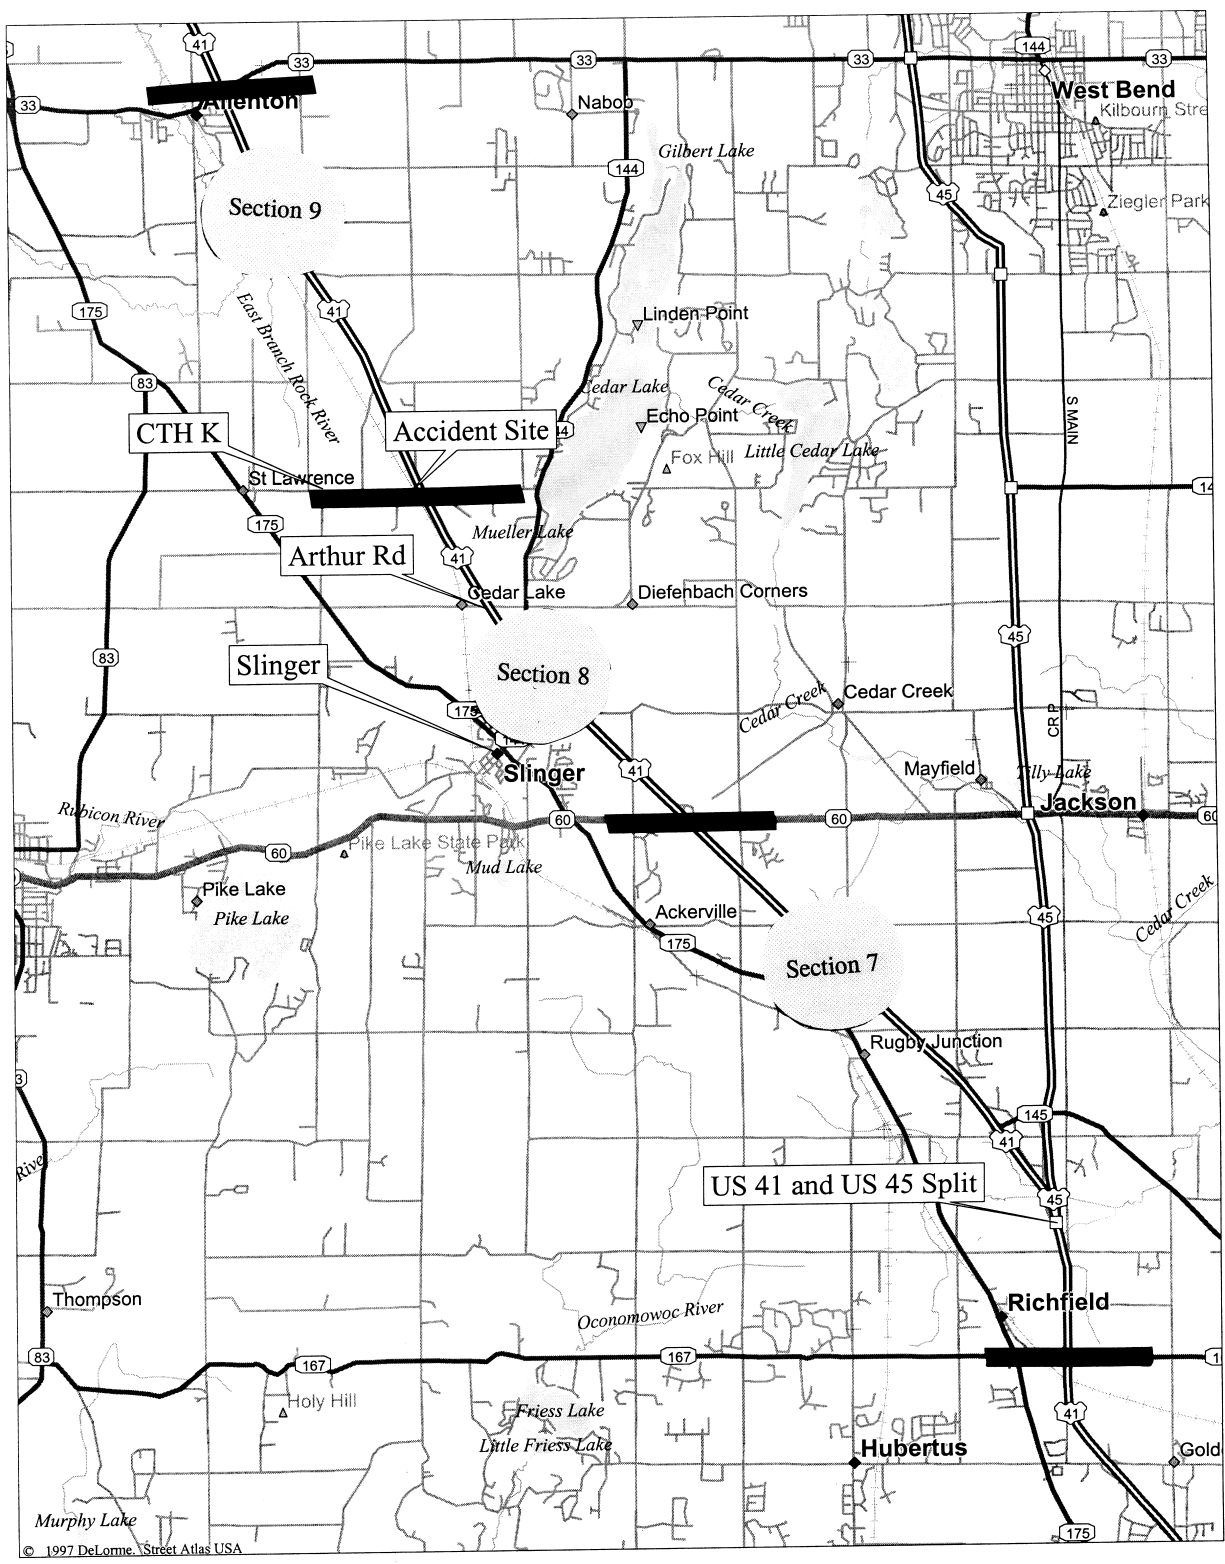
Figure 9 -- Snow section boundaries

On the morning of the accident, as the crews were plowing the blowing snow, the driver in section 8 noticed black ice forming in the right lane. He notified the other drivers, and they began applying salt and a wetting agent (liquid calcium chloride) to the roadway as well as to the ramps.

According to the drivers, it took an average of 1 1/2 to 2 hours to cover each section, including the ramps. The driver in section 8 said that, by about 5:15 a.m., he had completed a loop over the north- and southbound lanes in his section and his truck was empty. While en route to the maintenance shop to pick up another load of salt and wetting agent, he noticed that the southbound roadway was wet. He was reloading chemicals when he was advised that an accident had occurred at 5:52 a.m. in the northbound lanes near CTH K.

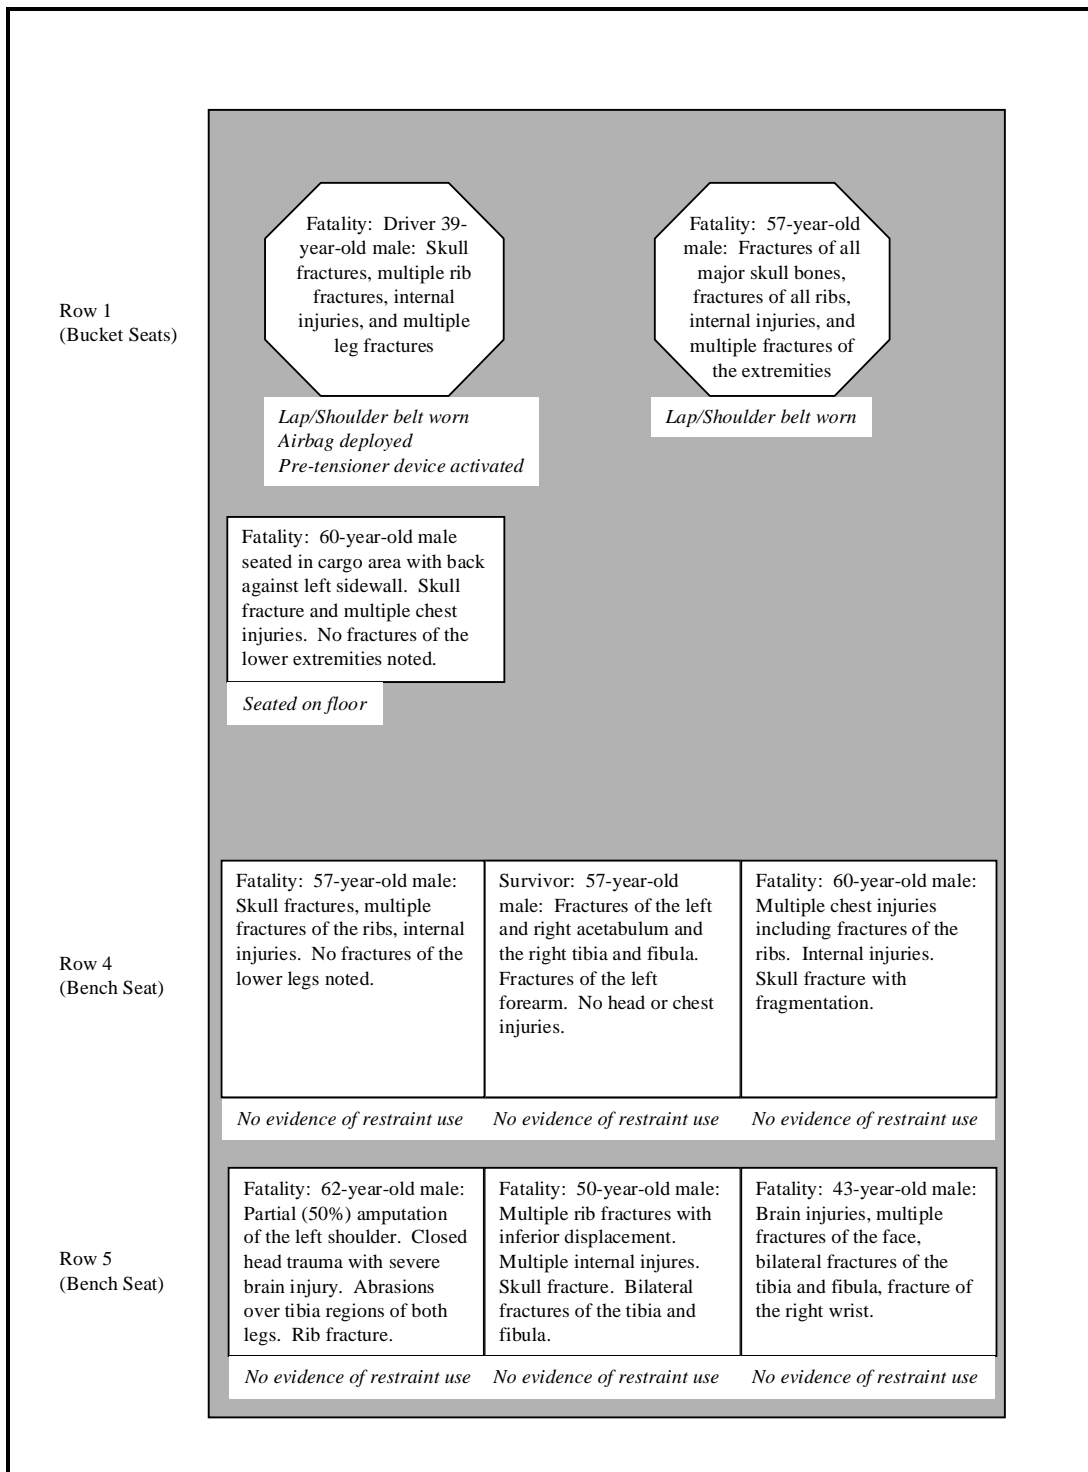
Figure 10 -- Injury distribution and restraint use

Restraint Use -- The refrigerator truckdriver, who was not injured, was wearing the available lap/shoulder belt. The doubles and flatbed truckdrivers, who received minor injuries, were both wearing the available lap/shoulder belts.

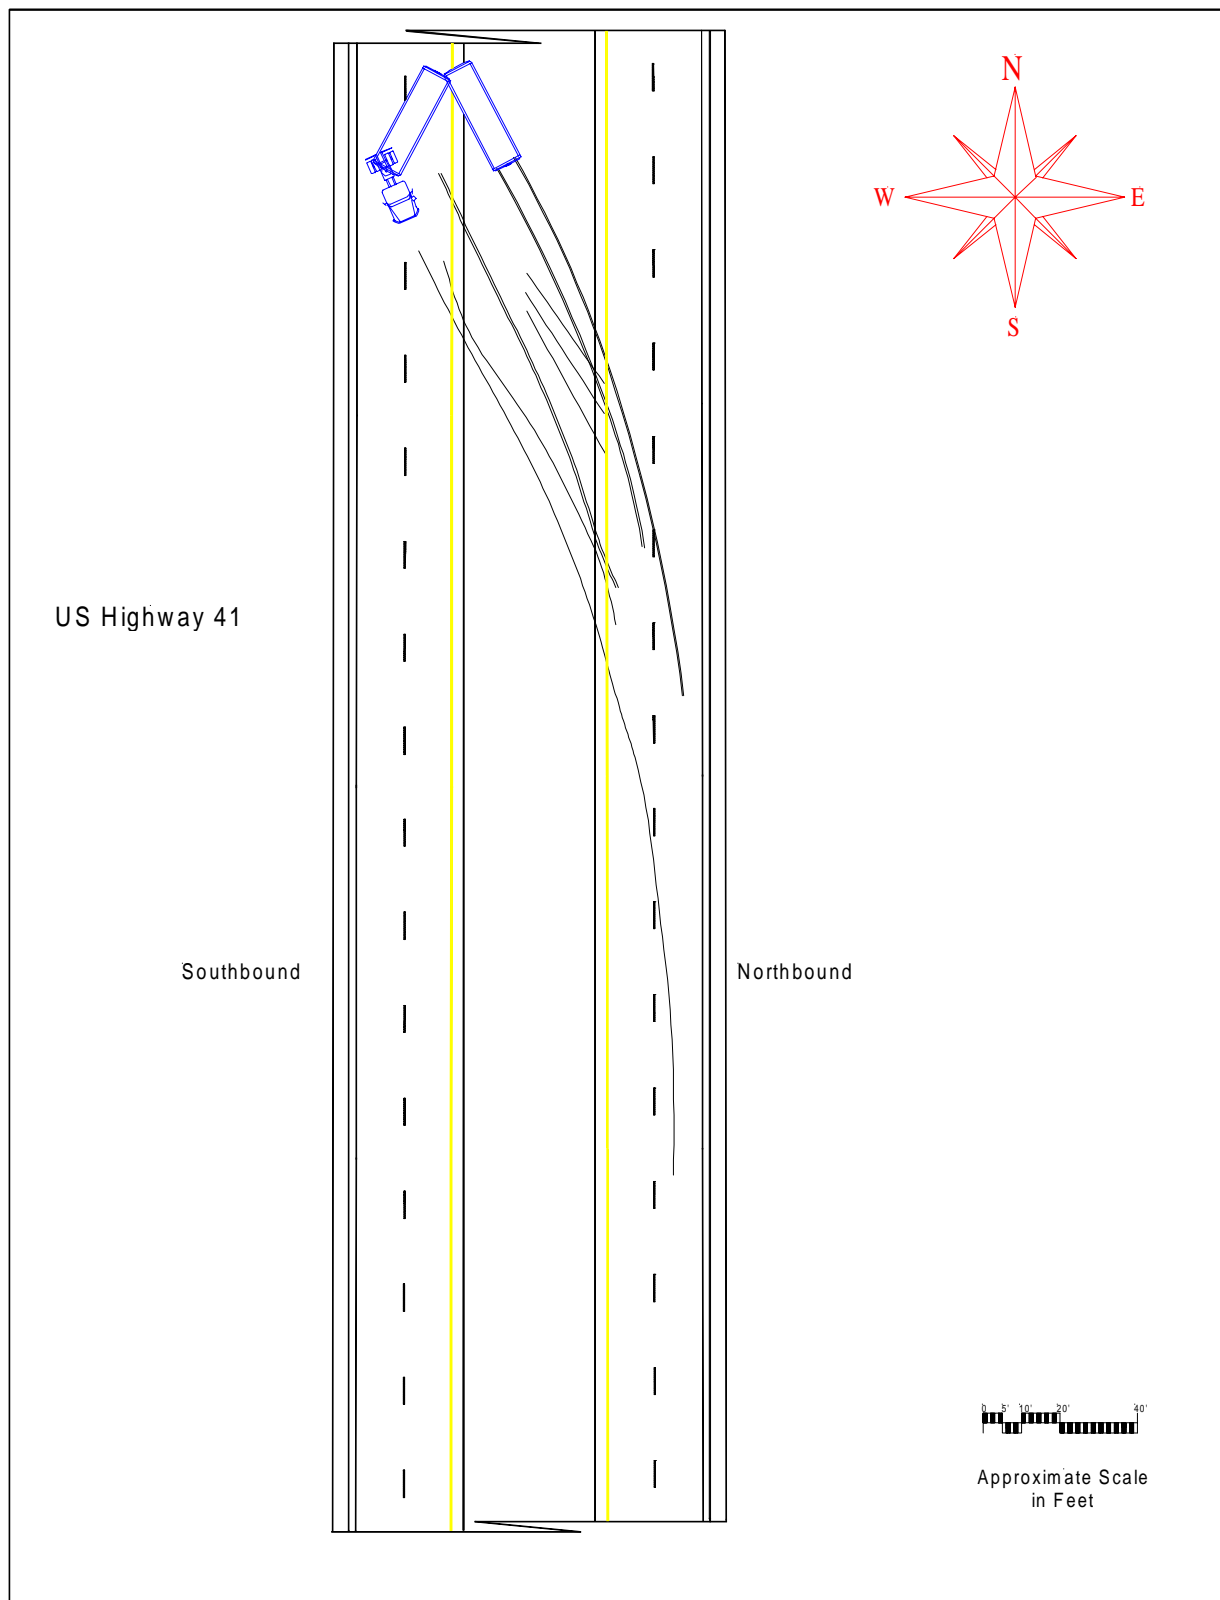
Figure 12 -- Jackknife diagram

Doubles Jackknife -- A typical jackknife occurs when the drive axle(s) on a tractor loses traction because of a locked or spinning wheel, and the tractor rotates into the trailer.⁵⁷ The situation develops quickly and usually results in a loss of control. Although a jackknife is most often caused by excessive braking or an excess power application for the available roadway friction, it can also be the result of downshifting, immediately letting off the accelerator, or wind acting on empty trailers. The Safety Board identified several factors that suggest how the doubles truck may have jackknifed.
