NATIONAL TRANSPORTATION SAFETY BOARD

HIGHWAY ACCIDENT REPORT

School Bus and Dump Truck Collision
Central Bridge, New York
October 21, 1999

**NTSB/HAR-00/02
PB2000-916202
Notation 7302
Adopted November 14, 2000**

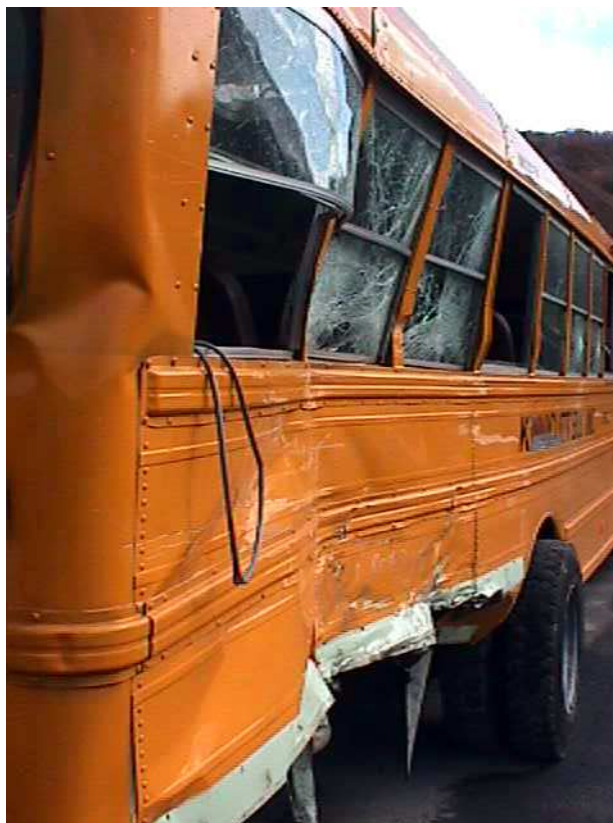
Figure 1. Exterior crush damage of school bus.

As the school bus approached the intersection, according to the chaperons, several children on board saw the sign for the Pumpkin Patch that was beyond the intersection and yelled. These children may also have released their belt buckles. One child reportedly stood up in the seating compartment. The busdriver, who was looking for SR-7, told investigating police that he saw the posted stop sign, slowed, but did not stop the bus, which then entered the intersection where the dump truck struck it on the right side behind the rear axle. (See figure 1.)

The Safety Board documented the impact damage to the school bus. The vehicle's fiberglass hood assembly was damaged and displaced at the forward hinge. The engine frame mounting and transmission bell housing were fractured, causing the engine and transmission to sag downward. The chassis' main frame rails were displaced to the left about 5.75 inches from their longitudinal axis. The bus body had 15 inches of intrusion on the right side behind the right rear axle. (See figure 1.) In addition to this contact damage, the bus had induced damage to side posts, roof bows, corner reinforcements, window frames and glass, the rear emergency exit door and frame, interior and exterior sheet metal and reinforcements, and the entrance door step well and frame area. The body-to-chassis mounting clips were found separated at the frame rail and at the floor panel deformation.

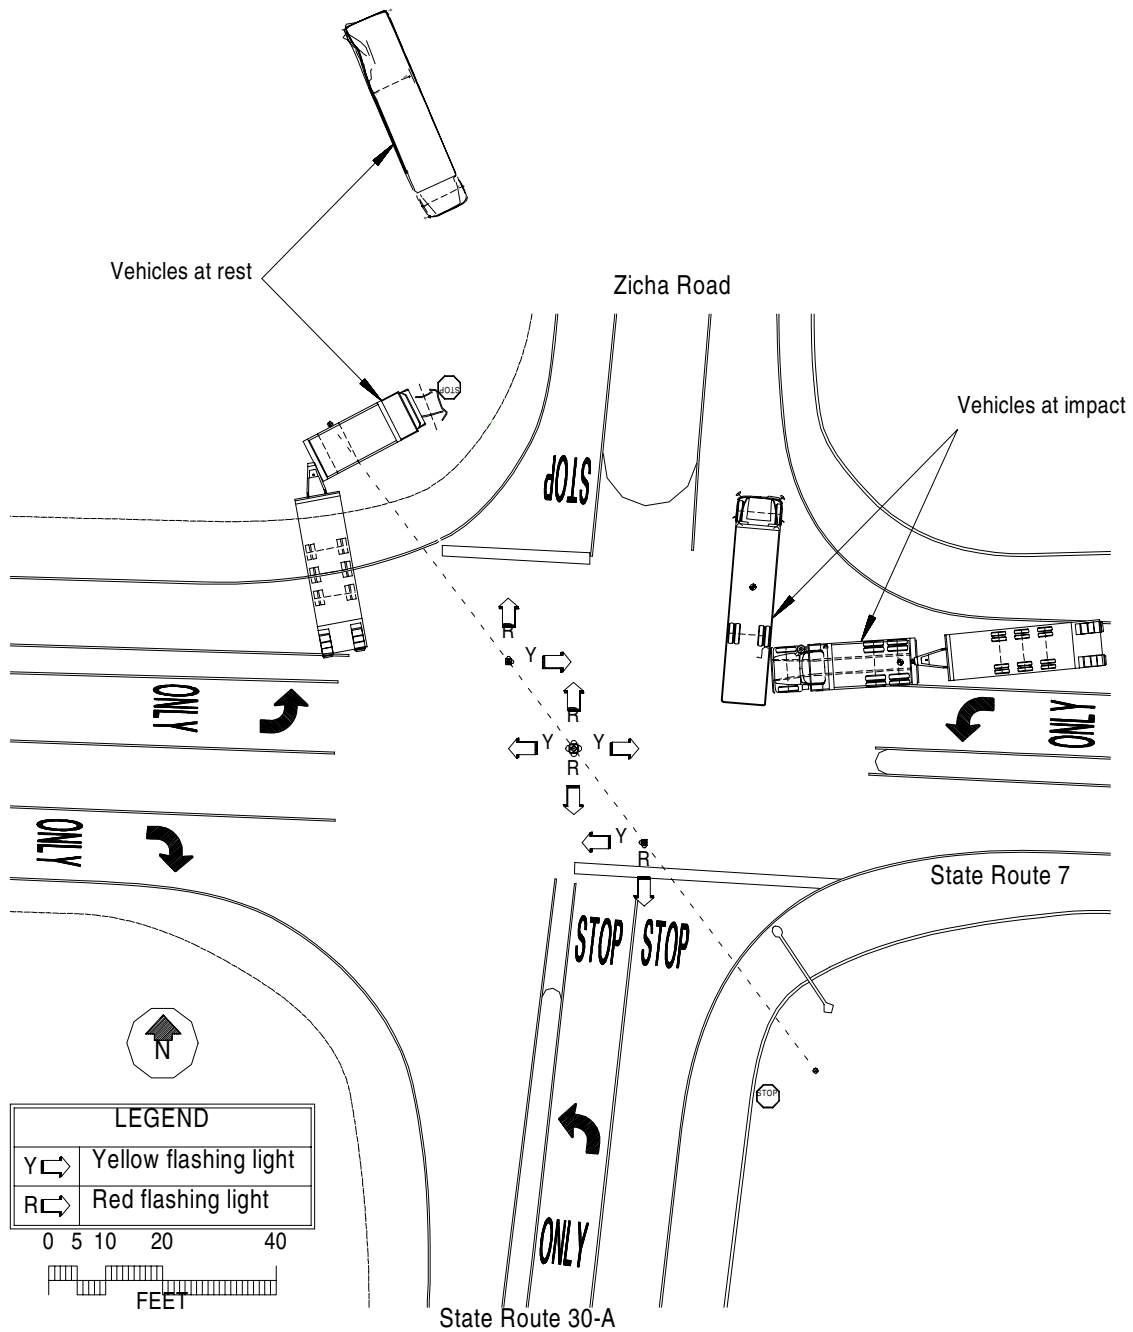
Figure 2. Diagram of vehicles at impact and final rest positions.

The school bus, after rotating about 145 degrees clockwise, slid approximately 100 feet and came to rest facing south. The dump truck, after rotating about 150 degrees clockwise, struck three highway guide signs and a utility pole; it then came to rest facing northeast. (See figures 2 and 3.)

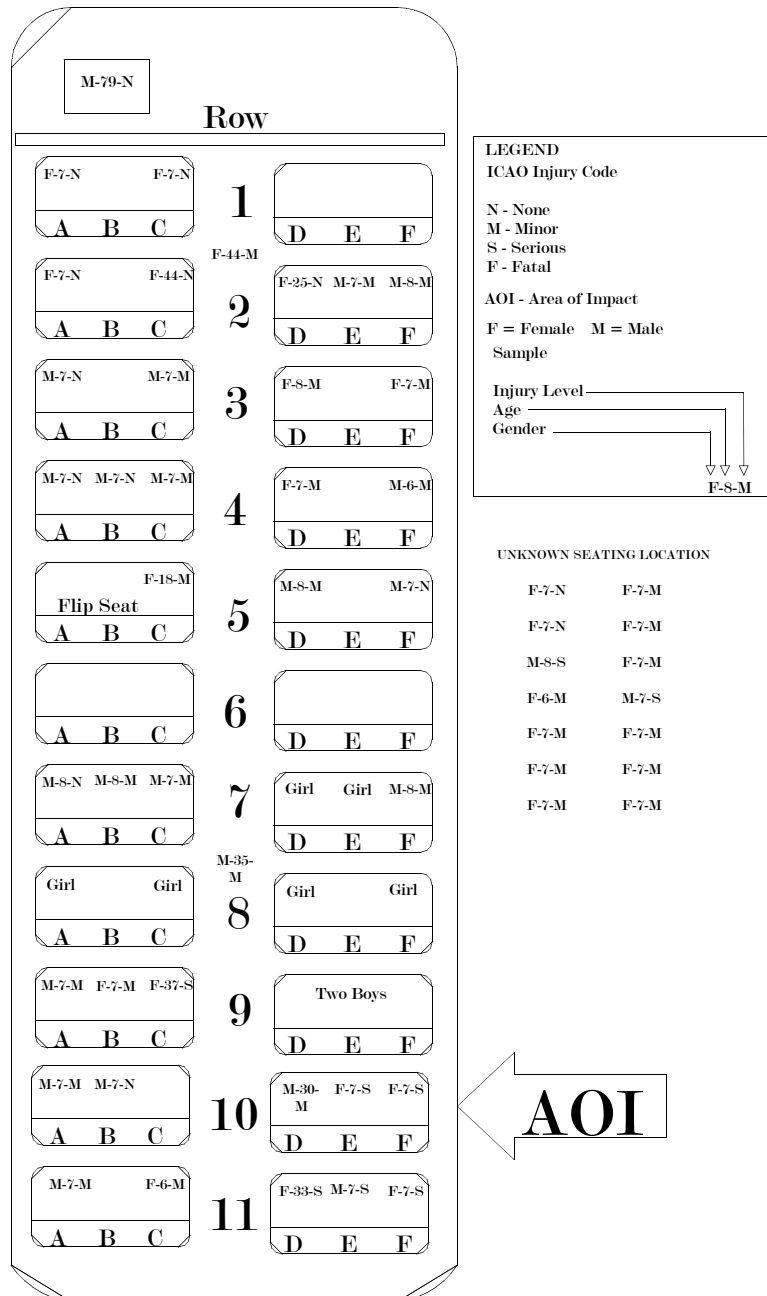
Figure 4. School bus seating and injury diagram.

Serious injuries included vertebra and skull fractures and internal injuries. Minor injuries included lacerations, abrasions, and neck strains. The most seriously injured passengers were seated in the area of impact. (See figure 4.)

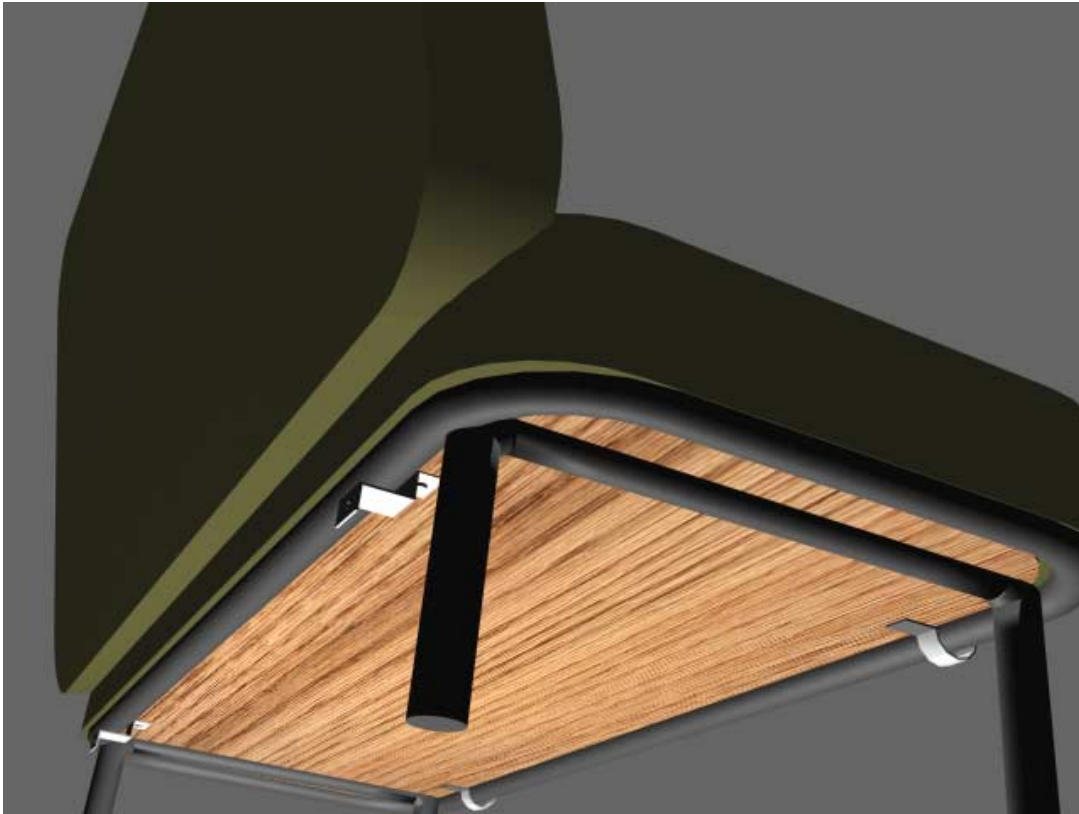
Figure 6. School bus seat cushion bottom, showing hinges and latching clips.

The school bus seat cushion bottoms were fixed to the seatframe with two hinges at the front and two latching clips at the base of the seat cushion bottom and seatback. (See figure 6.) After the accident, a number of these latching clips were found unlatched or loosely attached, so that the seat cushion bottoms were not fastened to the seatframes at the base of the bottom cushion and seatback. (See figure 7.) Some school buses are manufactured with seat attachments that are permanent, while others are manufactured with hinges and latches, such as on the accident bus. (The use of hinges and latches allows the removal or lifting of the seat cushion bottom for ease of cleaning.)
