**Passenger Vehicle Median Crossover  
and Head-On Collision  
With Another Passenger Vehicle  
Linden, New Jersey  
May 1, 2003**

**Highway Accident Report**

NTSB/HAR-06/02

**NTSB/HAR-06/02  
PB2006-916202  
Notation 7754  
Adopted February 7, 2006**

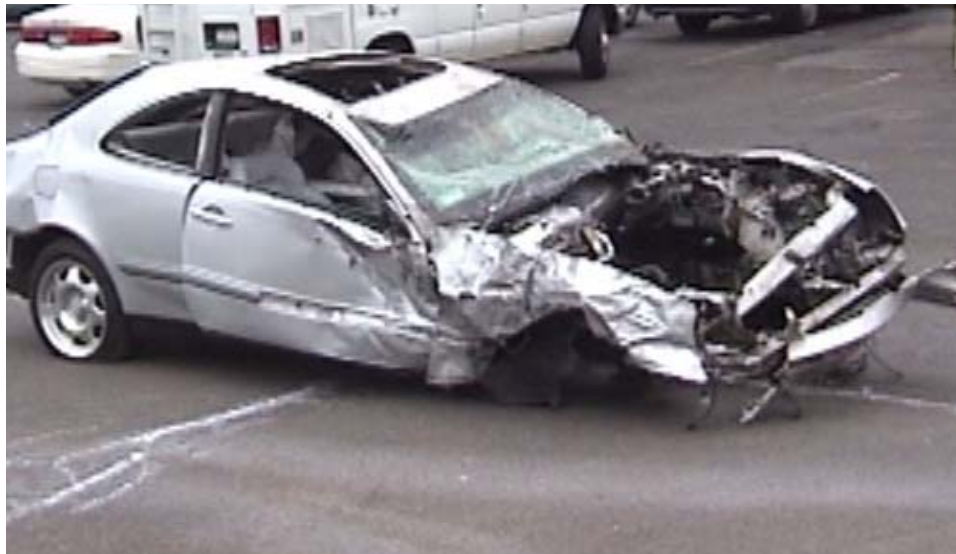
Figure 4. 1998 Mercedes Benz CLK320.

The vehicle sustained extensive contact damage, which was concentrated in the right front and left rear of the vehicle (see figures 4 and 5). The right-front body panels and hood had been crushed diagonally in the direction of the vehicle’s left rear. An indentation matching the shape and dimension of the Ford’s A-pillar<sup>9</sup> was located on the side of the right-front fender, about 1 foot forward from the Mercedes’ firewall. The hood had fully opened and had been

driven into the windshield. The impact to the left rear of the vehicle resulted from the subsequent collision with a wooden utility pole. The contact damage was semicircular in shape and extended about 2 feet into the trunk. In addition to the heavy contact damage, the roof of the Mercedes sustained some deformation, scrapes, and multiple scratches.

During the accident sequence, the right-front wheel and related suspension components became detached from the vehicle. The vehicle's engine and transmission became detached, as well, and were found in the southbound lanes approximately 77 feet from the Mercedes' final resting place. The exhaust system also became detached and was found approximately 92 feet from the Mercedes in the northbound lanes. Postaccident examination of the Mercedes detected no mechanical deficiencies.

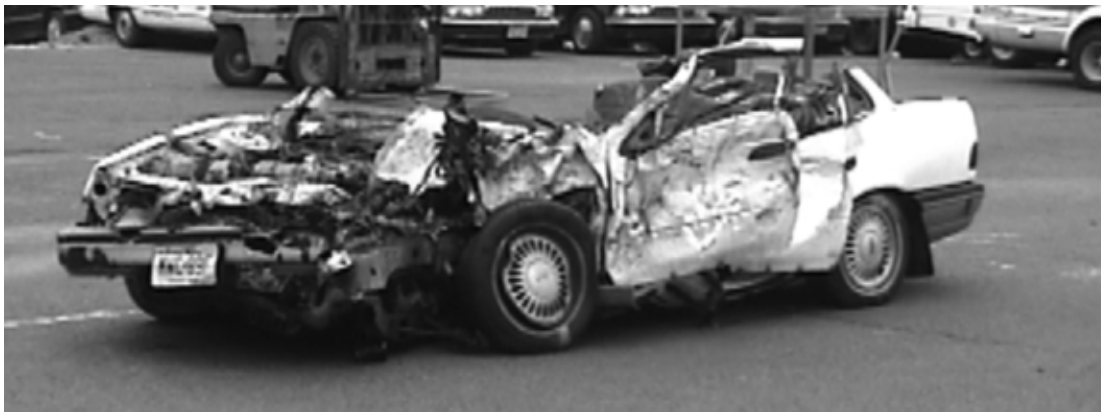
**Figure 6.** 1986 Ford Taurus.

Contact damage to the Ford was observed along the left side of the vehicle beginning on the left side of the front grill assembly (see figures 6 and 7). Additionally, the radiator core support was pushed in, and components on the top and left side of the engine also received contact damage. The most substantial impact to the left front was in the area of the wheel assembly. The entire left-front tire had been displaced rearward about 2 feet, and the wheel assembly had a circumferential indentation resulting from contact.

The contact damage along the left side extended across both doors and terminated just forward of the left-rear wheel. Deformation to the A-pillar was semicircular and directed inward toward the passenger compartment of the vehicle. The leading edge of the roof panel was pushed rearward and crushed down into the passenger compartment. The steering wheel received substantial deformation damage, and the steering column was

fractured. In addition to the contact damage from the accident, the vehicle had extensive damage and other contact damage resulting from extrication efforts.

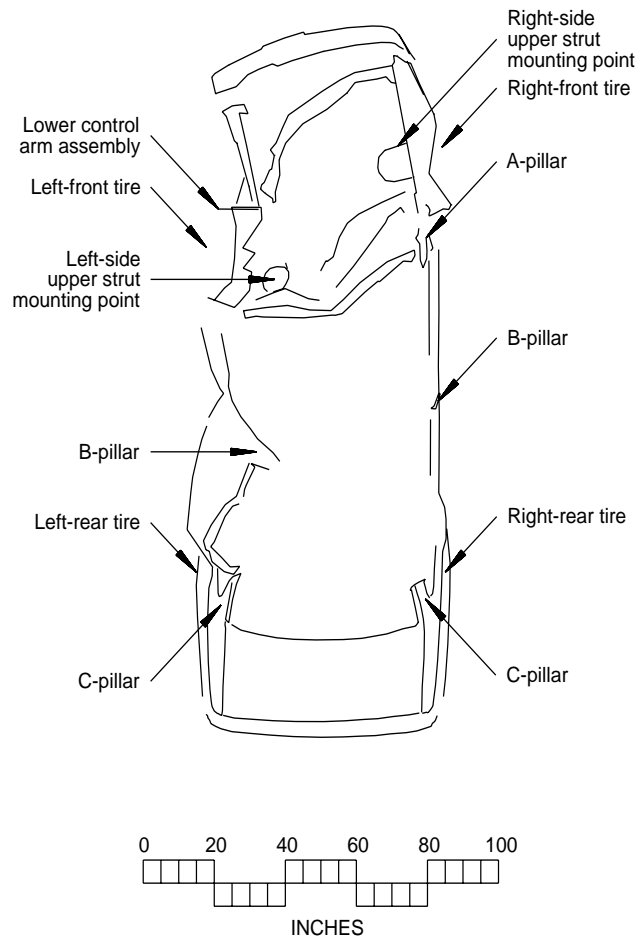
**Figure 7.** Crash profile of Ford Taurus.

Contact damage to the Ford was along the left side of the vehicle. It began at the front grill assembly, continued across both the driver and left-rear passenger doors, and ended just before the rear left wheel. The left side of the vehicle and the roof panel were pushed into the passenger compartment. The Safety Board concludes that the intrusion into the occupant compartments of the Ford rendered the vehicle occupant space unsurvivable.

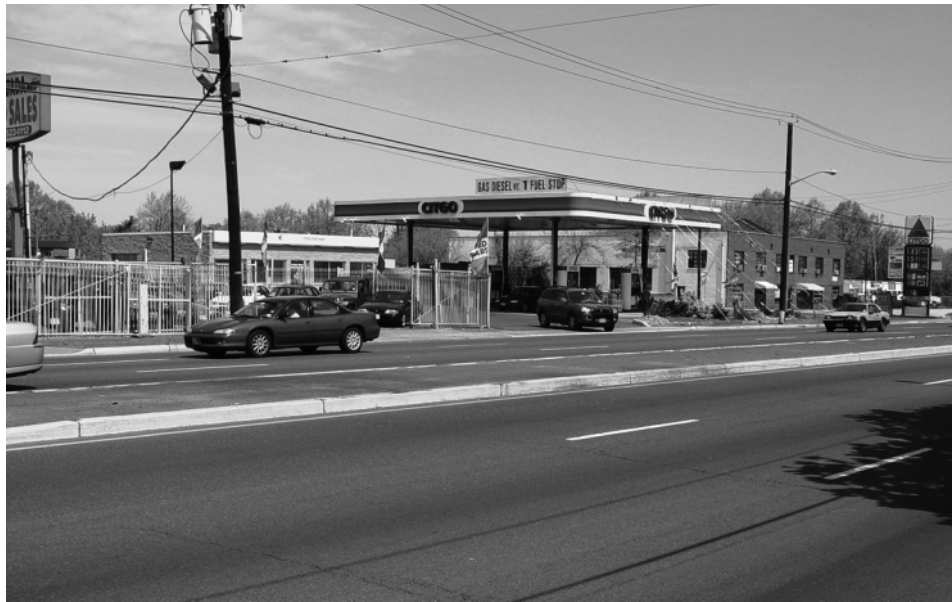
**Figure 8.** Raised curbed median near accident location.

The northbound and southbound lanes are divided by an 11.5-foot-wide raised median with 6-inch-high Portland cement concrete curbing. (See figure 8.) The median is backfilled with asphaltic concrete. The distance from the face of the vertical curb wall to the yellow edge lines is 1 foot. The cross section consists of a curb and gutter.

There was no median barrier at the accident site. A New Jersey-type median barrier<sup>10</sup> begins about 200 feet north of the accident site and continues north toward the Interstate 278 (I-278) interchange. This barrier was installed during the construction of the I-278 interchange in the late 1960s. Another median barrier was installed south of the accident location beginning at MP 39.4 in the town of Rahway. Black tire rubber smears and metallic scrapes were found on both median barriers during the Safety Board's

The accident segment of U.S. 1 had only a 6-inch-high raised concrete curb median to separate northbound and southbound traffic, for reasons that the NJDOT was unable to document. Consequently, no barrier was in place that could have prevented vehicles traveling in the southbound lanes from veering into the northbound lanes (or vice versa). However, median barriers were located north and south of the accident site. Physical evidence found on these median barriers, such as the black tire rubber smears and metallic scrapes, suggests vehicle contact with these taller structures.

The Safety Board concludes that a raised curb median, such as the one on U.S. 1 in the vicinity of the accident, is not sufficient to prevent crossover median accidents and can cause a vehicle to become out of control or airborne at the speeds at which vehicles travel on that segment of roadway. The Safety Board further concludes that had a median barrier been present at the accident site, the Mercedes probably would not have crossed from the southbound lanes into the northbound lanes and collided with the Ford.
