Ceiling Collapse in the Interstate 90 Connector Tunnel

Boston, Massachusetts

July 10, 2006

Highway Accident Report

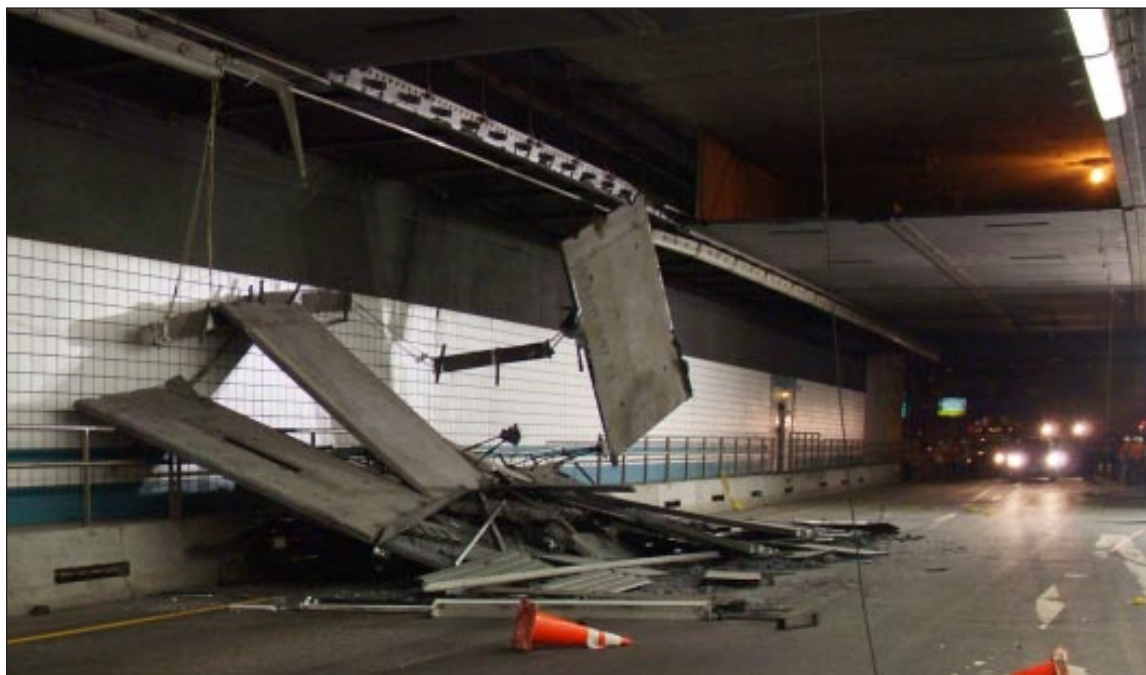
Figure 1. Postaccident scene with the crushed passenger car barely visible under the wreckage. The open area in the ceiling is the original location of the concrete panels. (Photograph courtesy Massachusetts State Police)

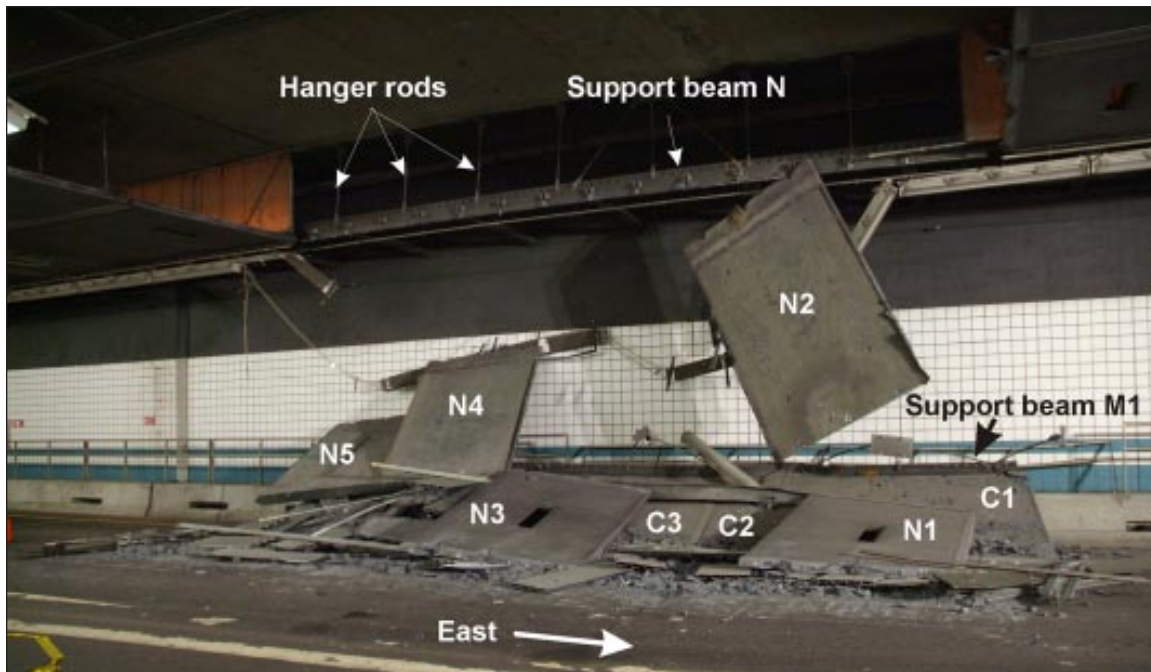
Figure 8. Looking north at the collapsed concrete panels before removal from the tunnel. Components shown as labeled for postaccident reconstruction. (Photograph courtesy Massachusetts State Police)

In addition to the concrete panels, the entire 40-foot length of support beam M1 and its hanger assembly fell onto the roadway or onto the wreckage. The hanger assembly included 8 vertical and 4 diagonal rod hangers, along with all 8 hanger plates and the 20 anchors that had attached the support beam to the tunnel roof. The north side of the ventilation duct enclosure also fell.

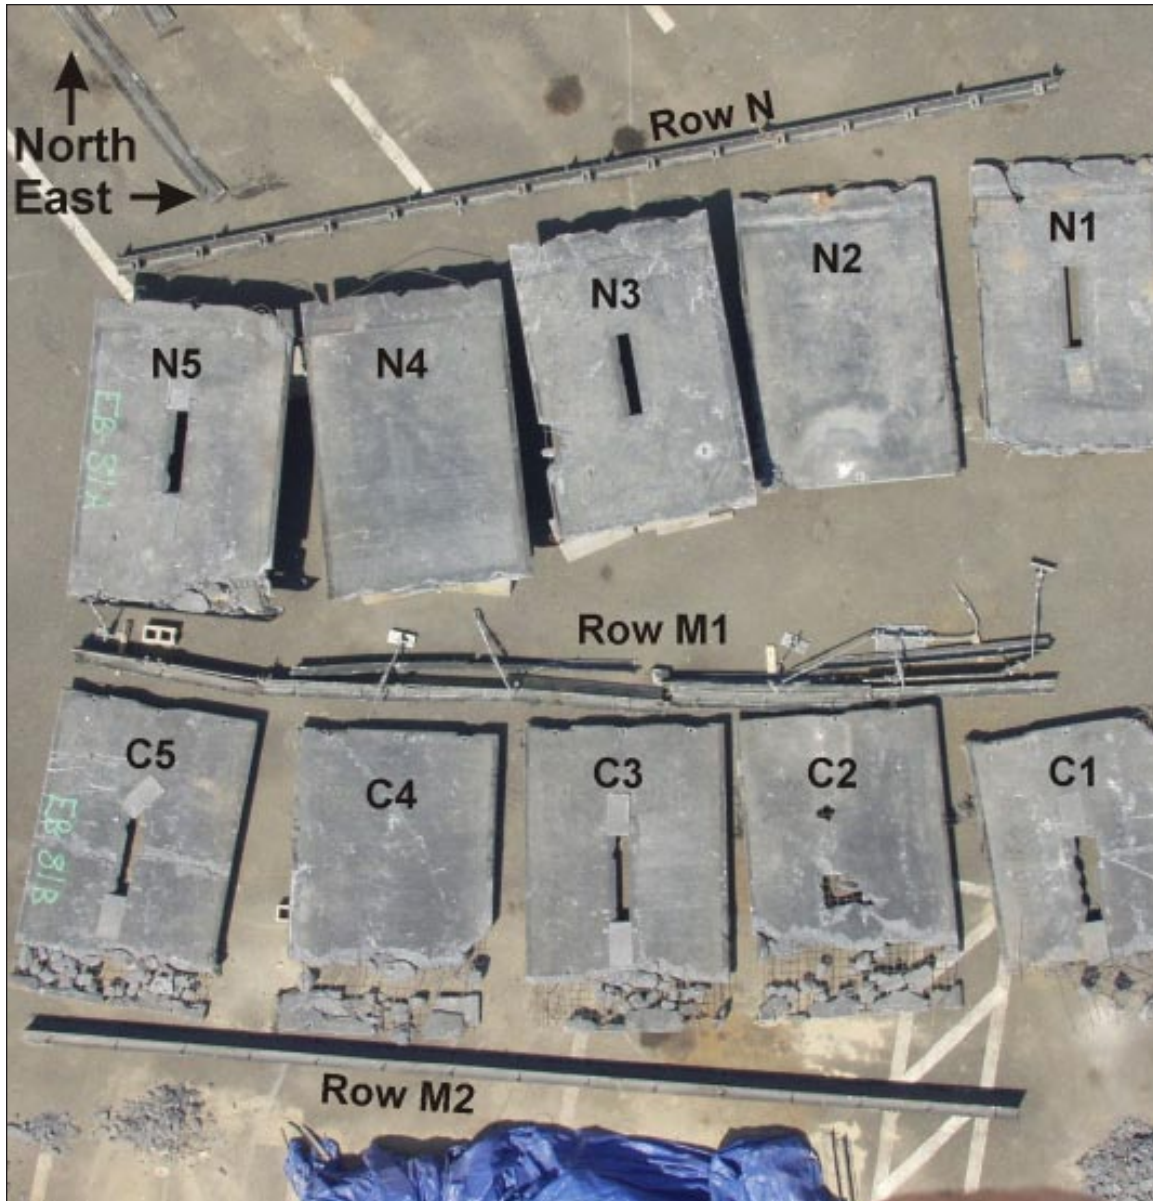
Figure 9. Collapsed panels after removal from the tunnel as rearranged in their original positions within the ceiling module. The upper surfaces of the panels are shown. (Photograph courtesy Massachusetts State Police)

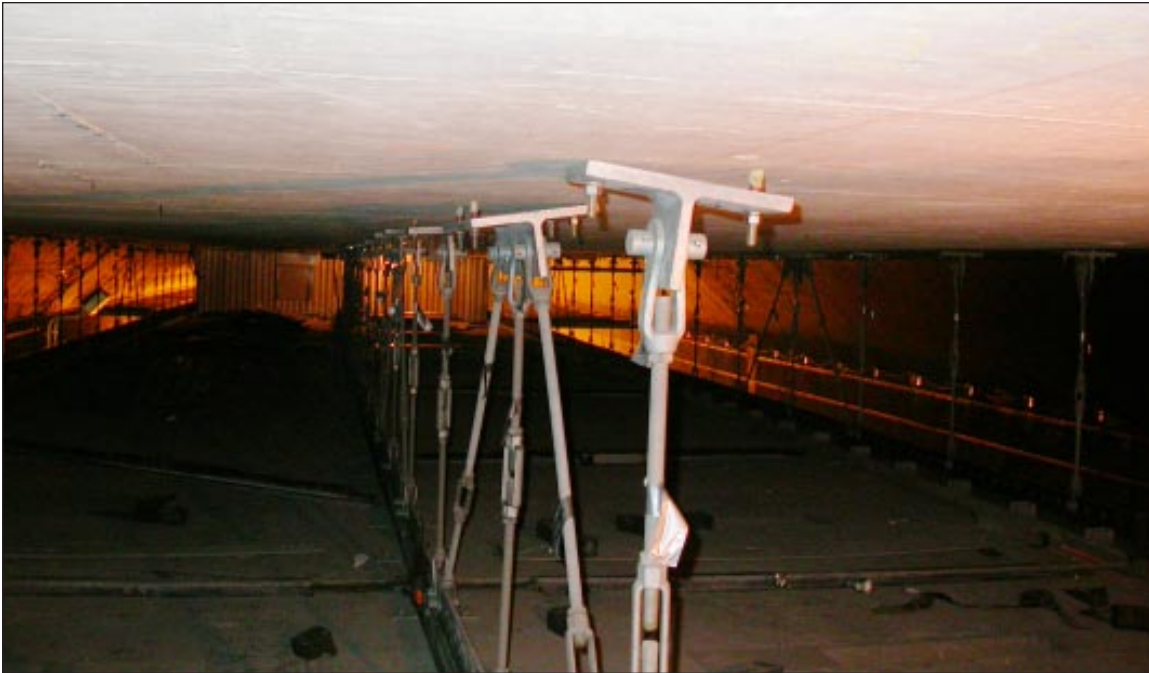
Figure 10 shows some of the roof hanger plates and anchors in the westbound tunnel portion of the D Street portal as they were just after the accident (though they were not involved in the accident). Several of these hanger plates show evidence of significant displacement (movement downward from their originally installed positions).

Figure 10. This photograph, taken in the westbound D Street portal tunnel after the accident, shows a number of roof hanger plates that have begun to pull away from the tunnel roof, including the two-anchor hanger plate in the foreground and the four-anchor plate adjacent to it.

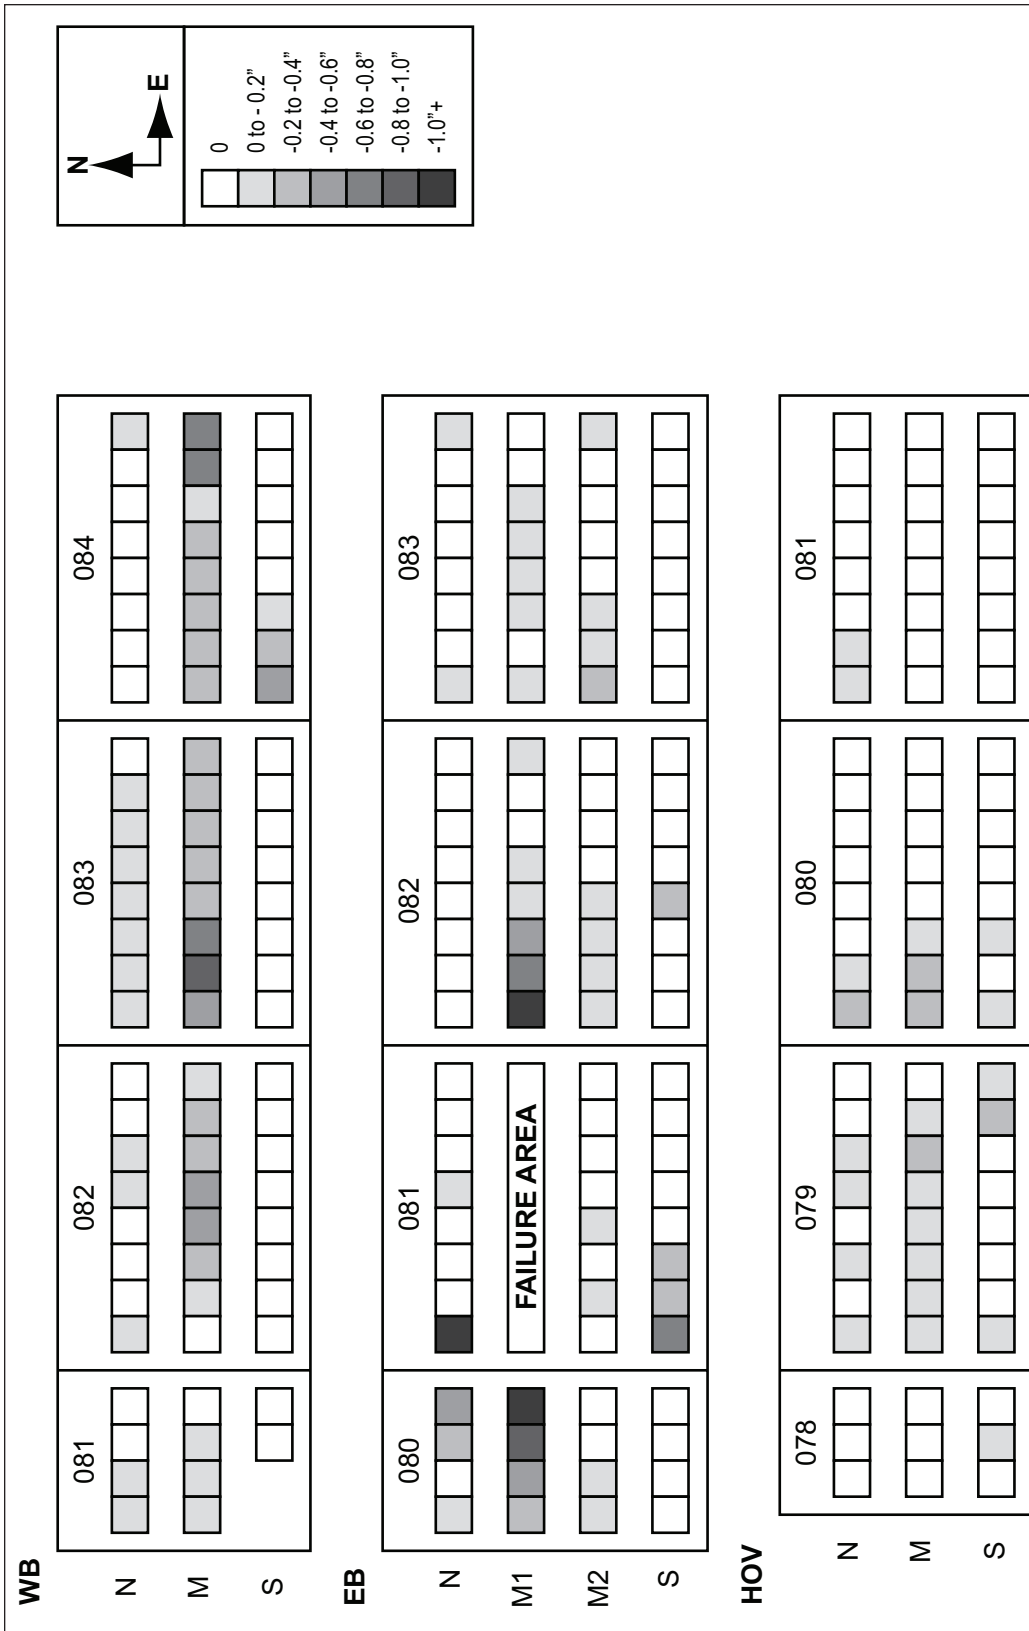
The examinations revealed that, in the westbound tunnel, 78 of the 198 anchors had displaced. In the eastbound tunnel, 57 of the 248 remaining (after the accident) anchors had displaced. In the HOV tunnel, 26 of the 188 anchors had displaced. The amounts of displacement ranged from less than 0.1 inch to more than 1.0 inch.

Figure 11. Graphic display of the displaced roof hanger plates found during postaccident inspection of the D Street portal tunnels. Each square on the chart represents a roof hanger plate (whether a two- or four-anchor plate). Shading of each square represents the amount of displacement.

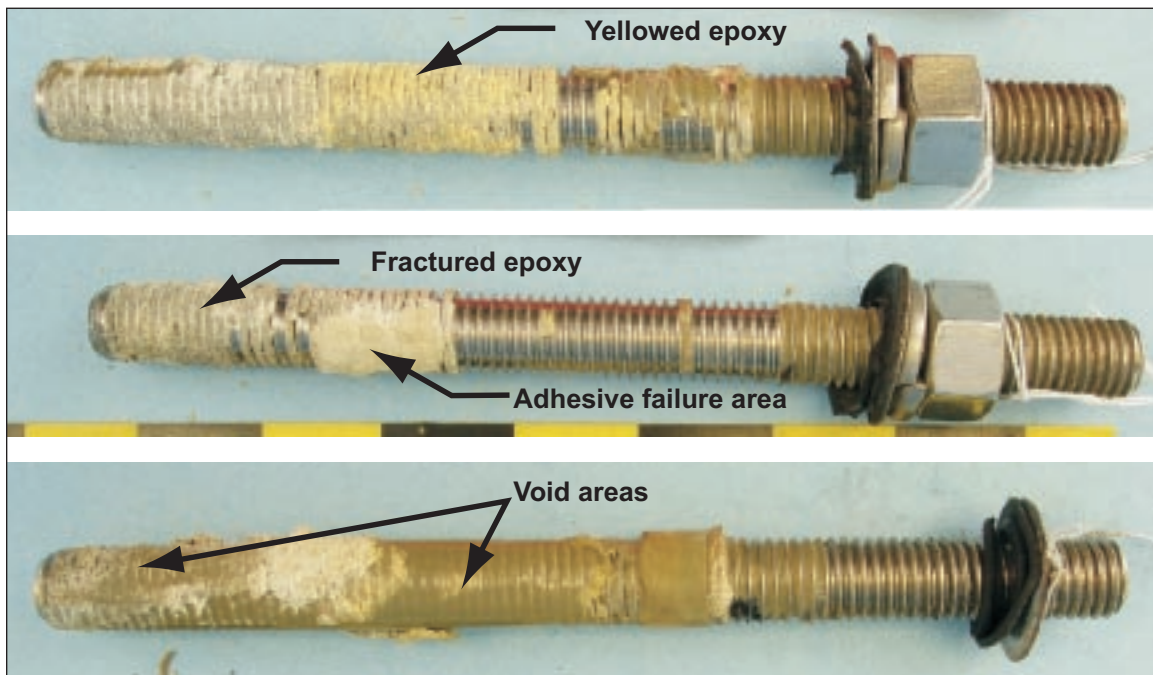
Figure 13. Three of the 20 failed anchors from the accident site illustrating epoxy features found on some of the anchors.

Of the 20 failed anchors from the accident site, all but one were found to have void areas that encompassed from 1 to 40 percent (average 10 percent) of their total embedment areas. Five of the anchors showed evidence of adhesive failure, with the most significant involving 29 percent of the embedment area. All of the anchors were missing epoxy, and 13 of the 20 had yellowed epoxy. Twelve of the anchors were bent. All but one showed evidence of overflow epoxy, typically extending $\frac{3}{4}$ inch below the embedment area. On three of these anchors, the nut had been threaded onto the area of overflow epoxy.

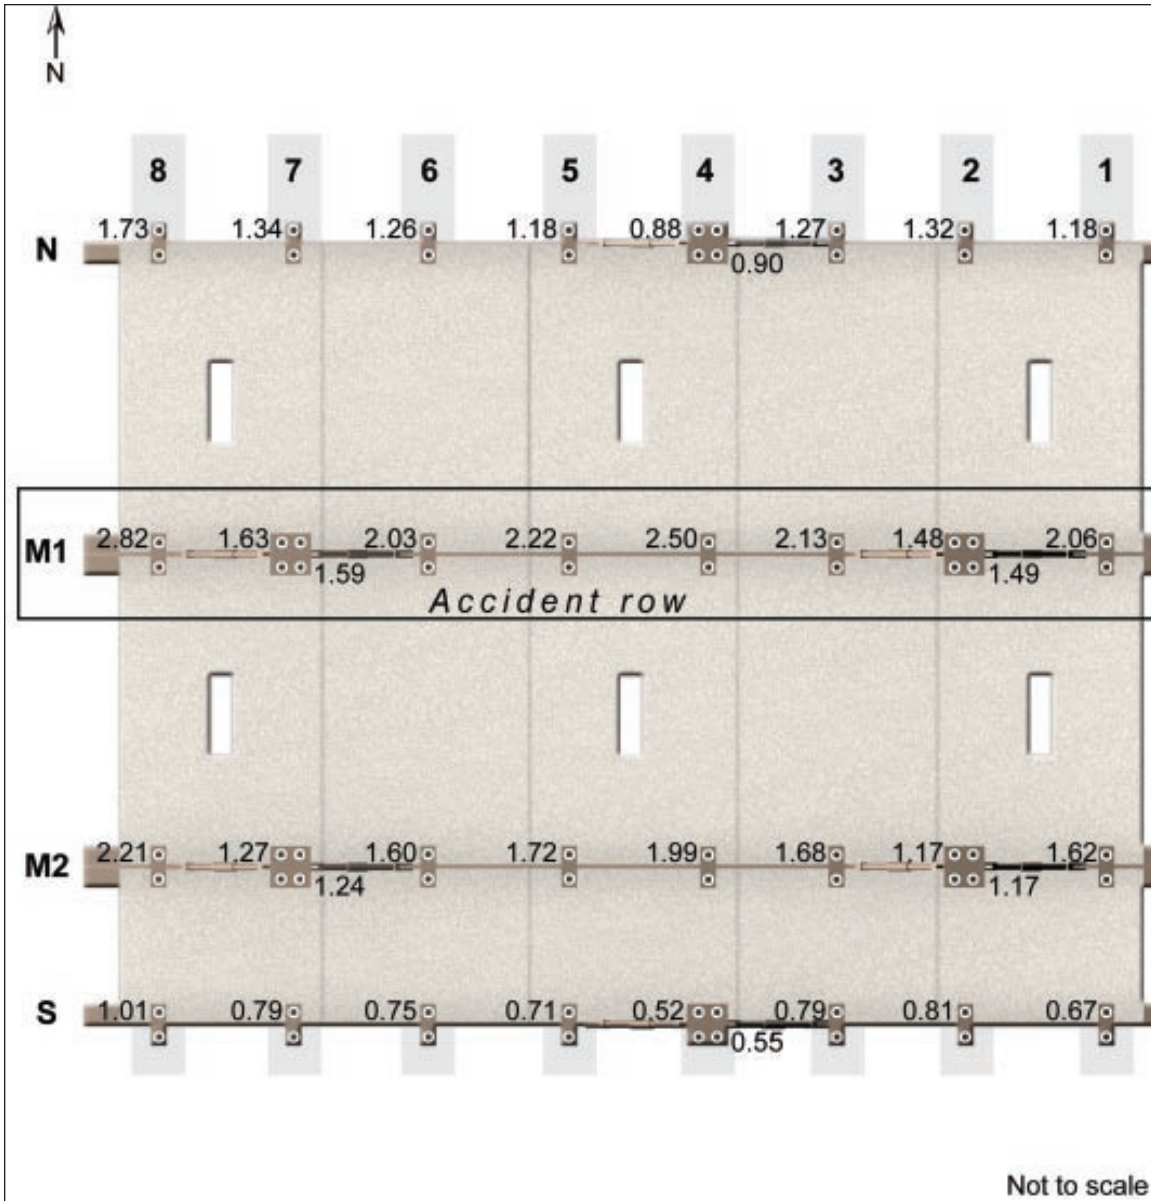
Figure 14. Plan view of the accident module’s roof hanger plates showing maximum anchor loading, in kips (1 kip = 1,000 pounds), as calculated for the Safety Board by the FHWA. These “worst-case” calculations assume no vertical load being supported by the diagonal hanger rods attached to the four-anchor hanger plates. Figures at the upper left of the four anchor plates represent the load on the two anchors on the west side of the plate; figures on the lower right show the load on the two east-side anchors. (For ease of identification in this report, hanger plates are numbered from east to west.)

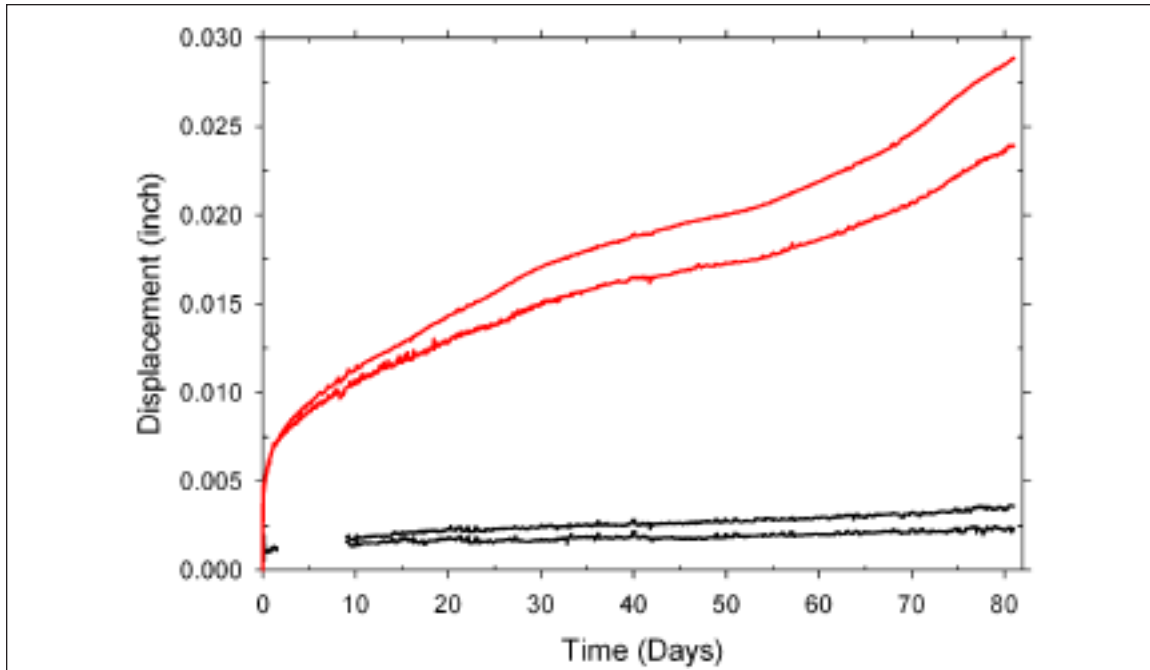
Fast Set epoxy and subjected to a 4,000-pound load displaced completely from the concrete slab before completion of the test. Figure 15 shows a graphical comparison of the displacement performance of anchors installed with Fast Set and Standard Set epoxies under a sustained load of 2,000 pounds. The graph displays the much more rapid onset and continuation of creep in the anchors installed with the Fast Set epoxy compared to those installed with the Standard Set version.

Figure 15. Displacement curves for test anchors installed with Power-Fast Fast Set (two upper curves) and Standard Set (two lower curves) epoxies under a 2,000-pound tension load. (Graphic courtesy Turner-Fairbank Highway Research Center)
