National Transportation Safety Board  
Washington, DC 20594

**Highway Accident Brief**

**Accident Number:** HWY-06-MH-013  
**Accident Type:** Rear-end chain-reaction collision  
**Location:** State Route 121, near Lake Butler, Florida  
**Date and Time:** January 25, 2006, 3:25 p.m. eastern standard time  
**Vehicles:** 1996 Thomas Built school bus  
1993 Pontiac Bonneville sedan  
2004 Freightliner truck tractor and 1998 Wabash box trailer  
**Owners/Operators:** Union County, Florida, School District  
Private owner  
Crete Carrier Corporation  
**Fatalities/Injuries:** 7 fatalities  
5 serious injuries  
6 minor injuries

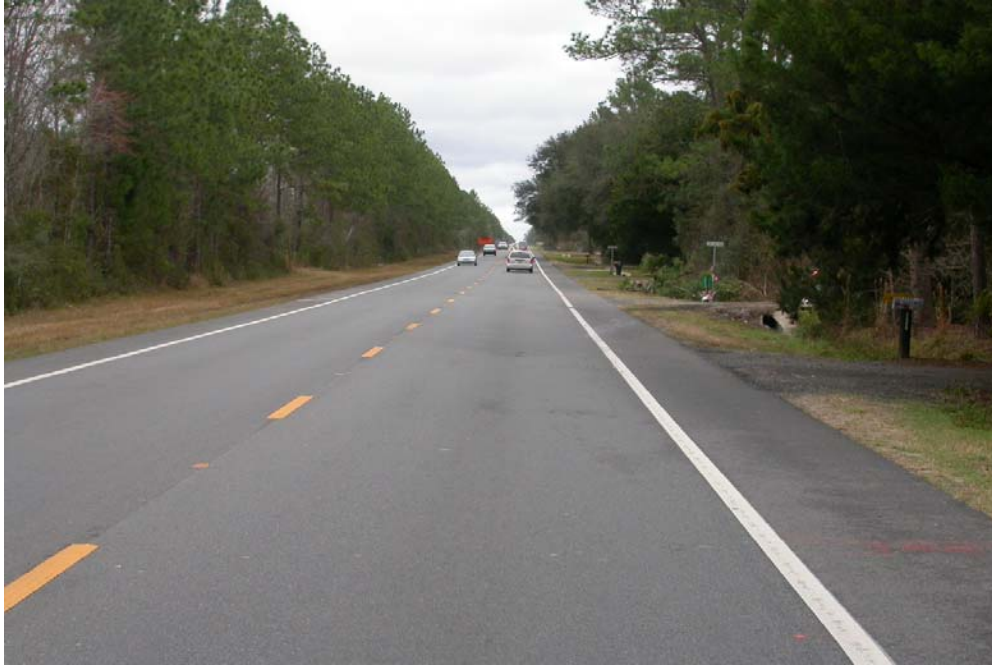
**Figure 2.** SR 121 approaching accident location.

At the accident location, SR 121 is a two-lane undivided asphalt roadway running north–south. The paved area consists of two 12-foot-wide main travel lanes, marked by solid 6-inch white lines, with a 5-foot-wide shoulder on either side. The paved shoulders border 3-foot-wide grass areas. A 6-inch yellow dashed centerline separates the northbound and southbound lanes. The speed limit was 60 mph, and speed limit signs were located 2.7 miles prior to the accident scene.<sup>2</sup> Figure 2 presents a view of SR 121 northbound, 375 feet prior to the accident location.

The 2003 *Manual on Uniform Traffic Control Devices* (MUTCD) recommends that *School Bus Stop Ahead* signs be installed in advance of school bus stops where the bus is not visible to road users for a distance of 500 feet.<sup>3</sup> FDOT provides similar guidance.<sup>4</sup> No school bus signs were located in the vicinity of the accident. The Safety Board conducted a sight distance test on January 31 and February 1, 2006, assisted by the Florida Highway Patrol, which showed that the school bus was visible for a distance of 3,087 feet, far above the recommended 500 feet. The alternating red warning lights on the rear of the school bus were visible at 1,382 feet. A regulatory sign stating *All Traffic Both Directions STOP While School Buses Load or Unload* was located about 4 miles in advance of the accident site.

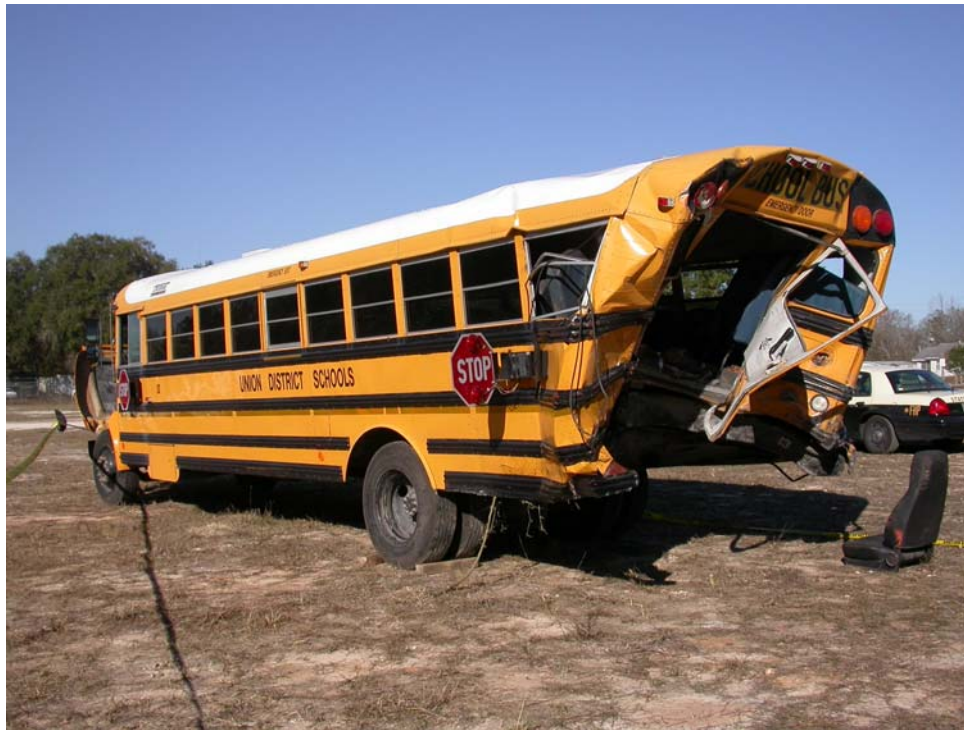
**Figure 3.** Accident school bus.

The bus sustained the majority of damage at the rear end, where it was struck by the Freightliner. The rear of the bus was pushed inward just left of center, which affected the entire rear surface area of the bus, to just below roof level. (See figure 3.) The maximum point of

inward intrusion was about 5 feet. The entire bus body was deformed from the rear-end damage, and the driver's seat was sheared off its pedestal mounting.

The tires on the bus met recommended manufacturer specifications and were in good condition. The steering and the suspension systems appeared to be normal. The brake on the left front axle was found to be out of adjustment and would have resulted in the bus being out of service according to the Commercial Vehicle Safety Alliance North American Standard Out-of-Service Criteria. However, the bus was nearly stopped at the time of the accident, and the braking system was not causal to the accident.

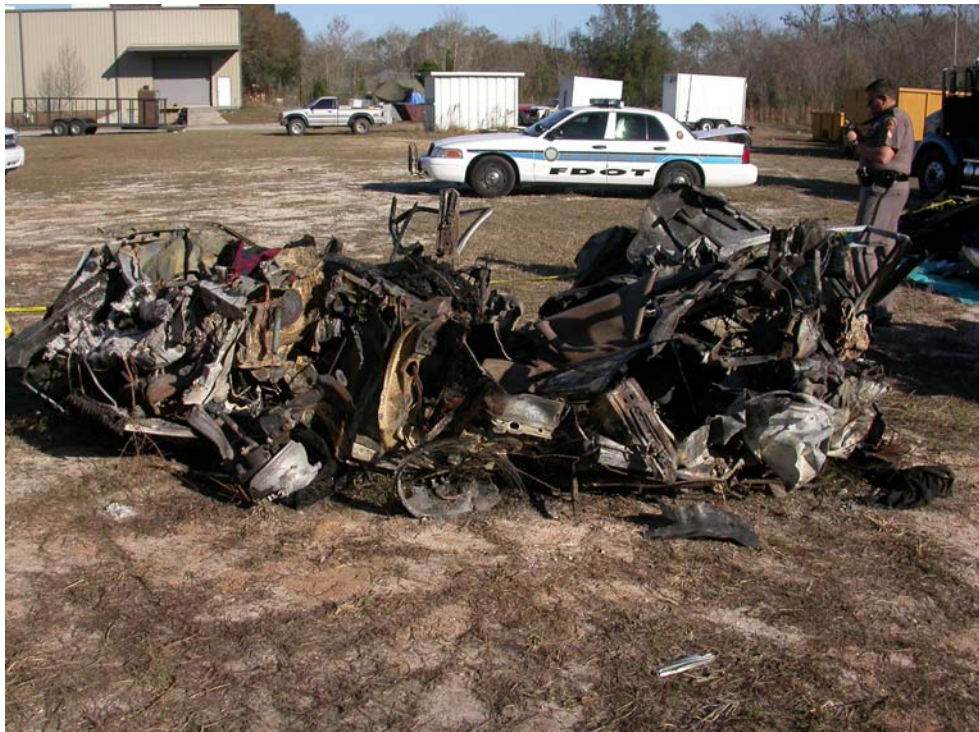
**Figure 4.** Remains of accident passenger car.

The vehicle was extensively damaged by the impact of the Freightliner and the postcrash fire, which consumed most of its nonmetal components. (See figure 4.) The Florida State Fire Marshal determined that the origin of the fire was the fuel tank located at the rear of the vehicle; the tank was found to have been breached as a result of the crash and to have come into contact with the pavement, introducing an ignition source. The fuel tank had a small tear from being ground into the pavement.

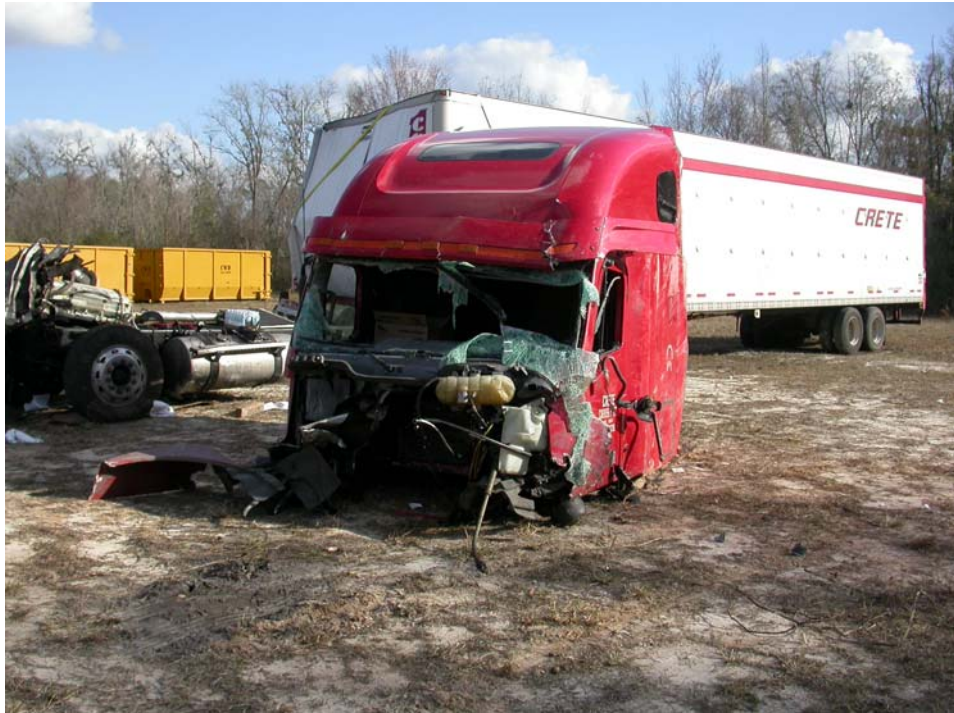
**Figure 5.** Cab portion of accident tractor.

The tractor and the front of the trailer, shown in figures 5 and 6, sustained the majority of the damage. The cab portion of the tractor was completely detached and separated from the tractor chassis.

The tires on the tractor were slightly narrower than the width recommended by the tractor specifications.<sup>6</sup> However, this discrepancy would not have affected the rolling radius or vehicle handling. Damage to the steering and suspension systems appeared to be a direct result of the accident. The brakes of the tractor and trailer were found to be in adjustment and in good condition.

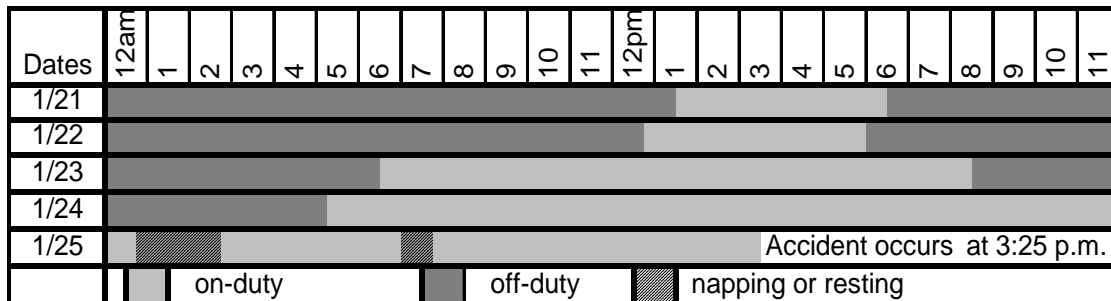
**Figure 7.** Duty status of Freightliner driver, January 21–25, 2006.

6:29 a.m. on Monday, January 23, and worked until 8:23 p.m. that evening, a total of 14 hours. On Tuesday, January 24, he began driving at 5:19 a.m., making two round trips from Jacksonville to High Springs and a half trip back to High Springs shortly after midnight on January 25. The driver said he slept in the sleeper berth for a couple of hours while the truck was being loaded. Then he made the return trip to Jacksonville. The driver said he “rested his head across the steering wheel” for an hour or two when he returned to Jacksonville. He made another trip to High Springs on the morning of January 25 and was on his way back to Jacksonville when the accident occurred, at 3:25 p.m. (See figure 7.) Prior to the accident, the last period of time the driver had to obtain significant sleep was when he was off duty from 8:23 p.m. on January 23 until 5:19 a.m. on January 24. With the exception of a 2-hour sleep period in the early morning of January 25 and 1–2 hours of rest about 7:00 a.m., the truck driver was awake for about 30 hours, and it had been 34 hours since his last substantial off-duty period. The DDEC showed that the truck had been driven a total of 13.5 hours and idled for 4 hours 13 minutes during this period.

The reduced quantity and quality of sleep would have made the truck driver susceptible to fatigue and impaired performance. Research has shown that—in spite of individual variations—a specific amount of uninterrupted sleep is necessary for each 24-hour period, usually about 8 hours, and subsequent alertness will be compromised without that sleep.<sup>13</sup> Additionally, sleeping less than 4 consolidated hours can impair performance for tasks that require vigilance.<sup>14</sup> Fatigue impairs information processing and reaction times, increasing the probability of errors.<sup>15</sup>

period, from 3:00–5:00 p.m. The Lake Butler accident occurred about 3:25 p.m., a time when the driver may have been predisposed to sleepiness, particularly after being awake for approximately 34 hours with short periods of time as the only opportunities for sleep.
