PB98-916402
NTSB/MAR-98/02

NATIONAL TRANSPORTATION SAFETY BOARD

MARINE ACCIDENT REPORT

Fire On Board the Panamanian Passenger Ship
Universe Explorer in the Lynn Canal Near Juneau, Alaska
July 27, 1996

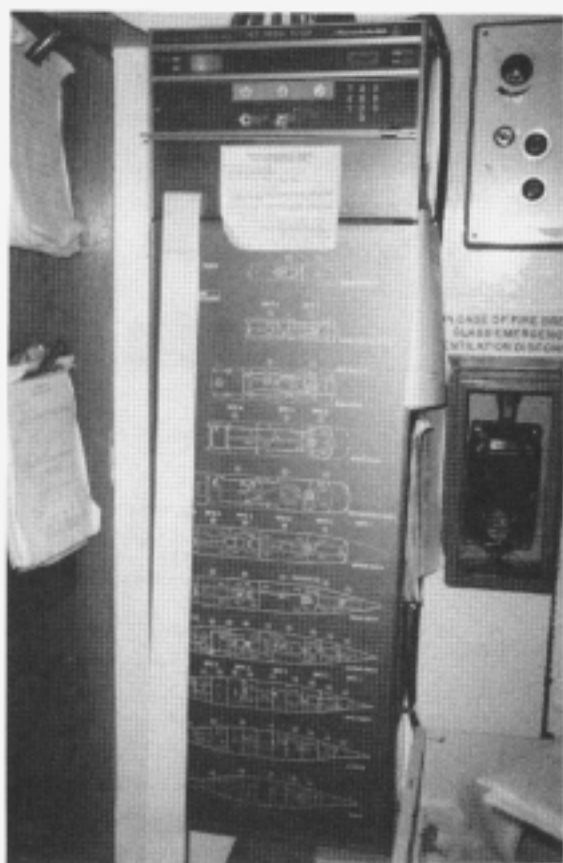
round. At 0259,² an audible heat-detector alarm sounded on the fire alarm panel on the bridge (figure 3). The second officer said he noted that the panel indicated the activated heat detector was in the main laundry on E-deck (figure 4). Thinking it might be a false alarm, he used a UHF radio to call and instruct the fire watch to investigate the alarm source in the main laundry. The fire watch said that he was on the Promenade deck near the swimming pool when he received the call and that, after acknowledging the radio transmission, he started toward the main laundry.

² The fire alarm panel printout indicates that this alarm sounded at 0256. According to the vessel operator, the fire alarm panel clock was about 3 minutes slow.

Figure 3—(Left) The fire alarm panel on the bridge showed a plan view of each deck. When an “addressable” fire detector was triggered, a corresponding panel light turned on, indicating the location of the detector. The panel generated a paper log of all activated fire detectors. The tape shown (left of the deck plans) is of the alarms logged during the *Universe Explorer* fire. (Right) Table shows order of alarms.

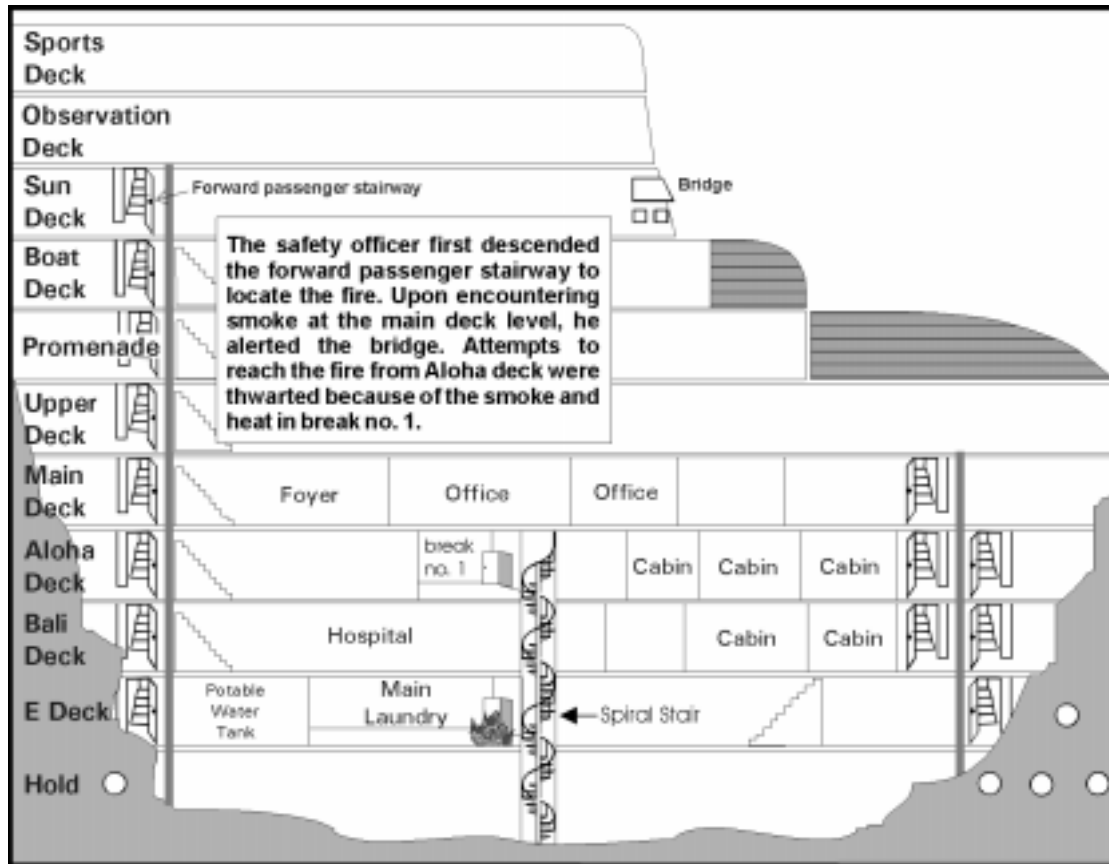
Figure 4—Side cutaway view of the *Universe Explorer*. The fire was in the main laundry on E deck, next to an open door to a spiral stairwell. The electromagnetic fire doors on E deck and Aloha deck remained open until the master ordered all fire doors closed. The crew deaths occurred in cabins and passageways forward of the spiral stairwell on the Aloha deck level.

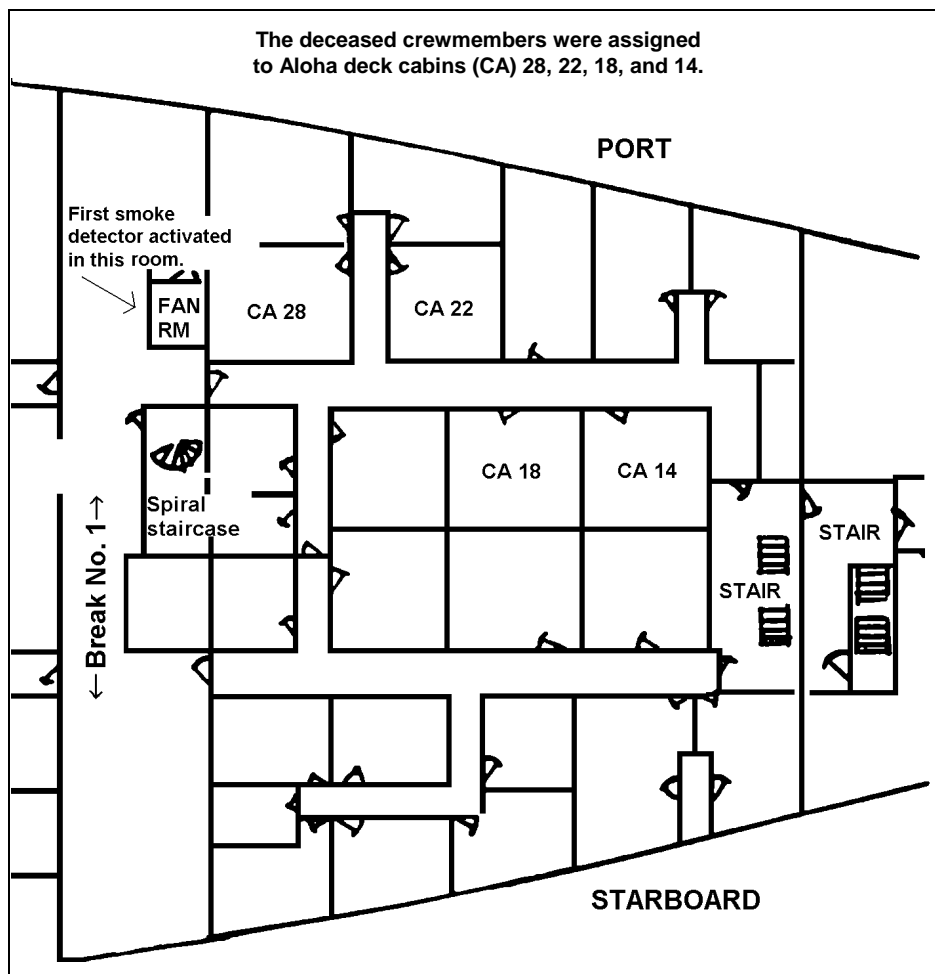
Figure 5—Plan view of Aloha deck. The second fire alarm that sounded on the bridge was triggered by a smoke detector in the fan room near break no. 1, an athwartship passageway. The nearby spiral staircase extended down from the Aloha deck to the Hold deck. On E deck, this stairway accessed the forward portion of the main laundry. The doors to the spiral stairway were remotely operated fire doors that remained open until closed by the bridge.

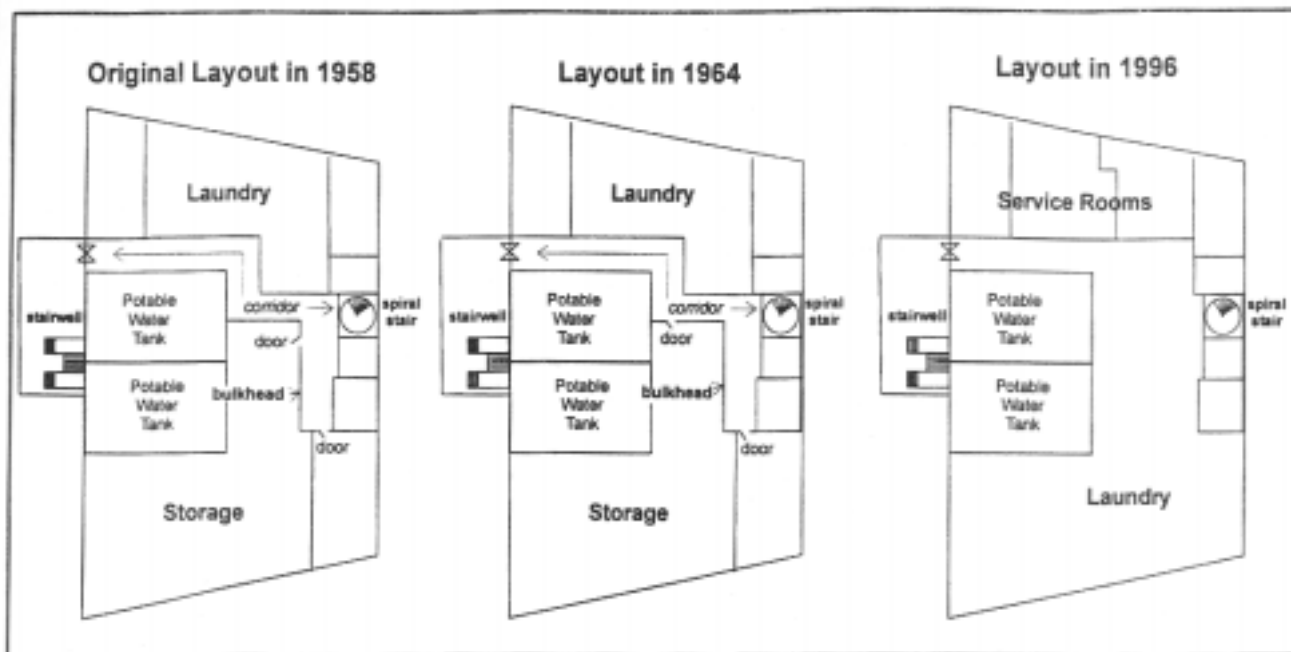
Missing Bulkhead—Original vessel construction plans show that the main laundry was on the port side of the ship and enclosed by bulkheads (figure 6). The 1958 plans indicate the presence of a bulkhead in the main laundry that created a corridor from the spiral stairway on the forward end to the stairway on the aft end of the compartment, separating the storage and laundry areas from the stairways in accordance with 46 CFR 72.05-20 (f), which states the following:

Figure 6—(Left) Main laundry layout as originally designed with a bulkhead forming a corridor between the forward and aft stairways and separating the storage and laundry areas from the stairways in accordance with 46 CFR, the U.S. interpretation of SOLAS 48. (Center) Layout as modified in 1964 and as shown on the vessel control plan. (Right) Layout of the main laundry as found during the postaccident examination.

During postaccident examination, Safety Board investigators observed that most of the corridor bulkhead had been cut away; only the top 12 to 18 inches of the bulkhead extended down from the overhead structural deck. Vessel officers had no information about when or why this bulkhead had been removed. V. Ships, the *Universe Explorer* operator, subsequently provided information stating that the main laundry area was modified between 1972 and 1974 at the Lloyd-Werft Shipyard, when the ship was being operated by Holland America Lines. The Safety Board found no records showing the nature of the modifications or when they were made. Lloyd's
