Marine Accident Report

**Grounding of the Small  
Passenger Vessel *Finest*  
Sandy Hook, New Jersey  
January 4, 2001**

**NTSB/MAR-02/03  
PB2002-916403  
Notation 7493  
Adopted September 17, 2002**

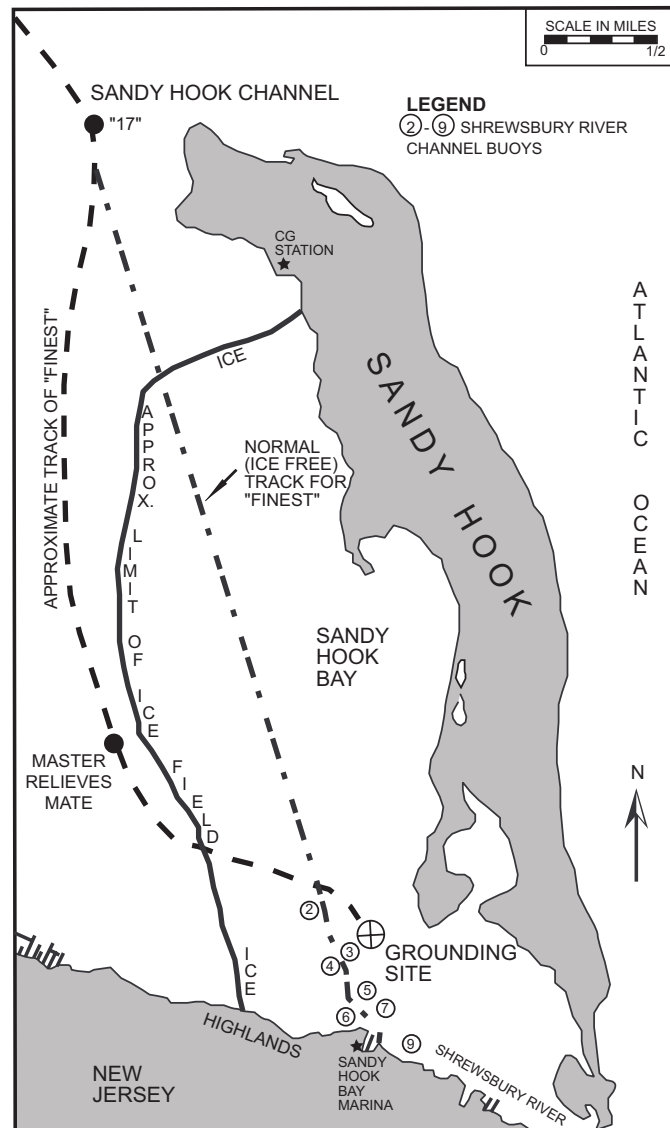
As the *Finest* passed buoy 17, about 1/2 nautical mile<sup>2</sup> west of the northern end of Sandy Hook Point, the master observed an ice field inside Sandy Hook Bay that extended from Sandy Hook peninsula about 1 mile into the bay. The vessel's normal trackline to the SHBM would have taken the vessel through the ice field. After passing buoy 17 and Sandy Hook Point, the senior deckhand, in accordance with the master's orders, changed to a southerly course toward the Atlantic Highlands breakwater. The new trackline ran parallel to the western edge of the ice field and allowed the vessel to operate outside of the ice. (See figures 3 and 4.)

**Figure 3.** Accident site.

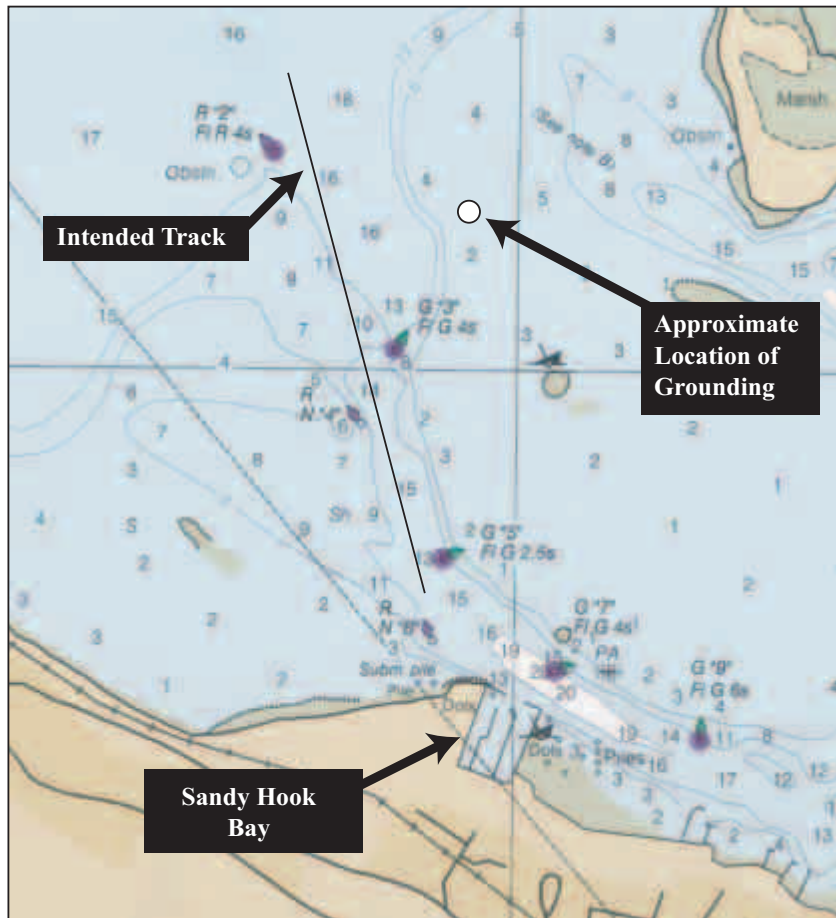
**Figure 4.** Section of the National Oceanic and Atmospheric Administration navigation chart No. 12401, showing channel course line, location of grounding site and SHBM. Water depths indicated are in feet at mean lower low water.

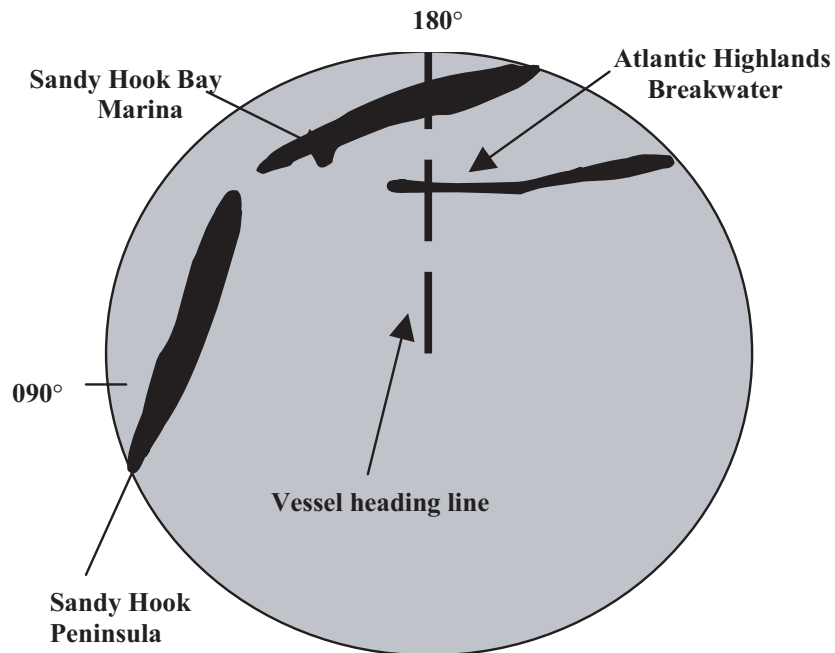
**Figure 5.** The radar presentation as the vessel proceeds on a southerly trackline ( $180^\circ$ ) toward Atlantic Highlands breakwater. The vessel is at center of the presentation. The dashed line is the vessel's heading line

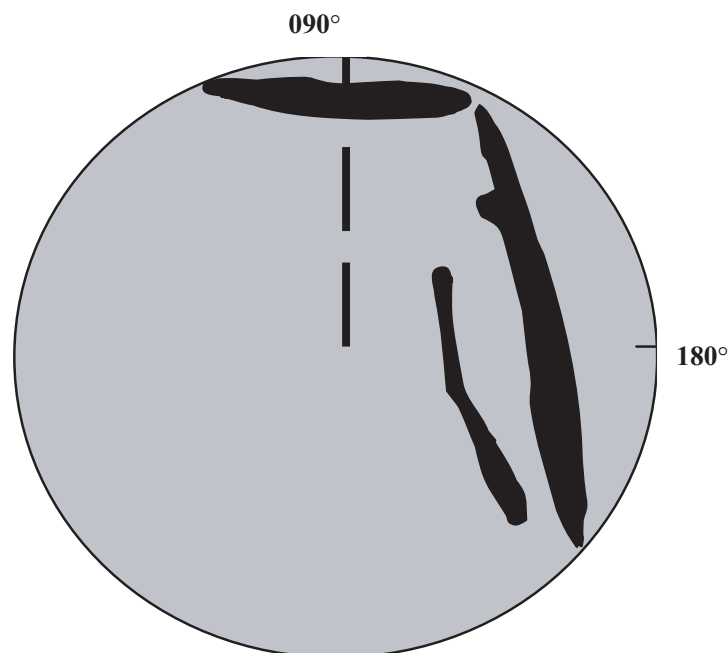
**Figure 6.** The radar presentation after the vessel turns left to the east toward Sandy Hook Peninsula and begins approaching the channel.

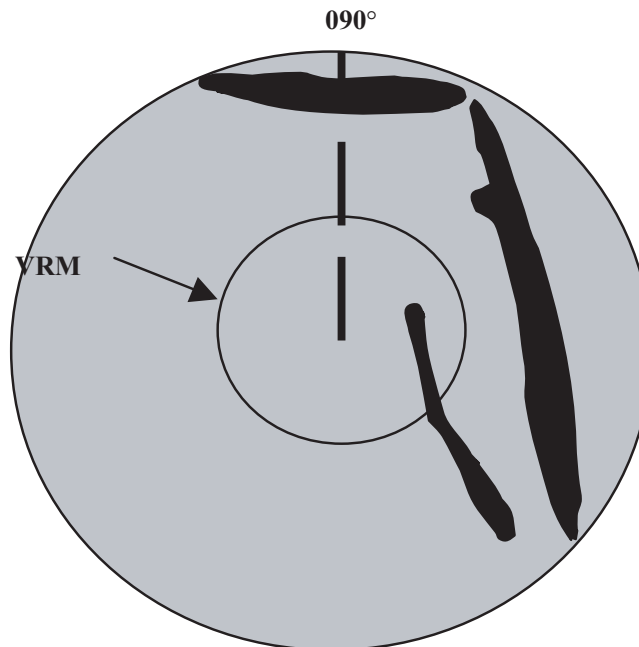
There were alternative methods of navigation that the master could have used to safely navigate the vessel into the marina. He could have set his radar's VRM to a range of 1/2 mile to serve as a danger marker. (See figure 7.) As he approached Sandy Hook Peninsula on his trackline, the distance to the land would close or decrease and would be readily apparent on the radarscope. When the distance to land was 1/2 mile, the range ring would appear to be tangent to the land mass and the vessel would be at the turn point. (See figure 8.) If the vessel continued toward the land without changing course, the range ring would pass over the land, indicating that the distance was less than the 1/2 mile from the vessel and that, as a result, the vessel would be approaching shallow water.

**Figure 7.** The VRM is set at the range that the vessel should be when it is to make the turn to the right toward the SBHM.

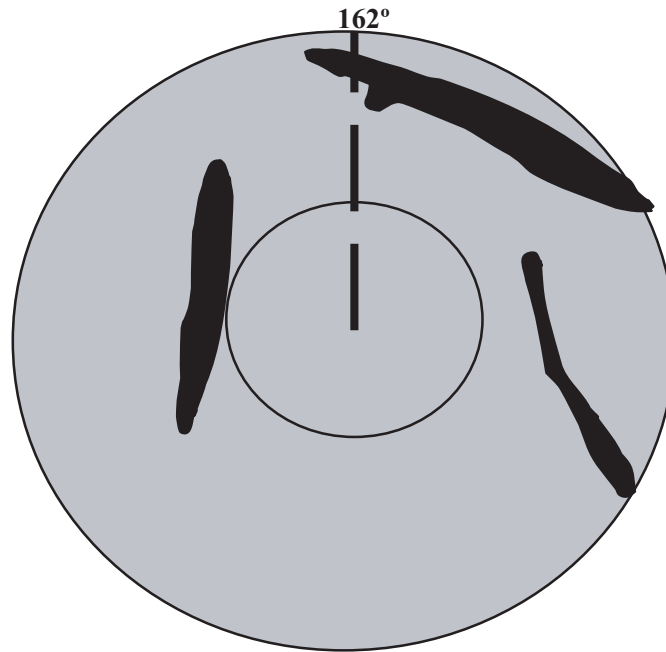
**Figure 8.** The radar presentation after the vessel turns to right toward the SHBM.

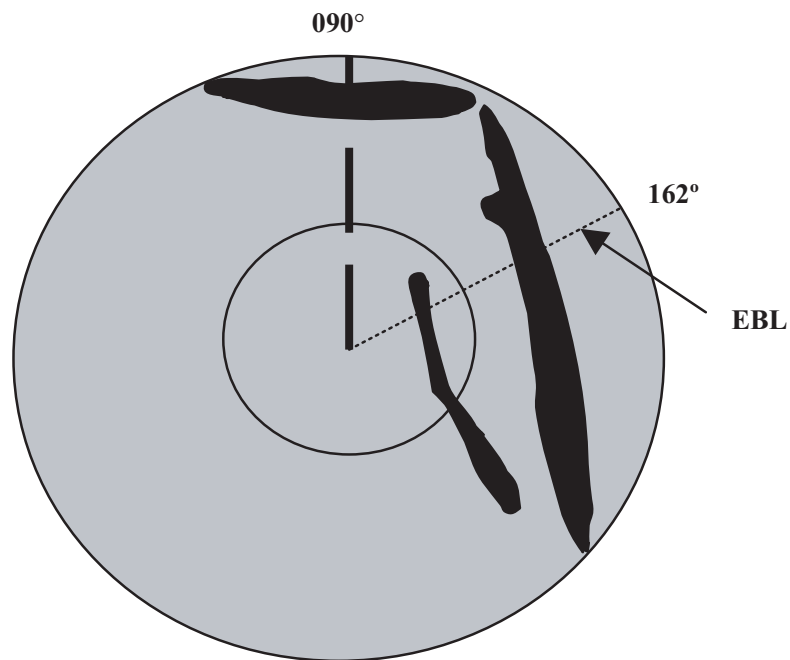
The master could have also determined the true course line of the channel and adjusted his EBL to display either the true or relative bearing from his easterly heading. (See figure 9.) At the point that the EBL was aligned into the marina, while the VRM became tangent with the land mass, the master would know that the vessel was at the point where it was safe for it to head toward the SHBM. (See figure 10.)

**Figure 9.** Electronic bearing line is set to the bearing that the vessel will have to change to when turning into the channel.

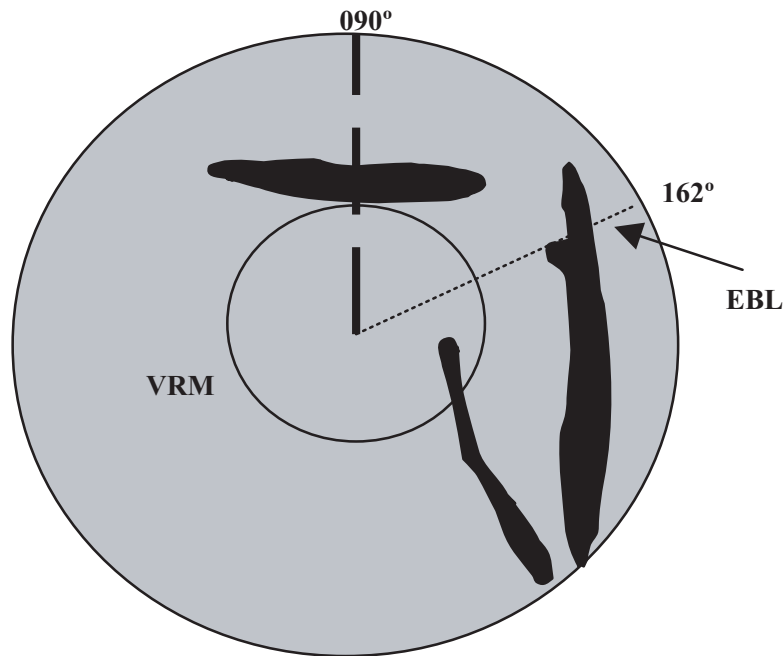
**Figure 10.** The VRM is tangent to Sandy Hook Peninsula and the EBL is tangent to the SHBM, indicating that the vessel is at the position to change course into the channel.

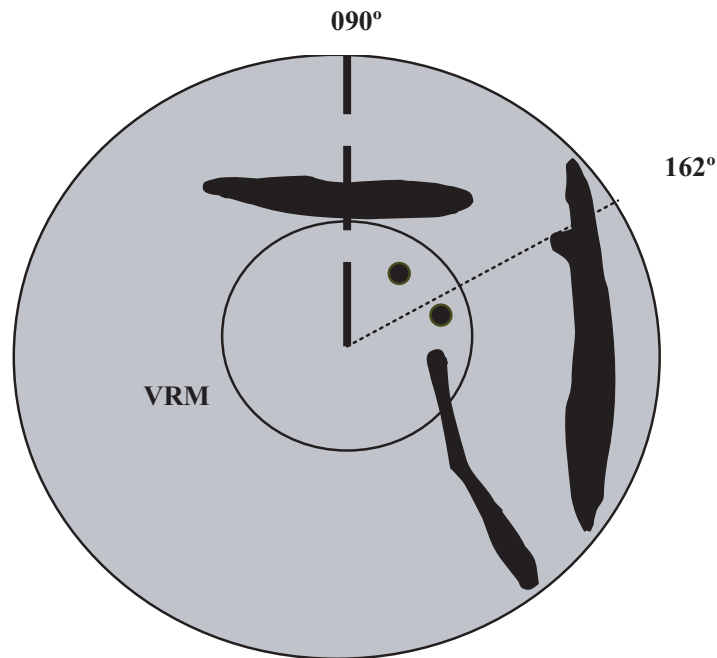
Beacons would be visible on radar and give the navigator a precise reference point to use in navigating regardless of conditions. (See figure 11.) Radar, especially in fog, is critical for determining the risk of collision. Because radar is used for collision avoidance and, at the same time, can be used for navigation, the importance of maintaining a radar watch cannot be overstated. Beacons that can be quickly identified by radar assist the mariner by allowing him to navigate and maintain a watch for other vessels at the same time.

**Figure 11.** The radar presentation with beacons in place marking the channel.

Install beacons to augment or replace buoys at the entrance to the Shrewsbury River channel. (M-02-18)
