**Sinking of the U.S. Small Passenger Vessel *Panther*  
Near Everglades City, Florida  
December 30, 2002**

**Marine Accident Report**  
**NTSB/MAR-04/01**

**Abstract:** This report discusses the sinking of the U.S. small passenger vessel *Panther* in the Ten Thousand Islands area of Everglades National Park, Florida, on December 30, 2002. The accident resulted in no deaths and one serious injury. Damage to the *Panther* was estimated at \$60,000.

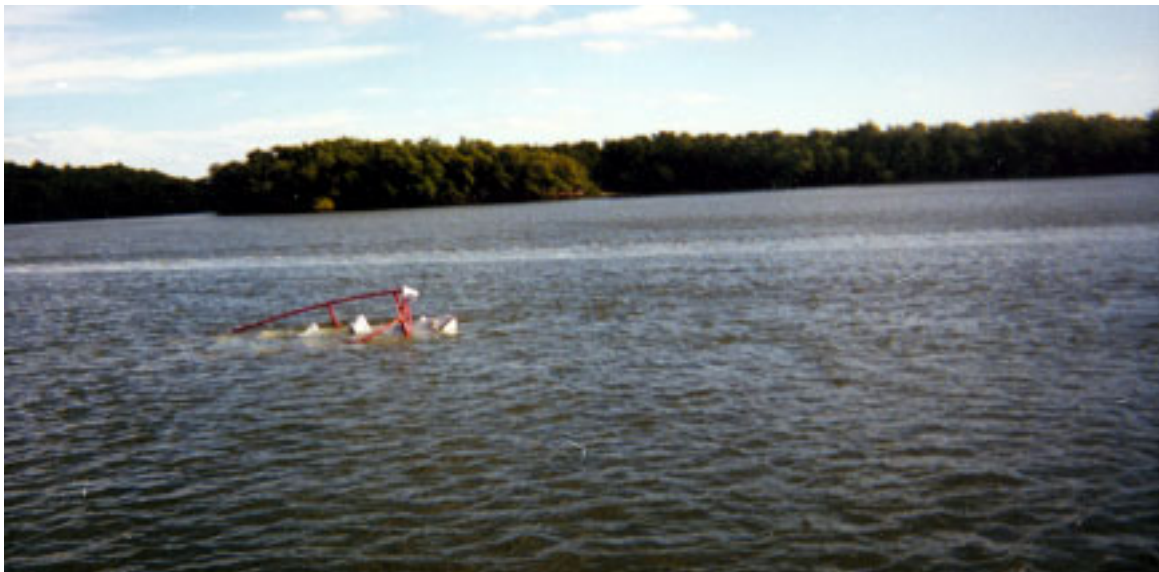
About 3 feet of bow rail remained above the water when the *Panther* sank (see figure 5). According to measurements made by Safety Board investigators, the water at the accident site was 10 to 12 feet deep.

**Figure 5.** *Panther* submerged in Indian Key Pass.

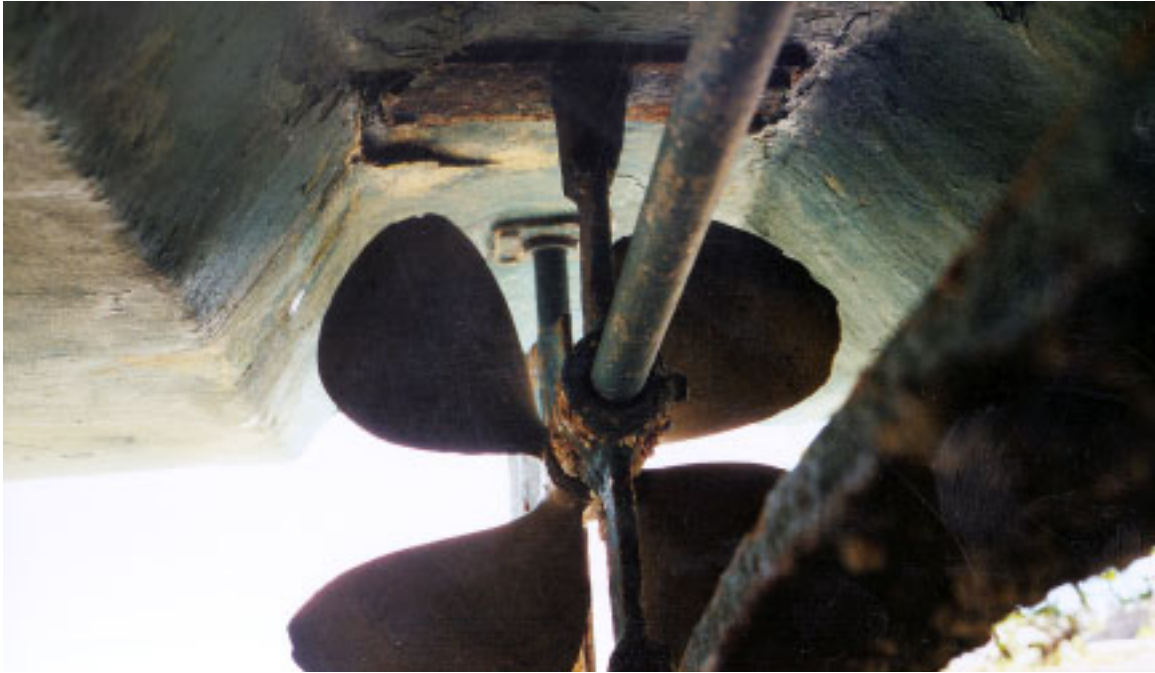
After the accident, the *Panther* was hauled out of the water and onto a marine railway owned by the tour boat company at the visitor center marina. When Safety Board investigators arrived, the vessel had already been partly dismantled and the bilge pumps disconnected. Safety Board and Coast Guard investigators examined the vessel and found a fracture in the underside of the hull, originating at the strut plate that supported the rudder post and steering assembly. The fracture was C-shaped, with each section of the C about 6 inches long (see figures 6a and 6b). The open part of the C, which surrounded the

strut plate, was pushed upward, creating an irregular opening about 2 inches long and 1 inch wide (see figure 6b). The investigators examined the plywood in the area of the C-shaped fracture in the hull bottom and found no evidence of deterioration due to wastage or rot.

**Figure 6a.** C-shaped fracture around strut plate.

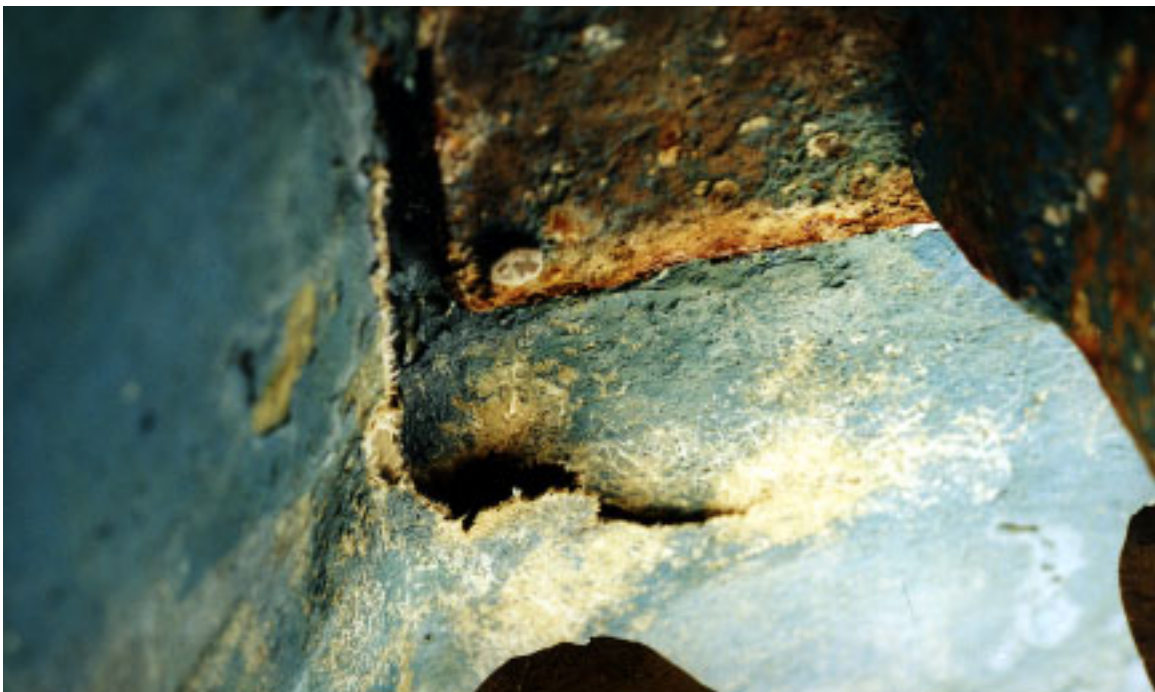
**Figure 6b.** Closeup of 2-inch opening in fracture around strut plate.

After the sinking, the owner's sons and the company maintenance men towed the *Panther* back to the marina. To pump out the vessel and allow it to be towed, the bottom of the vessel beside the strut support plate had to be plugged to stop the ingress of water. Throughout the tow, one of the men had to apply pressure to the plugged area to prevent incoming water from pushing out the plug. At the postaccident examination of the hull, Safety Board investigators did not find any other damaged sections of the hull. That indicates that there could not have been any other source of water leakage than the damaged area at the boat's shaft.

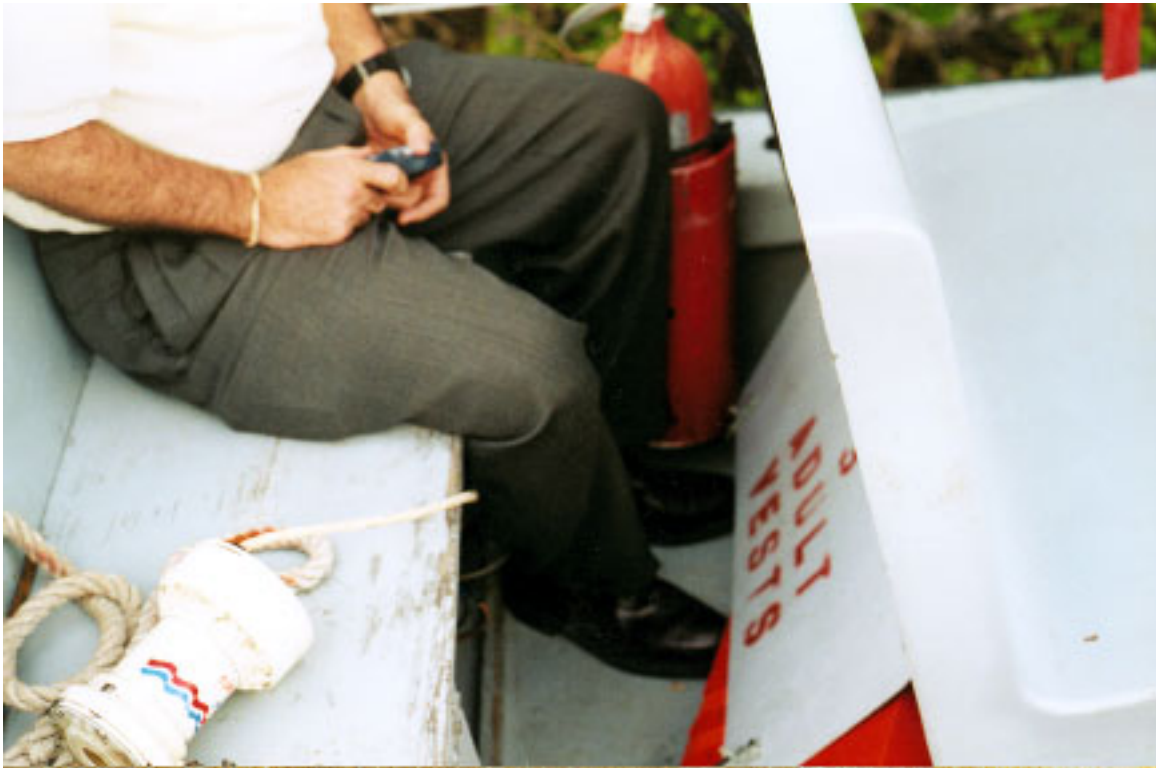
<sup>23</sup> According to 46 CFR 180.78, “life jackets must be stored in convenient places distributed throughout accommodation spaces,” and “each stowage container for life jackets must not be capable of being locked. If practicable, the container must be designed to allow the life jackets to float free.” Further, “each life jacket kept in a stowage container must be readily available.”

**Figure 7** Lifejacket locker on *Panther*.
