**Capsizing of U.S. Small Passenger Vessel *Lady D*
Northwest Harbor, Baltimore, Maryland
March 6, 2004**

Marine Accident Report

NTSB/MAR-06/01

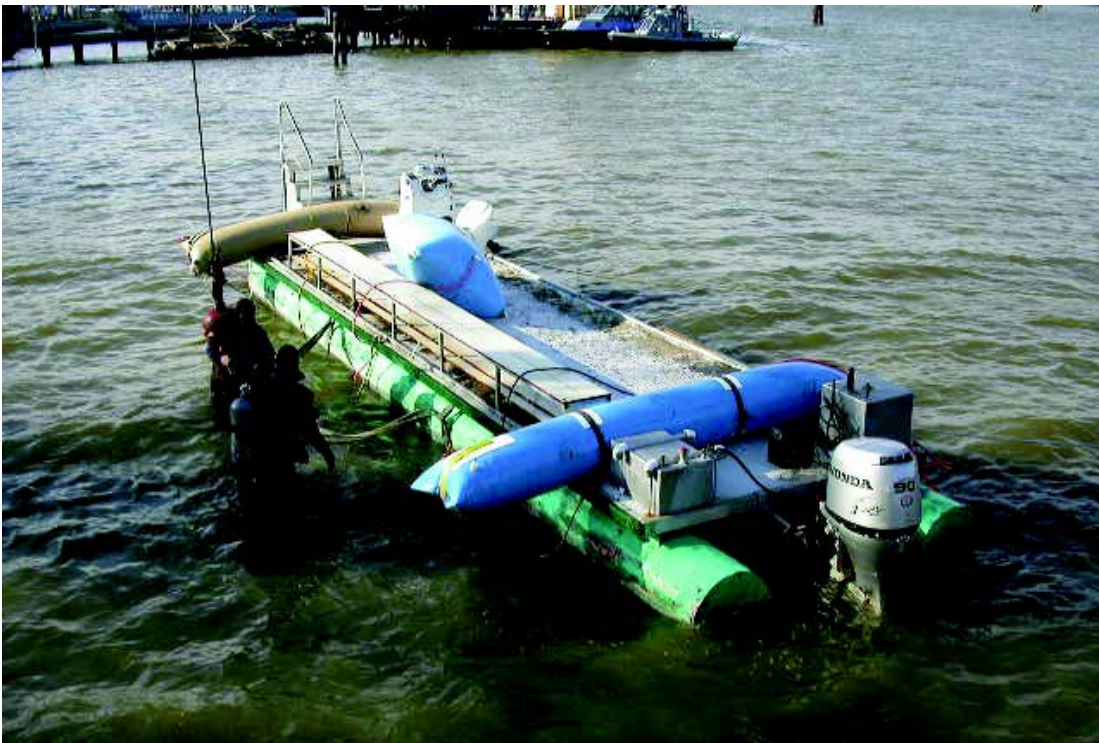
When the *Lady D* was righted on March 7, the day after the accident, investigators found that the wreckage comprised only the deck, pontoons, engine, fuel tanks, operator's console, and boarding ladder (figure 3). Part of the bulkhead from the aft end of the deckhouse was partially attached to the aft deck. To right the vessel, divers cut this partial piece loose. The rest of the deckhouse was missing and never recovered.

Figure 3. *Lady D* after being righted the day after the accident. Attached to the deck are airbags that were used to help right the vessel. Most of the deckhouse was missing and never recovered.

The port passenger bench was still attached to the deck of the wreckage. The starboard passenger bench was missing and was never recovered. The canopy section of the deckhouse was discovered during sonar searches of the harbor but was not recovered.

During a wreckage survey performed on March 9, investigators found the master's chair nearly detached from its mounting base and tilted to the starboard side. The starboard pontoon had damage on its aft outboard side (a dent and a hole). The steering

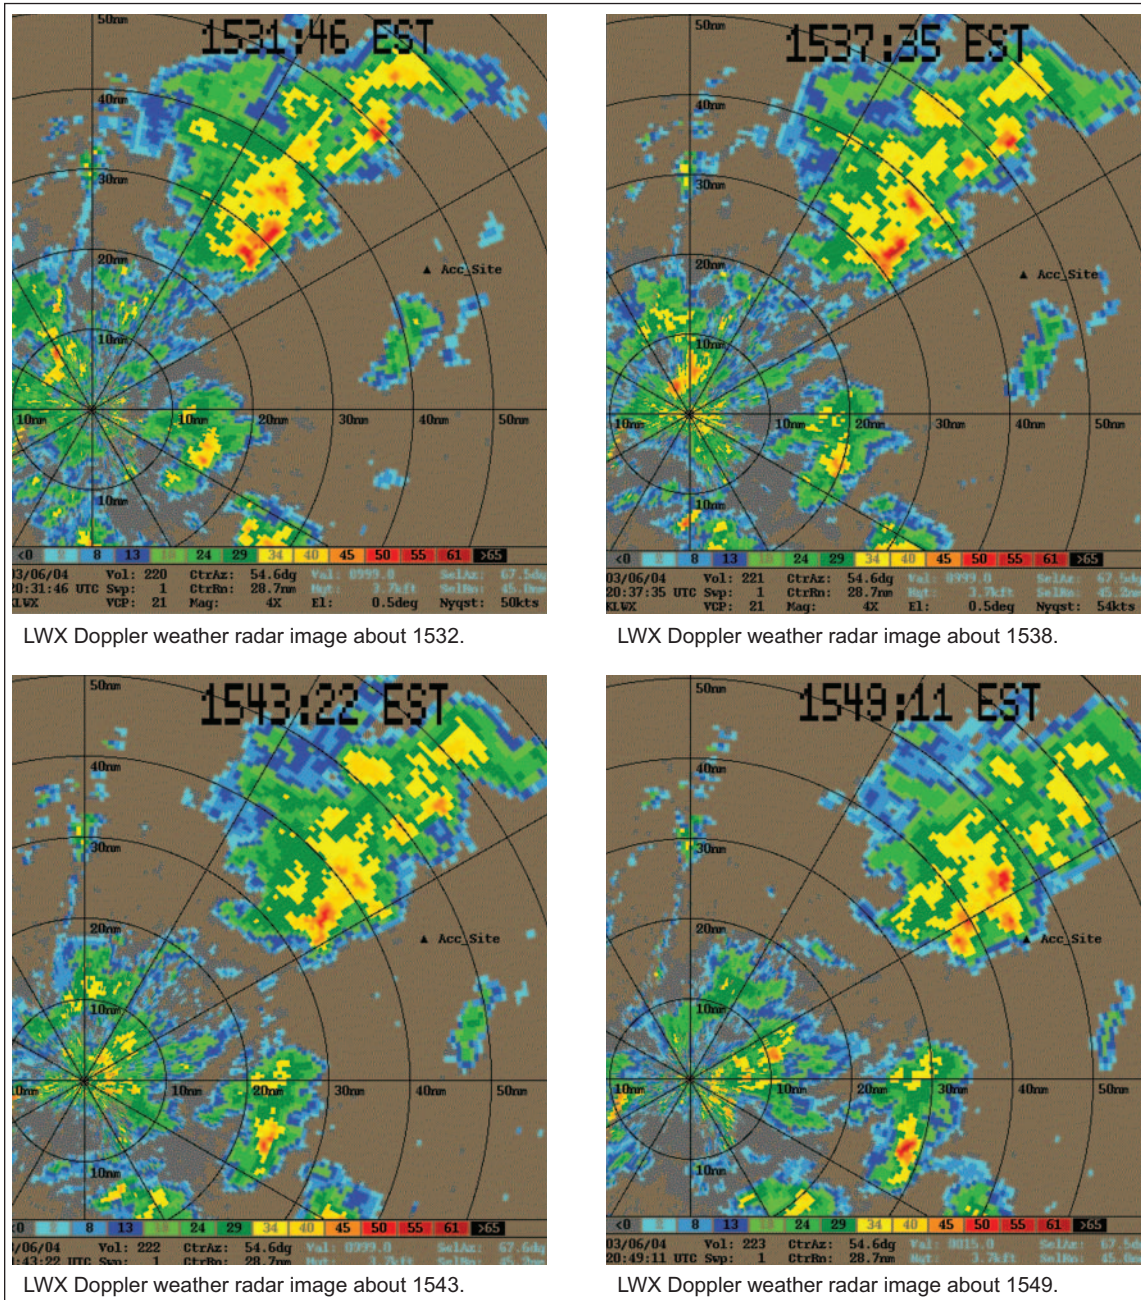
Figure 5. LWX Doppler weather radar images showing the movement of storms from west to east toward the Baltimore Inner Harbor during the period 1532 to 1549. When the Sea-port Taxi office manager radioed the fleet at 1558 that the worst parts of the storms were going to miss their area, she described conditions similar to those shown at 1549:11.

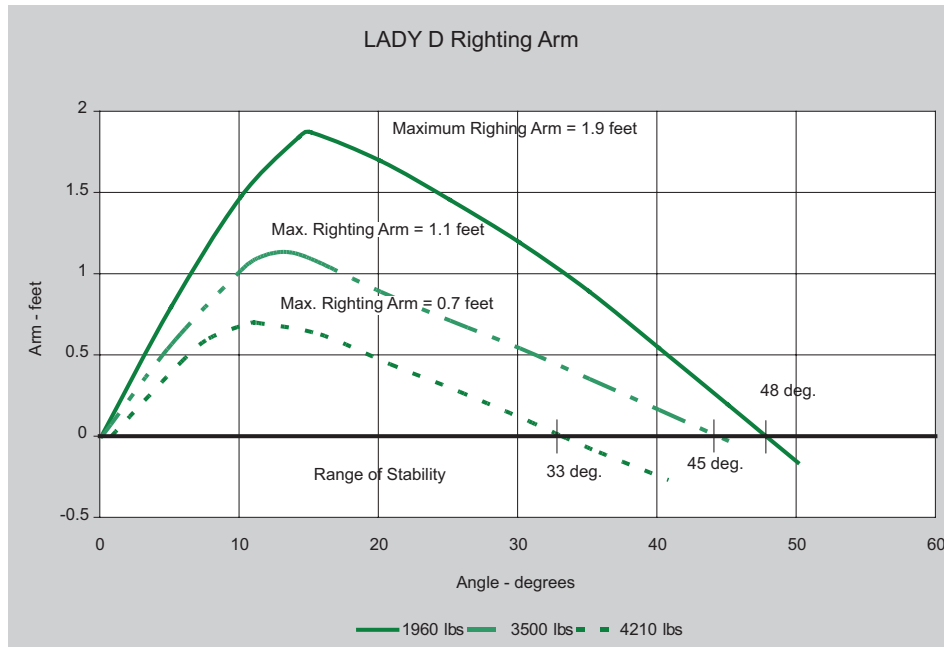
Figure 6. Righting arm curves for three load cases. The top, solid curve is for the first loading case of 1,960 pounds. The middle curve is for the second case with a 3,500-pound load. The bottom dashed curve is for the *Lady D* as loaded on the day of the accident (4,120 pounds).

The passenger load on the *Lady D* on the day of the accident therefore had a major negative effect on the vessel's intact stability. The weight of the persons on board the vessel increased its draft, which reduced the reserve buoyancy of the pontoons. The reserve buoyancy of the pontoons, especially of the downwind pontoon, is what produced the righting force that could counteract environmental forces that would heel the vessel farther over. Therefore, the loss of reserve buoyancy reduced the ability of the *Lady D* to resist environmental factors such as wind and waves on the day of the accident.

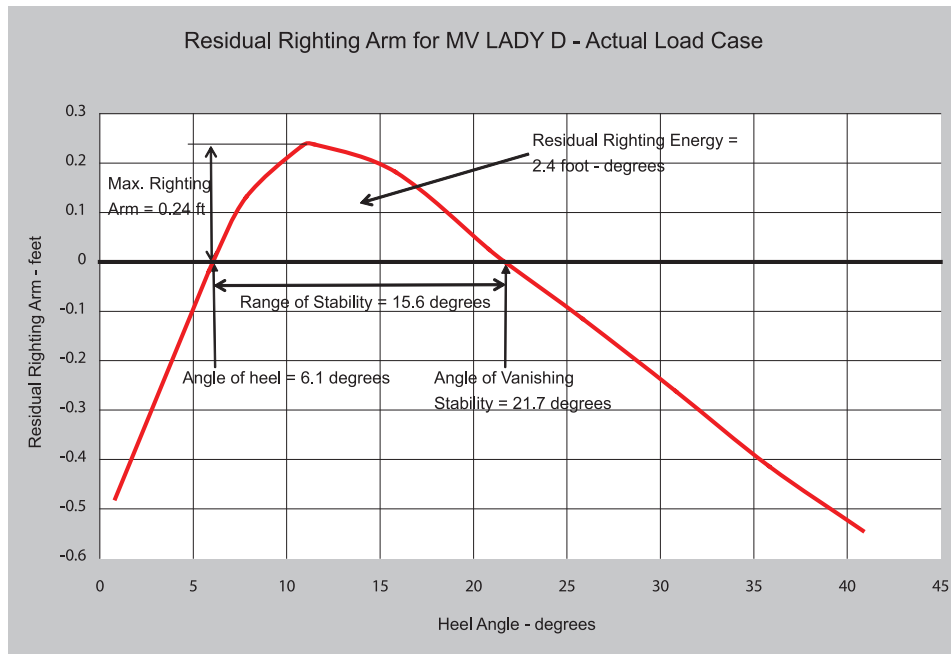
The static analysis of the effect on the vessel of wind alone showed that the force of a 40-knot wind was not adequate to overturn the vessel. Figure 7 charts the impact of a 40-knot wind on the intact stability of the *Lady D* as loaded on the day of the accident. The figure shows the vessel's "residual righting arm," which is the difference between the righting arm for the vessel and the wind-heeling arm. In calm water, a 40-knot wind would heel the vessel over to a 6.1° angle.

Figure 7. Residual righting arm for *Lady D* in 40-knot wind.

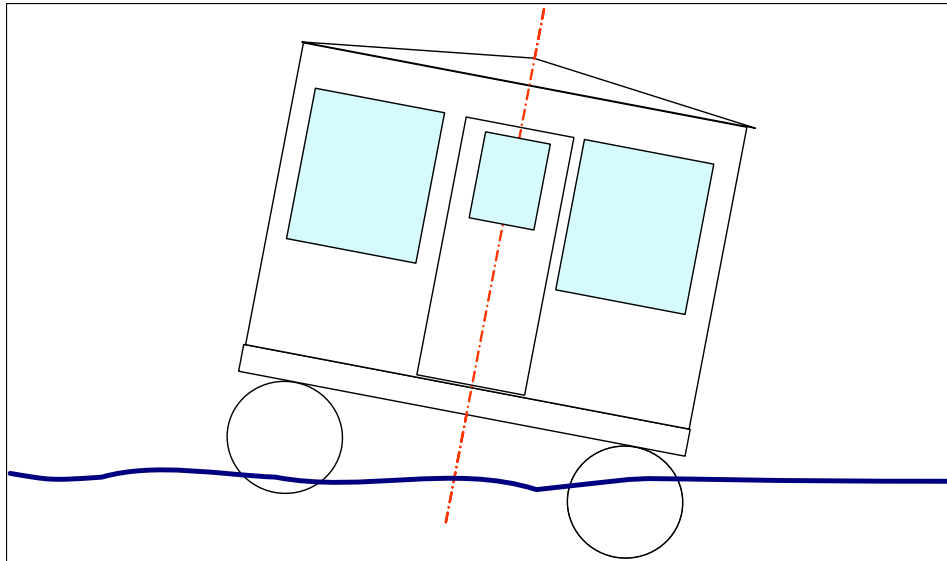
In the heeled condition, illustrated by figure 8, the *Lady D*'s pontoon on the side opposite the wind was almost completely submerged and had little reserve buoyancy left to counteract additional heeling forces. Thus, considering the *Lady D*'s load and wind conditions on the day of the accident, at an angle of slightly less than 22° of heel, the vessel would have had no reserve righting arm and nothing to prevent it from capsizing. At a wind speed of 40 knots, very little margin remained in the vessel's intact stability to counteract additional dynamic heeling forces. Any additional external force such as a wave hitting the boat, a rapid maneuver by the boat's master, or a shift in the boat's center of gravity due to passenger movements would have been enough to capsize the vessel.

The wave height at the time of the capsizing was about 1.25 feet, and the master was trying to maneuver the vessel to a safe haven. The Safety Board therefore concludes that the *Lady D* capsized as a result of the combined effects of the excessive load it carried and the wind and wave conditions experienced at the time of the accident.

Figure 8. Sketch of *Lady D* in the heeled condition.

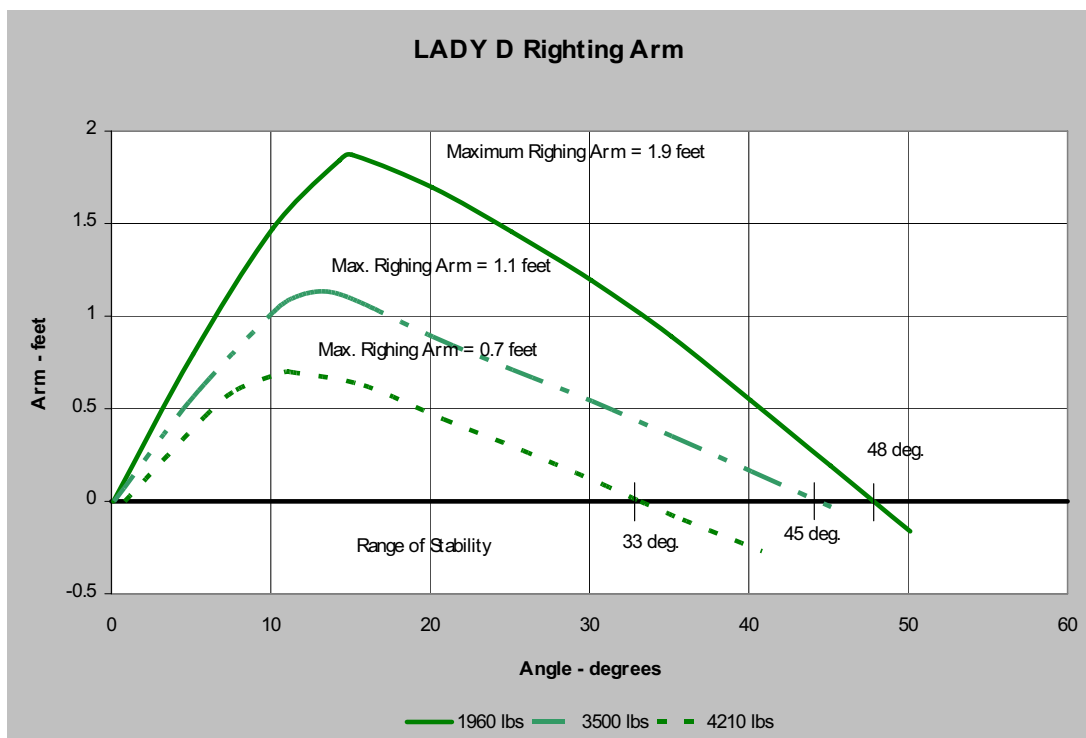
Figure 7 Righting Arm Curves for Three Load Cases

This figure shows how increasing the load carried by the vessel significantly decreases the maximum righting arm of the vessel and the range of stability. The maximum righting arm for the vessel in the first load case is 1.9 feet and it has a range of stability of about 48 degrees. In the second load case the maximum righting arm is 1.1 feet and the range of stability is about 45 degrees. In the third load case the maximum righting arm is only 0.7 feet and the vessel has a range of stability of only 33 degrees. On the day of the accident, once the LADY D reached a 33 degree angle of heel, there was no righting arm left to

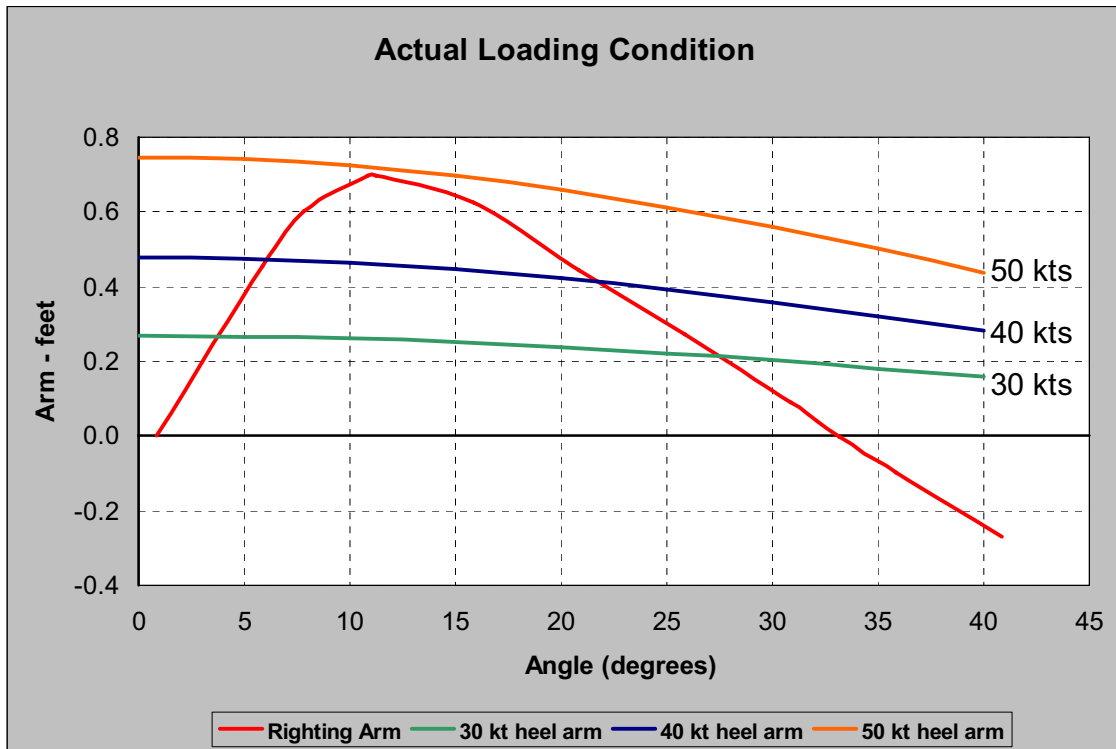
The ability of the LADY D, as loaded on the day of the accident, to resist wind heeling forces was examined for three wind speeds acting on the vessel's beam. The three wind speeds examined were 30, 40, and 50 knots. Wind heeling curves were generated for each of these wind speeds and they were plotted against the vessel's righting arm, as shown in Figure 8. The figure shows that as the wind speed increases the vessel losses "residual righting energy". In the 50-knot wind case, the wind heeling arm exceeds the vessels righting arm which would result in the vessel's capsizing. A steady state wind speed of 40-knots alone is not sufficient to capsize the vessel outright, but there is little "residual righting energy" remaining to counteract any other dynamic heeling forces such as wind gusts and waves.

Figure 8 Righting Arm versus Wind Heeling Arm for 3 Wind Speeds

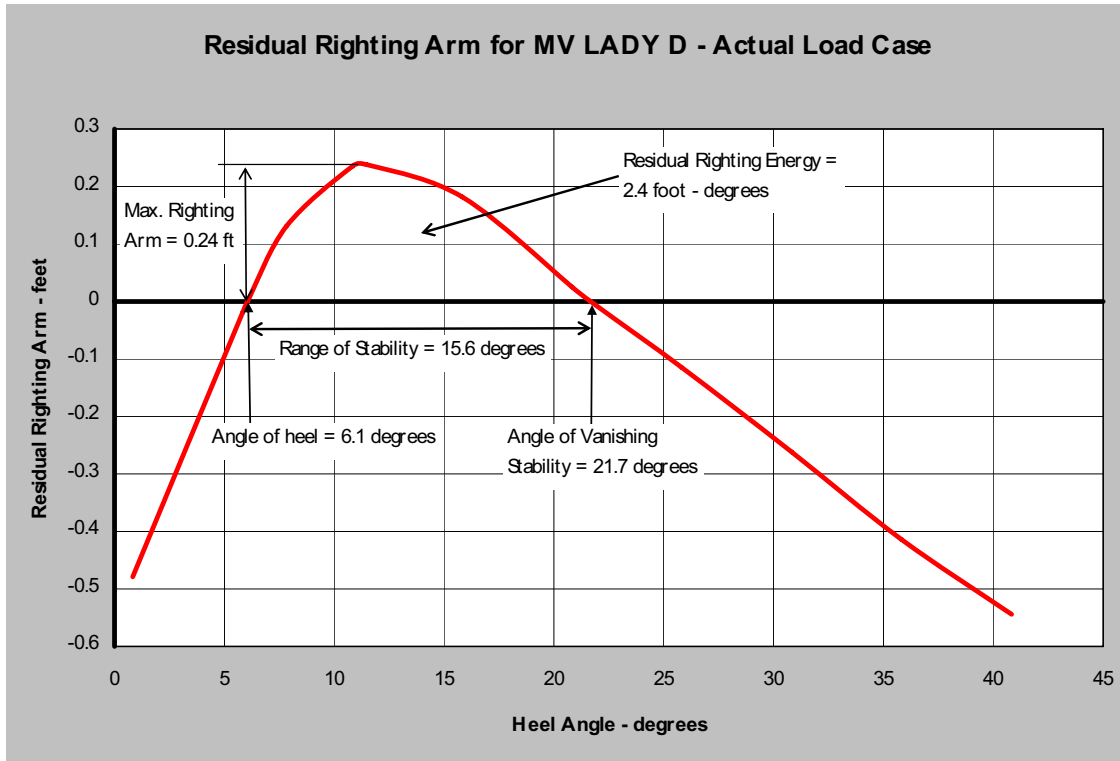
The impact of a 40-knot steady wind on the intact stability of the LADY D as loaded on the day of the accident is shown in Figure 9. This figure shows the “residual righting arm” for the vessel, which is the difference between the righting arm for the vessel and the wind heeling arm. The figure shows that a steady 40-knot wind would heel the vessel over to a 6.1 degree angle in calm water. Figure 10 is a sketch of the vessel looking at the bow in the heeled condition. The pontoon on the opposite side from the wind is deeply submerged and has little reserve buoyancy left to counteract any additional heeling forces. At an angle of slightly less than 22 degrees of heel, the vessel has no more righting energy and there is nothing to prevent the vessel from capsizing. Any additional external force (such as a gust of wind or a wave hitting the boat), a rapid maneuver by the boat’s captain, or a shift in the boat’s center of gravity due to passenger movements would be enough to capsize the vessel. At this wind speed there is very little margin remaining in the vessel’s intact stability to counteract any additional heeling forces.

Figure 9 Residual Righting Arm for LADY D in a 40-Knot Wind
