National Transportation Safety Board

Marine Accident Brief

Accident No.: DCA-09-LM-021
Vessel *Fire Island Belle*
Accident Type Engineroom fire
Location: Fair Harbor, New York
Date: September 20, 2009
Time: 1010 eastern daylight time¹
Owner/Operator: Fire Island Ferries
Property Damage: \$490,000
Injuries: None

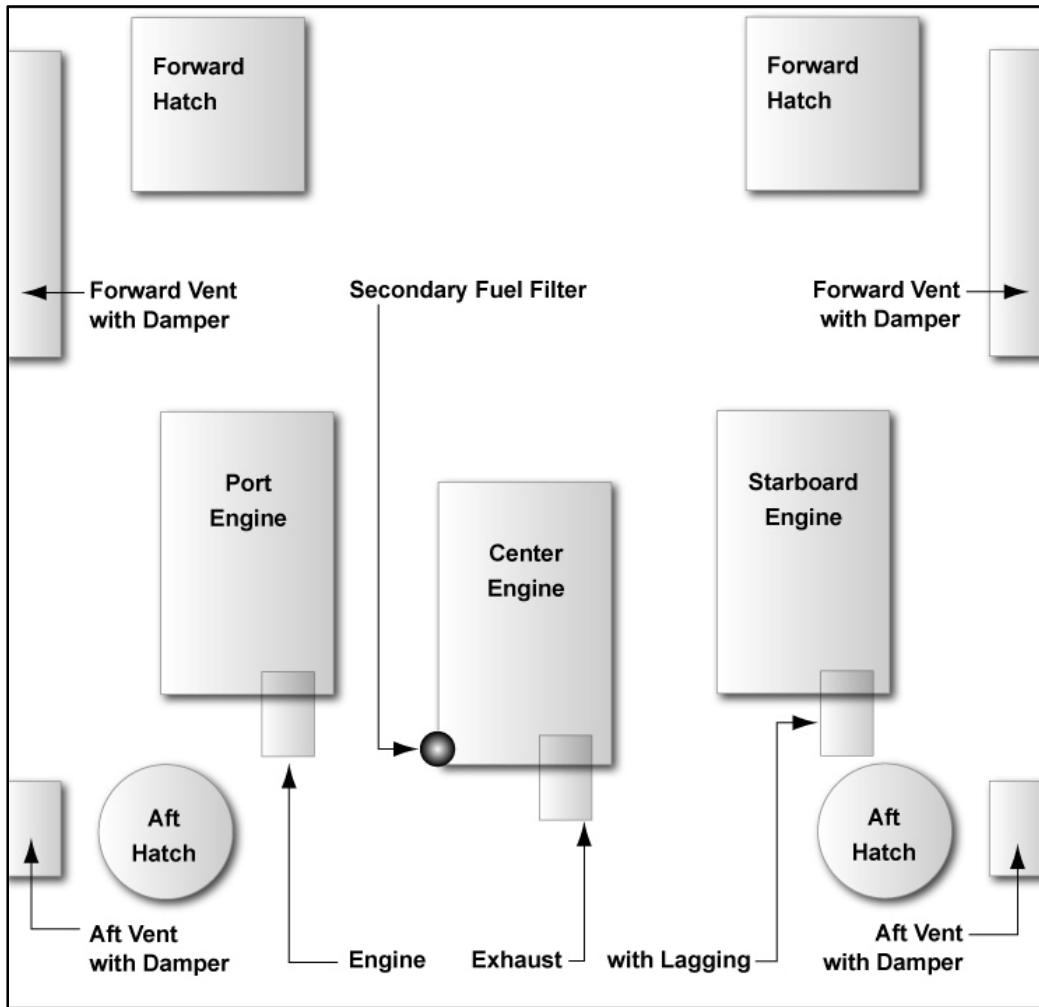
The master then entered the engineroom through the forward port access hatch. The engineroom contained three engines, port, center, and starboard, and four access hatches, two forward and two aft (figure 3). The master discovered fuel leaking from the pipe nipple connection to a T-fitting on top of the secondary fuel filter on the center engine. All three engines had experienced fuel leaks at that connection. As a result, the pipe nipples had been replaced on all three engines, most recently on the center engine, about 30 days before the fire.

Figure 3. Schematic of engineroom layout on *Fire Island Belle* (not to scale).

reasonable to conclude that during the voyage across the bay from Long Island to Ocean Beach, with all three engines running, pressurized fuel had sprayed from the crack in the pipe nipple up onto the exhaust duct for the port engine (refer to figure 3). Based on the fracture analysis, the master's discovery before the fire, and the history of issues with the nipple connection, investigators determined that diesel fuel coming from the fractured fitting on the center engine was the source of fuel for the fire.

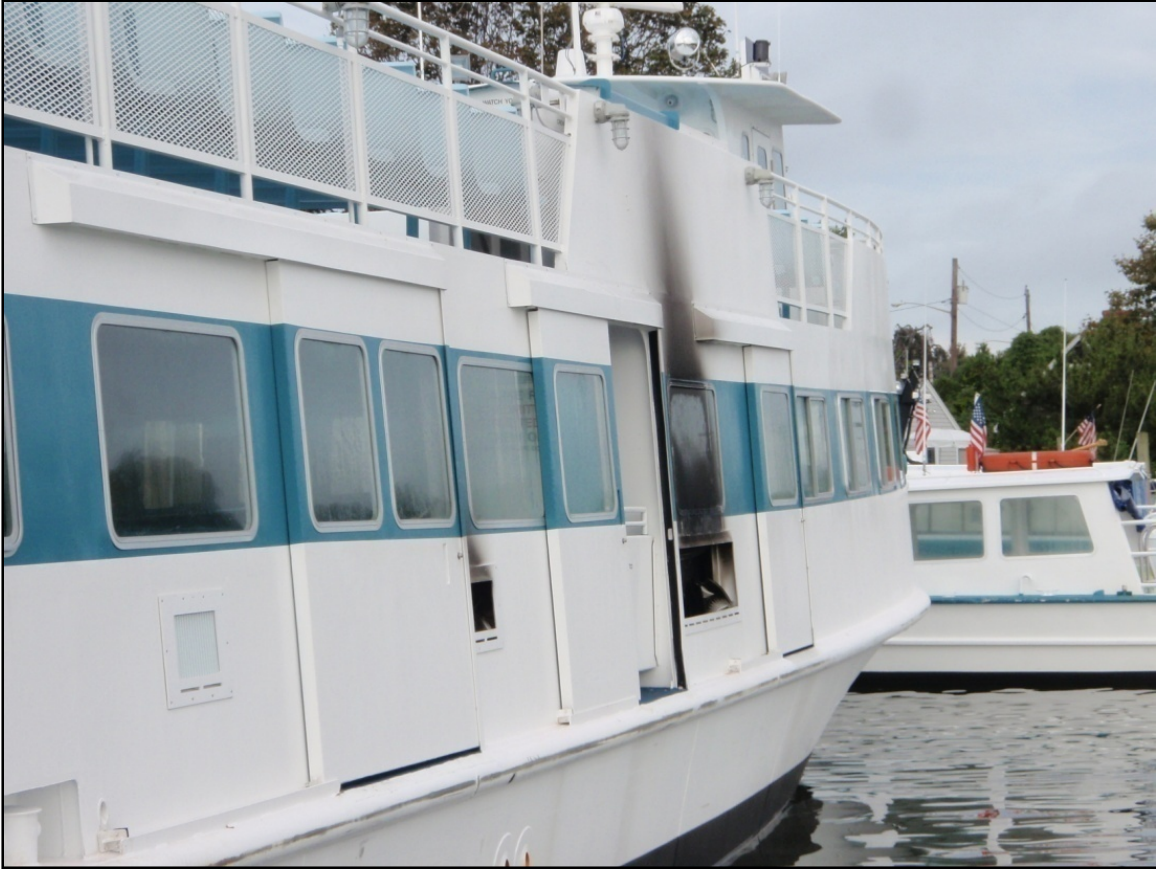
Smoke and other fire damage was limited to the engineroom and adjacent structures such as ventilation ducts and the aft access hatches. The only exterior damage was around the engineroom vent openings. Soot was visible on the outside of the hull above the dampers, with more soot on the starboard side than on the port side (figure 4). The Coast Guard–approved polyvinyl chloride (PVC) weather covers over the vents had melted. The starboard cover, which exhibited more melting than the cover on the port side, fell out of position and came to rest on top of the ventilation damper (figure 5). The cover did not interfere with the ventilation damper because the dampers had closed automatically when the fire suppression system was activated (see “Fire Protection System,” below).

Figure 4. Soot damage to vent opening on starboard side of vessel.

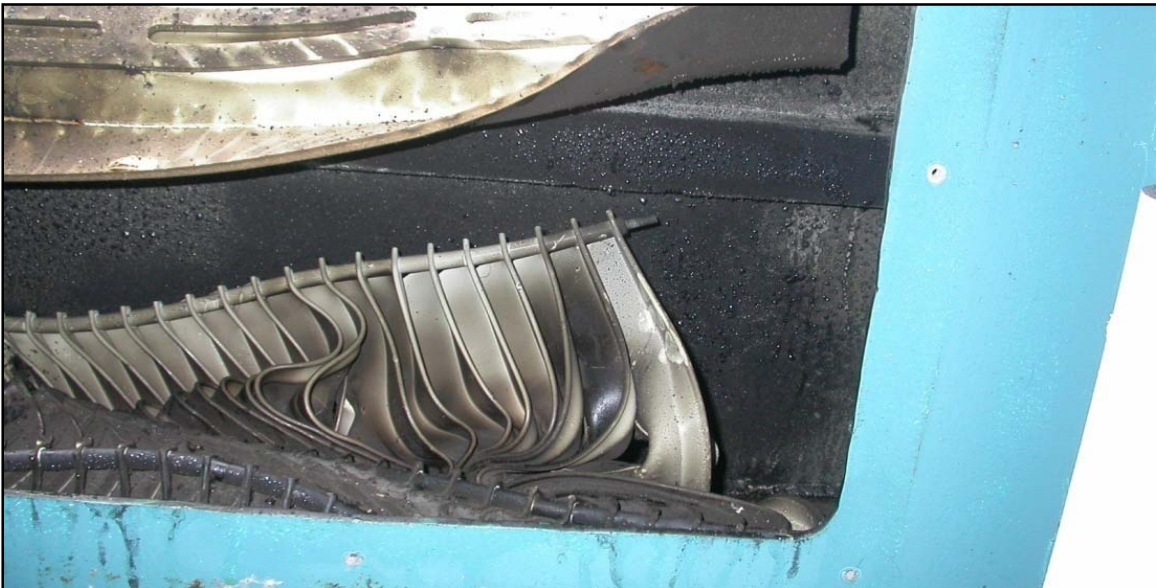
Figure 5. Closeup of damaged starboard vent cover (viewed from inside vent).

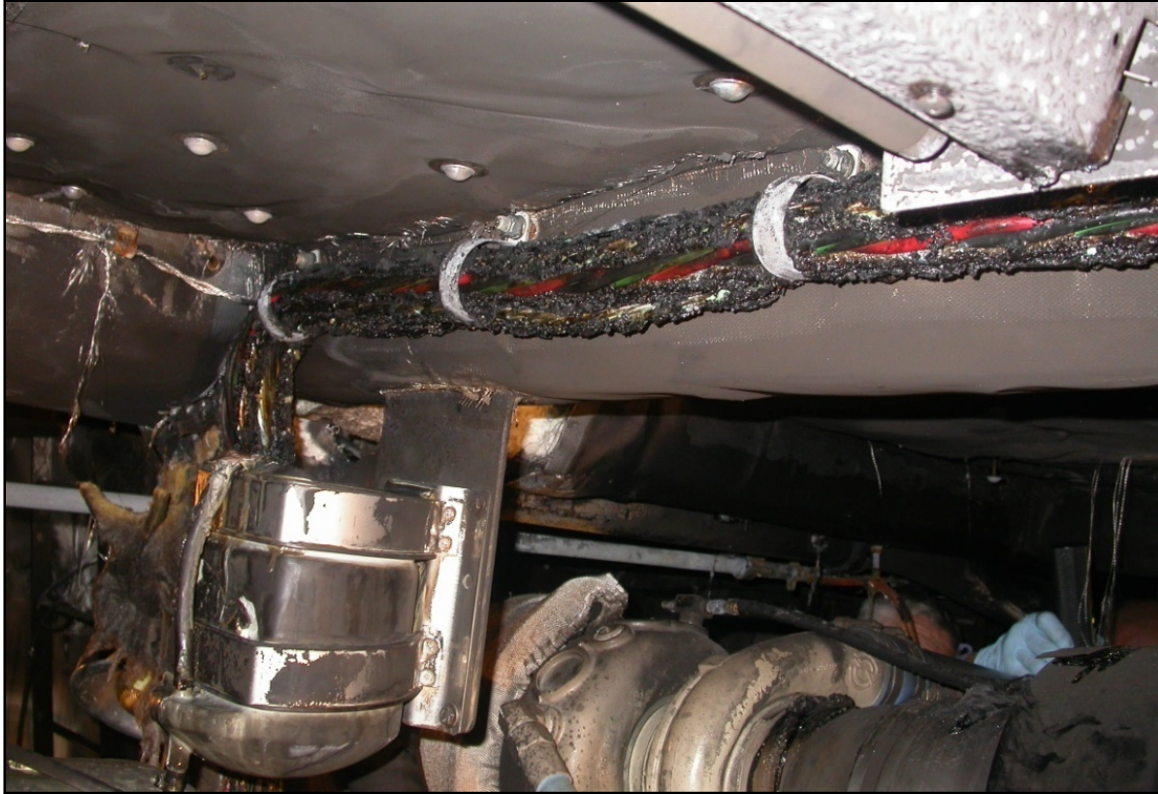
The engineroom showed varying degrees of fire damage. Damage in the forward section was limited to heavy sooting and some light thermal damage, particularly to plastic components, in the overhead forward of the engines. Damage was more severe near the engines, especially on the overhead between the center and port engines (figure 6). Thermal damage patterns extended 2 to 3 feet down from the overhead. One of the aluminum hangers for the fire suppression system piping had melted, and the hanger between the center and starboard engines had fractured. The lenses for the overhead lighting in the aft portion of the engineroom had melted away from the lights and dripped onto the surfaces below.

Figure 6. Damage to overhead wiring in engine room.

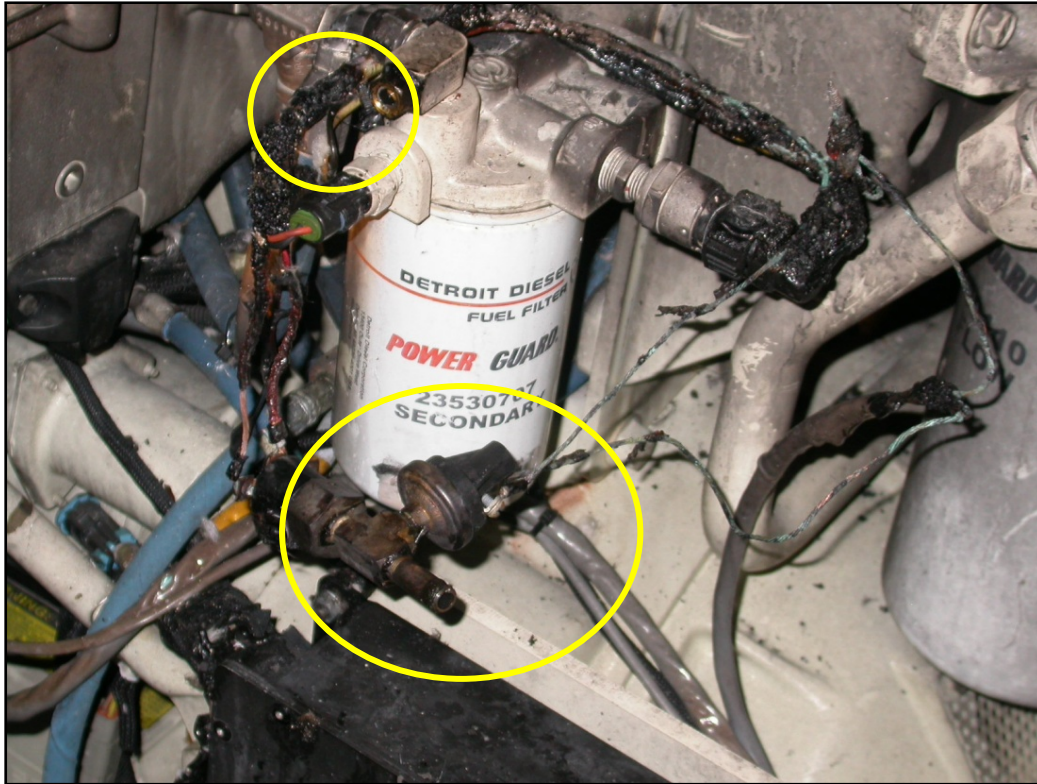
The only mechanical engine damage was a fractured pipe nipple connection on the center engine's secondary fuel filter (figure 7). The fractured nipple and adjoining fittings were removed and retained by the NTSB for further examination. The insulation on the wiring to the sensors attached to the T-fitting had melted, but the sensors were otherwise intact.

Figure 7. Fractured nipple (above) and associated fittings (below) on secondary fuel filter of center engine.

Shortly before the fire broke out, the crew had smelled fuel and the master had found fuel leaking from the nipple connection to the secondary fuel filter on the center engine (which was idling at the time). The postaccident laboratory examination found a fractured connection (pipe nipple) on the fuel filter. All three engines had experienced leaking at that connection. It is

The National Transportation Safety Board determines that the probable cause of the engineroom fire on the *Fire Island Belle* was the ignition of fuel that had leaked from a fatigue-fractured fitting on the center engine's secondary fuel filter, sprayed onto the lagging around the port engine exhaust duct, and seeped through a gap in the lagging onto the hot duct, where it caught fire.

- Altered the lubricating oil filtration system to activate by the ignition system rather than by the secondary fuel filter.
- Eliminated the pipe nipple and T-connector from the secondary fuel filter configuration.
- Added two-part insulation/lagging wrap to the exhaust ducting and duct hangers.
- Installed aluminum frames on the engineroom vent covers and aluminum mesh backing on the vents to keep the PVC part of the covers from falling inside the vents.
- Added another nozzle to the fire suppression system, making three nozzles in the engineroom—two over the engines and one forward.
- Updated the vessel's fire control plan.

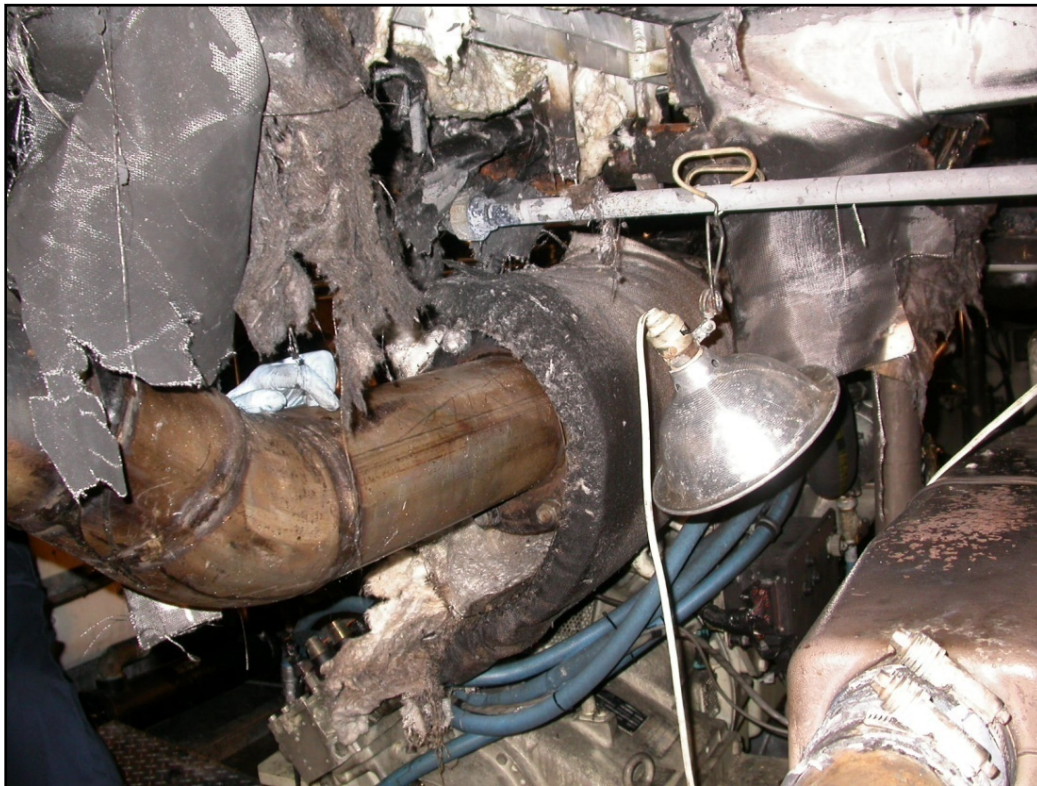
The lagging for the port engine exhaust duct, which was about 19 inches above the center engine's secondary fuel filter, was charred (figure 8). As noted earlier, parts of the lagging were removed by firefighters while searching for hot spots. Another section of lagging was removed to assess the condition of the duct underneath. The surface of the duct showed evidence of resolidified plastic, most likely from the lens of the overhead light. The duct hanger was not lagged.

Figure 8. Charred lagging on port engine exhaust duct.

The exhaust ducts from the vessel's engines, as the only exposed hot components in the engineroom, were covered with insulation (lagging). After the fire, the lagging on the port exhaust duct was removed. The lagging was charred both inside and outside, and molten plastic was observed on the surface of the duct, suggesting the presence of a gap in the stitching that held the lagging together. Therefore, the fuel from the center engine that had sprayed onto the port engine's exhaust duct could have leaked through the gap onto the hot surface of the duct, even after the center engine was shut down at Ocean Beach.

The engines were at idle while at the Ocean Beach dock, but the temperature of the exhaust from the port engine would have increased once the vessel got under way toward Fair Harbor. The autoignition temperature of the ultralow sulfur No. 2 diesel fuel used in the engines is 489° F. That temperature is below the temperature of the exhaust gas at full engine power (671° F). The apparent gap in the lagging demonstrates that despite the presence of insulation, the port exhaust duct was exposed, and fuel could therefore have contacted the hot duct. The gap in the lagging and the damage to the lagging itself suggest that the hot surface of the port engine's exhaust duct was the ignition source for the fire.

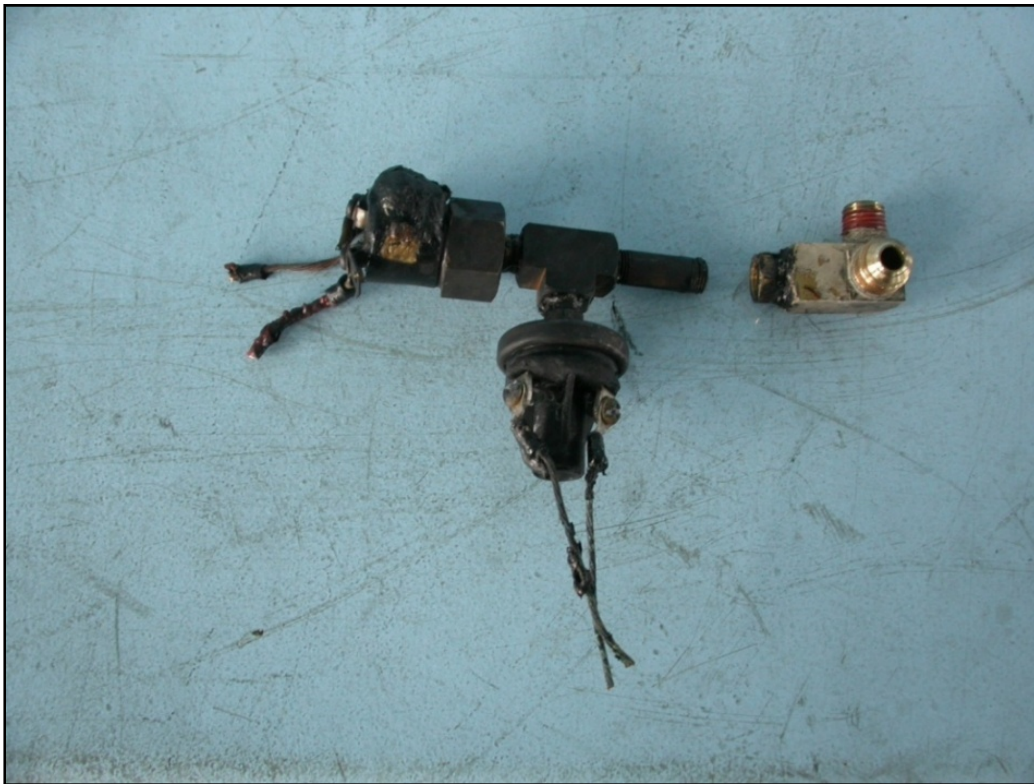
The NTSB materials laboratory in Washington, DC, examined the fractured pipe nipple from the secondary fuel filter on the center engine (figure 13). The nipple was constructed of 3/8-inch seamless steel pipe (1/8 American Standard pipe), commonly referred to as black steel. Examination by stereomicroscope and scanning electron microscope revealed a fatigue fracture (crack) that went through the wall of the pipe and part-way around it. The dimensions, chemistry, and hardness of the pipe nipple were measured and compared with appropriate standards for seamless steel pipe. The measurements were within specifications.

Figure 13. Pipe nipple and T-fitting from center engine.
