**Rupture of a Railroad Tank Car Containing  
Hazardous Waste  
Freeport, Texas  
September 13, 2002**

**Hazardous Materials  
Accident Report**

**NTSB/HZM-04/02**

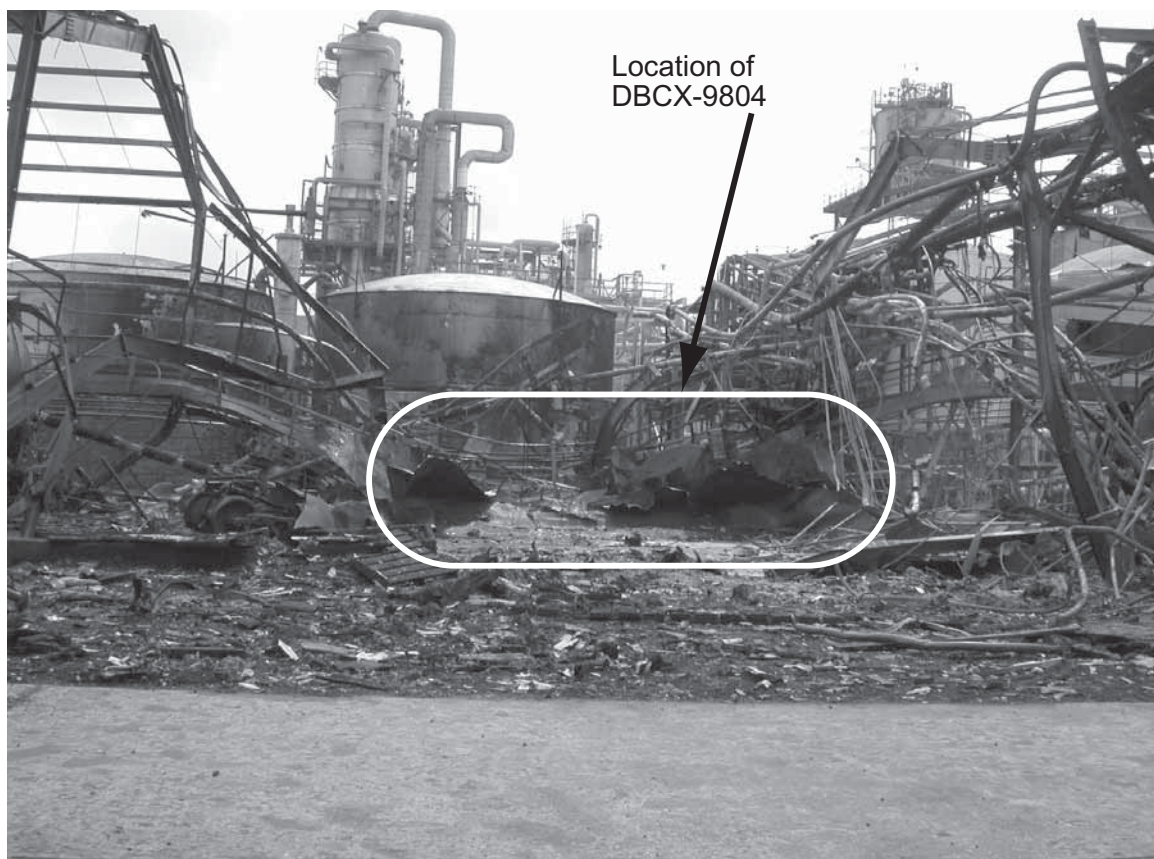
**Figure 1.** Damage to transfer area caused by catastrophic rupture of tank car DBCX 9804.

The transfer station where DBCX 9804 had been, the highway cargo tank that had been receiving the waste, and a second tank car in the vicinity were destroyed. The station structure east and west of the blast site was severely damaged. Two storage tanks containing oleum immediately to the north/northwest of the accident scene were damaged by flying debris, leading to the oleum release.

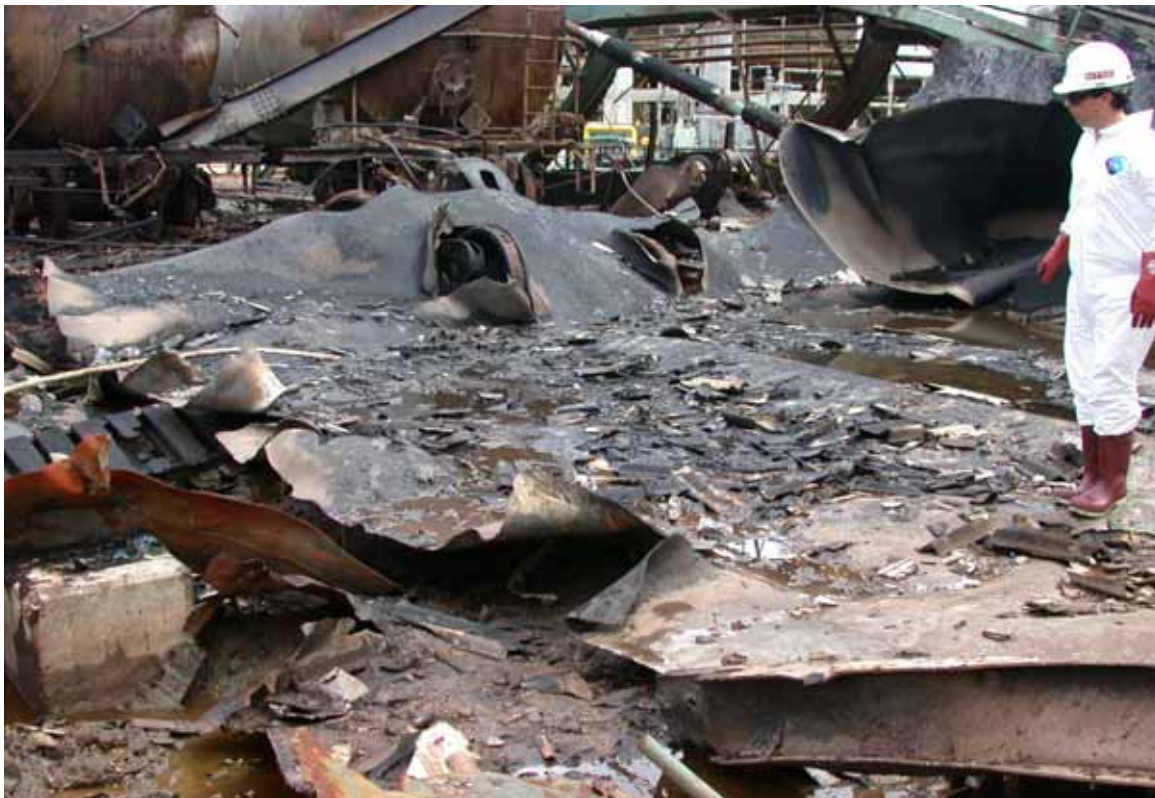
Tank car DBCX 9804 split longitudinally near its top. The split ran the length of the tank car. Two circumferential tears on opposite sides of the car ran from the area where the dome housings had been to about halfway down the sides of the tank car. The tank's fracture surfaces were consistent with overstress fracturing. The sides of the tank car had unfolded into a flattened position. (See figure 3.) The pressure relief valve was not found. One dome housing (without the cover) that contained the valves and fittings was found on the adjacent Dow Chemicals facility property about 1/3 mile south of the accident site. The second dome housing (containing the 6-inch access opening) was not found. Both tank car heads were separated from the tank car shell. The B-end head was found about 25 feet west of the flattened tank car, and the A-end head was found about 125 feet to the east.

**Figure 3.** Postaccident photo showing a Safety Board investigator standing on flattened portion of railroad tank car DBCX 9804.

Although the pressure relief valve for DBCX 9804 was not recovered after the accident, the events described by the witnesses at the scene on September 13, 2002, indicate that the pressure relief valve was functioning and venting vapors up to the time the tank car ruptured. Witnesses recalled that the pressure relief valve opened and reset itself two or three times between about 8:40 a.m. and 9:00 a.m., began to constantly vent about 9:00 a.m., and continued to constantly vent until the rupture occurred about 9:30 a.m. Witnesses also reported hearing a high-pitched whistle around 9:00 a.m. and seeing a stream of white vapor come from the pressure relief valve as it constantly vented. During postaccident inspection of the tank car, investigators found a longitudinal tear along the top of the tank car and circumferential tears near the dome housings.
