**UNITED STATES
NUCLEAR REGULATORY COMMISSION
REGION IV
611 RYAN PLAZA DRIVE, SUITE 400
ARLINGTON, TEXAS 76011-4005**

December 19, 2005

**SUBJECT: COOPER NUCLEAR STATION - NRC SPECIAL INSPECTION
REPORT 05000298/2005014**

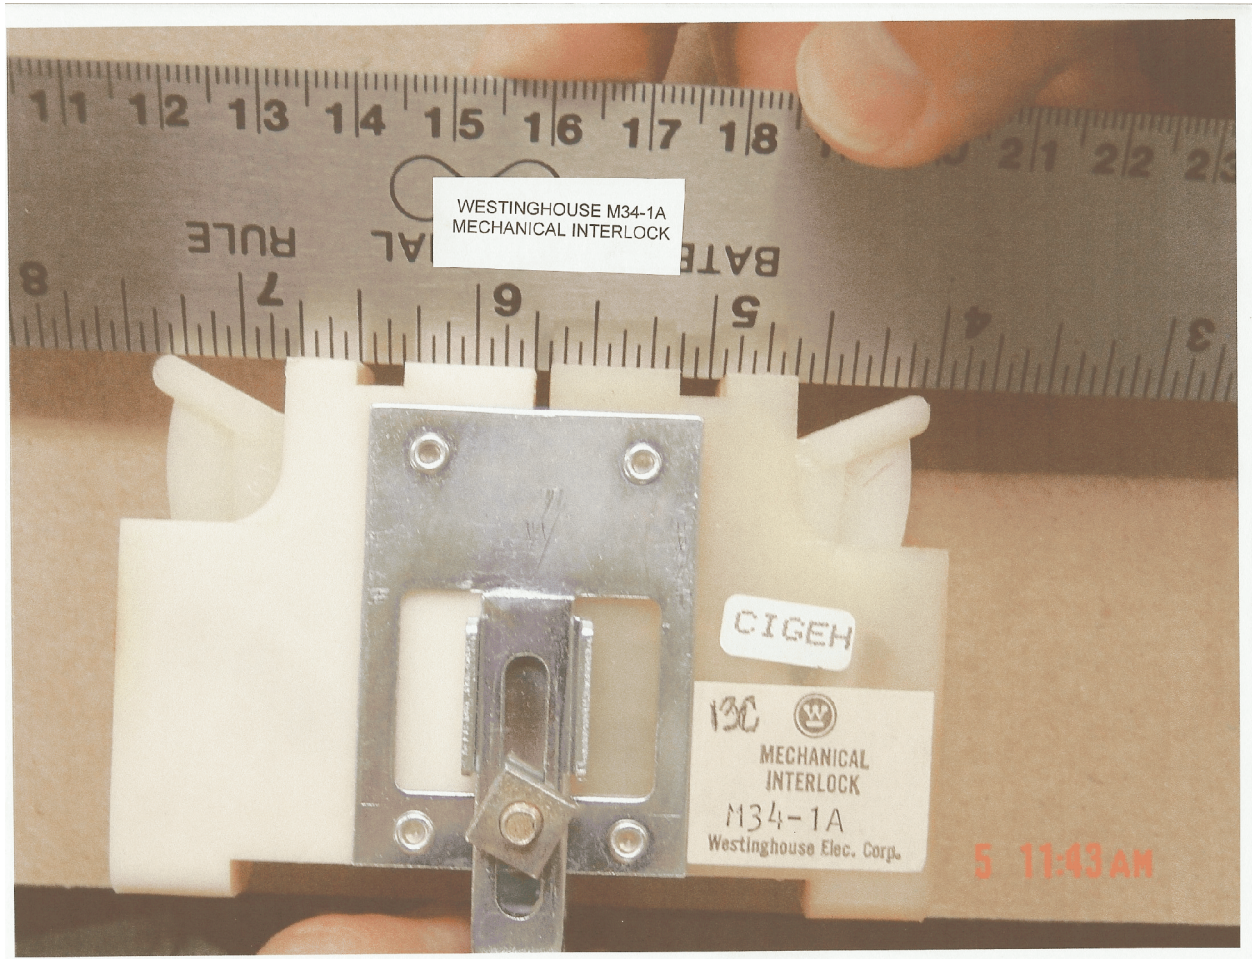
Figure 2: Westinghouse M34-1A Mechanical Interlock

During troubleshooting on RHR-MOV-MO13C and RHR-MOV-MO15B, the licensee determined that the mechanical interlock between the contactors in each of the starter assemblies was deformed. This deformation caused the interlock to bind such that when a valve operation was demanded from the control room, the associated contactor would energize but would not have sufficient force to move the interlock. In the case of RHR-MOV-MO13C, this binding caused the close contactor to remain energized in an attempt to close the valve until it overheated, causing the control power fuse to open. In the case of RHR-MOV-MO15B, the successful operation of the valve on the second attempt indicated that the failure mechanism was intermittent in nature. The licensee also determined the most likely cause for the deformation was a manufacturing issue with the starter assemblies. The interlock is mounted to the backplate of the starter assembly with an "L" bracket which is held in place by a single screw. The mounting holes for the interlocks in these two starter assemblies were off-center; therefore, external force had to be applied to the edges of the interlocks in order to mount them using these holes. Over time, the external force caused stress relaxation in the nylon plastic case of the interlock, which resulted in misalignment of the internal components and caused the interlock to bind.

The licensee's long-term corrective actions for the motor starter assembly failures include a modification to all the mechanical interlocks used in Westinghouse full voltage, reversing motor starter assemblies at Cooper. This modification will replace all existing interlocks with new interlocks that have a slotted screw hole machined in the mounting bracket. The interlock will be mounted using the existing holes in the assembly backplate and will be adjusted so that no external force is applied to the case. The licensee believes this modification will eliminate the failure mechanism.
