NTSB National Transportation Safety Board

Flight Deck Automation Working Group

Robert Sumwalt
September 10, 2008

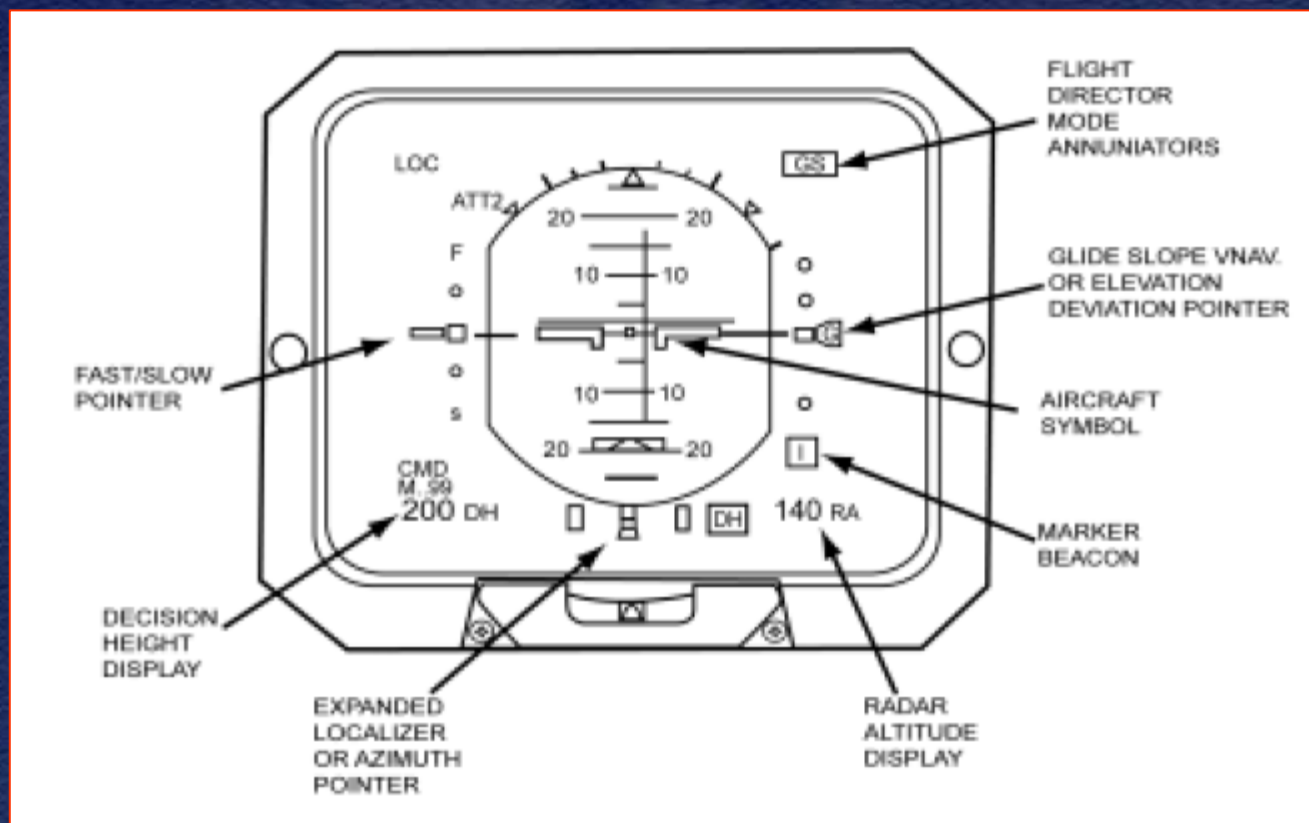
G-3 at Houston

- Aircraft had GS indicator on Left side of PDF.
 - Fast/Slow on Right side
- Configuration of other company aircraft flown by accident pilots:
 - 5 had GS on Left
 - 3 had GS on Right
- AC 25-11 (July 16, 1987) recommends that GS indication be located on Right side of display,
 - Accident aircraft was manufactured before this guidance was issued.

“The pilots most likely mistook the fast/slow indicator for the glideslope indicator throughout the approach sequence.”

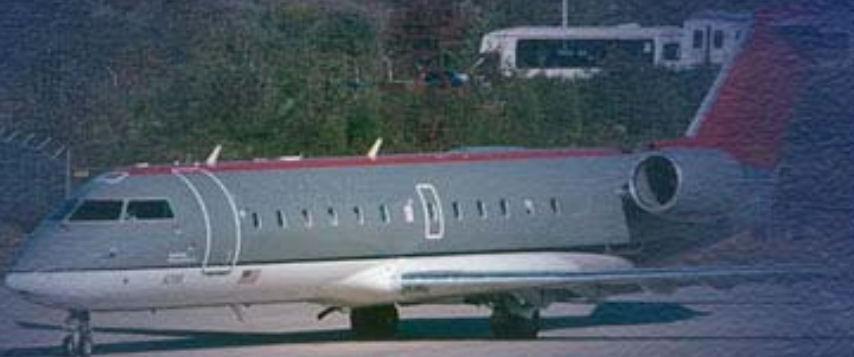
Pinnacle Airlines Flight 3701 Jefferson City, Missouri

“The Safety Board concludes that the flight crew’s inappropriate use of the vertical speed mode during the climb was a misuse of automation that allowed the airplane to reach 41,000 feet in a critically low energy state.”

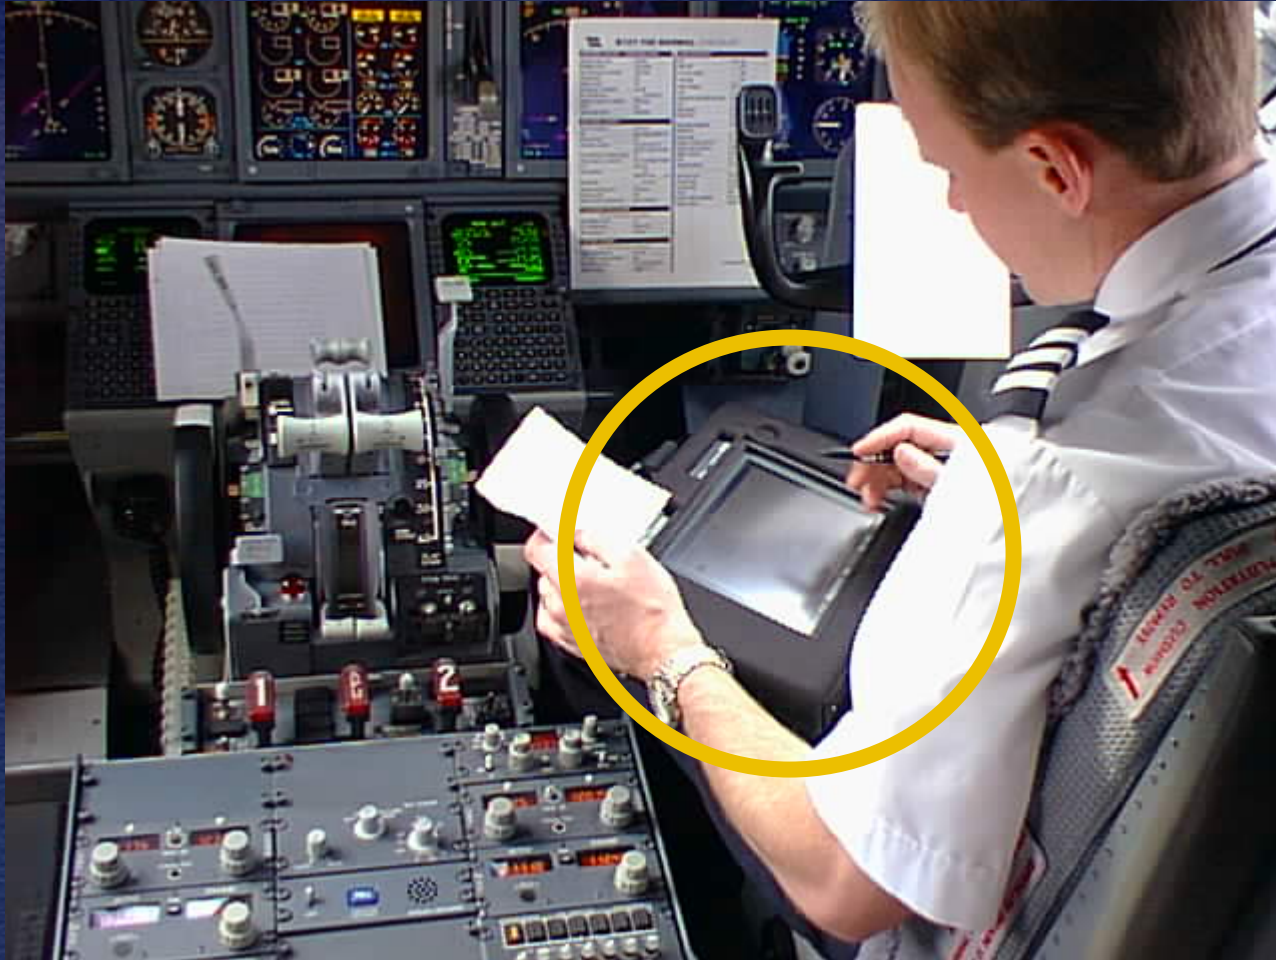
Onboard Performance Computer

- OPC assumptions:
 - Reverse thrust use assumed
 - Tailwind component limit (5 kt)
- Had the actual 8 kt tailwind component been displayed, the stopping value would be **-260 feet**

“Require that all 14 CFR Part 121 and 135 operators ensure that all onboard electronic computing devices they use automatically and clearly display critical performance calculation assumptions.” (A-07-58)

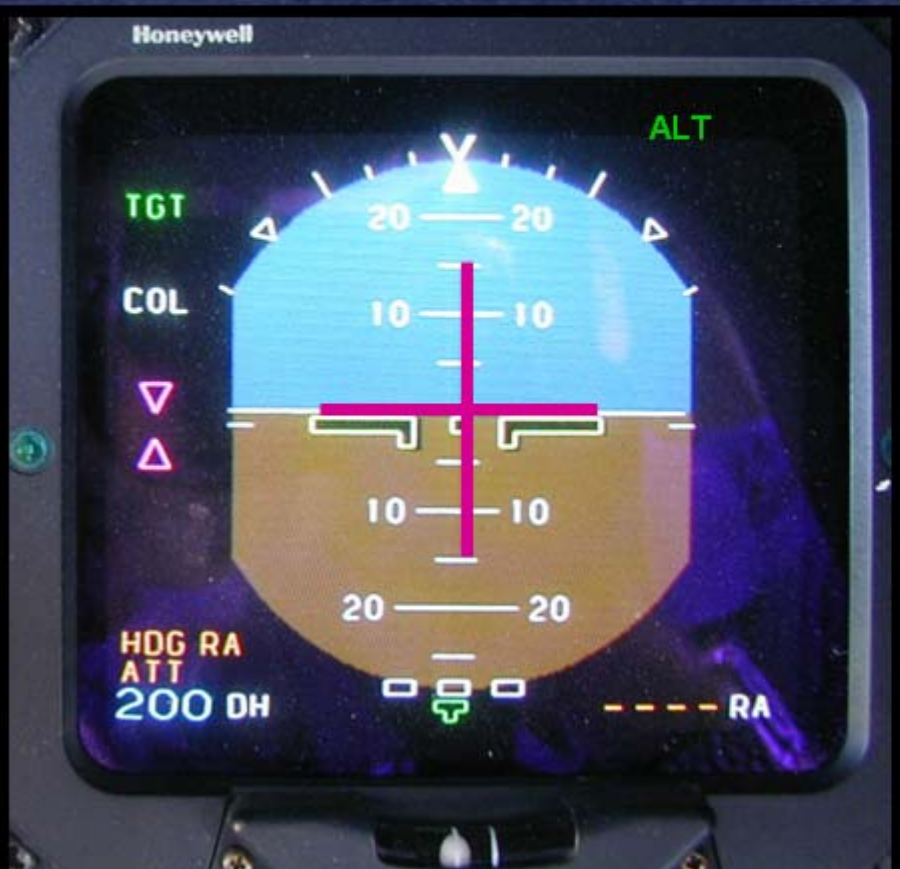
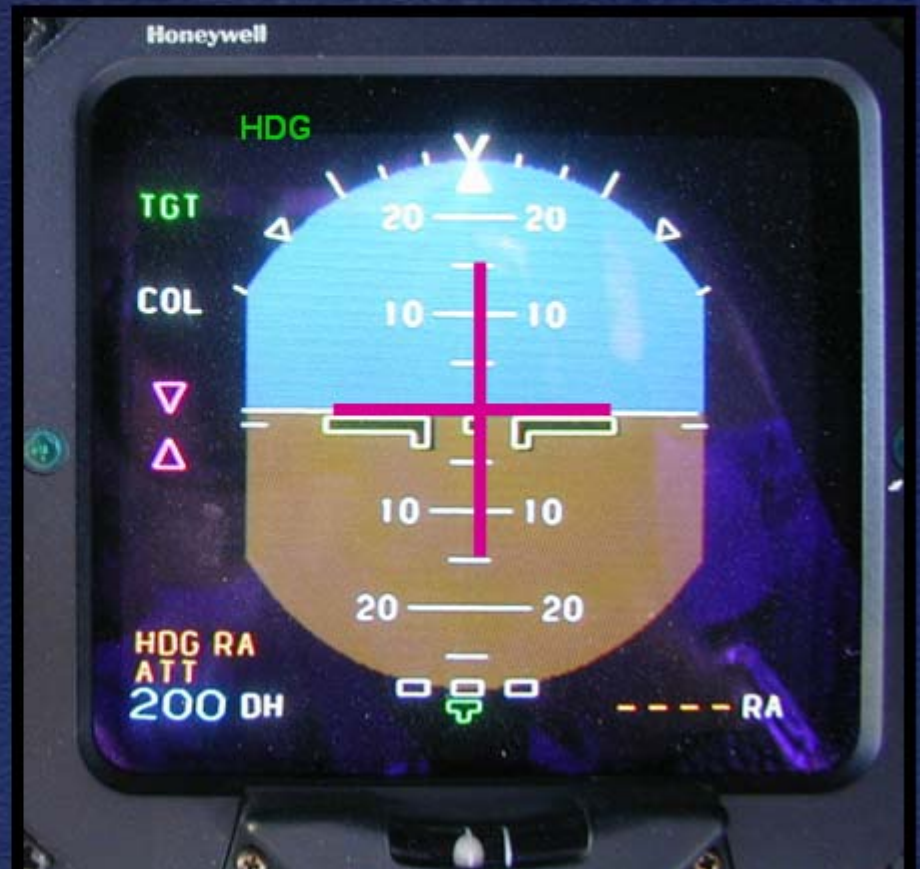
Pitch command cue

Roll command cue

- Ensure that all operators of helicopters equipped with either the SPZ-7000 or SPZ-7600 dual digital automatic flight control systems provide training that includes information on flight director and coupling status annunciations; the command cue presentations when only the pitch or the roll mode is engaged; and, if applicable, the differences between the SPZ-7000 and the SPZ-7600. (A-06-20)

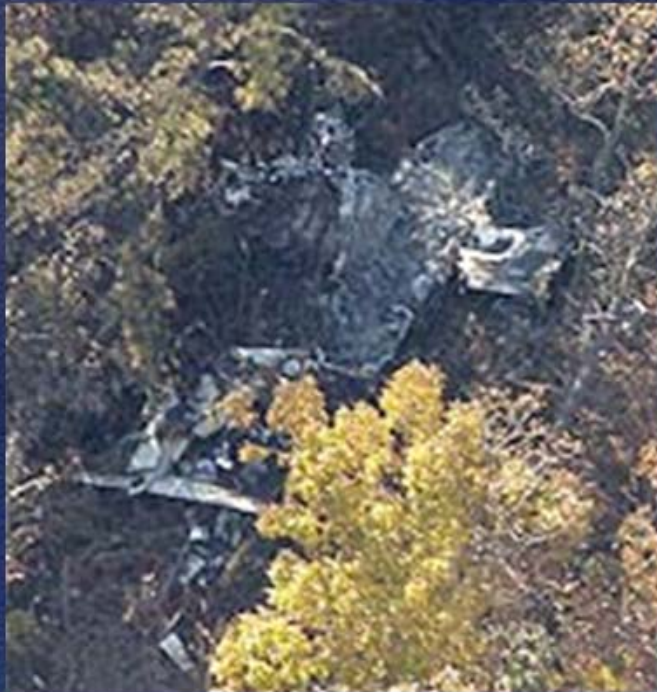
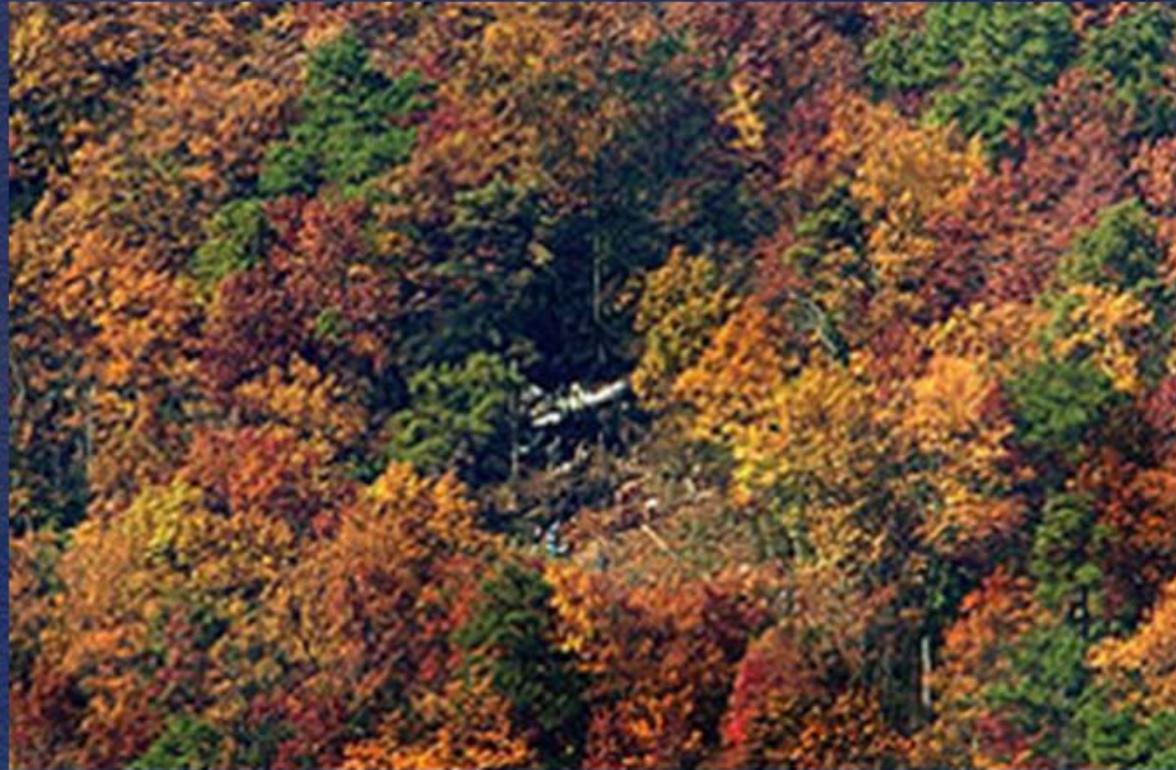
Hendrix Motor Sports

- GPS not certified for IFR
- BALEs intersection and airport were waypoints
- GPA auto-sequenced to airport
