## **BLM Non-Serious Accident Investigation**

### **Drive Shaft Failure on BLM Southern Nevada District Engine 5442**

**Date of Accident: July 10, 2011**

**Date of Report: August 13, 2011**

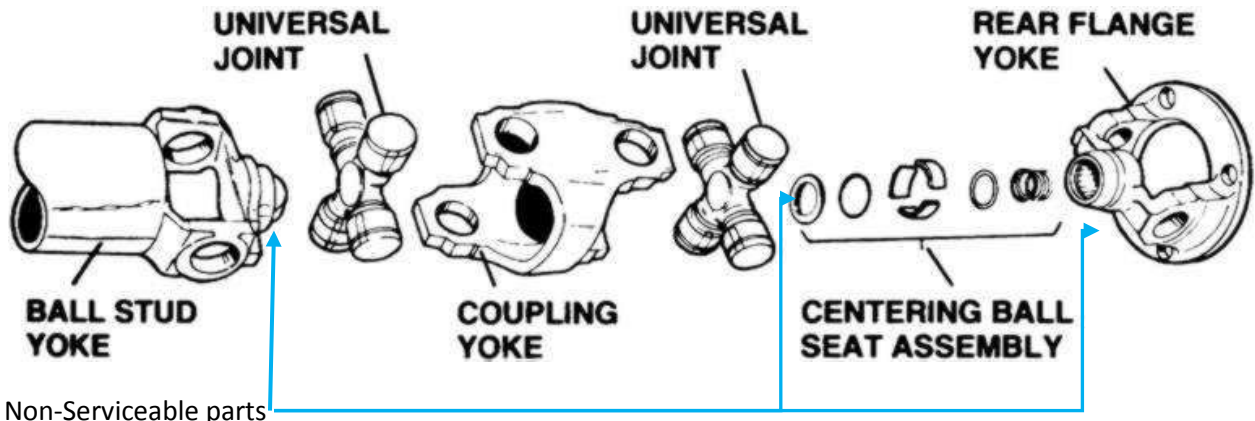
**Discussion:** BLM engine 5442 had the original drive shaft replaced in a safety recall issued by International in the May 2005 Safety Recall G-05501-R2 (See attachment # 1). The drive shaft installed has a non-serviceable part. The centering ball and seat assembly section inside the coupling yoke of the drive shaft is non-serviceable at the field level (Figure 1). This was identified as the major contributing factor to the failure.

**Figure 1** Typical Double Cardan Joint Exploded View

**Recommendation 1:** The BLM National Fire Equipment Program Manager should identify all BLM engines affected by International's May 2005 Safety Recall G-05501-R2 and issue guidance requiring the following actions:

- All identified engines must be taken to International or Dana/Spicer dealers for removal and thorough inspection of the drive shaft/joints.
- Substandard drive shafts must be ordered and replaced.
- On an interim basis, engines awaiting replacement drive shaft may remove the existing substandard drive shafts and operate in two wheel drive mode. Firefighting tactics and safety considerations must be adjusted accordingly.
- International will be providing front hubs manufactured by Fabco as they become available (see attachment #3).
- Until replacement hubs are installed, remove the front drive shaft for any long distance travel over 40 MPH (Follow International drive shaft installation recommendations).

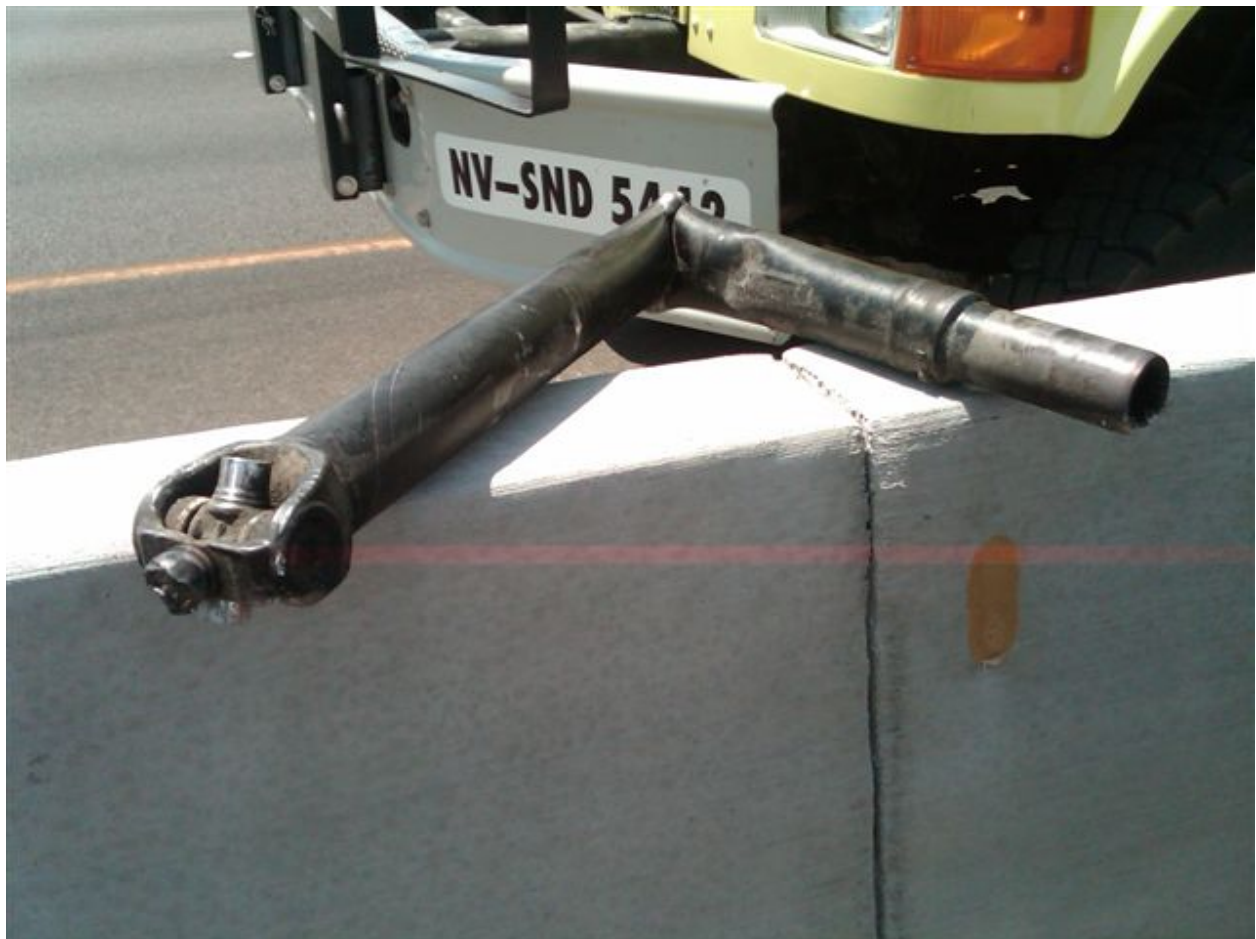
**Figure 2** Driveshaft recovered at scene

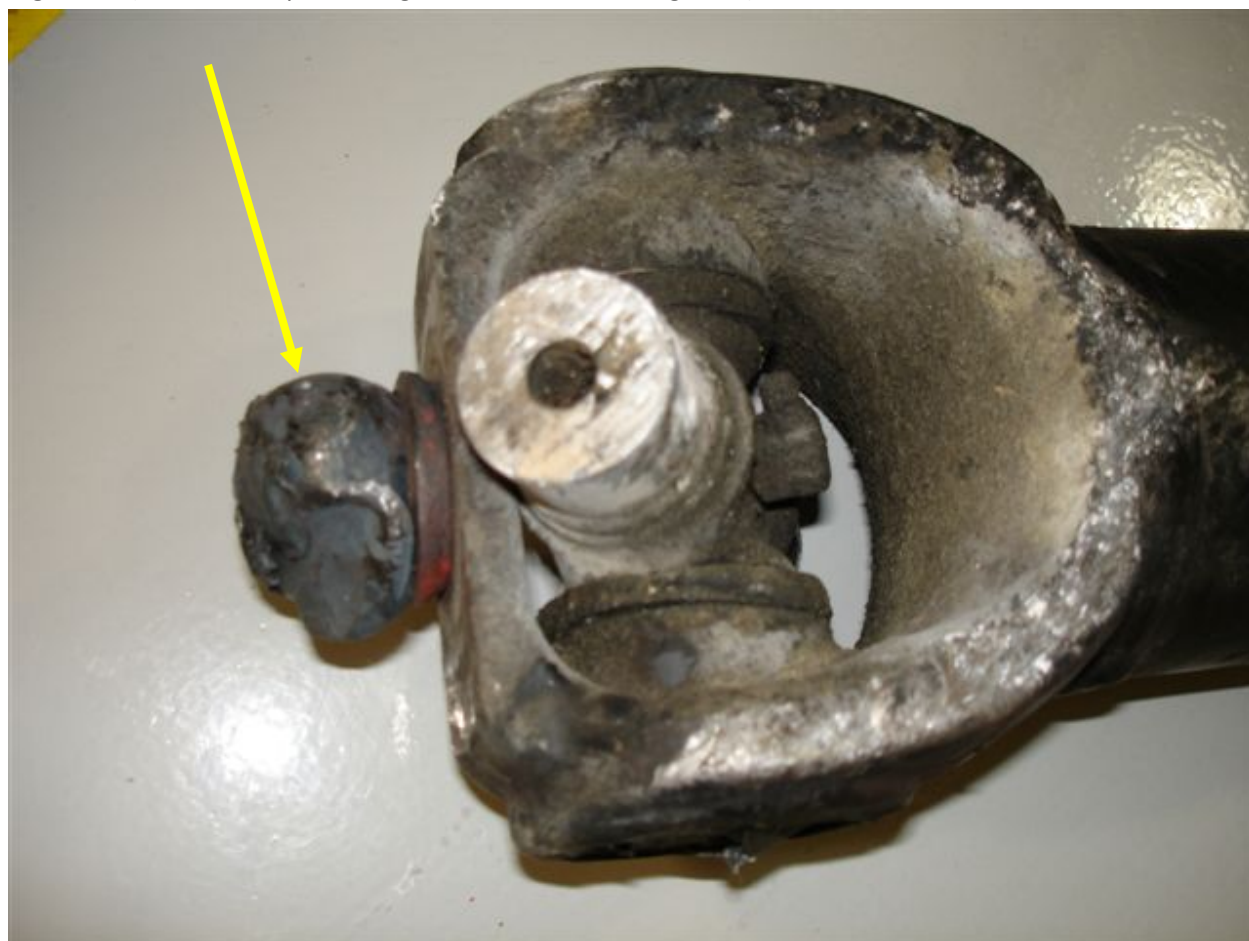
When the joint wears out due to lack of grease (Figures 2a and 3) it will limit the normal flexibility of the joint on the drive shaft, which causes wear and heat until one of the parts fails. The McCandless International Truck service manager and his lead technician stated that the centering ball and seat assembly had failed due to lack of grease. They stated that the multiple cardan joint design on this style of drive shaft will allow for service of the u-joints but not the centering ball and seat assembly in between the u-joints.

**Figure 2a** (Note close up of bluing of ball due to lack of grease)

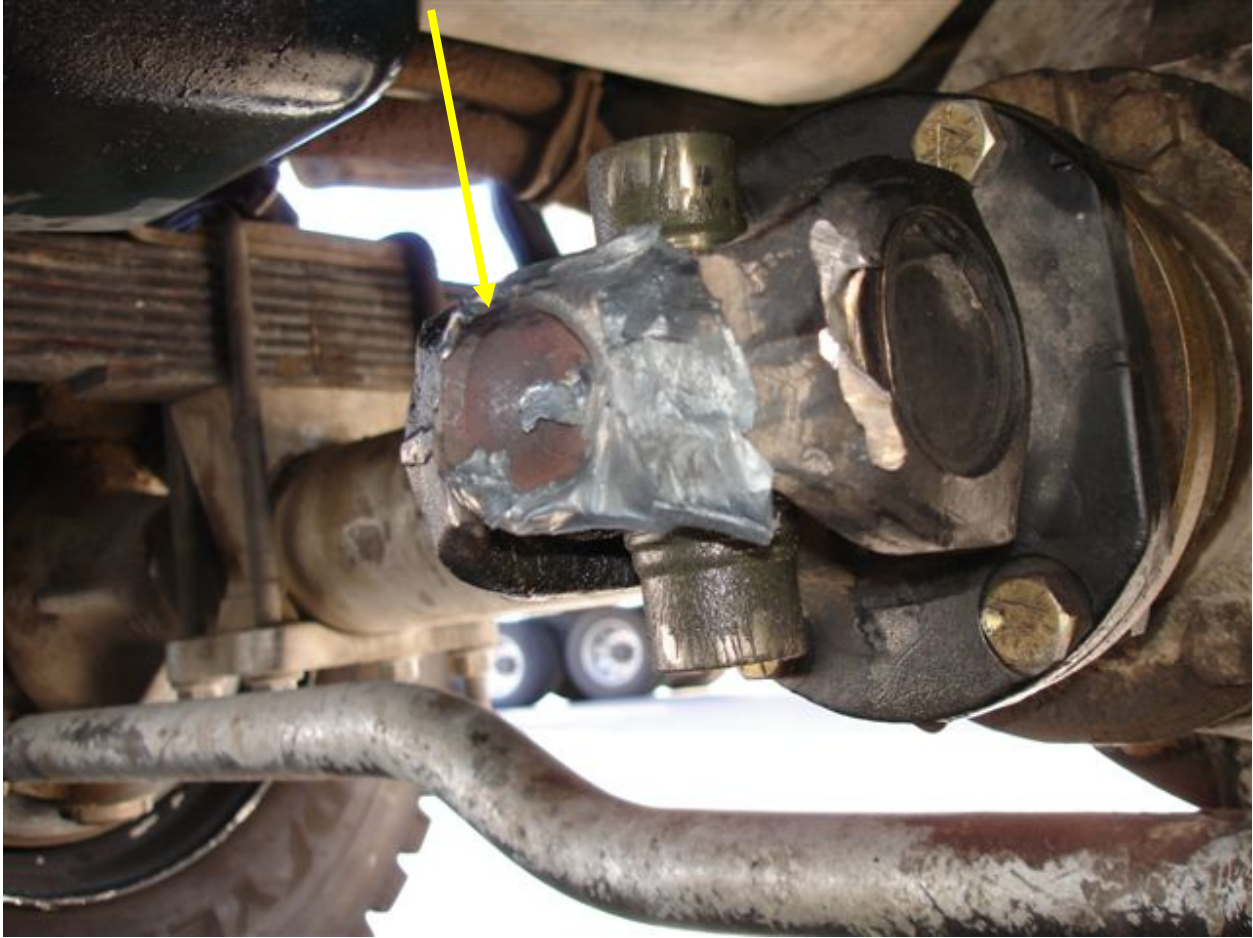
**Figure 3** Front Axle Yoke (Note rust color and signs of lack of grease in the seat)

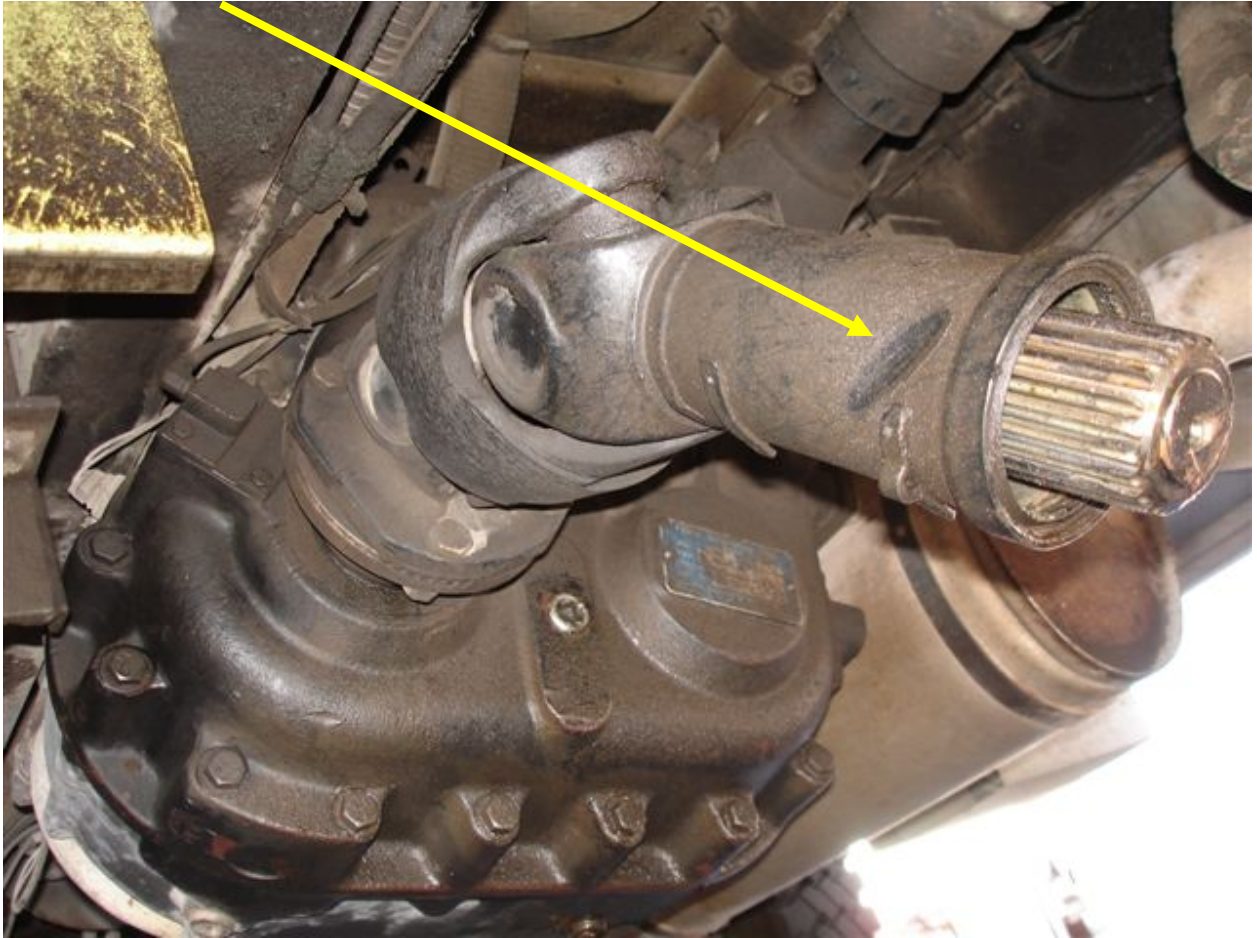
**Figure 4** Transfer Case Section of driveshaft. (Note big dent next to splines that part of the drive shaft hit the frame of the truck)

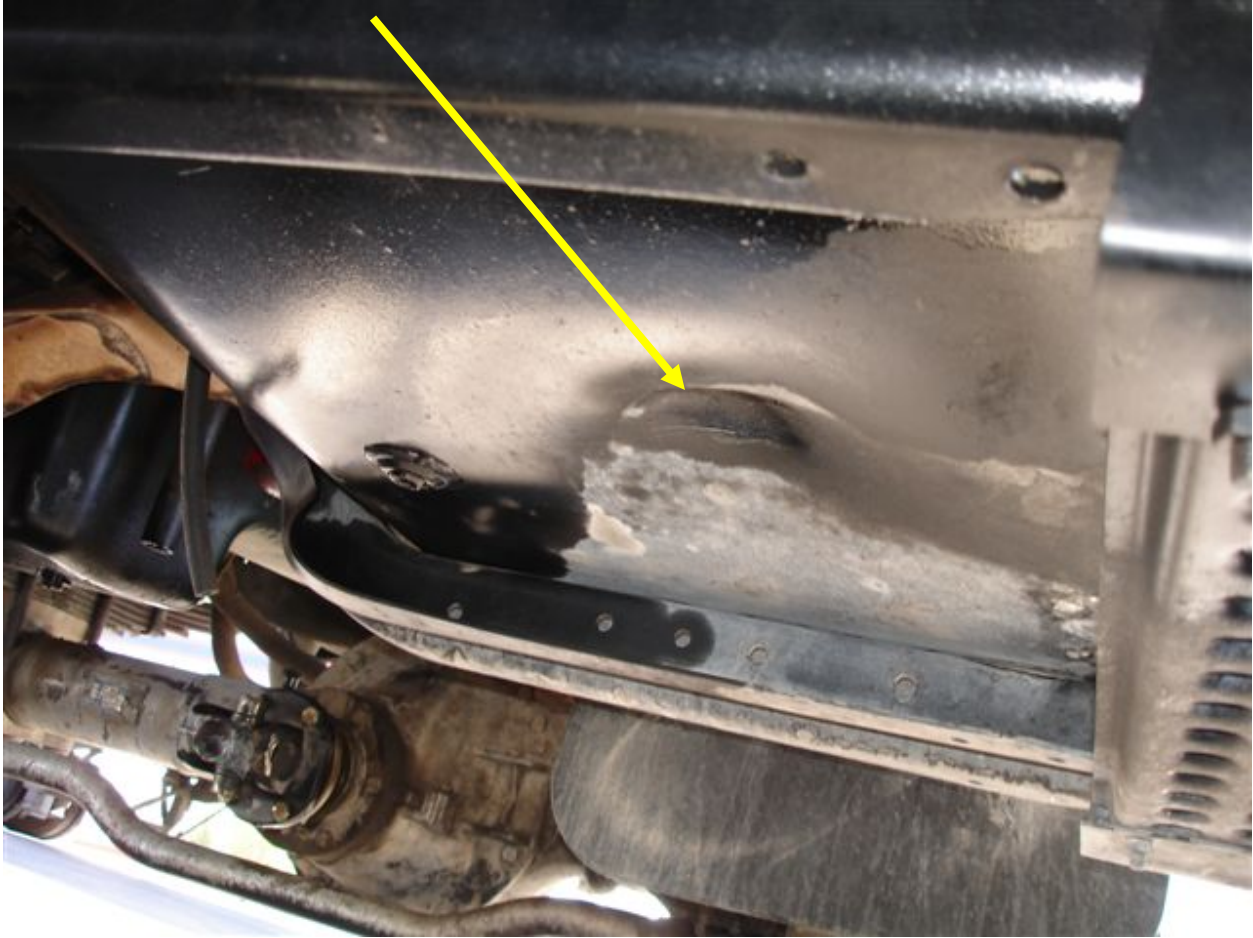
**Figure 5** Fuel tank dented and leaking.

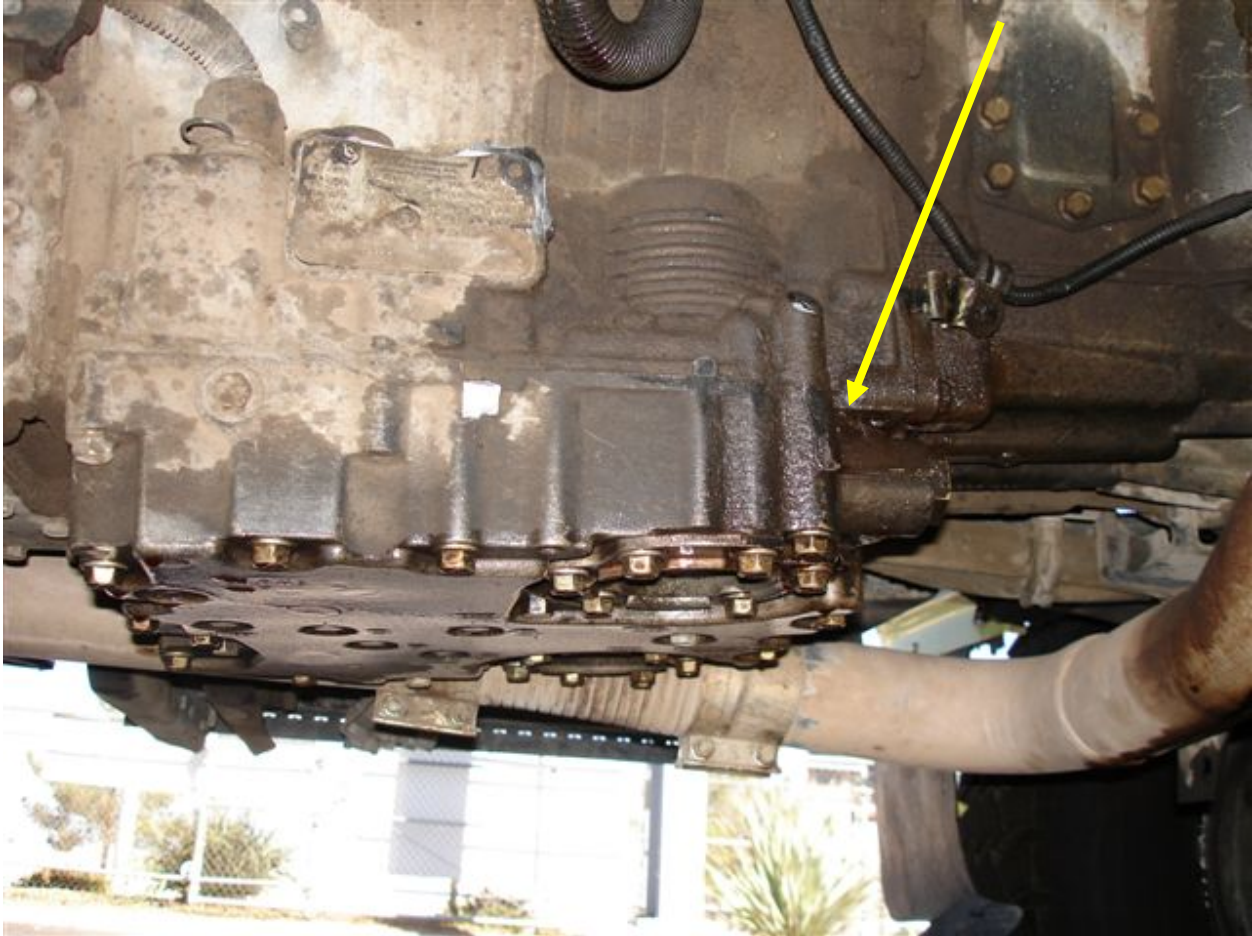
**figure 6** Transmission Cracked and Leaking from driveline hitting the case of the transmission.

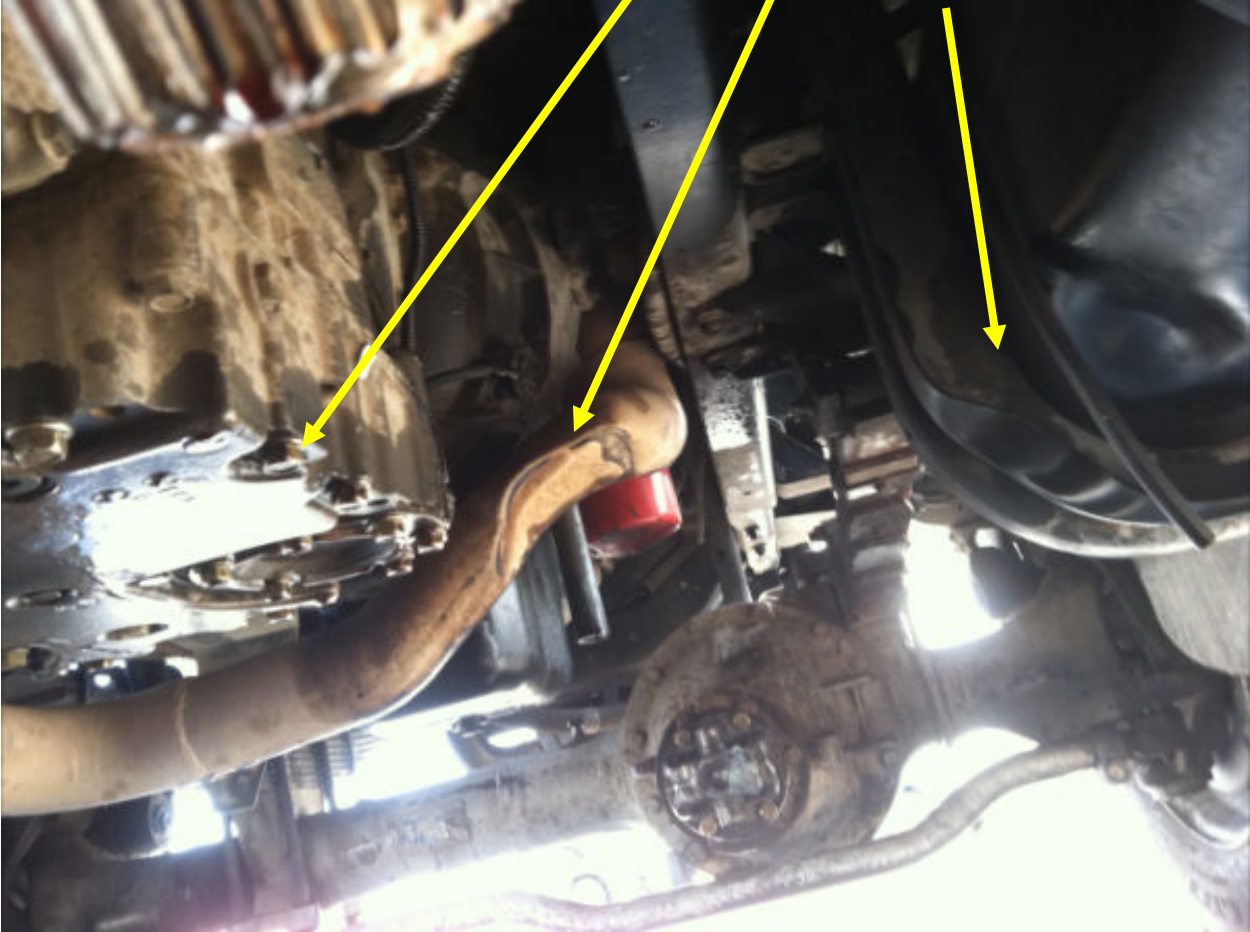
**Figure 7** View from transfer case (note damage to transmission, exhaust, and fuel tank)
