# **Reservoir Road Fire**

## **Non-Serious Wildland Fire**

### **Accident Investigation**

Prepared by:  
**Joe Snyder, Safety Officer Type 2 (T)**

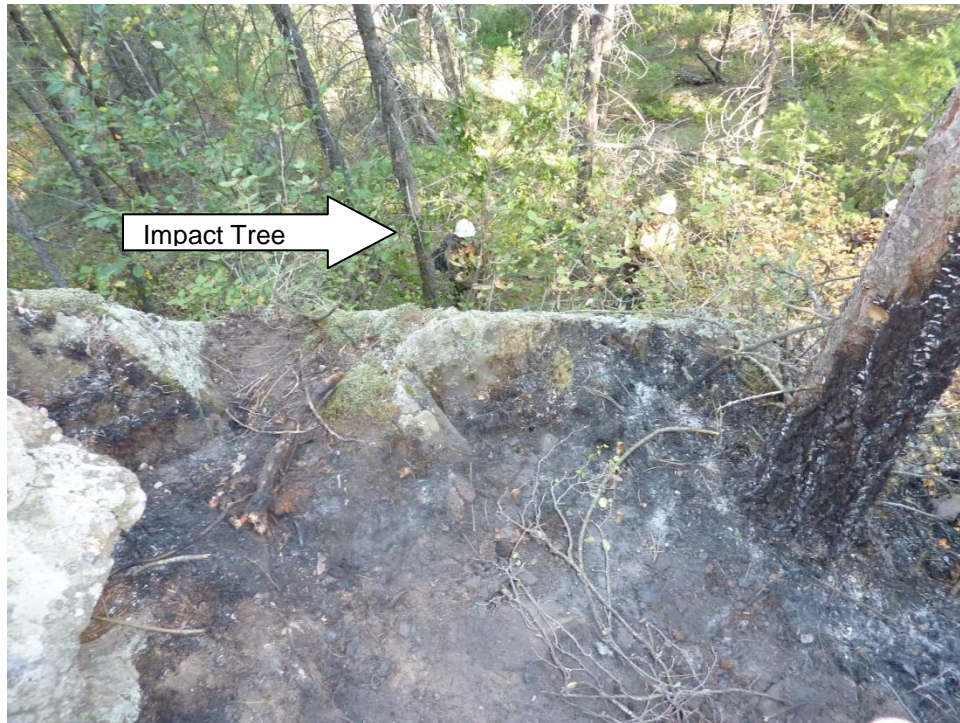
Crew member's position on rock face immediately prior to the fall was witnessed by crew EMT. The crew member's fall and final resting location were also witnessed by the crew EMT. He fell approximately 8-10 feet from where his feet were positioned on the rock face. The overall height of the rock face was approximately 15 feet in the section where the crew member was positioned prior to the fall. The crew member's hard hat remained on his head during the fall and after having impacted the tree. The hard hat impacted the tree in the front right quarter area.

Looking downhill from top of rock face.

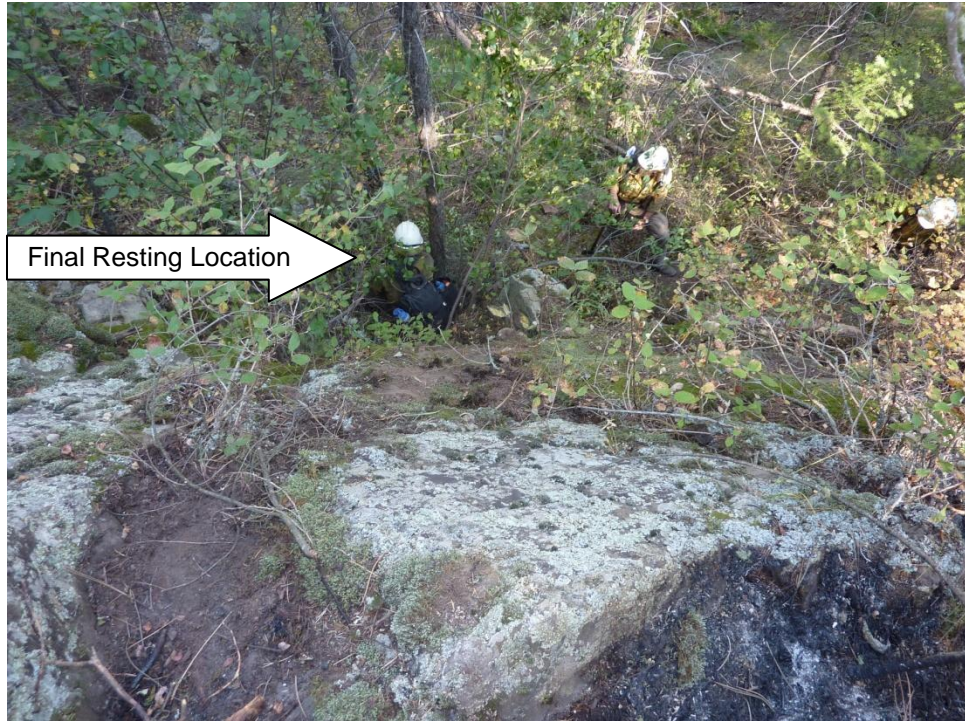
Looking down the rock face from which the crew member fell. Picture illustrates final resting location of crew member.

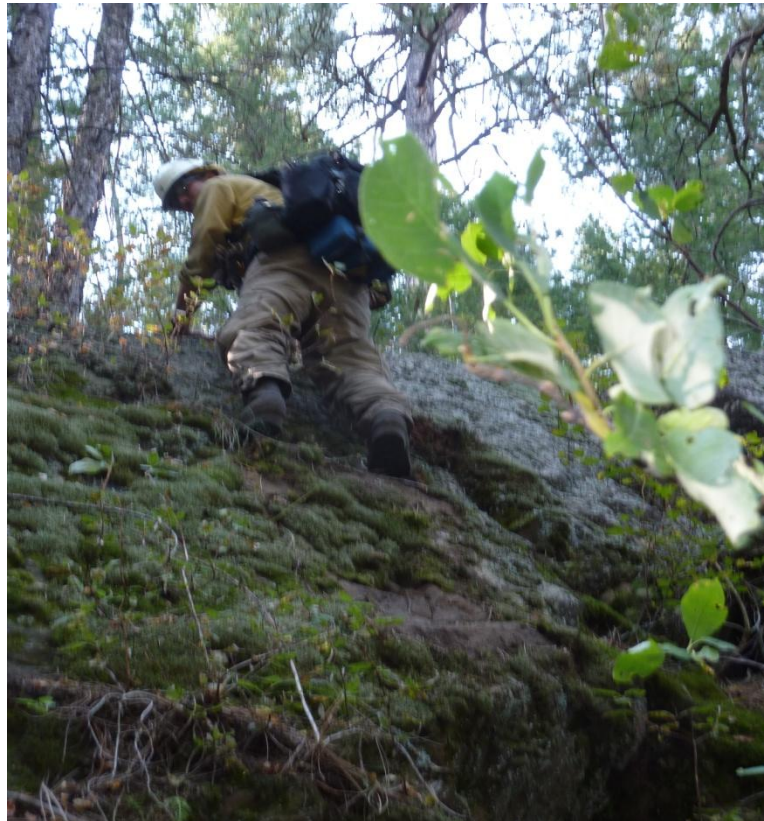
Postaccident illustration of crew member's approximate location on rock face prior to fall.

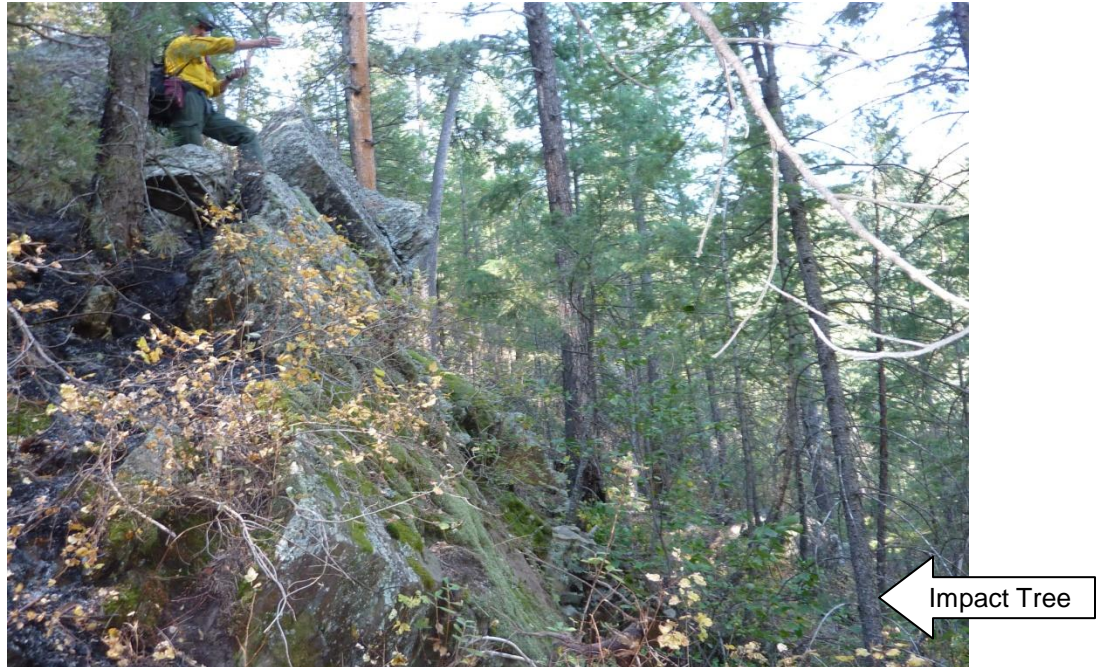
View from side of rock face.

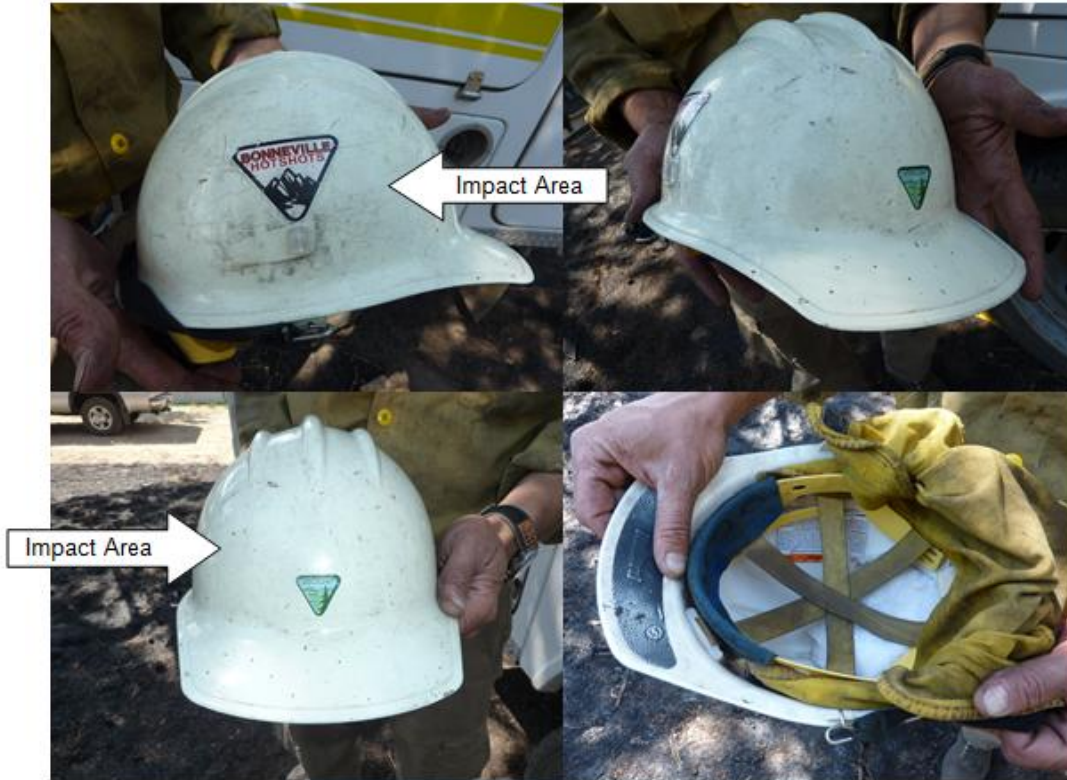
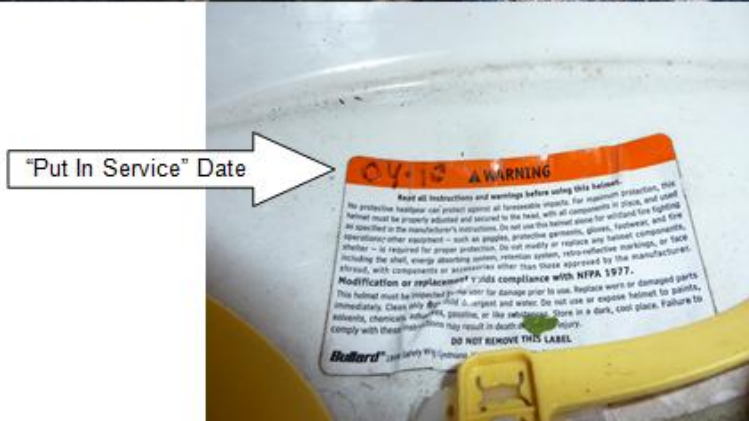
The hard hat was inspected post accident, with the following notations:

1. No visible damage or deformation was noted to either the shell or suspension.
2. The date of manufacture stamp was: August 12, 2009.
3. The crew had written with black marker a "put in service" date of 4/10 on the decal inside the shell.

5. The crew member's hard-hat performed to design specifications. The crew has a hard hat inspection/and replacement procedure in place as per head protection guidelines in the Interagency Standards for Fire and Fire Aviation Operations, also known as the "Red Book." Crew protocol mandates that all hard hats be replaced every 3 years, unless they have been damaged and retired prior to that time.

3. Institute a periodic inspection schedule for trauma kits.
4. Implement a hard-hat inspection and replacement schedule to ensure compliance with the design specifications and guidance in *Interagency Standards for Fire and Fire Aviation Operations*, Chapter 7.
