NASIRIYAH FIRE STATION
NASIRIYAH, IRAQ

SIGIR PA-06-053
JULY 24, 2006

SUBJECT: Report on Project Assessment of the Nasiriyah Fire Station, Nasiriyah, Iraq
(Report Number SIGIR-PA-06-053)

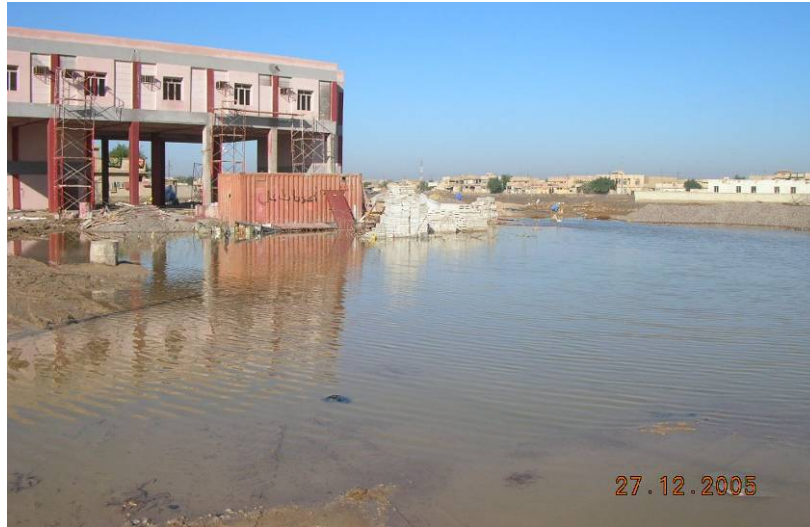
plain and the topography of the fire station site is level. The site does not drain very well since it is relatively flat. Site Photo 1 shows standing storm water runoff in front of the fire station site. The city street is located approximately 125 meters (m) away from the fire station.

**Site Photo 1. Standing water on the front side of the of the fire station –
Photo provided by USACE**

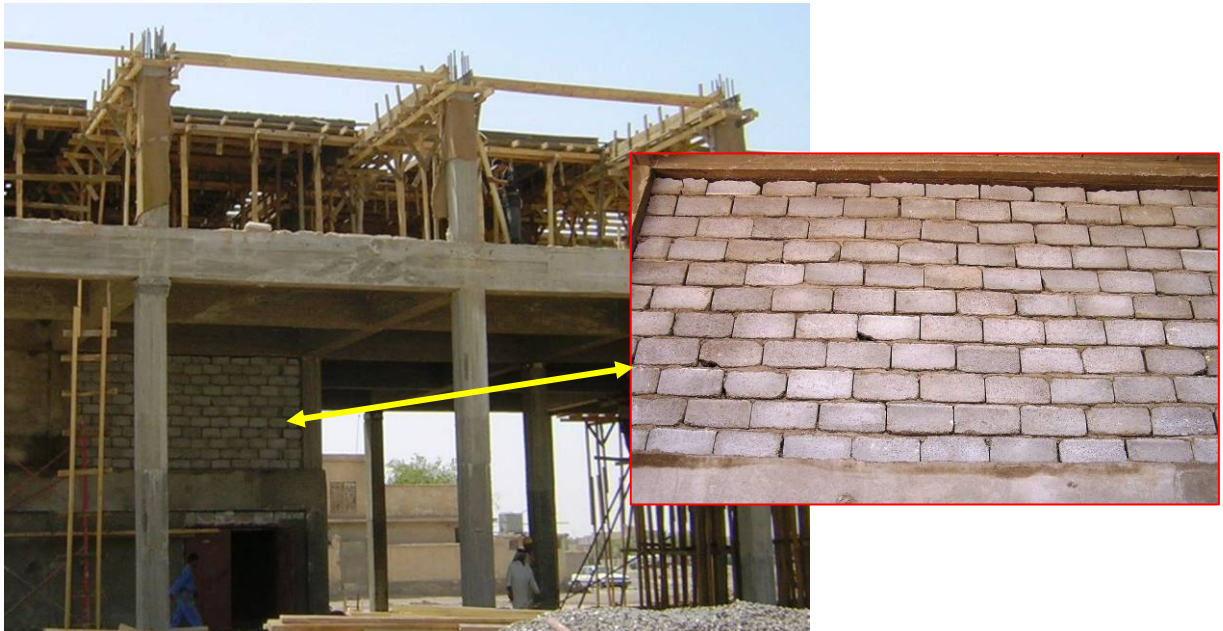
construction progress photos, the contractor utilized bricks (Site Photo 8) and block (Site Photo 9) to construct masonry walls. The drawings did not specify the type of bricks required for the construction of the block walls.

Site Photo 9. Block wall on mezzanine level – Photo provided by USACE

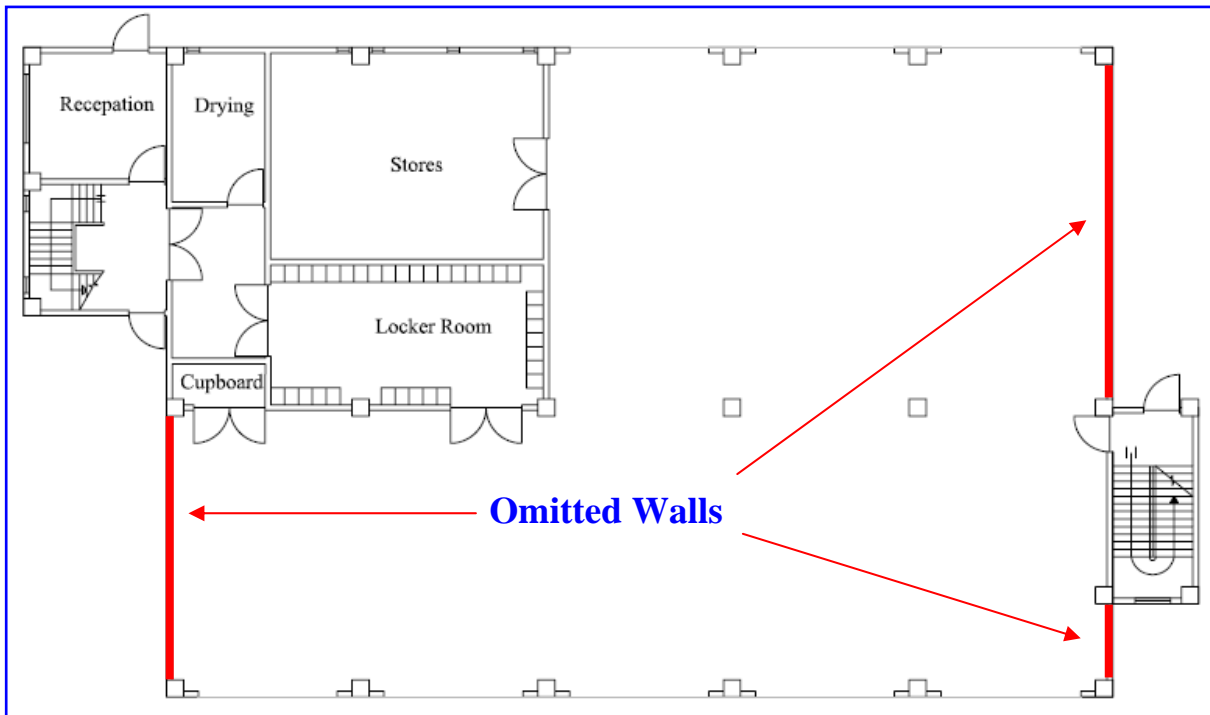
Also, the contractor failed to construct exterior walls at ground level on each side of the fire station. The USACE QAR discussed the missing non-load bearing walls with representatives of the ICDD, and the ICDD reported that the walls were not necessary. Since the walls were not load bearing, the walls were omitted from the contract requirements. The omitted walls on each side of the building are shown in Diagram 1.

Diagram 1. Ground floor plan showing location of exterior walls not constructed

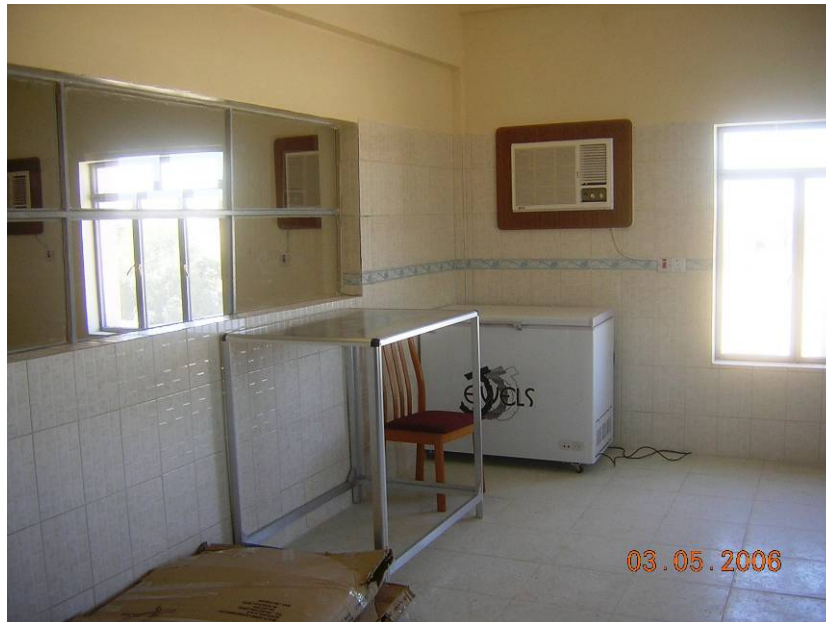
For finishing the exterior and interior walls and ceilings, the bill of quantities listed plastering and painting. The bill of quantities required the plastering of exterior walls with a sand cement mortar and the interior walls and ceilings with a gypsum plaster. For flooring, the contractor installed terrazzo floor tile in all areas except for the kitchen and bathroom areas, where ceramic tile was utilized. In addition, ceramic tile was used on the showers and water closet walls, as well as on the other wall surfaces in the bathrooms. In the kitchen, as shown in Site Photo 11, the contractor placed ceramic tile on the walls to a height equal to the top of the window.

Site Photo 11. Kitchen with ceramic tile wall covering

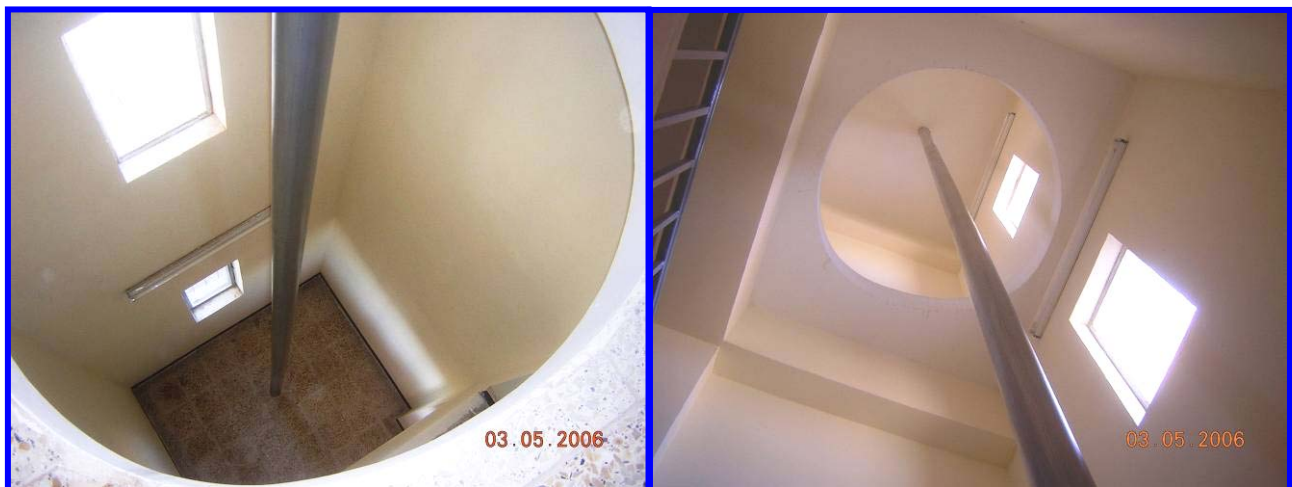
Another architectural feature in the building inherent with fire stations is the fireman's pole. The contractor's design showed a four inch diameter steel pole to provide direct access to the ground floor level from the living areas on the third level. Site Photo 12 shows two perspectives of the completed fireman's pole and the opening through the floor slab.

Site Photo 12. Top and bottom perspective of the fireman's pole

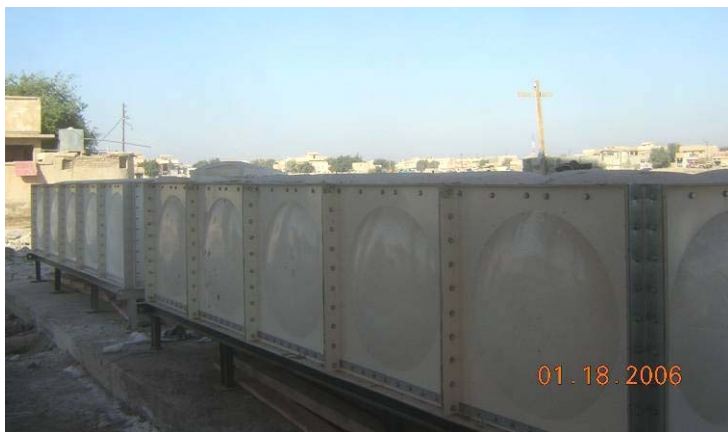
The contract design required two water storage tanks, each with a capacity of 10 cubic meters (m^3) to be constructed at the ground level on one side of the station. In addition, the design included eight, one m^3 roof top water tanks. Through a review of the construction progress photos, we verified the installation of the two ground level tanks, and five roof top tanks, although we could not determine their capacity. Site Photos 13 and 14 show the two types of water tanks installed at the fire station.

**Site Photo 13. Surface level 10 m^3 water tanks –
Photo provided by USACE**

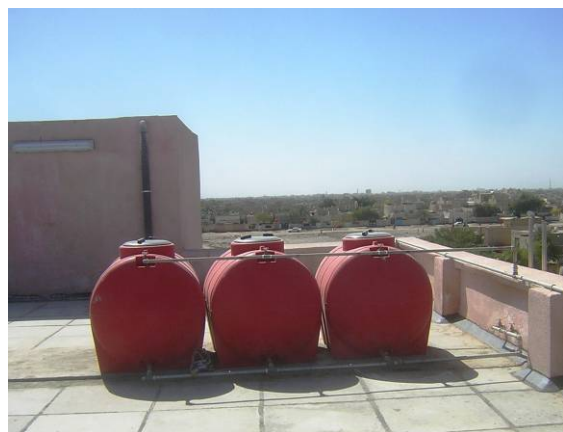
**Site Photo 14. Roof top water tanks –
Photo provided by USACE**

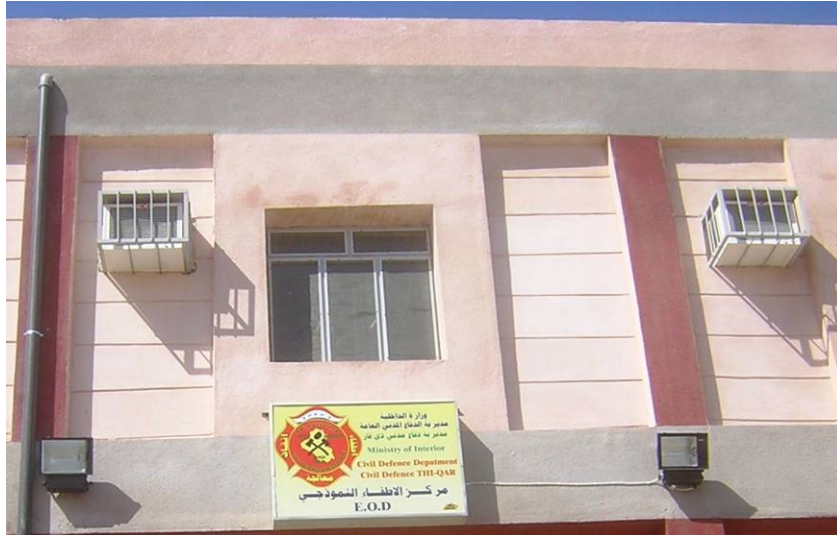
The design required two sizes (1.5 and 2 ton) of window type heating, ventilation and air conditioning (HVAC) units for the fire station. There were no details in the design drawings showing the wall opening or installation requirements. However, review of the QA information indicated no discrepancies in their installation. Site Photo 15 shows two window HVAC units installed in the fire house.

Site Photo 15. Window type HVAC units on third level of the fire station – Photo provided by USACE

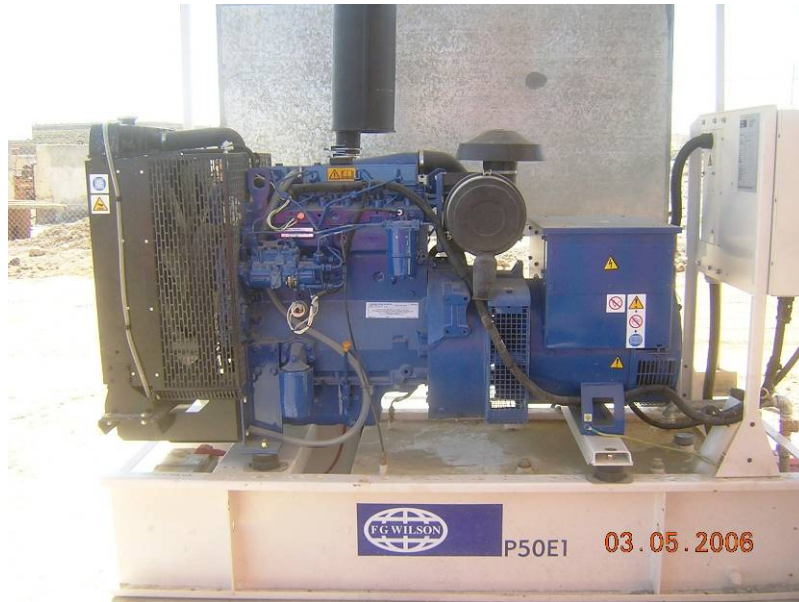
The design drawings required a 50 kilovolt amp generator to be located adjacent to the building on a concrete pad. Site Photo 16 shows an “F. G. Wilson” generator, model P50E1 installed at the fire station. The assessment team reviewed the catalog cut information provided by the USACE PE, and verified the generator met the contract requirements.

Site Photo 16. Generator installed at the fire station – Photo provided by USACE
