609TH IRAQI NATIONAL GUARD
BATTALION GARRISON
THI QAR GOVERNORATE, IRAQ

SIGIR PA-06-056
JULY 25, 2006

SUBJECT: Report on Project Assessment of the 609th Iraqi National Guard Garrison,
Thi Qar Governorate, Iraq (Report Number SIGIR-PA-06-056)

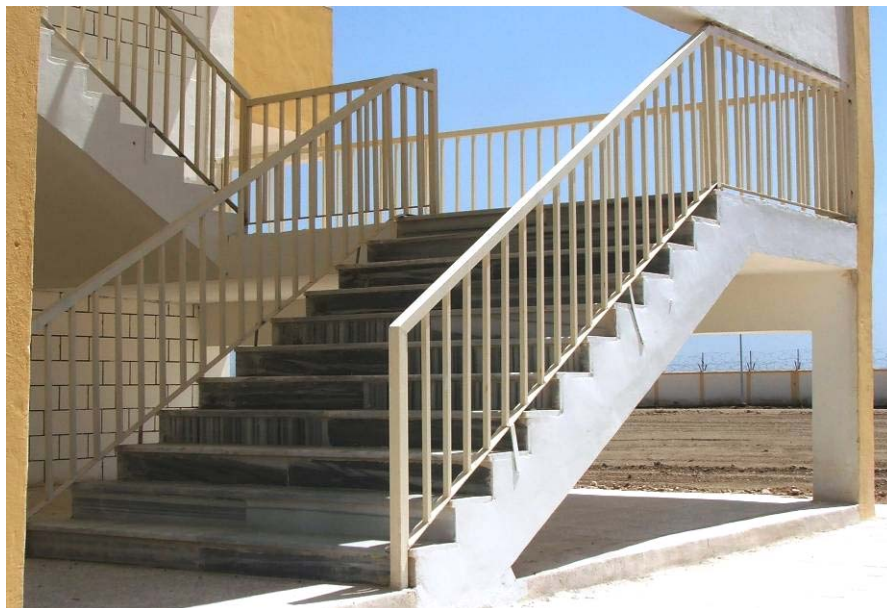
The design for each barracks building required two external stairways to access the second story and the roof. The design called for concrete steps, with no finish to the step other than painting. However, marble tile had been placed as the finish for each step in all six sets of stairs in the three buildings. According to the USACE PE, the contractor installed the marble tile at no additional cost to the Government. Site Photo 4 provides an example of one of the sets of stairs finished with the marble tile.

Site Photo 4. Exterior stairs in the barracks finished with marble tiles

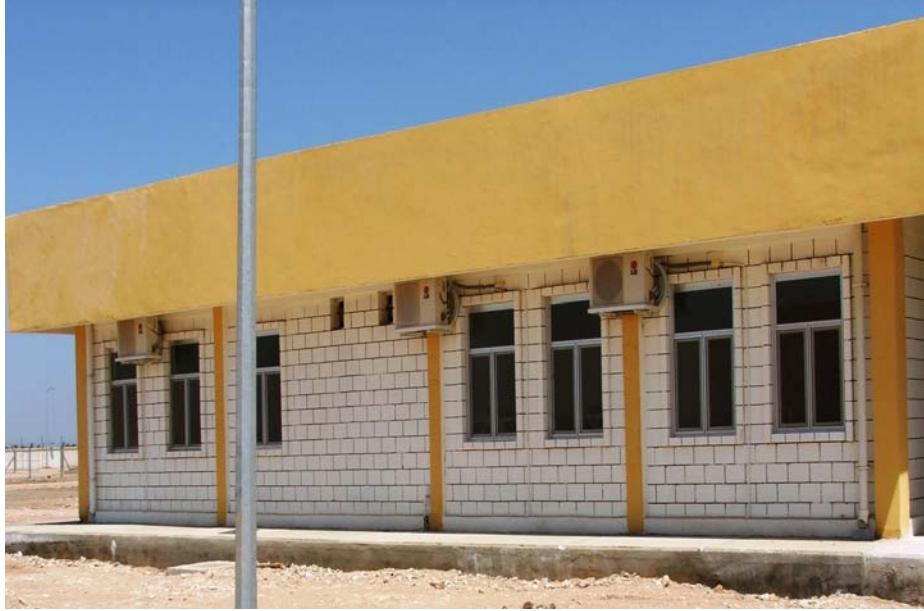
The design also required window HVAC units, although the contractor installed split system units instead of window units after they proposed the substitution at no cost change to the Government. The USACE Resident Office subsequently approved the change. Site Photo 6 shows the exterior of one of the company's headquarters, which includes three of the HVAC condensing units mounted on the exterior wall.

Site Photo 6. Company headquarters building

Based on the review of the design, and our observations on site, the construction of the company headquarters buildings met the requirements of the design.

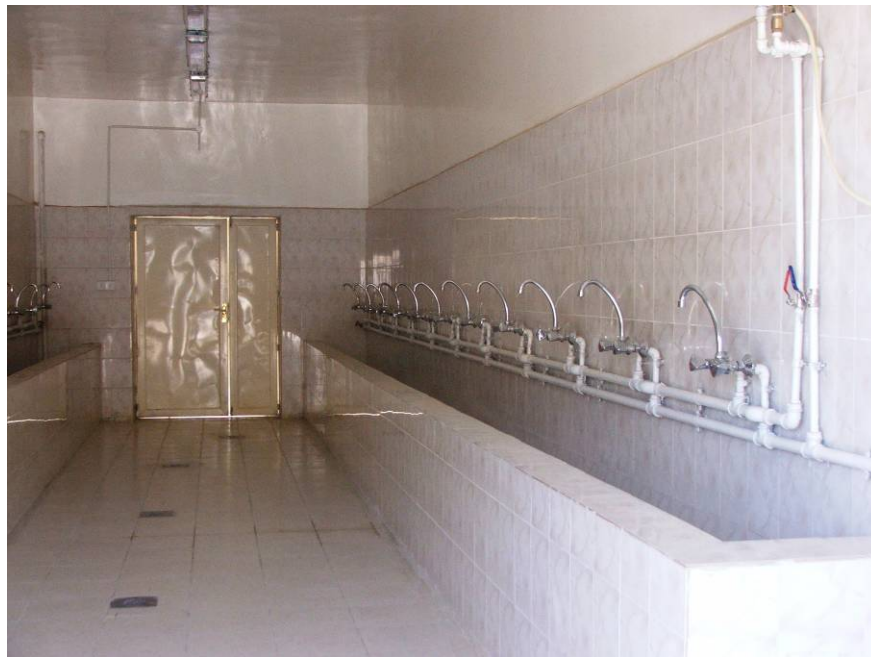
Site Photo 9. Hand washing station in one of the shower and toilet buildings

Based on the review of the design and our observations, the shower and toilet buildings and interior finishes appeared to be constructed as designed. However, similar to the barracks buildings, on some of the doors, there were gaps between the exterior door and the doorframe as seen in Site Photo 9. As noted earlier, the USACE PE, subsequent to this site visit, instructed the contractor to correct the problem and the contractor agreed to install weather stripping and door sweeps.

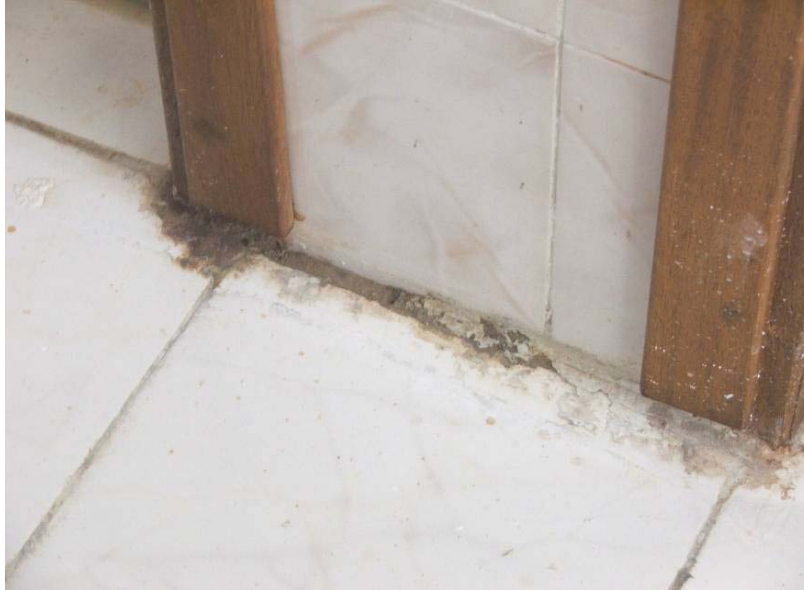
In addition to the doors, we found the floor tile in many areas needed cleaning. According to the USACE PE, this had been a continual problem and it had been

listed as a deficiency on the USACE Quality Assurance Representative's deficiency tracking log. Additionally, in some areas, particularly near the walls or corners of the showers or water closets, we found the quality of workmanship associated with the ceramic floor tile grouting to be poor. Site Photo 10 provides an example of grouting workmanship, showing excess material left on the floor tile and dirty grout. One factor affecting the quality of workmanship, especially with finish work activities, was the requirement to utilize local labor. The USACE PE informed us that in order to maintain good relations with the local Iraqi leaders, the contractor was compelled to hire local labor, the majority of which were unskilled. The use of unskilled labor on this project directly influenced the quality of workmanship.

Site Photo 10. Dirty and excess grout material left on ceramic tiles

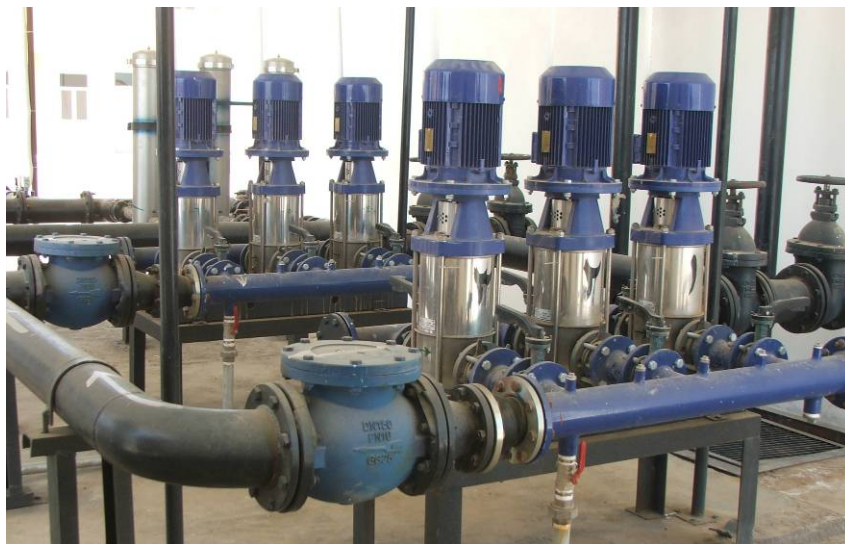
The pumping facility design included two sets of three booster pumps (one set to serve in standby mode). Each pump, rated at 24 cubic meters per hour at 50 m of head, is designed to pump water from the storage tanks to the garrison buildings. The design also included three, 5 micron cartridge filters inside stainless steel housings to filter out sediments prior to the water entering the service line to the garrison buildings. Site photo 20 shows the booster pumps. During the site visit, we did not observe any deficiencies associated with the pumps, filters, piping, and valves, including any evidence of leaks or loose connections.

Site Photo 20. Two sets of booster pumps, and cartridge filters are in the background

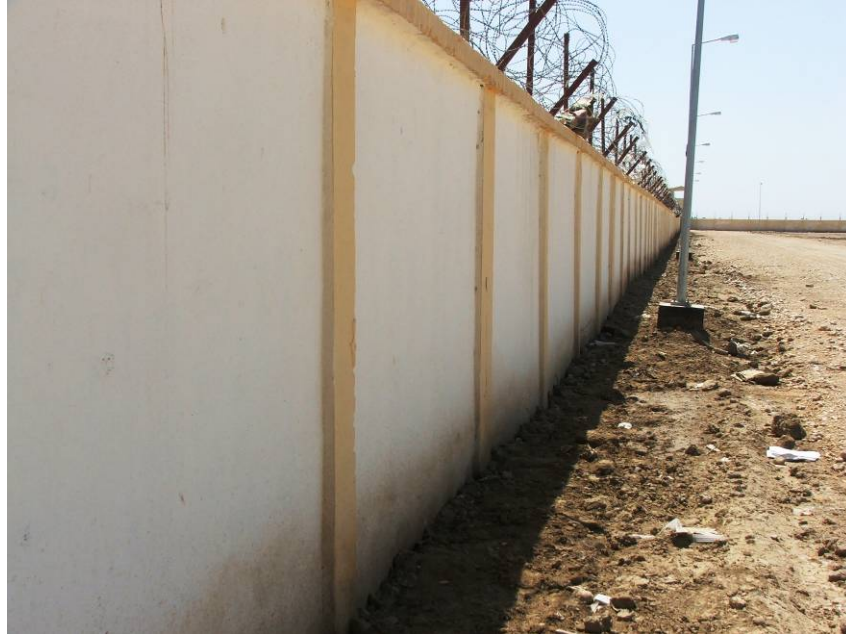
Site Photo 21. One section of the perimeter wall

The design required a 2.5 m high block wall capped with a concrete coping, with three strands of rolled barbed wire on top of the wall. The foundation support for the perimeter wall included reinforced concrete footers to support the columns and a reinforced concrete tie beam under the wall between the columns. According to the architectural plans, at every 2.5 m, a supporting column was required along the wall with expansion joints required every 10 m. However, in the structural plans, a supporting column was required every 3 m and expansion joints every 12 m. Based on our observations, it appeared the contractor followed the spacing requirements from the structural plans. Further, we did not see any evidence of cracking or other noticeable defects along the portion of the south wall that we inspected. The construction of the wall in this section exhibited good quality workmanship.
