BAGHDAD RAILWAY STATION
REHABILITATION
BAGHDAD, IRAQ

SIGIR PA-06-057
JULY 25, 2006

SUBJECT: Report on Project Assessment of the Baghdad Railway Station
Rehabilitation, Baghdad, Iraq (Report Number SIGIR-PA-06-057)

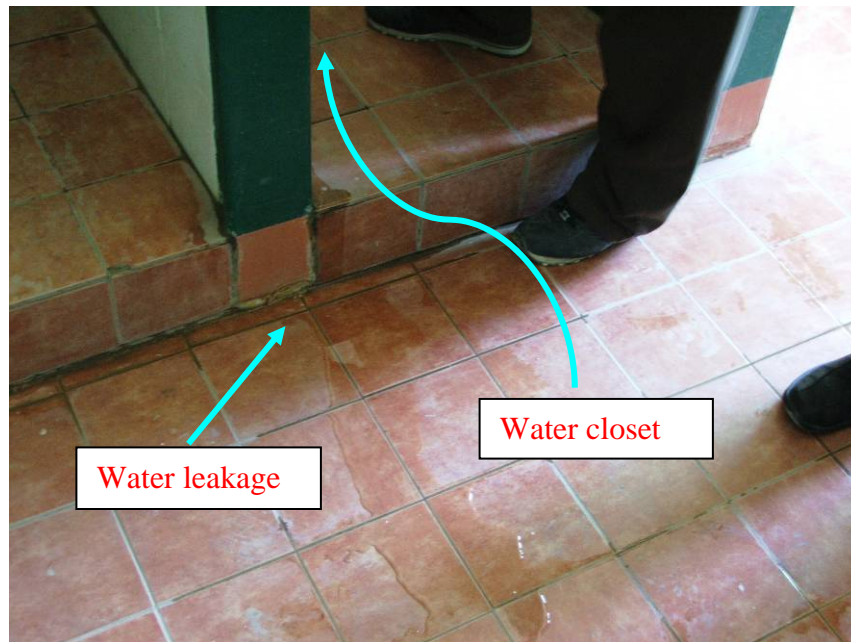
Bathrooms included a floor drain near the middle of the floor. On some of the bathrooms, water faucets were adjacent to the toilets to facilitate cleaning. The bathrooms were renovated according to the design. However, based on information provided to us by the USACE DRE, in three of the bathrooms, because of space constraints, the floor's slope was not enough to adequately drain the water to the

floor drain and to the toilets within the water closets. Thus, water continually ponds and has eventually permeated along the interface between the bathroom floor and the step into the water closet as shown in Site Photo 21.

Site Photo 21. Standing water in one of the station's bathrooms

At the time of the assessment, the USACE DRE and contractor were working to develop a solution that would eliminate the standing water while satisfying the requirements of the IRR.

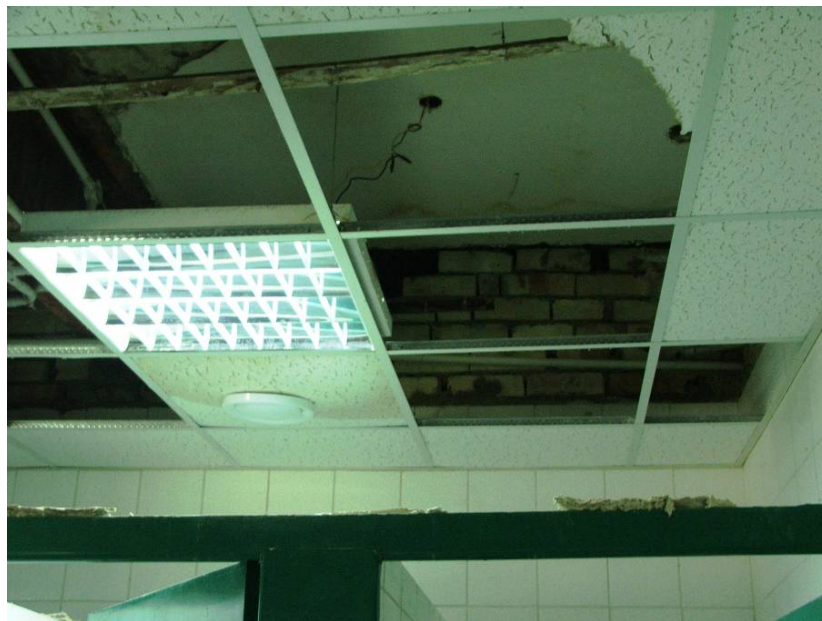
As a result, water has leaked into the bathroom on the floor below, causing damage to the suspended acoustical ceiling. Site Photo 22 shows some of the damage that occurred in the bathroom below.

Site Photo 22. Water damage to the suspended ceiling

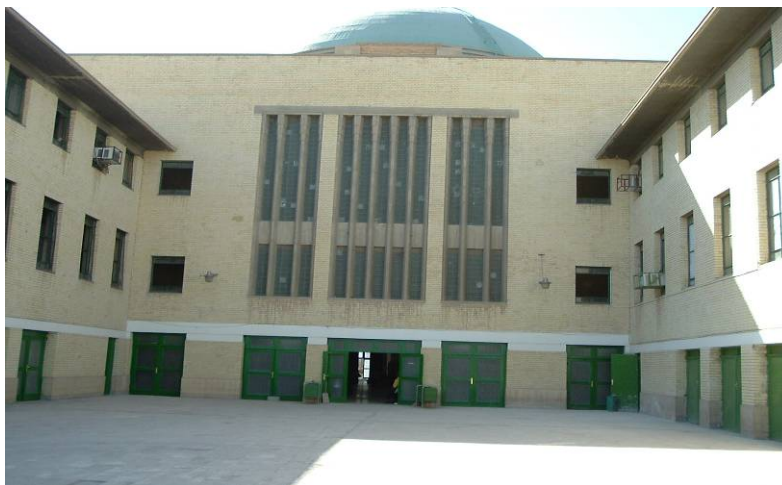
There is a pending modification to add the following: a Reverse Osmosis water purification unit for the chillers; install a canopy in the rear of the station (Site Photo 28); install drainage piping for the passenger platform area; demolish two damaged cafeterias; and install an incoming 11 kV feeder from the Iraq National Grid to serve as a redundant feeder. In addition, as mentioned earlier, discussions are still ongoing between the Resident Office, IRMO and GRD/PCO officials regarding the new sewage station pumps, maintenance of the gardens, and other items that the IRR

Site Photo 28. Rear view of railway station – site of future canopy
