AL KASIK WATER STORAGE TANKS
AL KASIK MILITARY TRAINING BASE
AL KASIK, IRAQ

SIGIR PA-06-071
JANUARY 08, 2007

SUBJECT: Report on Project Assessment of the Al Kasik Water Storage Tanks, Al Kasik
Military Training Base, Al Kasik, Iraq (Report Number SIGIR-PA-06-071)

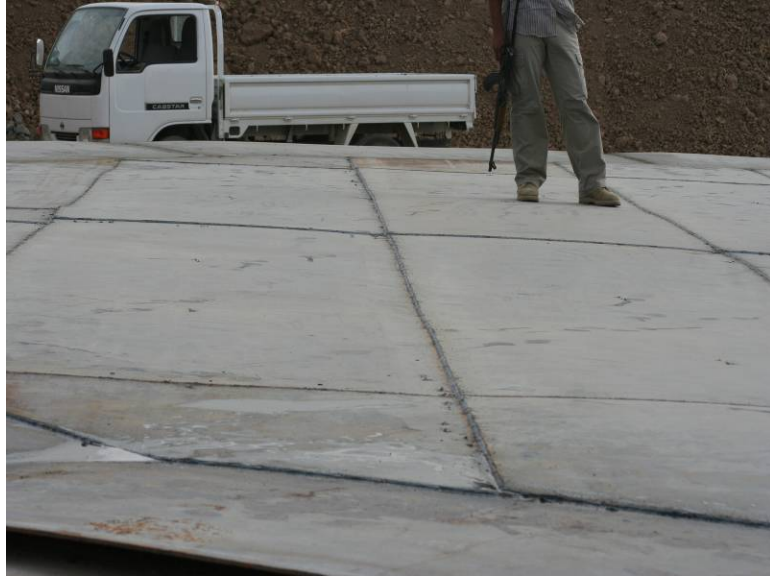
The floors and walls were comprised of flat sheets of 8 mm thick S 235 JR steel joined together with welds using E6013 welding rod. Much like a gig-saw puzzle, flat S 235 JR 8 mm sheets were cut and pieced together to form the tank floor or annular plate. A QC report photo dated May 6, 2006 shows steel sheets cut and pieced together to ensure proper fit (Site Photo 6). After the fit was approved by the contractor's QC manager, the sheets were joined together by welding the entire length of all seams to form the water tank's floor / annular plate. An example of welded annular plates on a tank foundation is shown in Site Photo 7.

Site Photo 7. After fitting, the sheets were welded along seams to form a sealed tank floor.

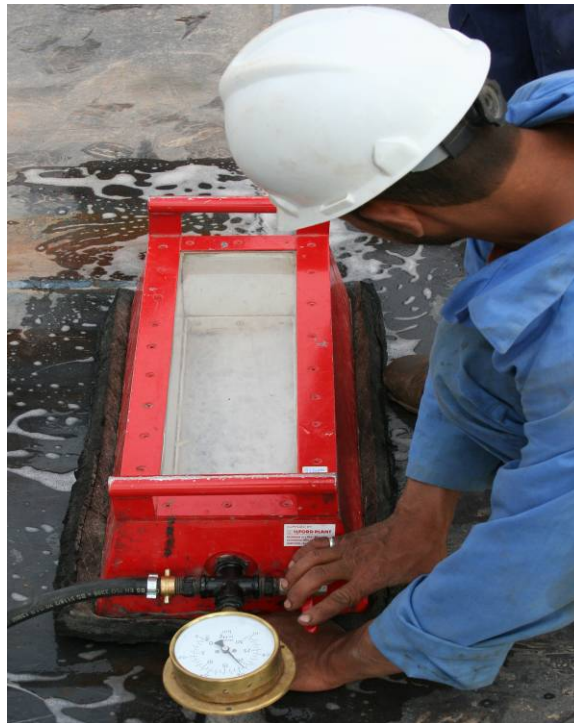
After the final welds were completed on the annular steel plating, a vacuum test was performed. A vacuum box was used to test the effectiveness of the welds on each floor plate weld. In Site Photo 8, a worker used a vacuum box (red device) after soapy water was applied to the surface area around the weld to test for leaks. The test operator placed the vacuum box with rubber base over the soapy water to create an air tight seal. To complete the test, the vacuum valve on the side of the box was opened to evacuate the inner chamber. The test operator watched through the box's window as the vacuum was applied. Along with a loss in measured vacuum, leaks visually appeared as bubbles under the window.

Site Photo 8. A vacuum box was used to test for leaks along floor welds.

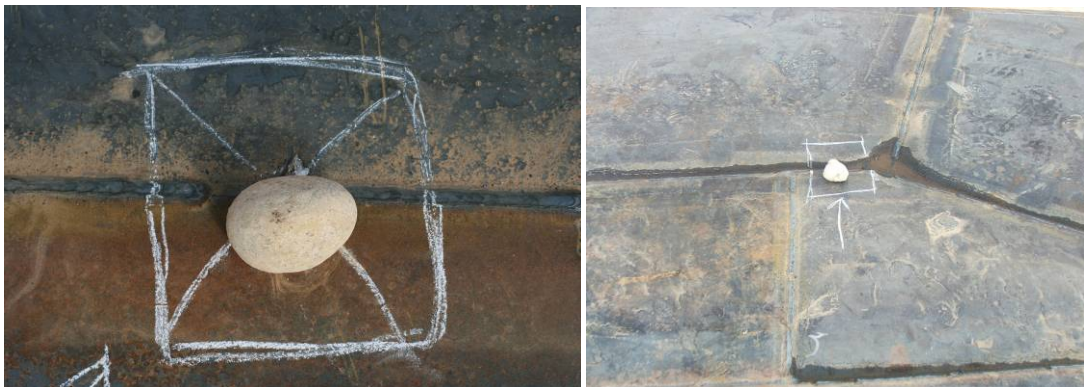
Site Photos 10 and 11. Stones and chalk mark leaks in the steel plating.

Accordingly, all welds that leaked were scheduled for repair and retested in compliance with the contractor's welding procedures. All leaks were marked with chalk and stones to ensure that leaks were located and properly repaired before retesting. Site Photos 10 and 11 show stones and chalk used to mark leaks.

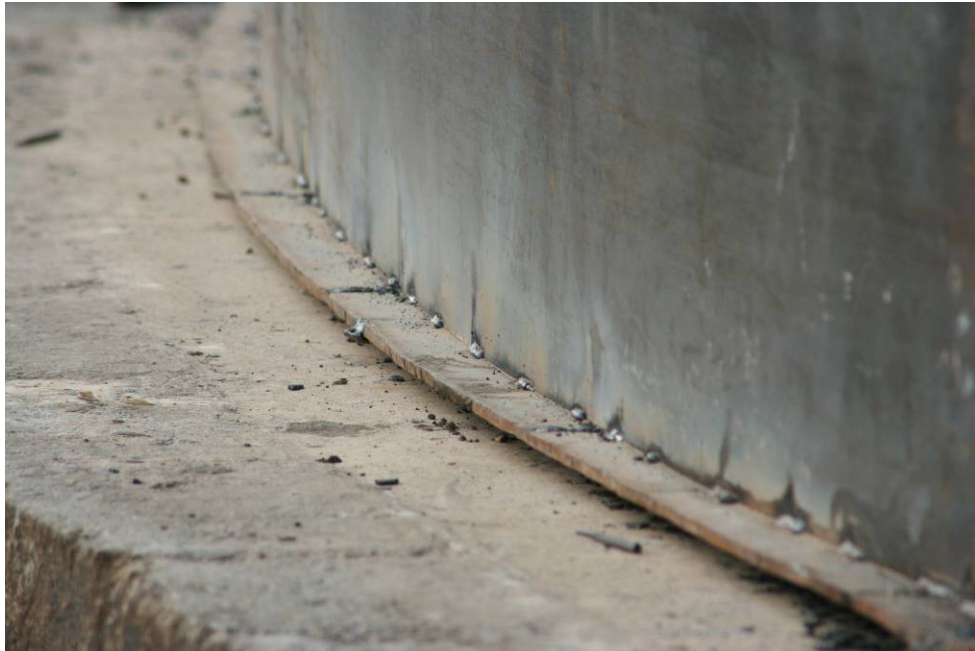
In order to anchor the sheets to the base and fasten adjacent sections, tack welds were utilized. Site Photo 13 shows tack welds along the base of the tank while Site Photo 14 shows the initial fastening of adjacent steel section of wall plating.

Site Photo 13. Tack welds temporarily attach wall plate to floor.

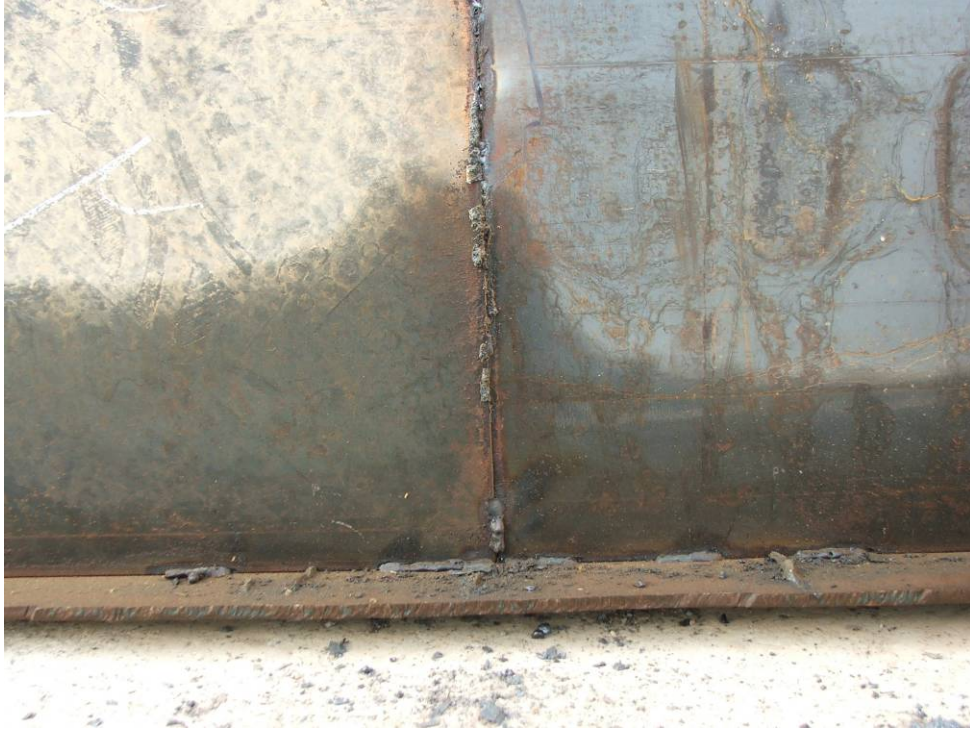
After the first two runs were completed, a diesel penetrant test was performed to determine if the welds held a seal. That test consisted of application of light diesel fuel (kerosene) to the weld's surface. Penetration of diesel through the weld indicated failure or leakage. Procedures dictated that all leaks would be repaired and retested. Site Photo 15 shows where the diesel fuel passed through the weld after a 24-hour dwell² period on the outside of the tank. Site Photo 16 reveals a leak in the inner weld of the after the 24-hour dwell period.

Site Photo 15. Diesel penetrated the welds within 24 hours of test.

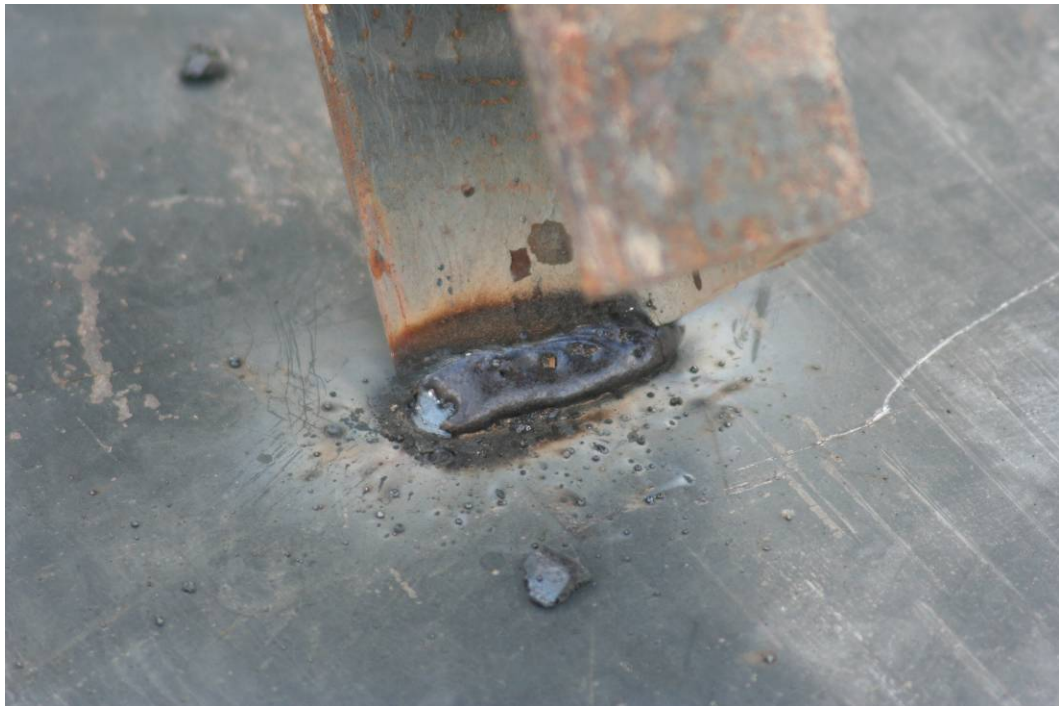
The contact edges of the steel beams were tack welded to the adjacent plates. Site Photos 18 and 19 show the top and bottom tack welds used to attach the steel supports to the tank base and walls. Vertical and horizontal runs (welded seams) were required to attach the plates that make-up the tank's walls. Supporting steel beams were removed once support was no longer needed and welds were secure.

Site Photo 19. Bottom ends of steel beams are tack welded to the floor plates.

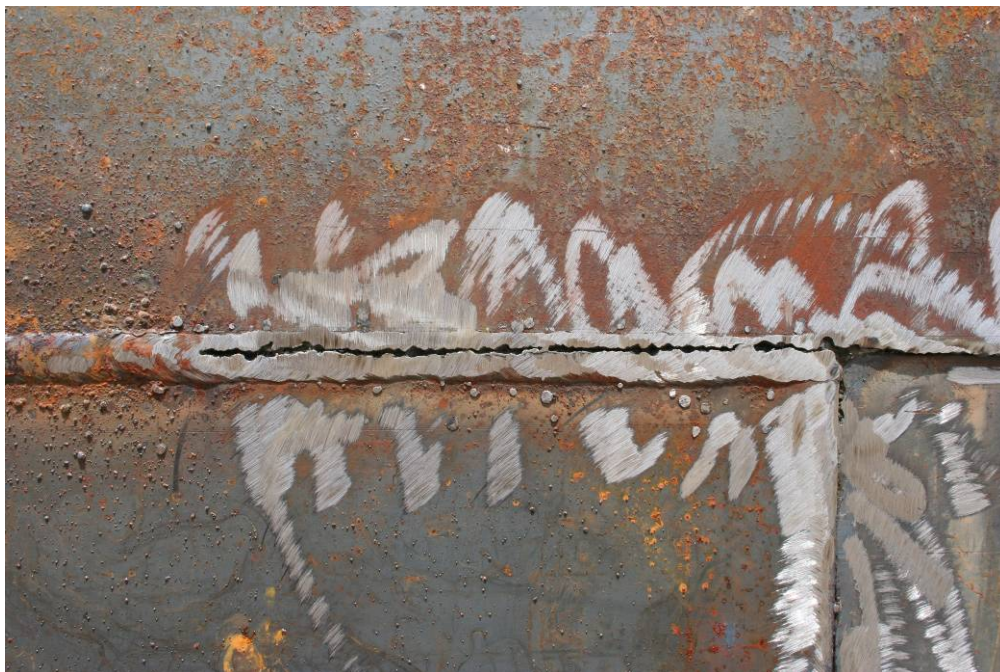
beads were “back ground” to the plate metal. Site Photo 20 shows the back grinding process while Site Photo 21 shows a weld grounded flush with the plate steel.

Site Photo 21. Close-up of bead ground flush with plate steel.

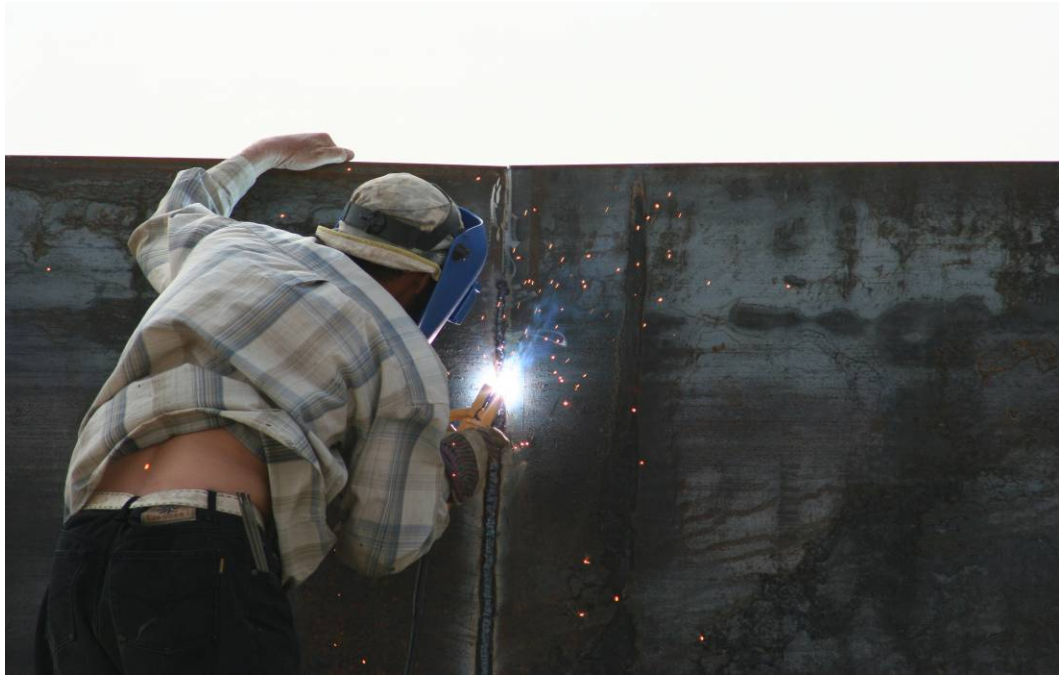
Site Photo 23. Worker completes second run vertical weld on a shell plate.

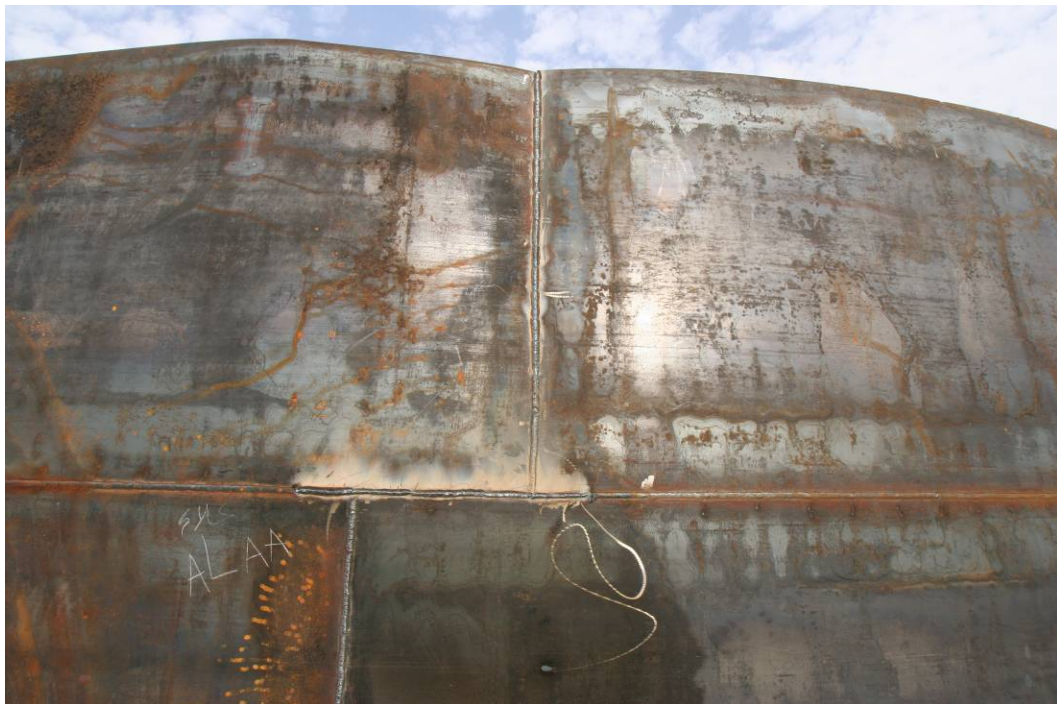
Site Photo 24. Completed second run on a vertical weld of a shell plate.
