RIGHT BANK DRINKING WATER TREATMENT
PLANT REHABILITATION

SUSTAINMENT ASSESSMENT

SIGIR PA-07-106

OCTOBER 22, 2007

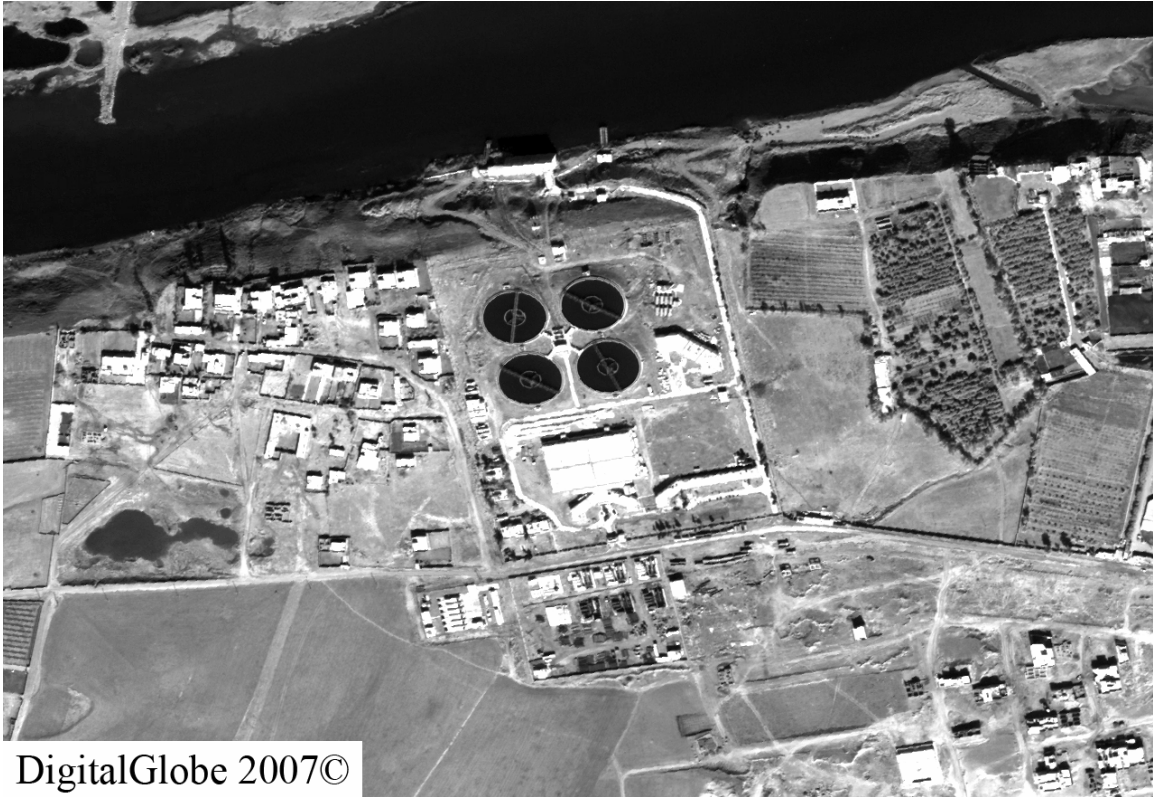
Aerial Image 1. Imagery overview of the Right Bank Drinking Water Treatment Plant taken on 27 FEB07.

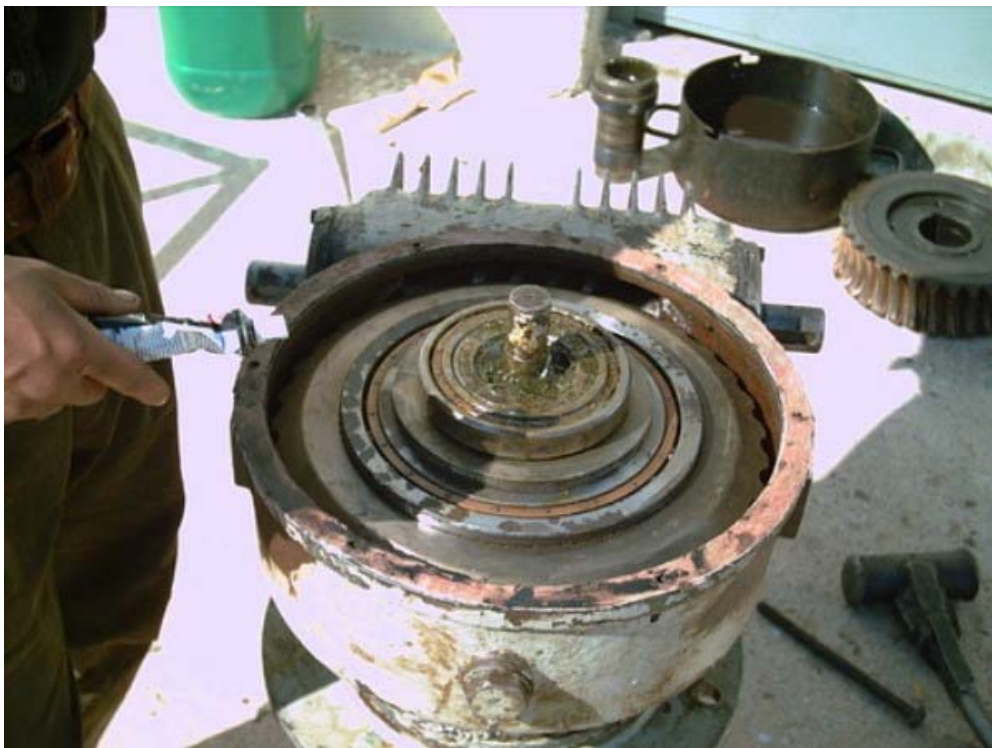
Site Photo 3. Maintenance work on flush mixers (Photo courtesy of USACE)

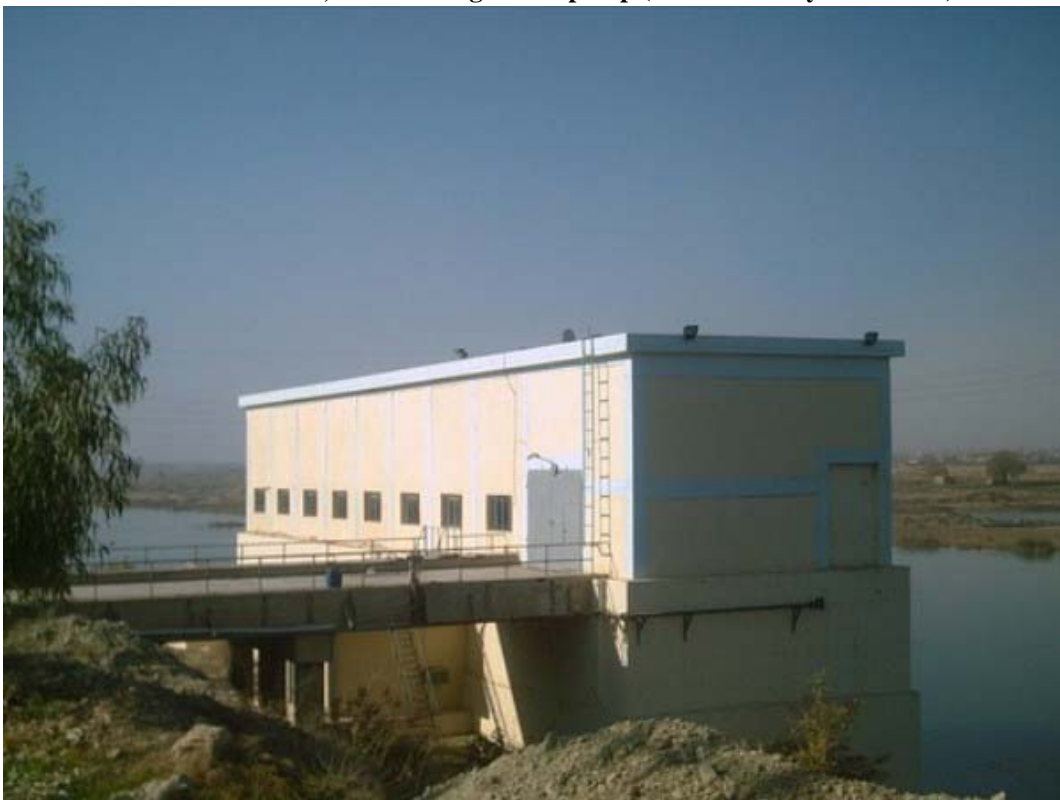
Site Photo 5. Low- lift pumping station's newly renovated exterior (Photo courtesy of USACE)

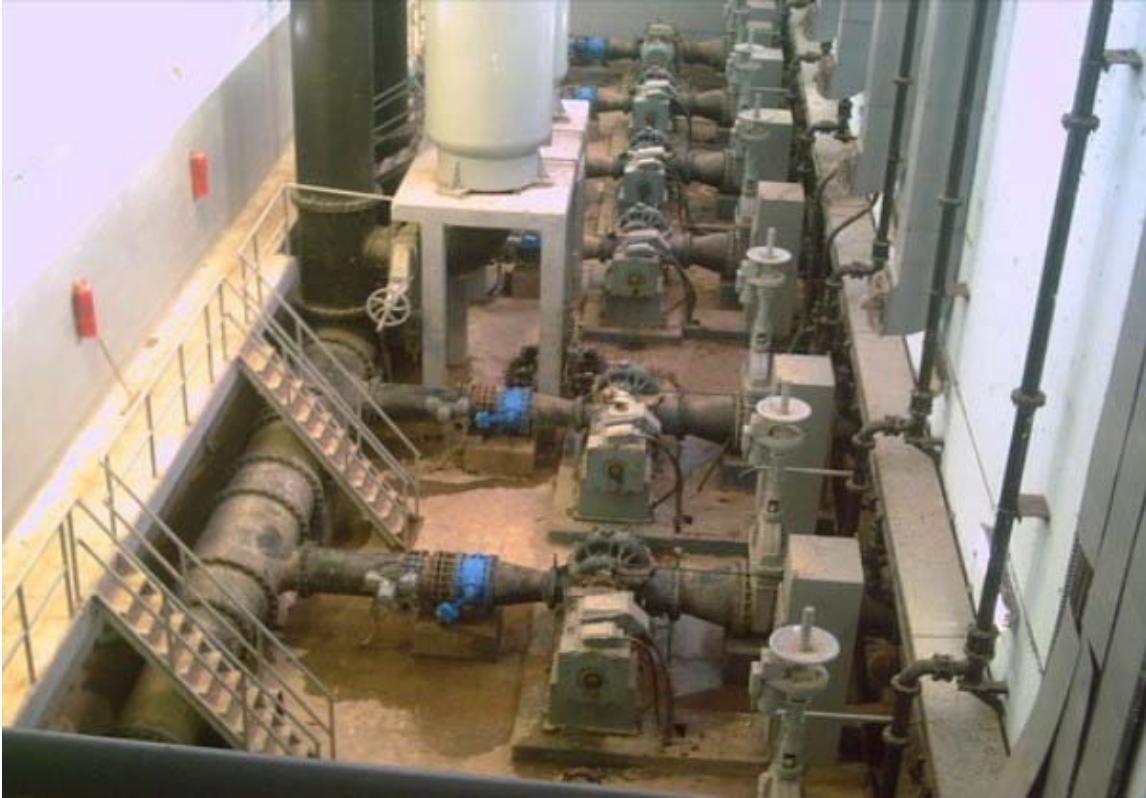
Site Photo 6. Low-lift pumping station's newly renovated interior (Photo courtesy of USACE)

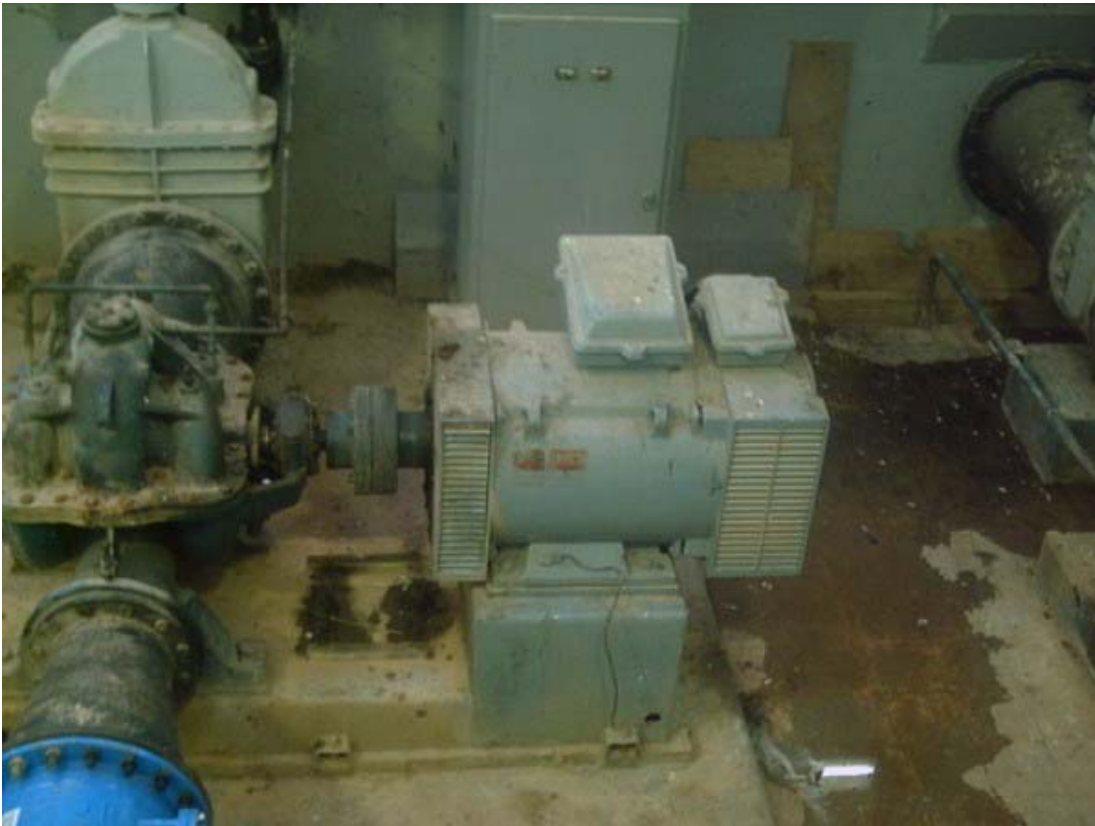
Site Photo 7. Low-lift pumping station's 180-kilowatt motor (Photo courtesy of USACE)

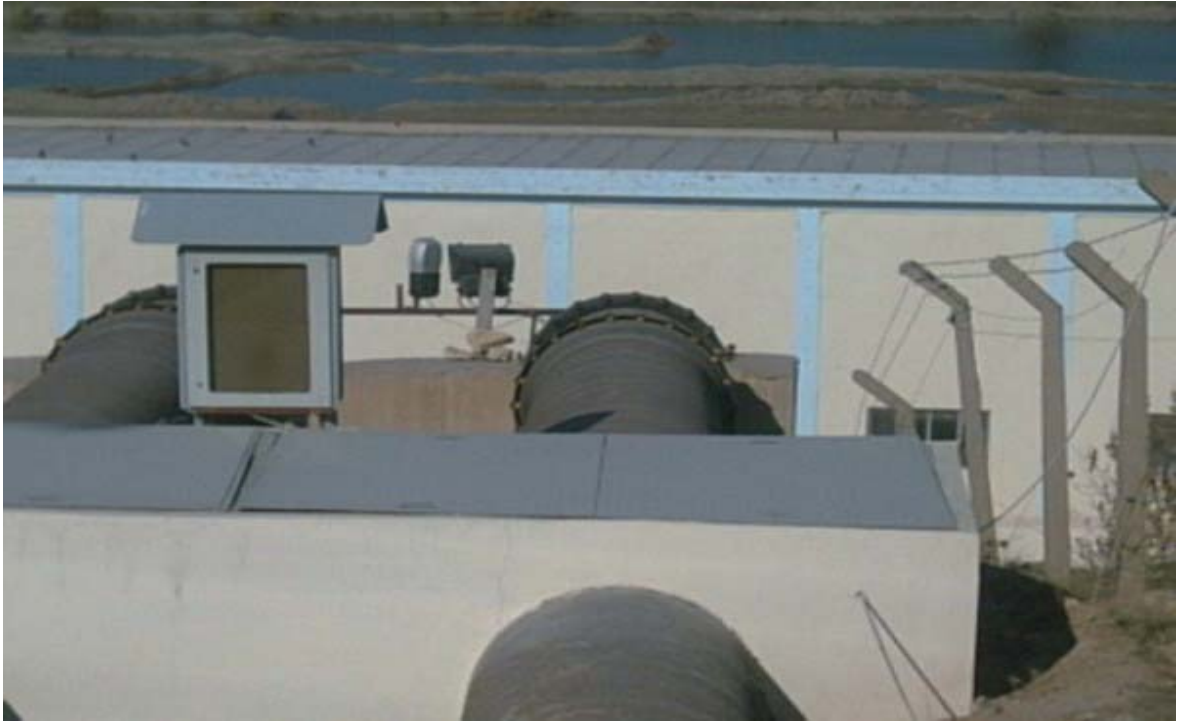
Site Photo 8. Low-lift pumping station's flow meter (Photo courtesy of USACE)

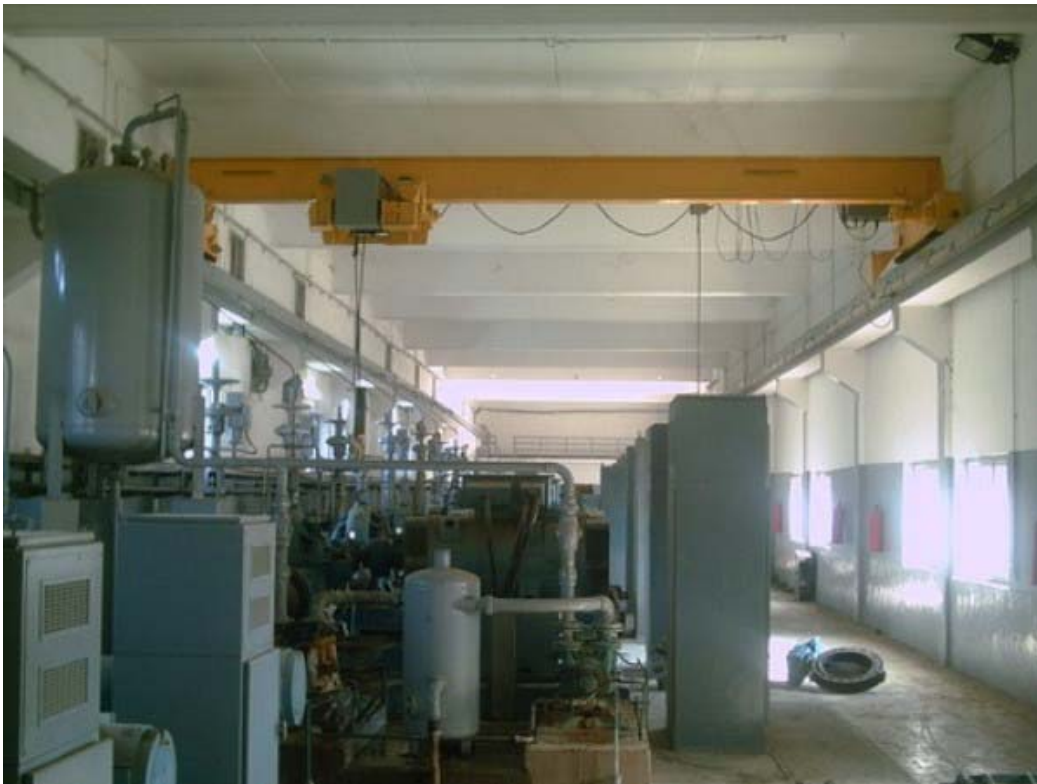
Site Photo 9. High-lift pumping station's building interior (Photo courtesy of USACE)

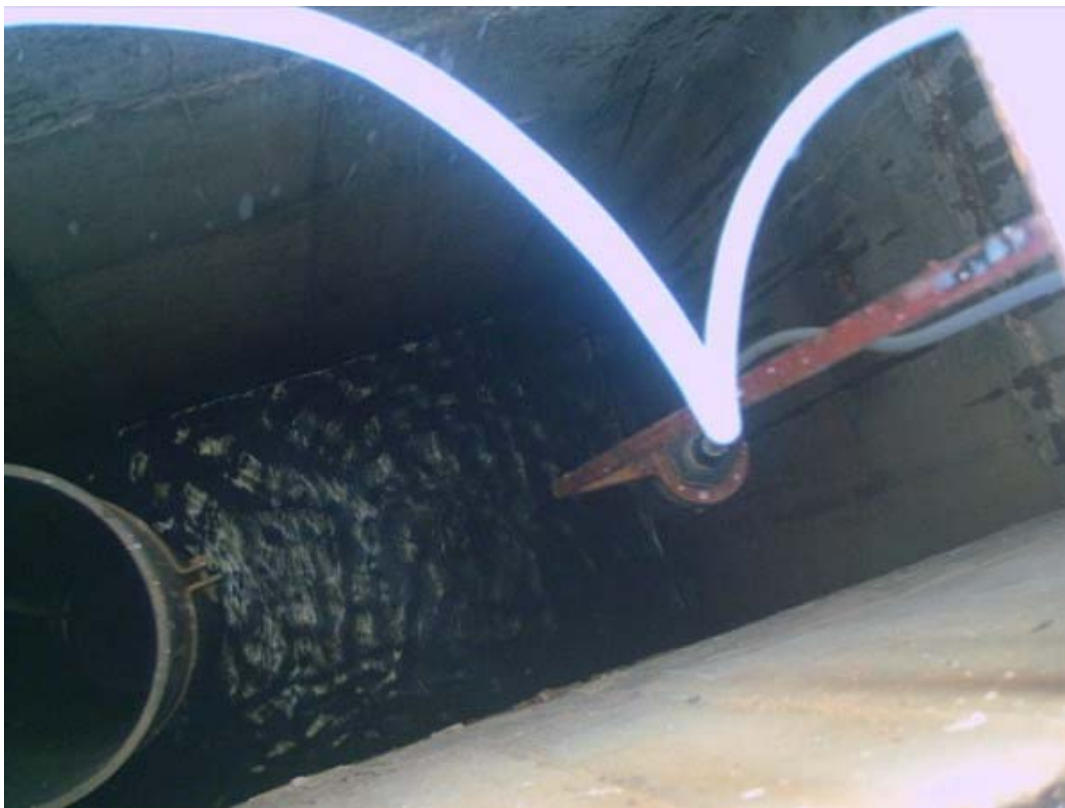
Site Photo 15. Water level indicator (Photo courtesy of USACE)
