**REHABILITATION OF THE MANSOUR
PUMP STATION**

SUSTAINMENT ASSESSMENT

**SIGIR PA-07-111
JANUARY 24, 2008**

SUBJECT: Report on the Rehabilitation of the Mansour Pump Station in the Al Amerea area of Baghdad, Iraq (Report Number SIGIR PA-07-111)

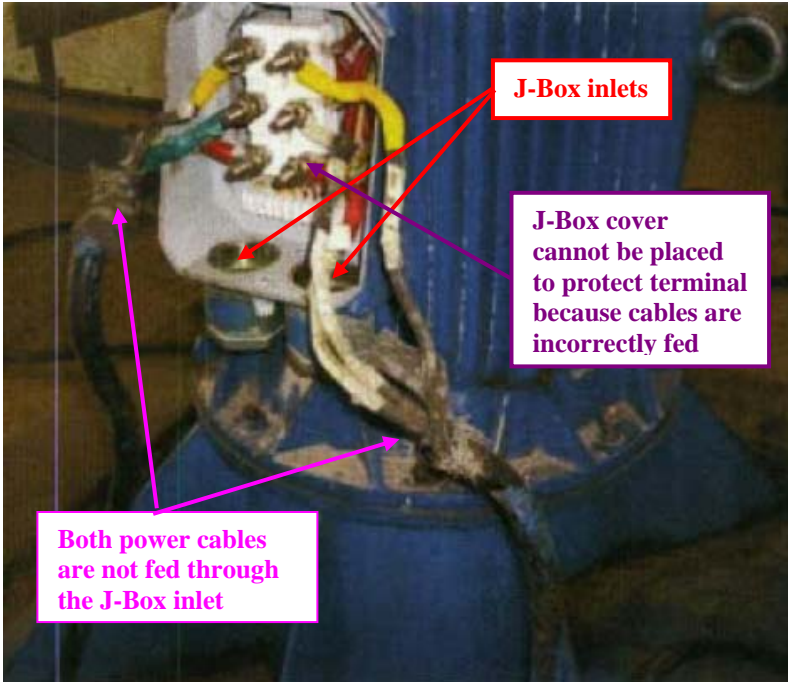
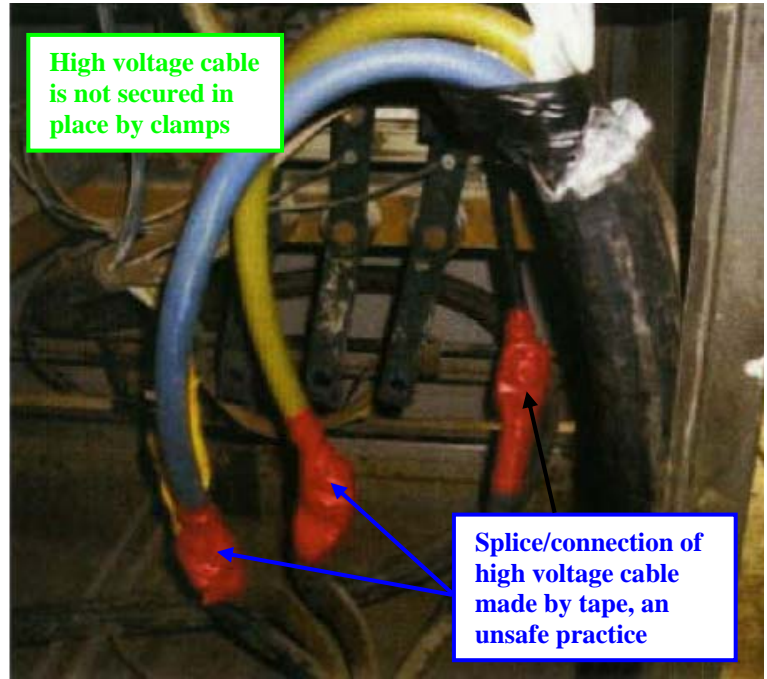
A review of the photographs taken during the final inspection provides insight into the installation techniques and practices employed by the Phase 3 contractor. For example, the contractor used very poor and potentially dangerous installation techniques while attempting to connect a vertical pump motor (Site Photo 6) and the 100 mm submersible pump control panel (Site Photo 7). Finally, the USACE representative performing the final inspection had to point out that an electrical fire within the 300 mm vertical pump control panel necessitated repair of the control panel (Site Photo 8). The electrical fire is evidence of poor installation techniques used by the contractor.

Site Photos 6 and 7. Dangerous installation connecting the vertical pump motor and the 100 mm submersible pump control panel.
 (Photos courtesy of USACE)

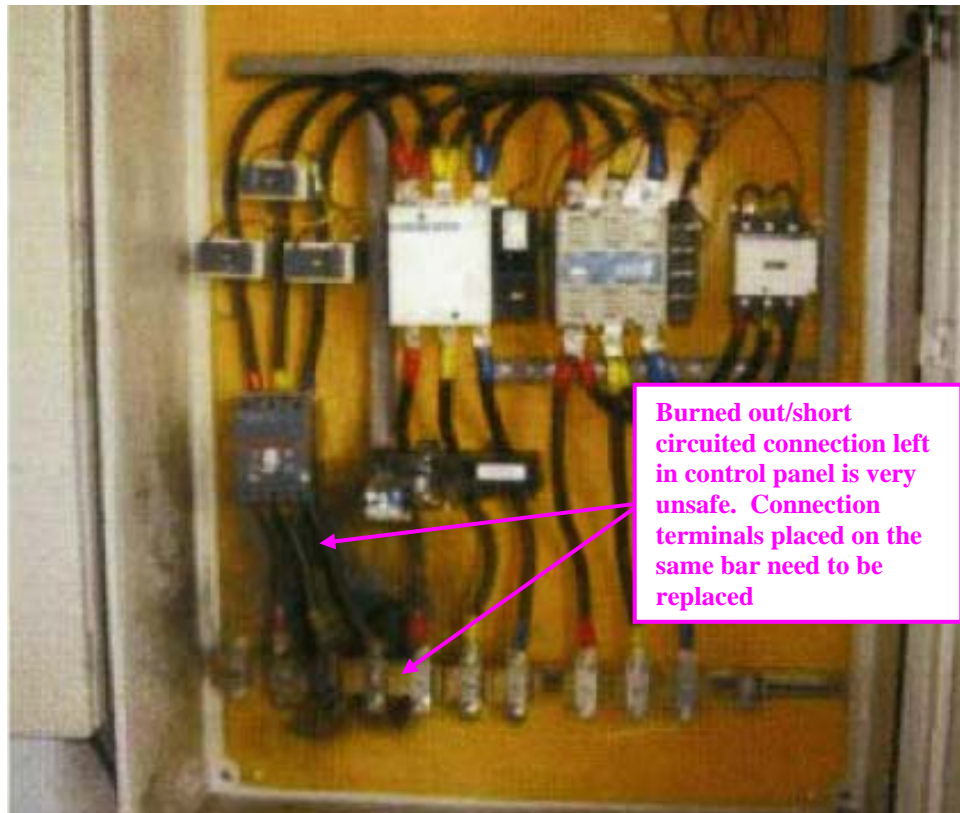
Site Photo 8. Electrical fire within the 300 mm vertical pump control panel.
 (Photo courtesy of USACE)

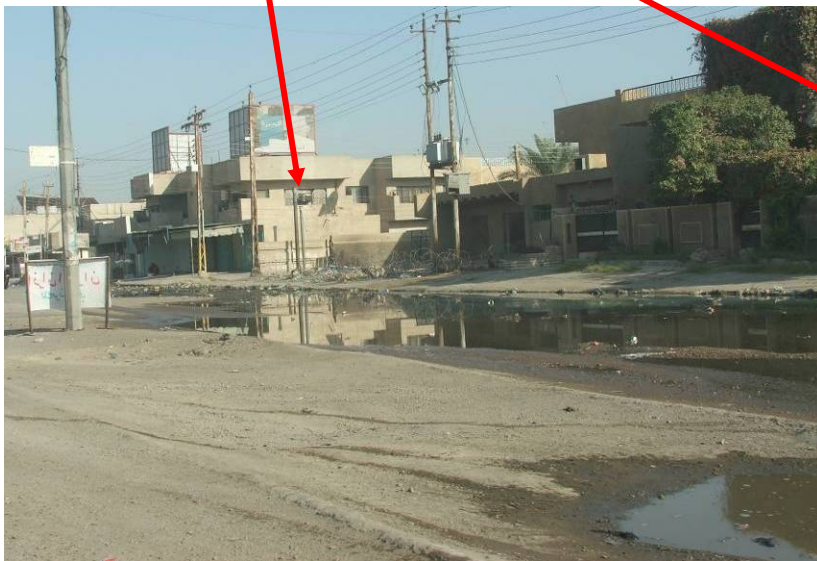
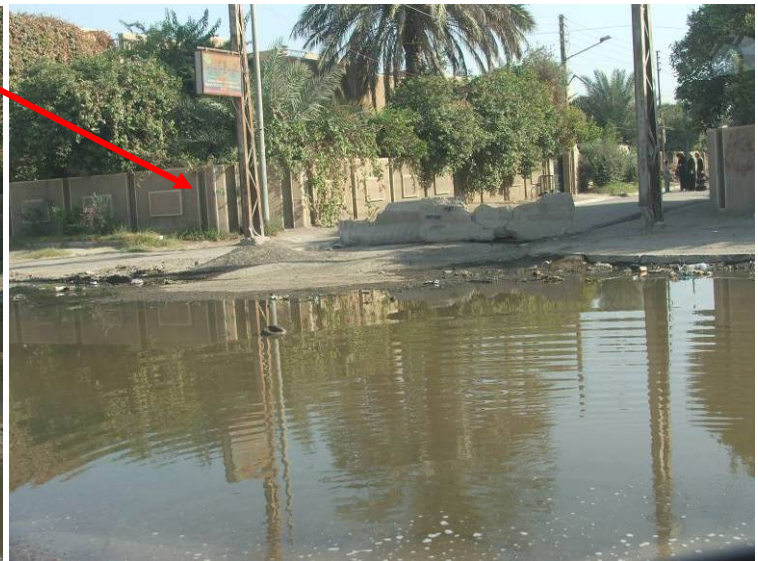
During our first site visit, we identified streets in the Al Amerea area with backed up sewer water and streets with no sewer water back up (Aerial Image 2 and Site Photos 9-11). While we conducted our site visit, a concerned resident of the area angrily complained about the backed up sewer water on his street.

Site Photos 10 and 11. Flooded streets in the Al Amerea area

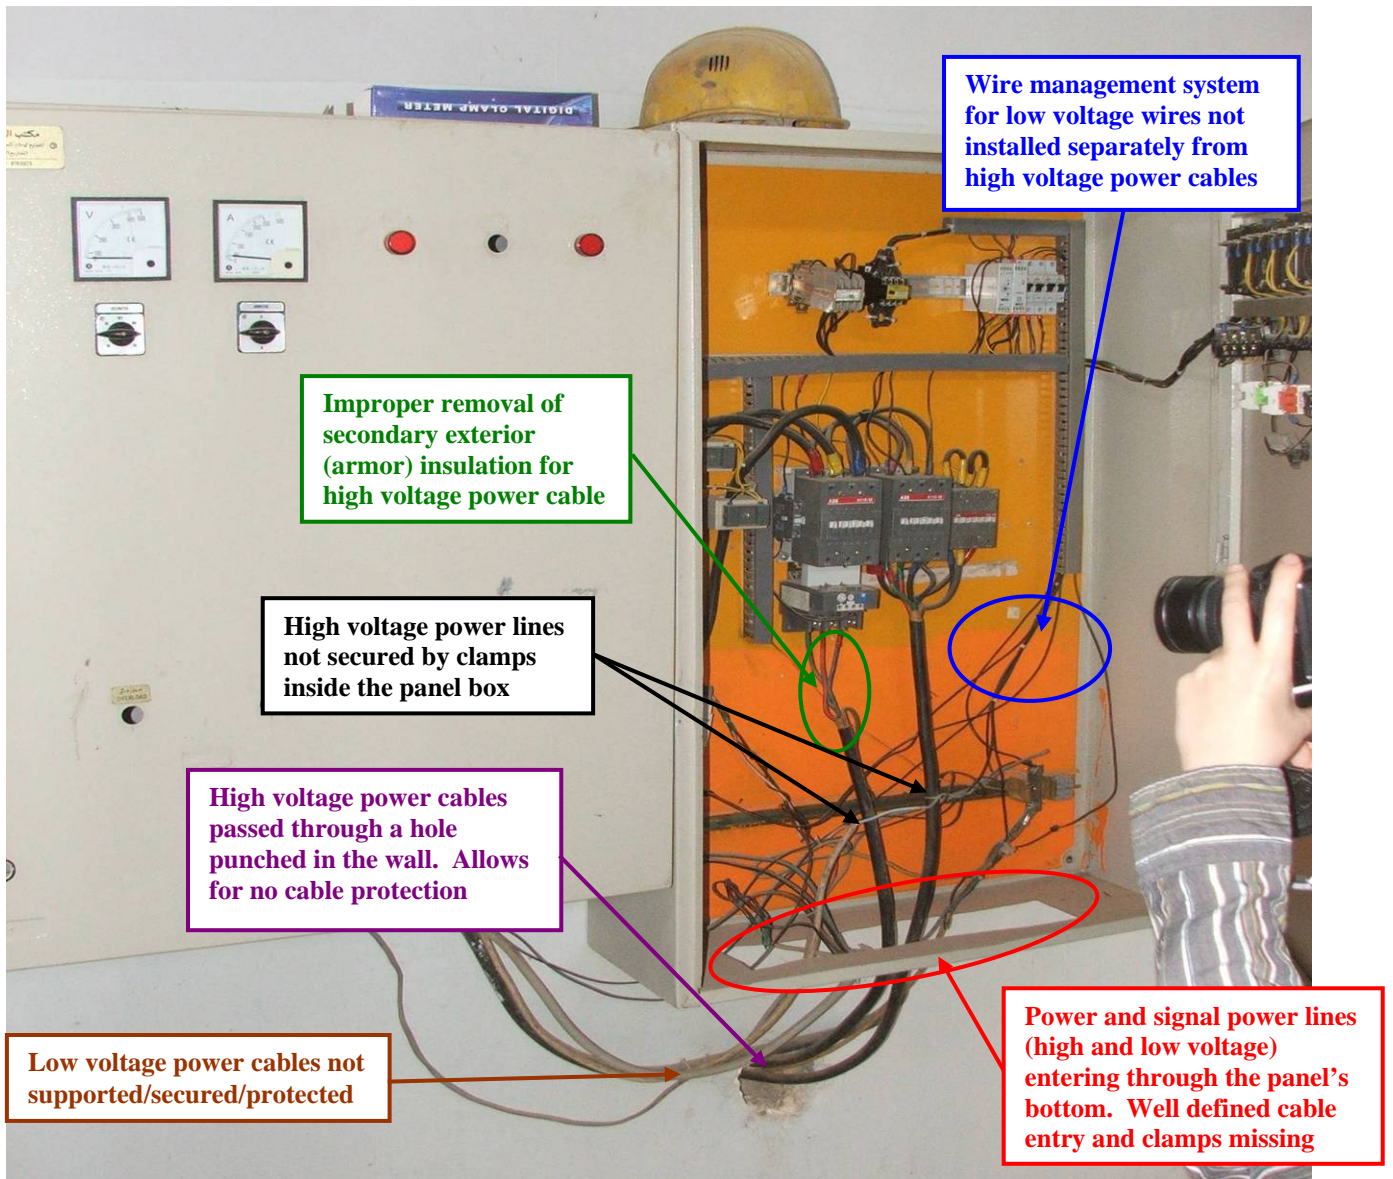
We located the control panel for the 300 mm submersible pump (Site Photo 14) and identified potentially hazardous electrical wiring techniques, which leaves the pump station at risk for either a malfunction or a fire. For example, high voltage power cables and low voltage signal cables dangle and cross each other, which increase the chance of pump and/or motor failure via electromagnetic disruption. In addition, one high voltage wire was terminated short, which increases the potential for an electrical fire.

Site Photo 14. Control panel for the 300 mm submersible pump

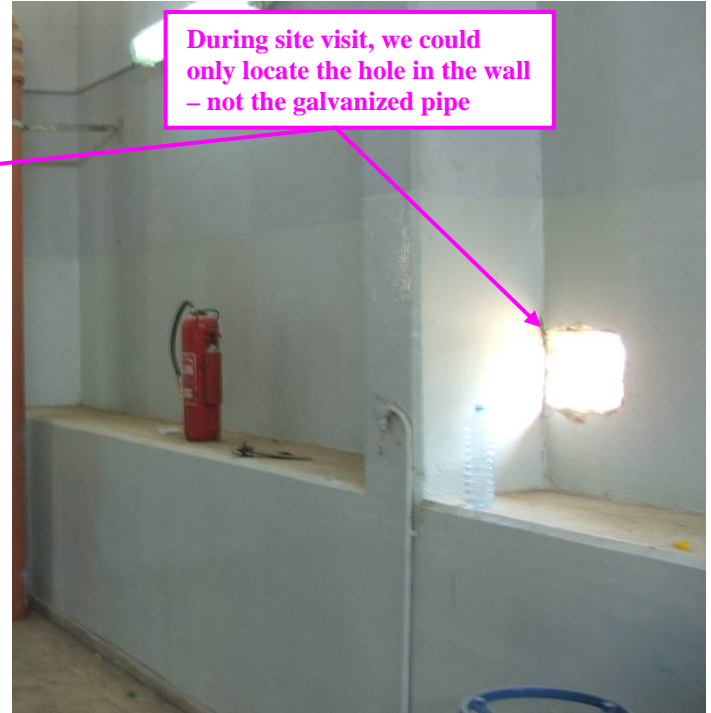
During our site visits, we first noticed that the galvanized pipe for the submersible pump that was installed by the contractor had been removed (Site Photos 15 and 16).

Site Photo 16. Location of where the 15m of galvanized pump and the 100mm submersible pump should be.

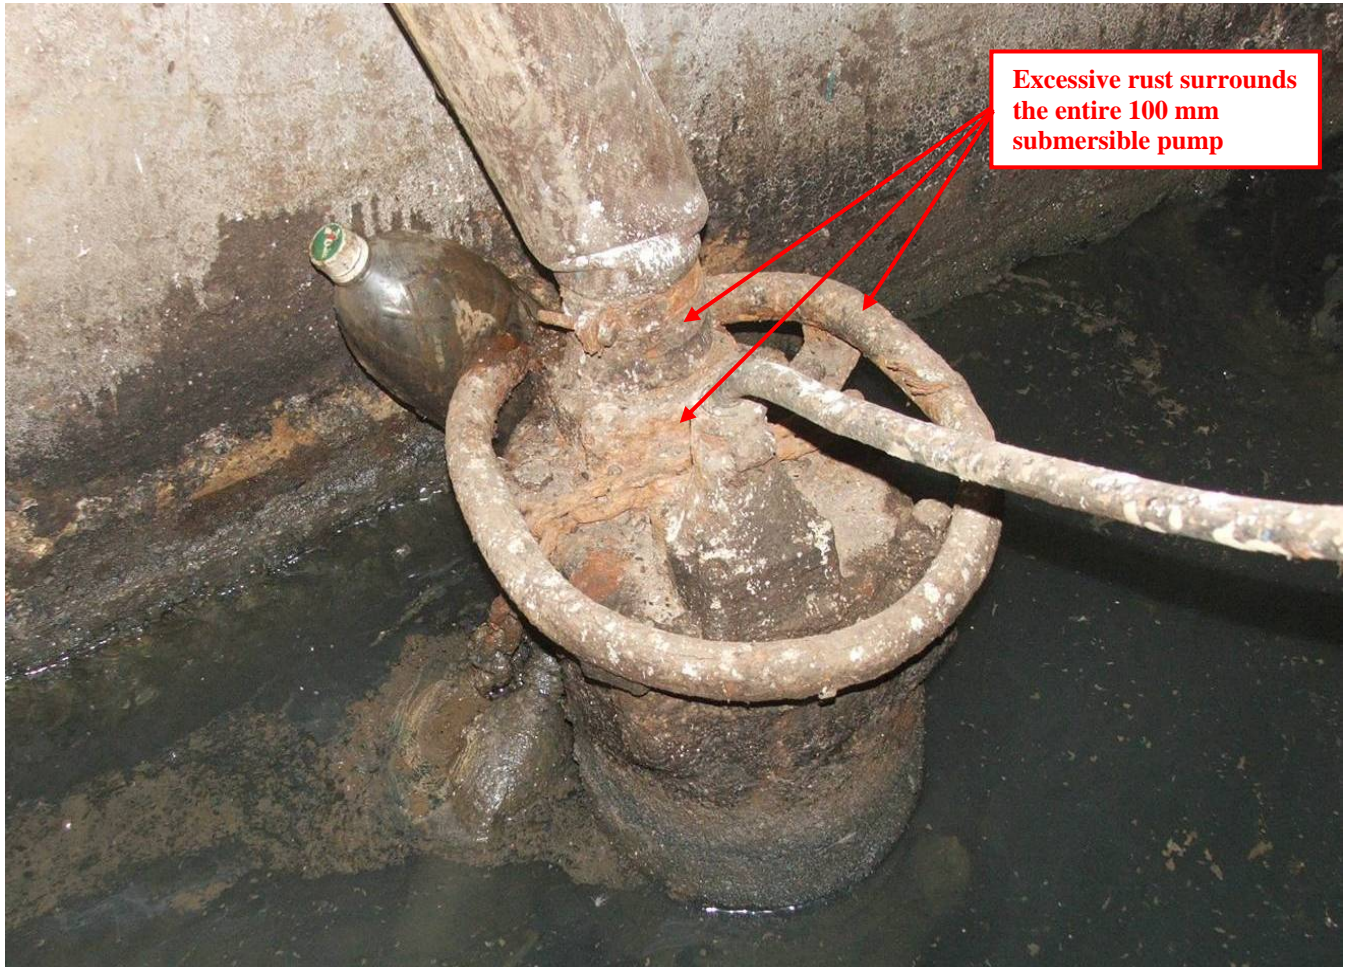
SIGIR determined the contractor did not install the 100 millimeter submersible pump required by the contract. Instead SIGIR found a severely rusted and corroded submersible pump approximately 20 to 30 years old.

Inside the dry well, the pump station operator identified the 100 mm submersible pump (Site Photo 17), which was heavily rusted and corroded. We determined the submersible pump to be approximately 20-30 years old. The pump station operator stated this was the pre-existing submersible pump. Apparently, the galvanized pipe was never “installed” by the contractor; instead it was temporarily used to empty water within the dry well and then removed. The pump station operator stated a new submersible pump was never installed by the contractor and the current location of the galvanized pipes is not known. Consequently, the contractor was paid \$16,900 for a 100 mm submersible pump and 15 m of galvanized pipe not provided for the pump station.

Site Photo 17. Heavily rusted and corroded 100 mm submersible pump

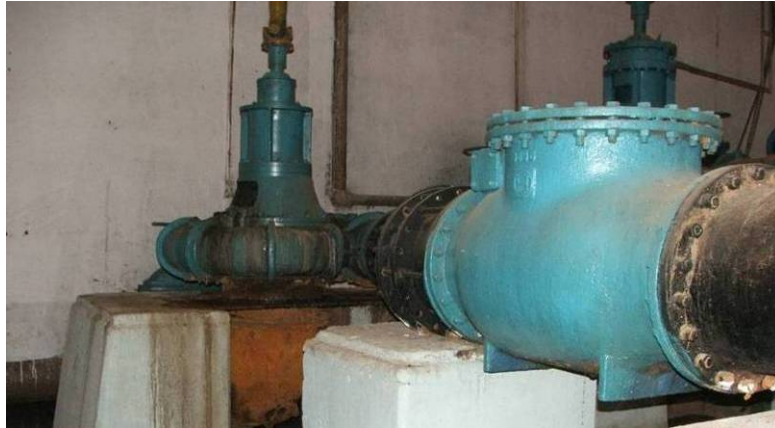
file, this pump was installed in March 2007; however, we identified significant amounts of rust and corrosion on this pump, which causes us to seriously doubt the claim this is a new pump. For example, the excessive amount of rust and grease around the nuts and bolts area is highly suspect for a “new” pump installed approximately 8 months ago (Site Photo 19). Also, the significant amount of water leakage from this pump causes us to believe this pump is either not new or not properly installed. A newly and properly installed vertical pump should not suffer from the significant water leakage we witnessed (Site Photo 20).

Site Photo 18. 350 mm vertical pump

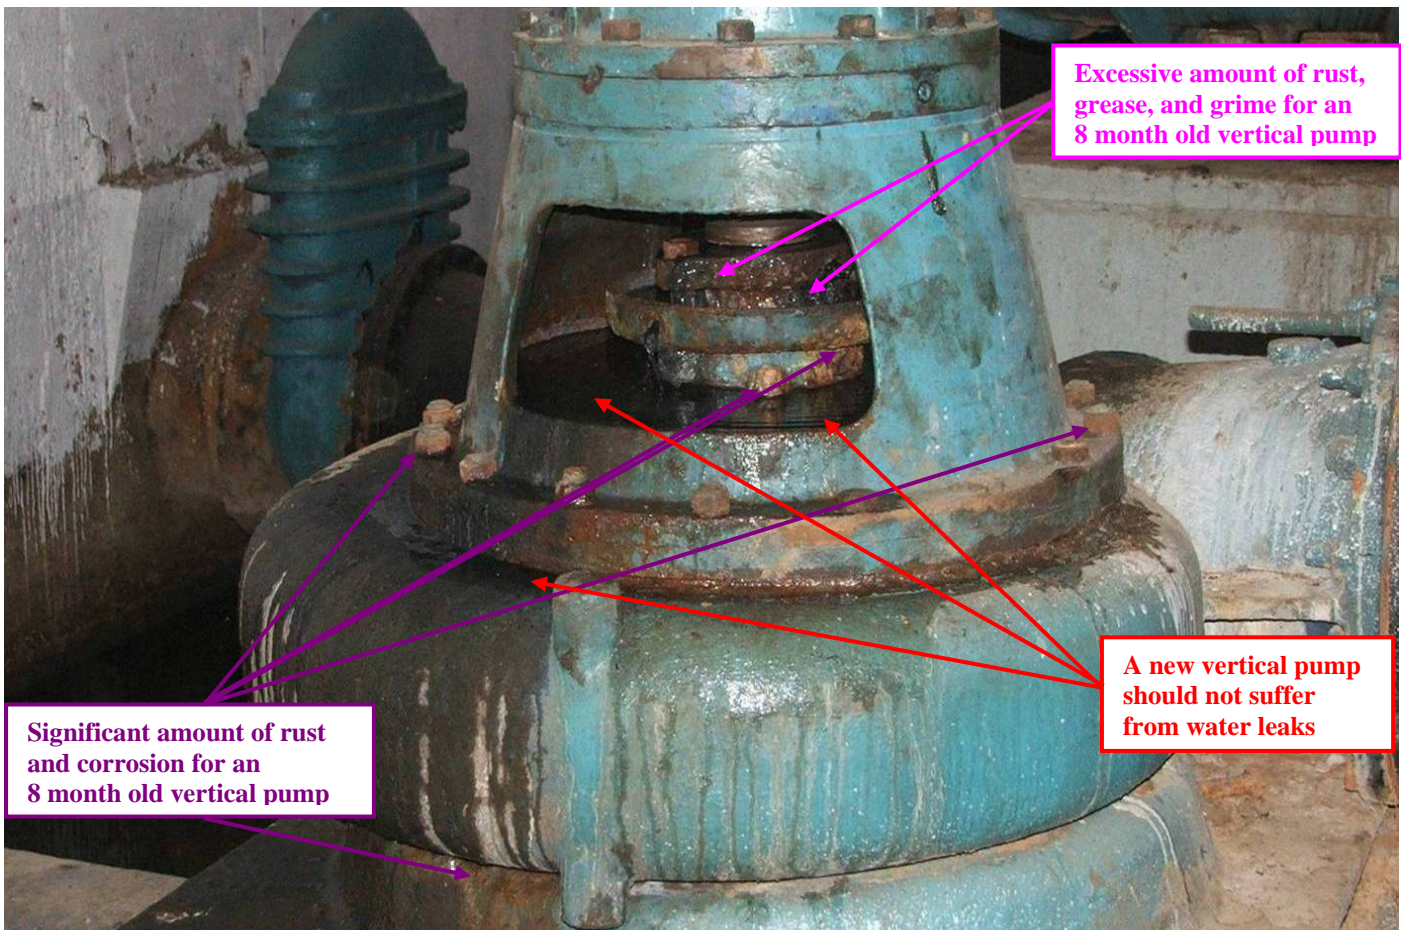
Excessive amount of rust, grease, and grime for an 8 month old vertical pump

A new vertical pump should not suffer from water leaks

Significant amount of rust and corrosion for an 8 month old vertical pump

Site Photo 19. Rust indicates that the 350 mm vertical pump is either not new or not properly installed

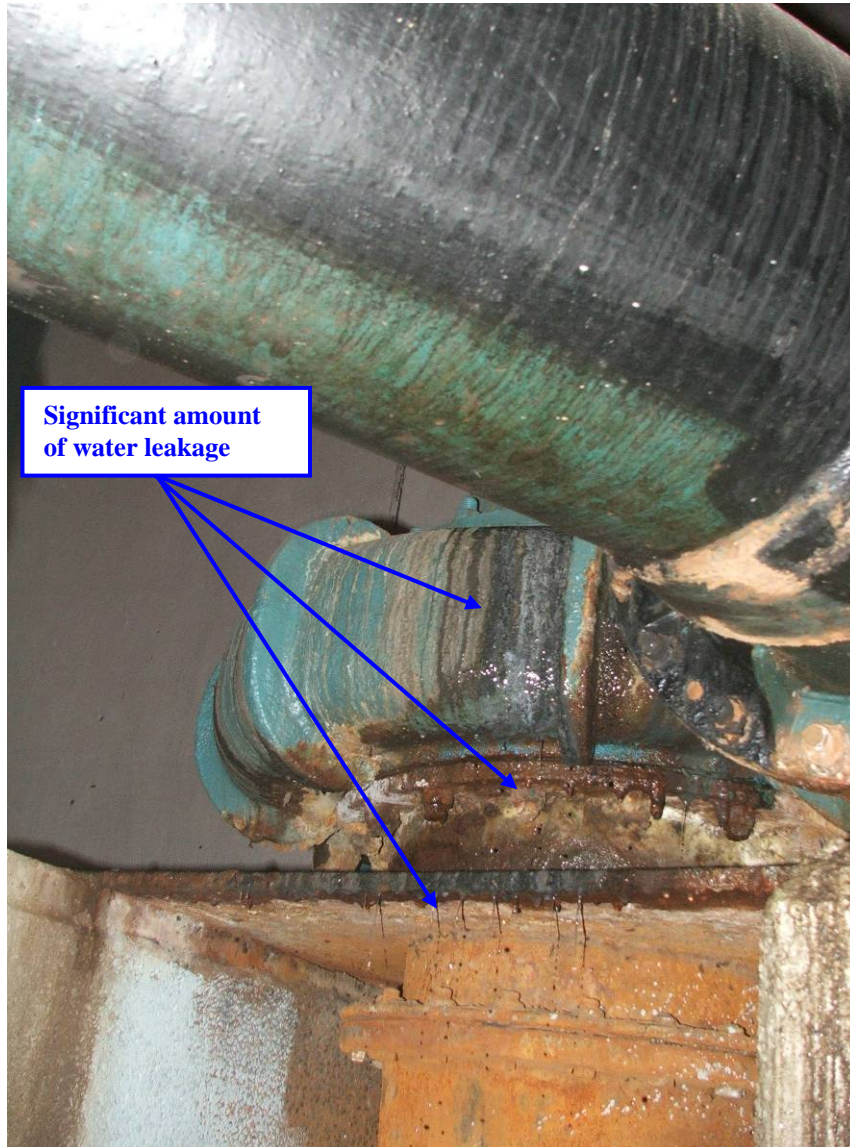
Site Photo 20. Significant water leaking witnessed from the 350 mm vertical pump

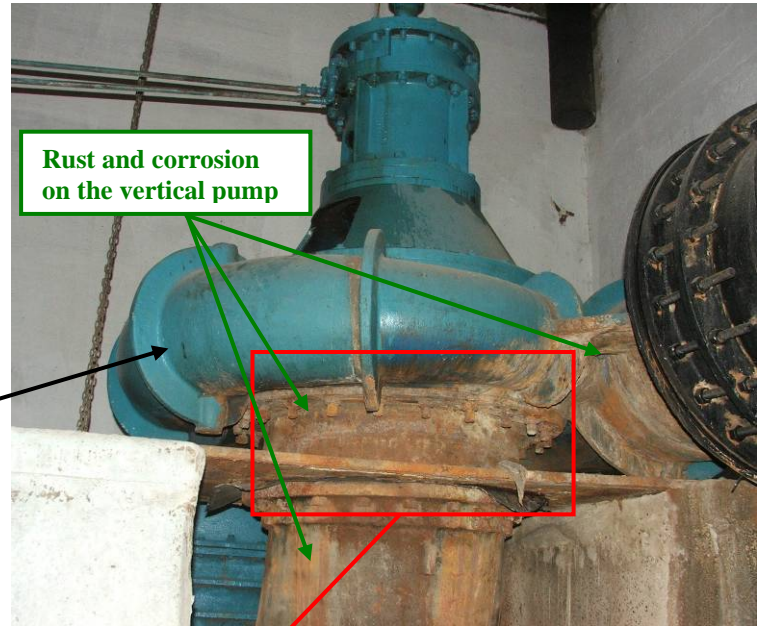
During our site visits, we identified significant amounts of rust on the bottom of all four vertical pumps and the nuts and bolts connecting the vertical pumps to the outlet pipes. For example, in the case of the 800 mm vertical pump, the bottom of the pump is severely rusted as well as the nuts and bolts connecting it to the outlet pipe (Site Photos 23 and 24). There are only two possible reasons to explain the significant amount of rust on the bottom of the newly installed vertical pumps – either the pumps installed were used (and previously rusted) or the contractor did not properly install the vertical pumps. Poor installation of the vertical pumps would result in water overflowing the pump causing rust to form.

Site Photo 23. View of rust SIGIR Inspectors witnessed on the same vertical pump

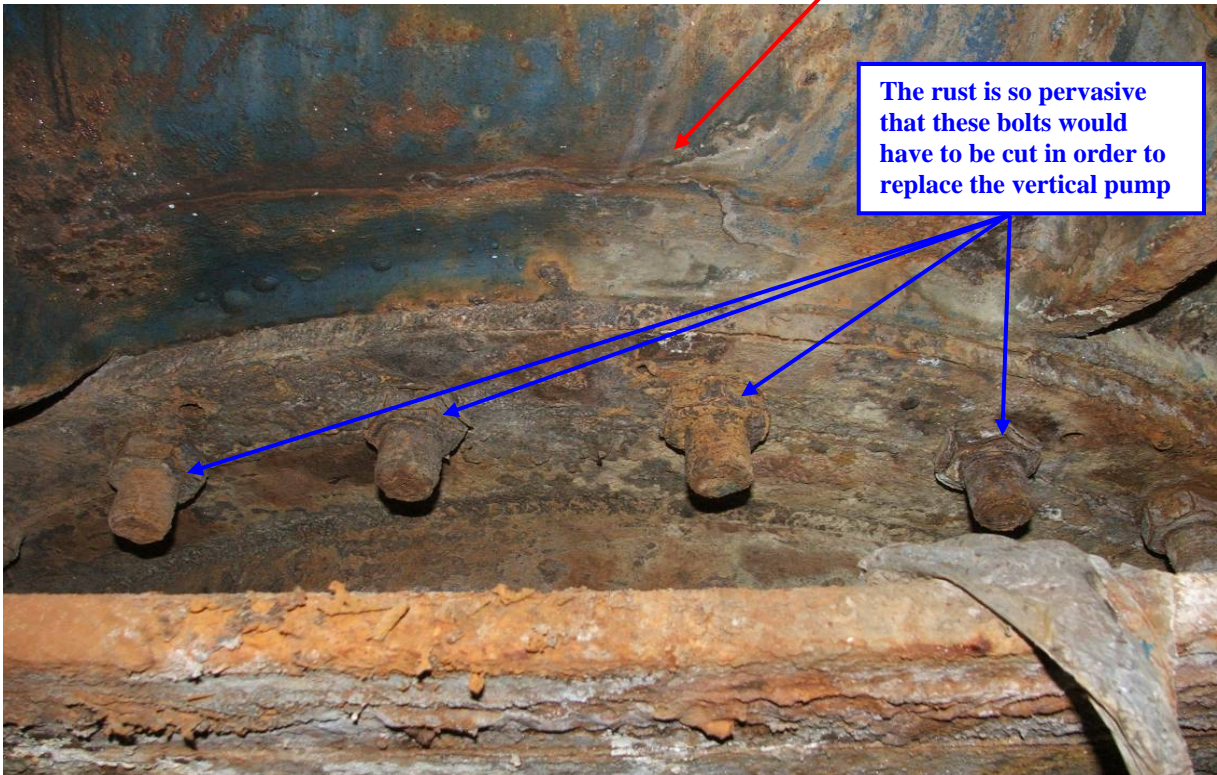
Site Photo 24. Close up view of Site Photo 23

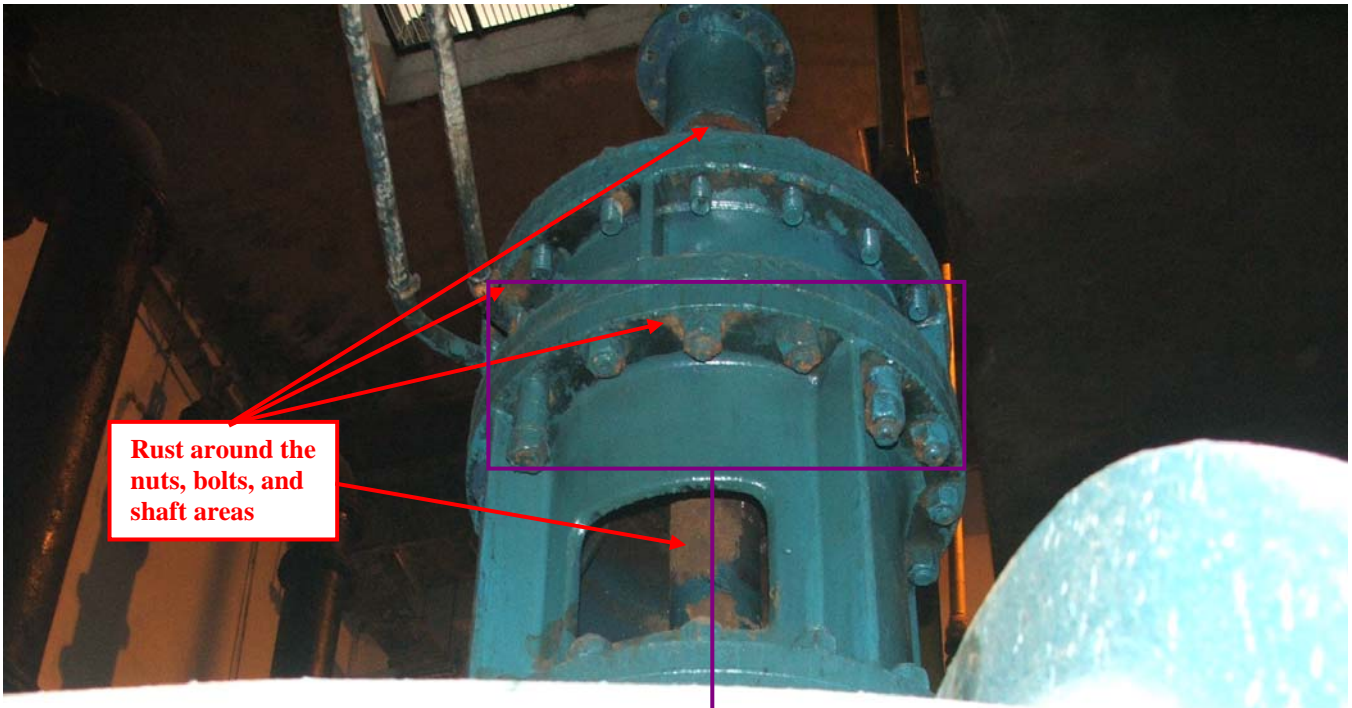
For the 600 mm vertical pump, we also witnessed a significant amount of rust for a pump that was installed in January 2006. The Phase 4 contract required the painting of the vertical pump; however, the excessive amounts of rust are visible through the paint, especially around the nuts and bolts and the shaft areas (Site Photos 25 and 26).

Site Photo 25. View of the 600 mm vertical pump

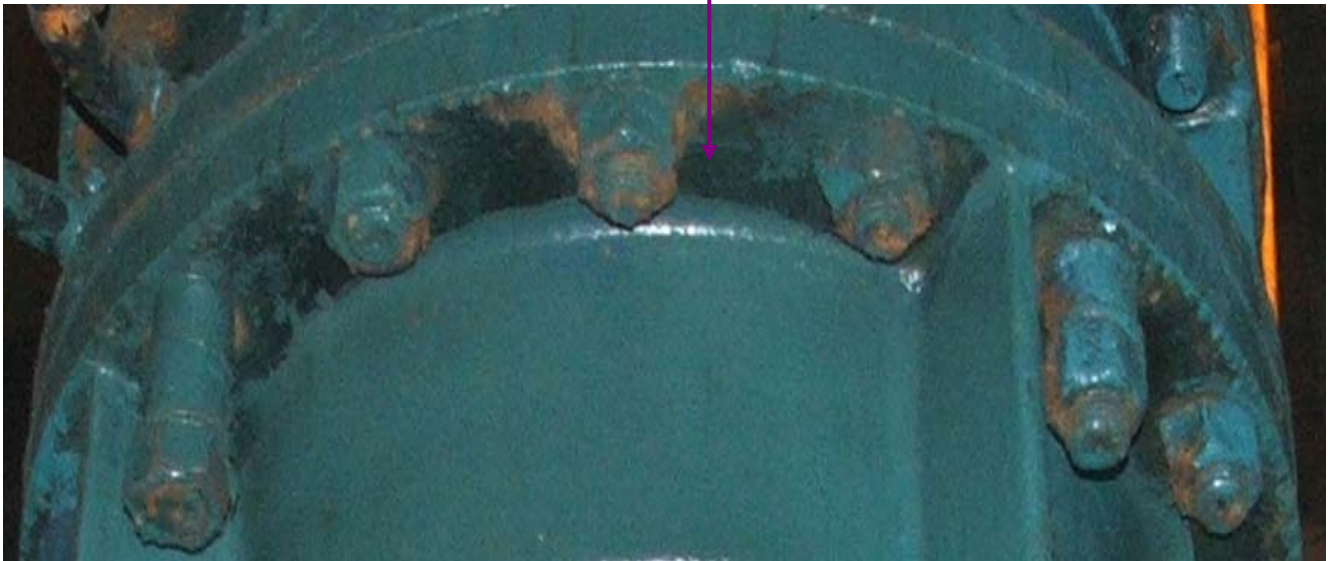
Site Photo 26. Close up view of Site Photo 25

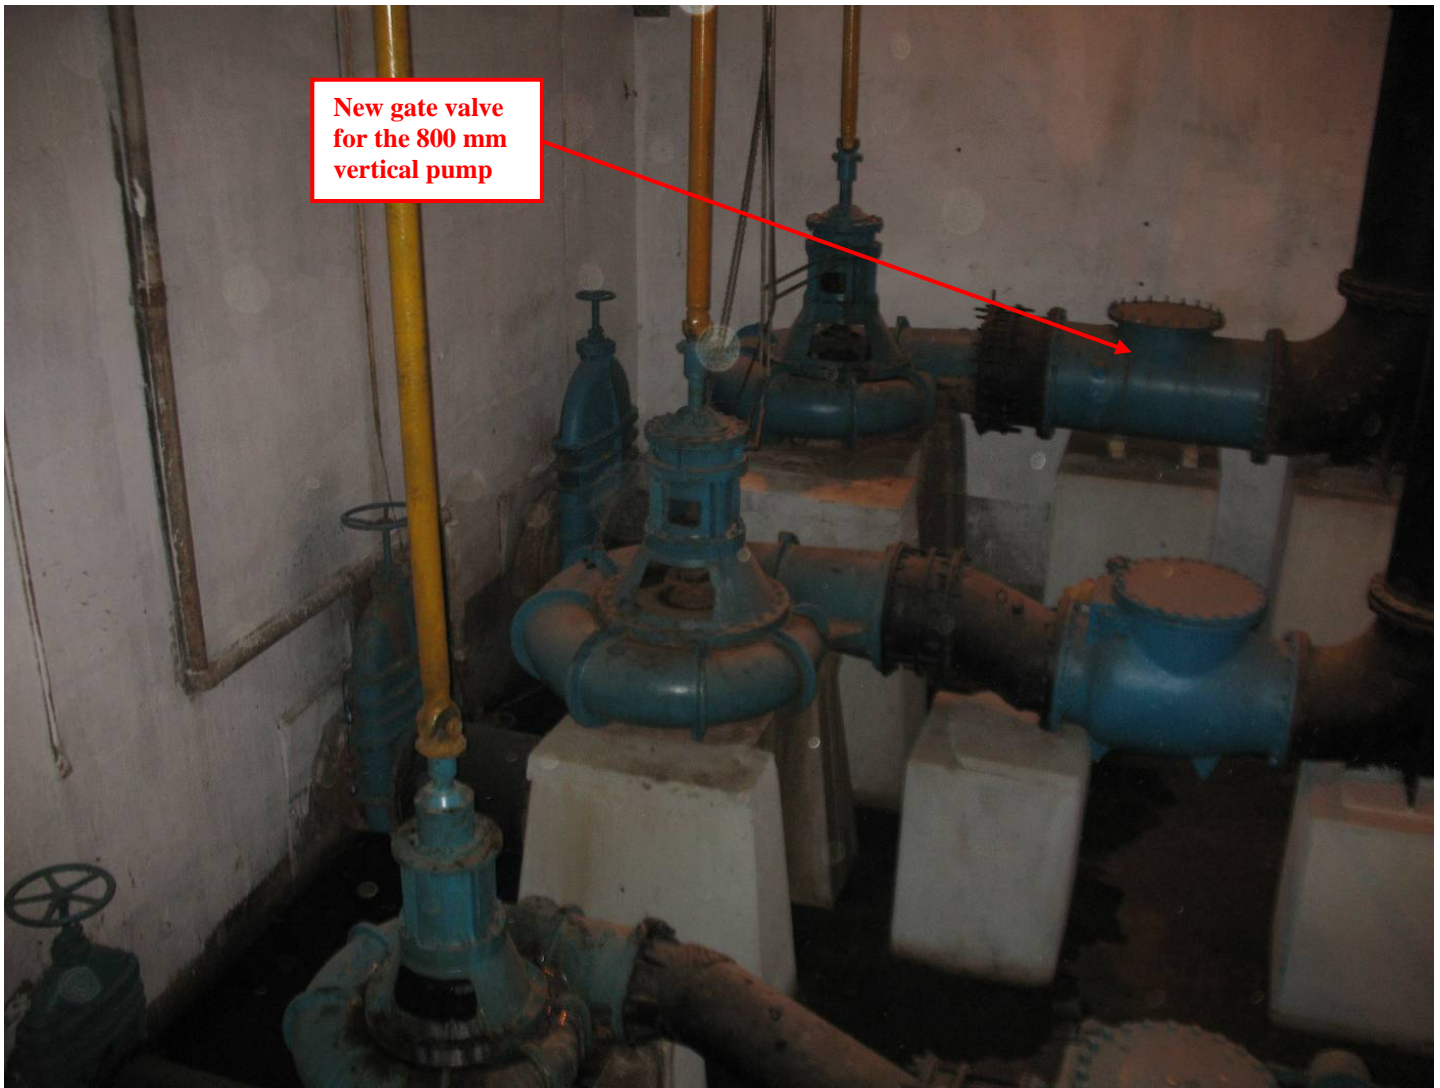
During our site visits, we identified the replacement of only the 800 mm vertical pump gate valve (Site Photo 29). The replacement gate valve is a different shape and size than the pre-existing gate valves, which required the contractor to reconfigure the connection with the outlet pipe from the vertical pump. According to the Phase 4 contractor, the original gate valve collapsed as a result of years of rust and corrosion (Site Photo 30).

Site Photo 29. View of the vertical pumps within the pump station dry well

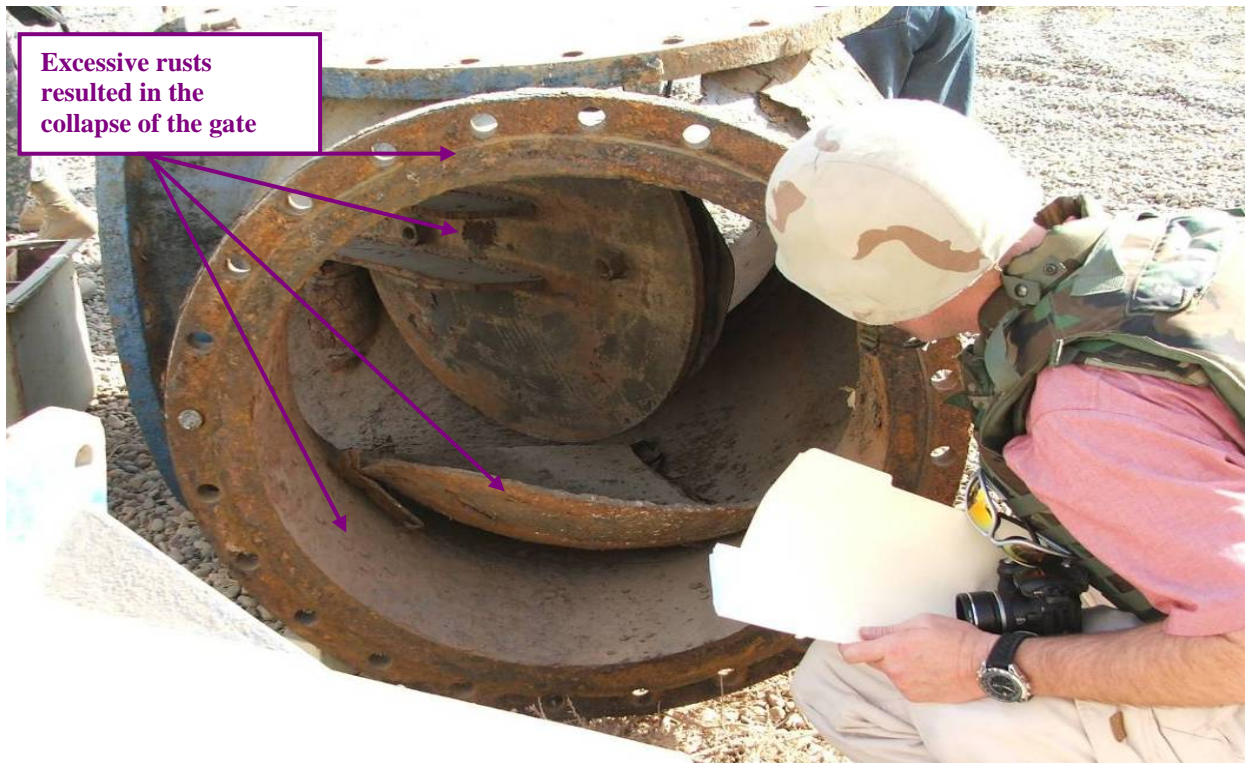
Site Photo 30. View of the original gate valve for the 800 mm vertical pump

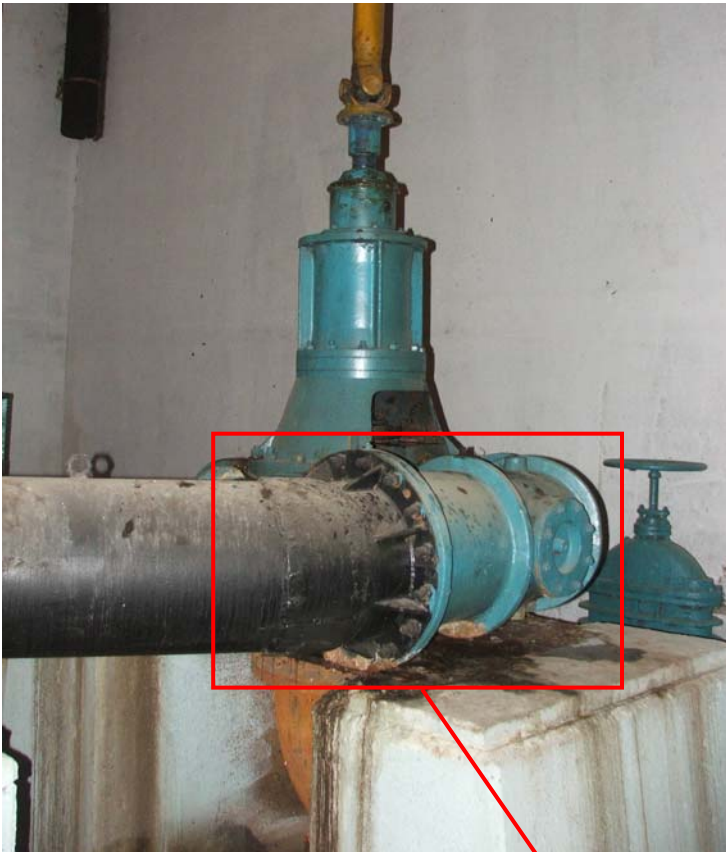
To make the determination of whether to repair or replace a vertical pump gate valve required the contractor to remove the gate valve and inspect it to see if significant rust and corrosion were present and also determine the quality of the nuts and bolts. We saw no evidence that the contractor attempted to remove the gate valves for the 350 mm, 500 mm, and 600 mm vertical pumps. For example, several nuts and bolts to the 350 mm vertical pump gate valve were so rusted that it would be impossible to remove them without cutting them off (Site Photos 31 and 32). The only work performed by the contractor for these three vertical pump gate valves was painting.

Site Photo 31. View of 350 mm vertical pump gate valve

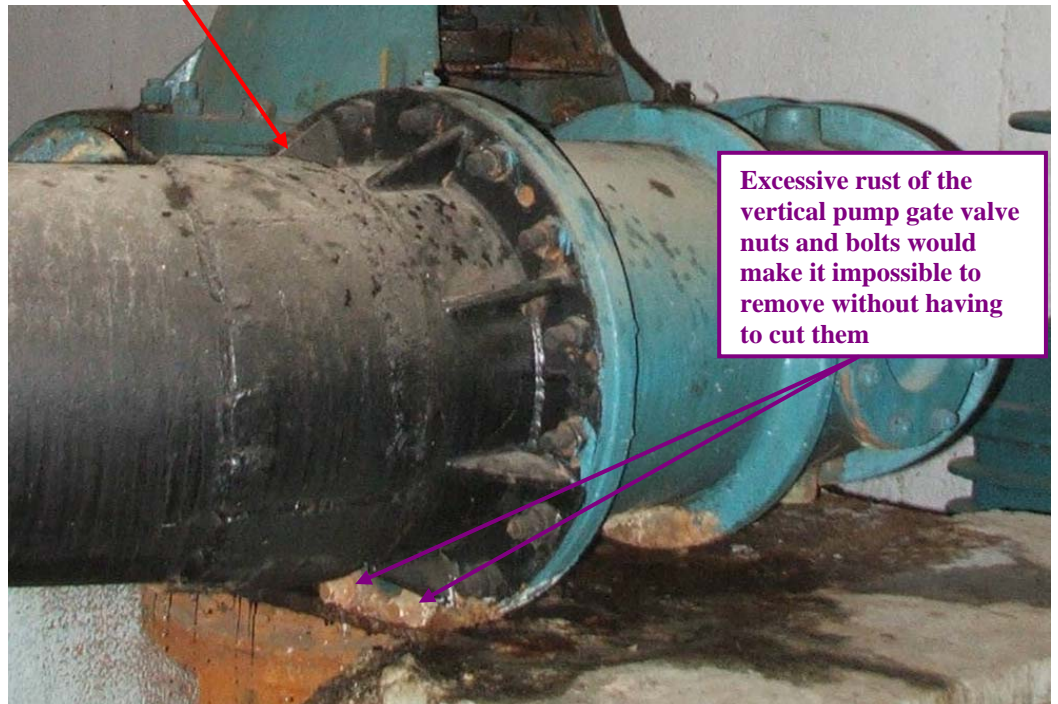
Site Photo 32. Close up view of Site Photo 31

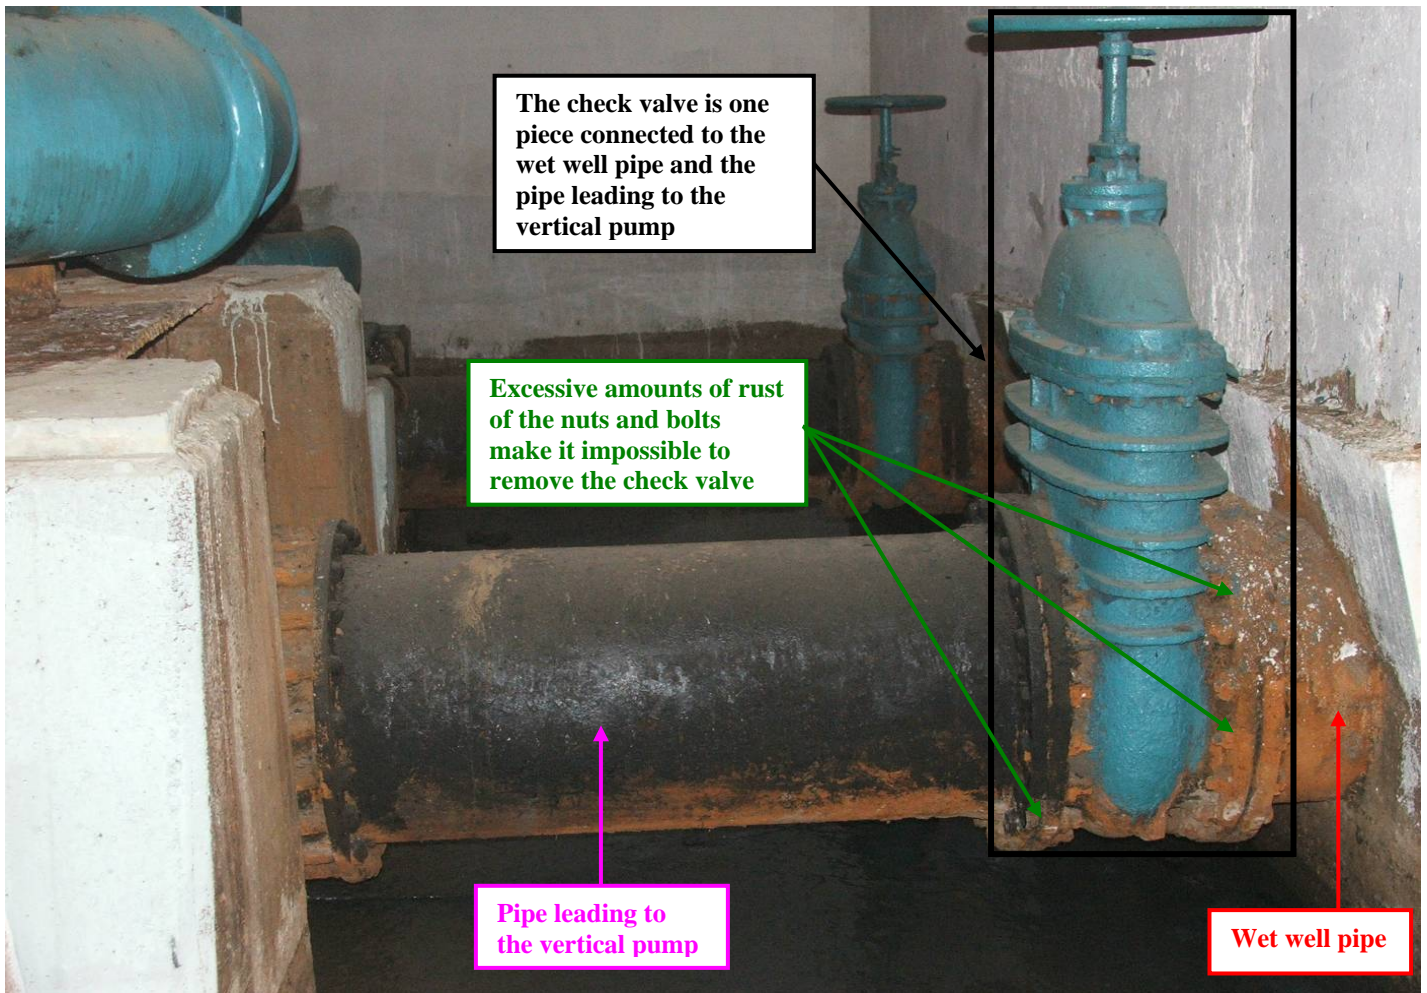
Further, two different contracts required the repair or replacement of check valves and gate valves. SIGIR determined that the contractors simply painted over the pre-existing check valves and gate valves.

As with the gate valves, the rehabilitation of check valves would require the contractor to remove each one to determine if significant rust and corrosion were present. For the check valves, we also saw no evidence that the contractor did anything except paint over the rust on the existing valves. For example, the 350 mm and 500 mm vertical pump check valves are so significantly rusted onto the inlet and outlet pipes that there is no possible way it could have been removed and inspected (Site Photo 33). It appears the contractor only painted over the rust on the pre-existing check valves.

Site Photo 33. View of the check valves for the 350 mm and 500 mm vertical pumps

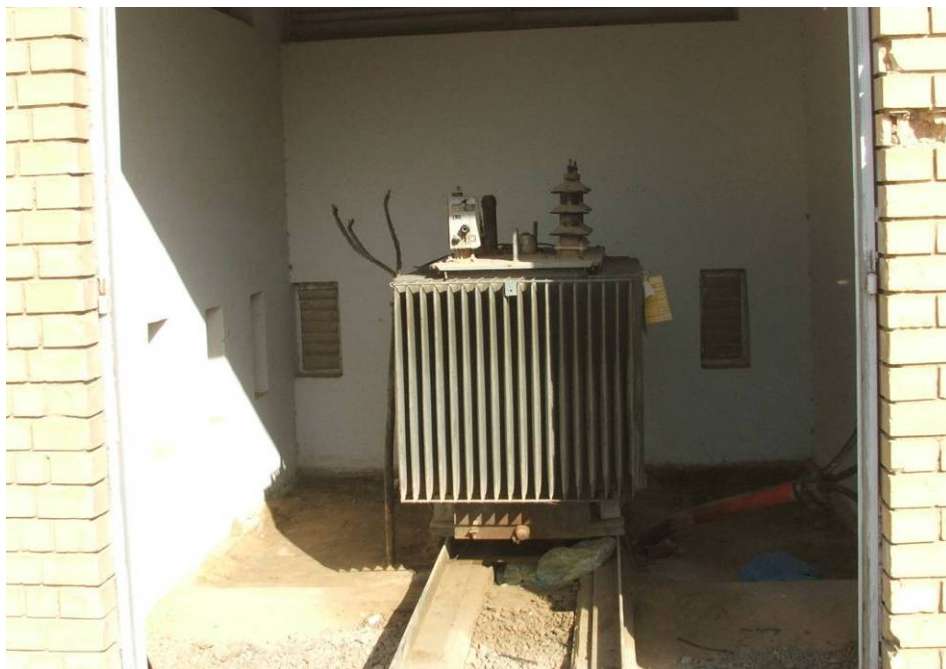
According to 2-1 ID personnel, an 11 kilo-Volt (kV)/3.3 kV (850 kVA) transformer is needed to capture electrical power through the national grid to operate the 600 mm and 800 mm vertical pumps.

Site Photo 34. Pump station's old and poorly maintained transformer.

1. Provide and install a step-down 11 kilo-volt /3.3 kilo-volt (850 kilo-volt Ampere) transformer with all required cables, main power panel, breakers, sub-panels, distribution panels and control panels for the Mansour Pump Station to capture and use available power from the national grid to operate the 600 millimeter and 800 millimeter vertical pumps.
2. Determine whether the various existing vertical pumps, motors, and associated components at the Gulf Region Central facility are still functional. If they are functional, house them in an area safe from environmental conditions and determine an appropriate project for them.

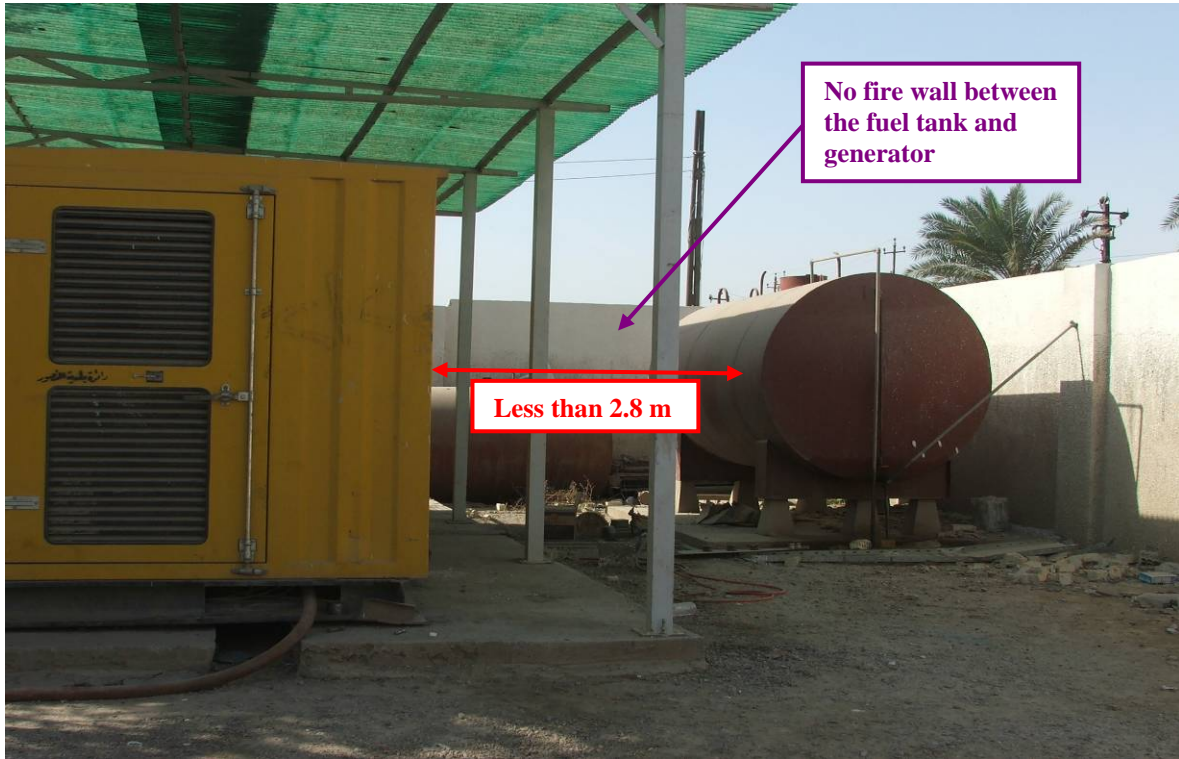
During the site visits, we identified the fuel tank and determined that it was still not located between the two generators and a fire rated wall was not constructed between it and the 750 kVA generator (Site Photo 35). Even though the daily QA report identified an instance when the contractor did not perform according to the contract's requirements, no action was taken against the contractor by the USACE. Consequently, the fuel tank is not located centrally between the two generators and continues to pose a potential fire hazard for the pump station.

Site Photo 35. Location of the pump station fuel tank

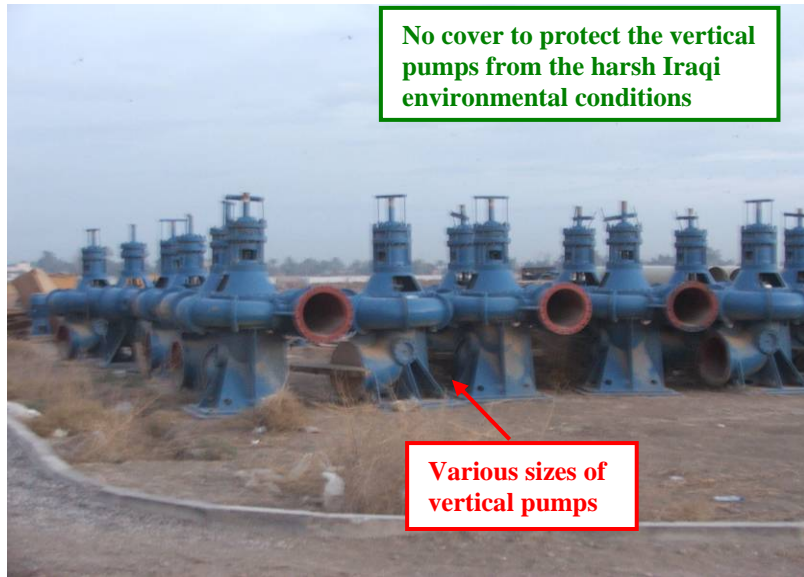
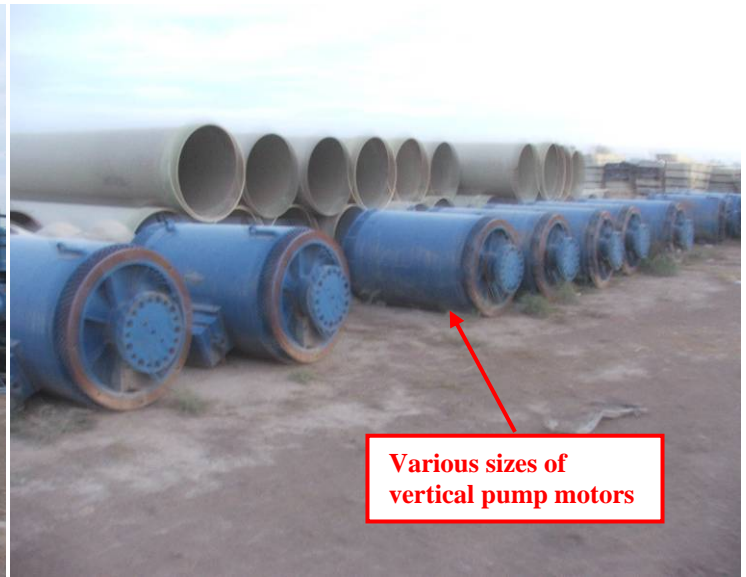
While not intended for the Mansour Pump Station, SIGIR is concerned that this critical equipment has been sitting idle at Gulf Region Central since 2005. Pump stations throughout Iraq are in need of vertical pumps and motors. In addition, SIGIR observed that the vertical pump motors were lying on their sides, which over time will result in degrading of the equipment (Site Photo 39). Several million dollars in equipment is neither being used for its intended purposes nor protected from the elements. For example, dirt, sand, and rain may make their way into the motor’s ball bearings, which could result in the failure of the motors. This equipment needs to be housed in a protective environment to eliminate the possibility of further damage. Because this equipment has been sitting outside in the elements for two years, the possibility exists that the equipment has been damaged. Therefore, a thorough inspection of each piece of equipment will be required to determine if the equipment is still functional.

Site Photos 36 and 37. Vertical pumps, motors, and accessories located behind the GRC HQs living quarters
