**REHABILITATION OF THE MANSOUR
PUMP STATION**

SUSTAINMENT ASSESSMENT

**SIGIR PA-07-111
JANUARY 24, 2008**

SUBJECT: Report on the Rehabilitation of the Mansour Pump Station in the Al Amerea area of Baghdad, Iraq (Report Number SIGIR PA-07-111)

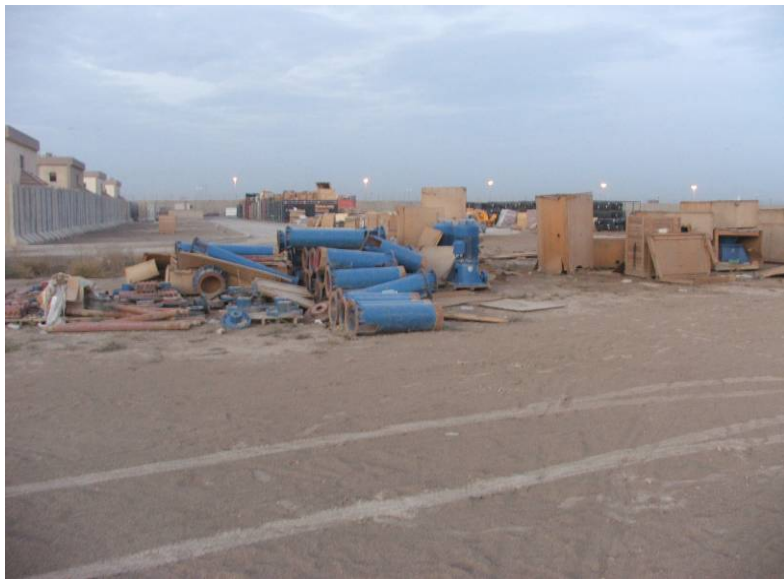
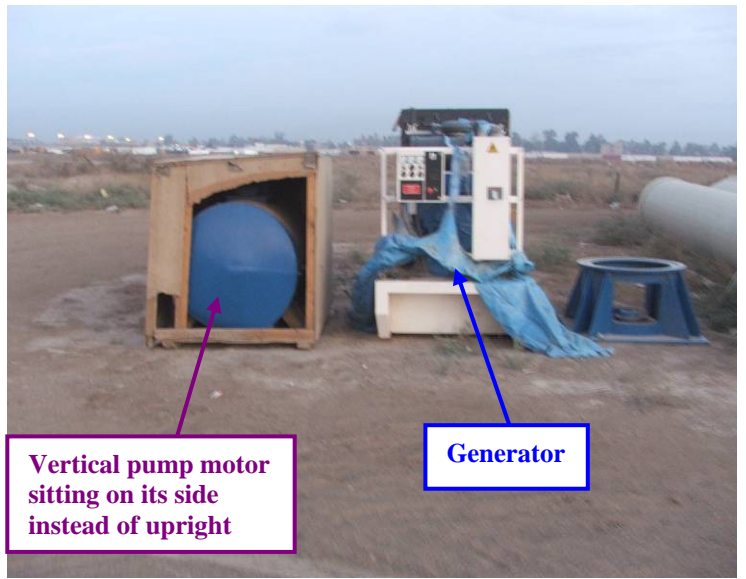
While not intended for the Mansour Pump Station, SIGIR is concerned that this critical equipment has been sitting idle at Gulf Region Central since 2005. Pump stations throughout Iraq are in need of vertical pumps and motors. In addition, SIGIR observed that the vertical pump motors were lying on their sides, which over time will result in degrading of the equipment (Site Photo 39). Several million dollars in equipment is neither being used for its intended purposes nor protected from the elements. For example, dirt, sand, and rain may make their way into the motor’s ball bearings, which could result in the failure of the motors. This equipment needs to be housed in a protective environment to eliminate the possibility of further damage. Because this equipment has been sitting outside in the elements for two years, the possibility exists that the equipment has been damaged. Therefore, a thorough inspection of each piece of equipment will be required to determine if the equipment is still functional.

Site Photos 38 and 39. Additional parts and accessories located behind the GRC HQs living quarters
