IRAQI ARMY FACILITIES
UNDER THE IRAQ SECURITY FORCES FUND
DIYANAH AND DEBECHA, IRAQ

SIGIR PA-07-114
JANUARY 17, 2008

SUBJECT: Report on Construction and Renovation of Iraqi Army Facilities at Diyanah and Debecha, Iraq (Project Number SIGIR PA-07-114)

Iraqi Army Facilities Diyanah and Debecha, Iraq

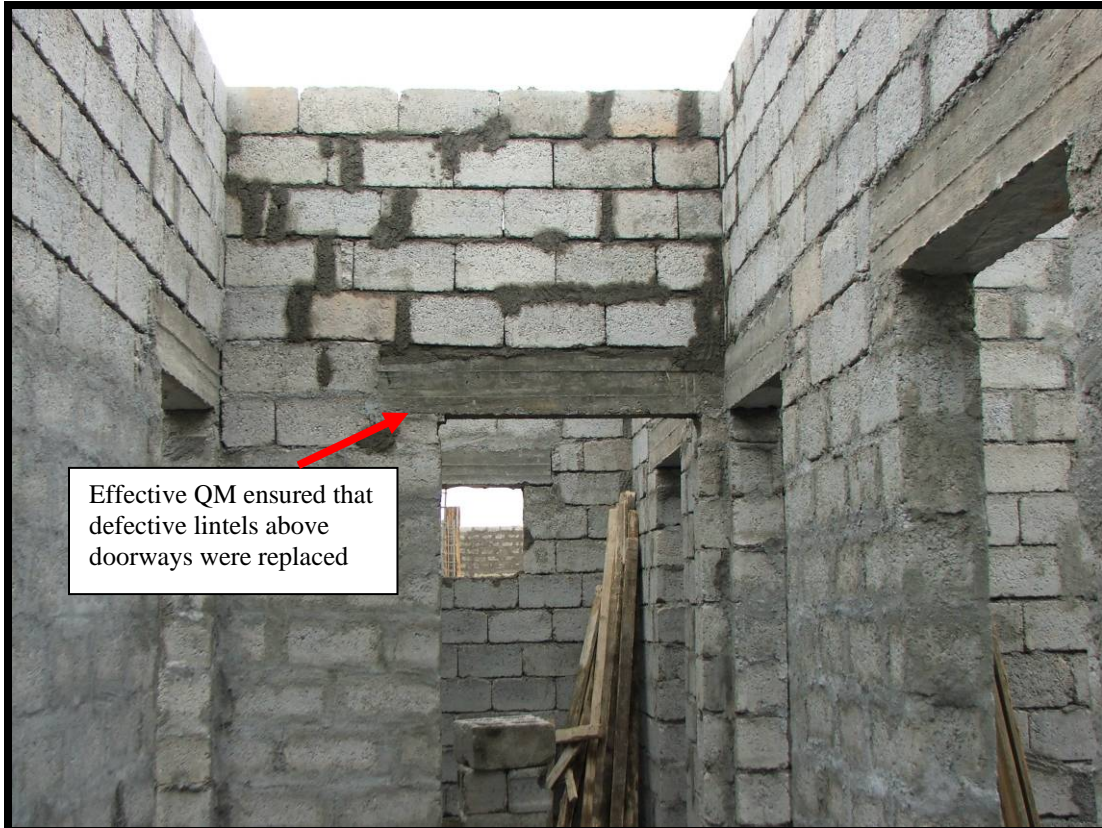
Both QA and QC reporting at Debecha were adequate and effective. For example, the Title II Daily Quality Report dated 21 November 2007 documented that two substantive deficiencies should be addressed. The report cited that lintel beams were not properly placed above openings in block walls (doors and windows) and that backfill and compaction processes were not in accordance with the SORS. The QC and QA personnel have worked together to resolve both issues.

Site Photo 1 shows one of numerous lintel beams throughout the project that was reworked and cast-in-place to comply with specifications. Site Photo 2 shows where backfill and compaction process have been modified to comply with specifications². Subsequent compaction tests verified by an independent laboratory confirmed that soil compaction requirements were met.

Site Photo 1. Subcontractor reworked lintels.

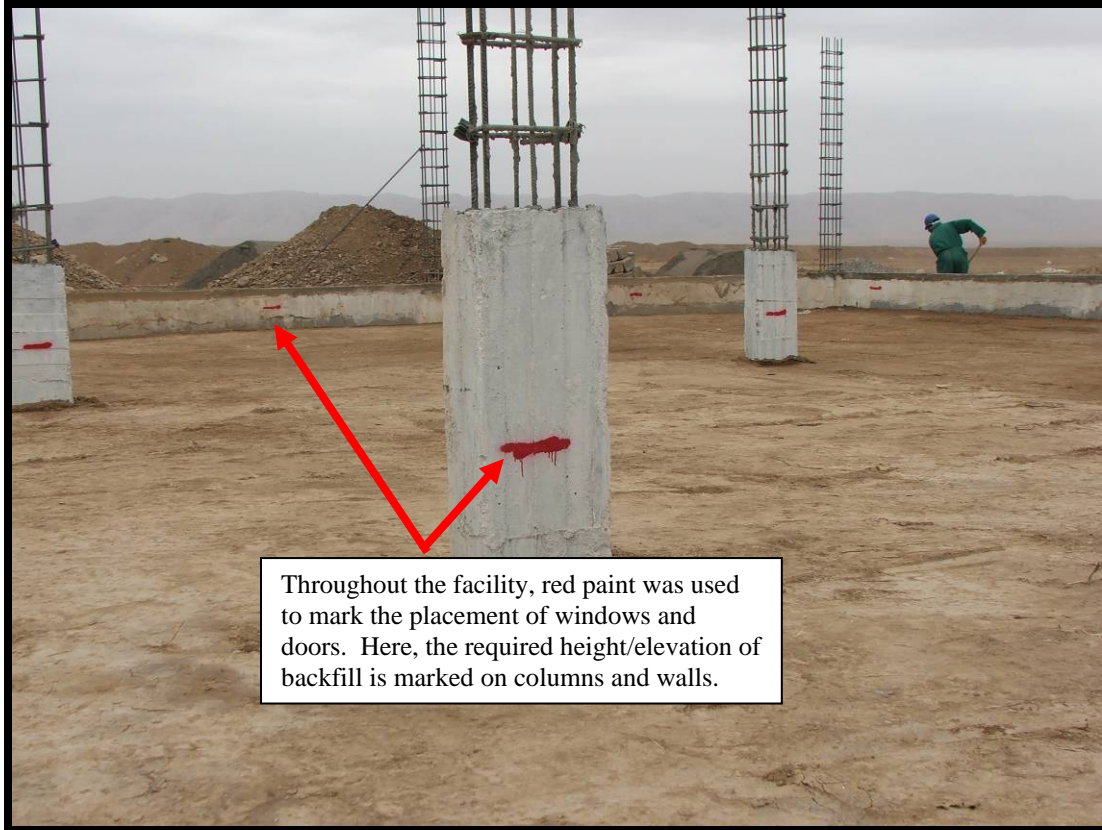
² Specifications required that backfilled layers of soil should be compacted every 20 centimeter (7.8"). However, the Title II representative cited that some layers were as thick as 35 centimeter (13.8"). Accordingly, initial laboratory test results confirmed that some backfill soil was not sufficiently compacted.

Site Photo 2. Backfill requirement marked.

To improve processes to backfill and compact soil, the contractor purchased field soil testing equipment (Kessler Dynamic Cone Penetrometer) to estimate the strength characteristics of fine and granulated soils³. To date, QM practices have been effective and provide for reasonable assurance that construction quality at Diyanah and Debecha should be acceptable.

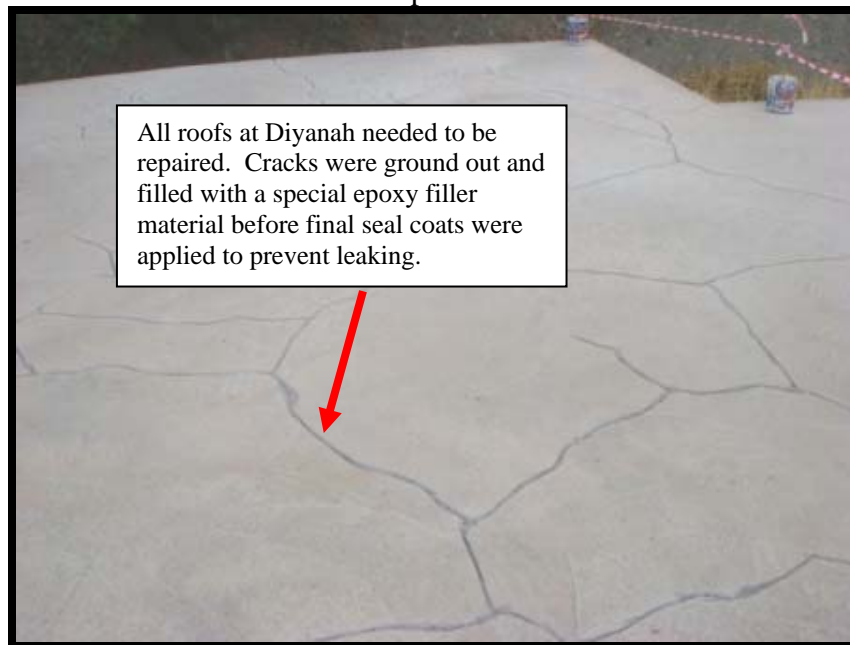
Based on the contractor's technical survey of the Diyanah site, roofs throughout the complex of buildings were in a deteriorated condition prior to renovation. As a result, there was interior water damage to numerous buildings. Site Photo 5 shows an example of existing cracks in roofs most likely caused by shrinkage of the original concrete roof casting. In addition, expansion joints in the original construction were improperly designed and had to be removed, redesigned, and reconstructed. Subsequent repairs and renovation will be addressed later in this report.

**Site Photo 5. Before repair, water leaked through cracks in the original roof.
(Photo courtesy of Toltest)**

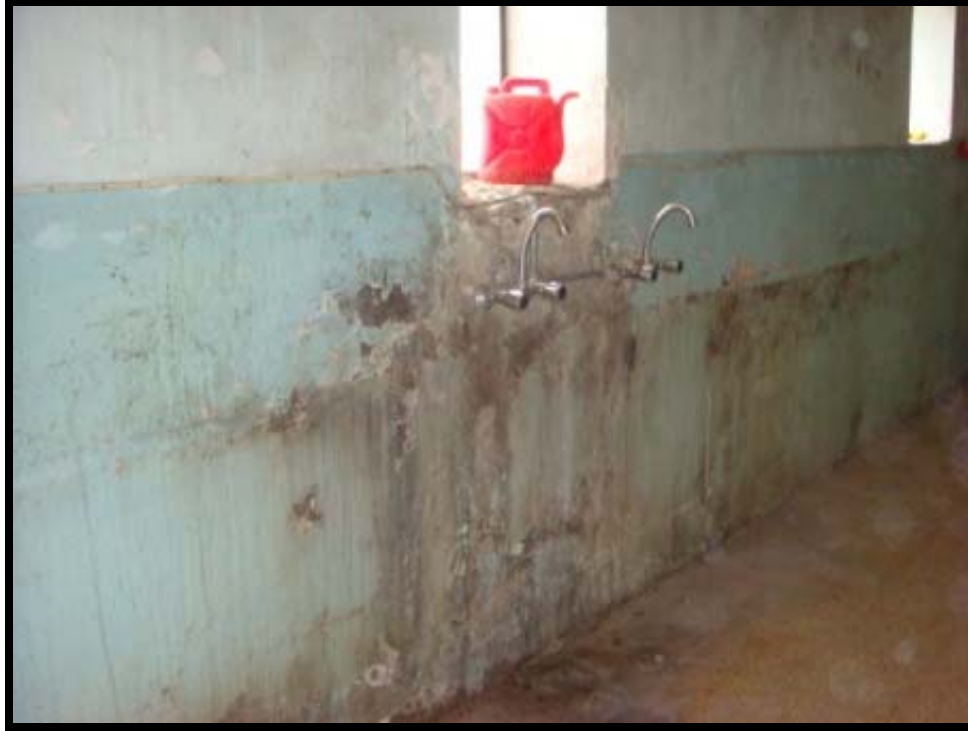
Site Photo 7 shows a food preparation area in a dining facility before the renovation project was started and the absence of a tiled wall surface in the high water use area. The original painted plaster retained moisture and the risk for bacteria growth increased. Subsequent repair and restoration will be discussed later in this report.

**Site Photo 7. Before renovation, food prep areas appeared unsanitary.
(Photo courtesy of Toltest)**

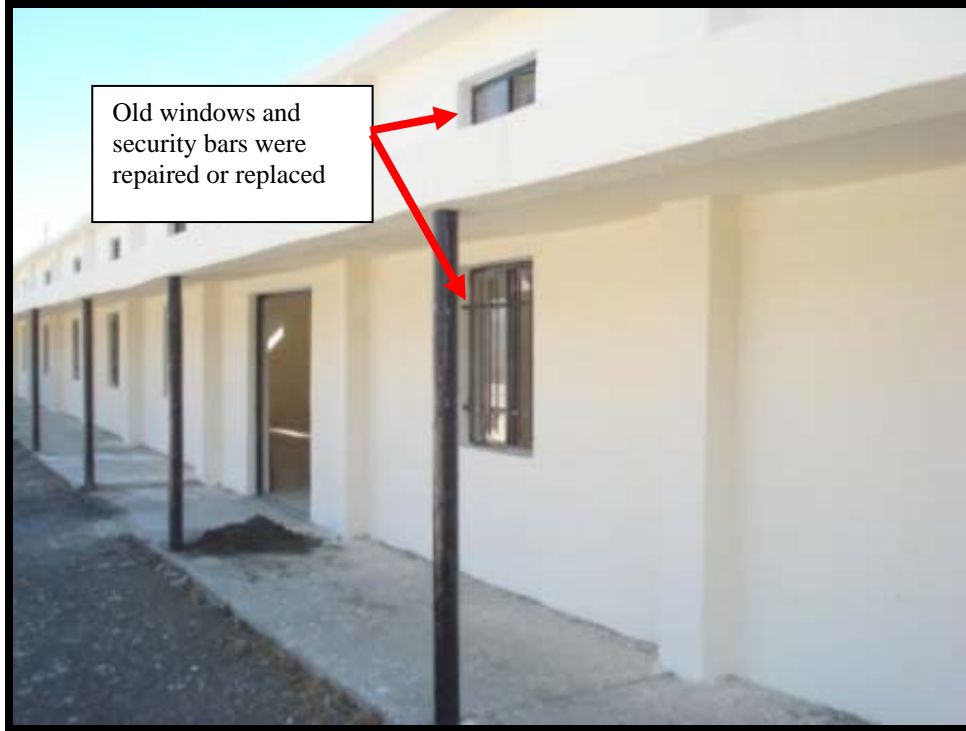
Site Photo 10 is representative of buildings following renovation including exterior painting. Substantial repair work preceded the final exterior painting process. Site Photo 11 shows where workers repaired cracks and removed loose exterior plaster/stucco. Large sections of damaged or loose stucco were replaced with new plaster/stucco in preparation of exterior painting. Patch work over cracks and flat surfaces was covered with wire mesh to ensure bonding between the original wall and the fresh plaster/stucco.

Site Photo 10. Typical building exterior following renovation. (Photo courtesy of Toltest)

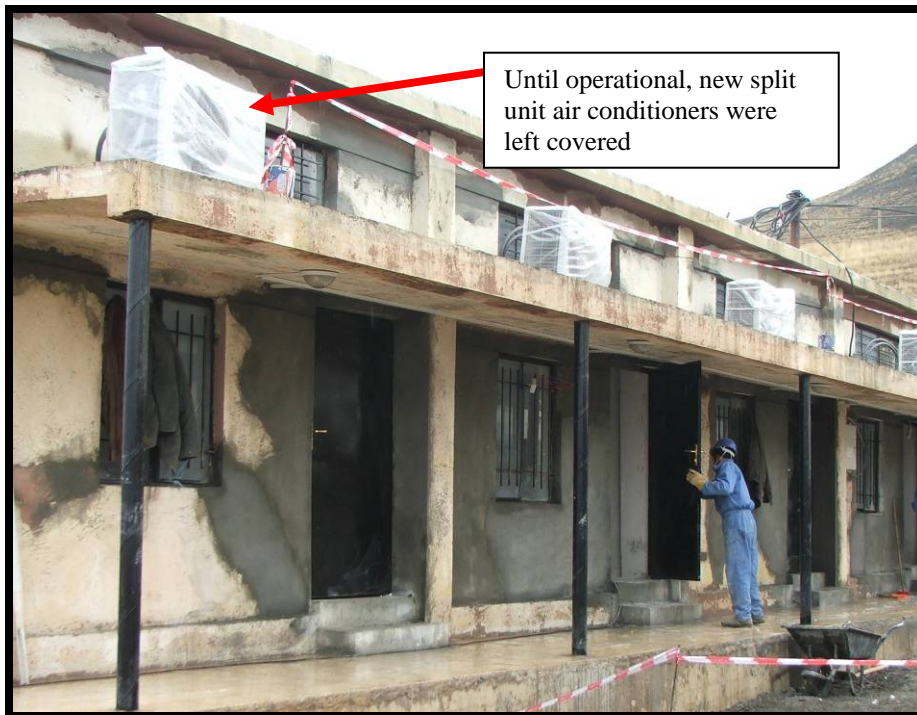
Site Photo 11. Exterior renovation work in progress.

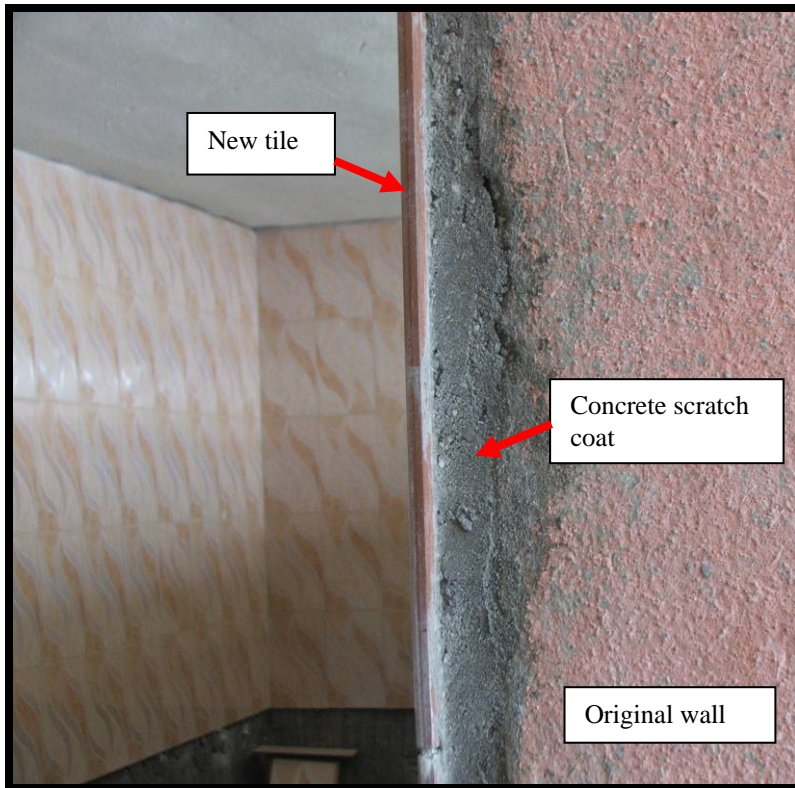
In accordance with contract requirements, tile was used to cover the walls in high water use areas. Site Photo 12 was taken in the food preparation area of one of the two dining facilities at Diyanah. The photo shows that loose material was removed from the original wall. Then a scratch coat of concrete was applied to form a uniform surface for subsequent tile installation. All tile work observed was satisfactory. All tile joints were

exactly horizontal or vertical and evenly spaced the entire length of the tile because plastic spacers manufactured to uniform dimensions were used. The plastic spacers were placed in the corner of each tile ensuring alignment with the three other adjacent tiles. In addition, the walls were flat.

Site Photo 12. Wall tile work was high quality throughout facility.

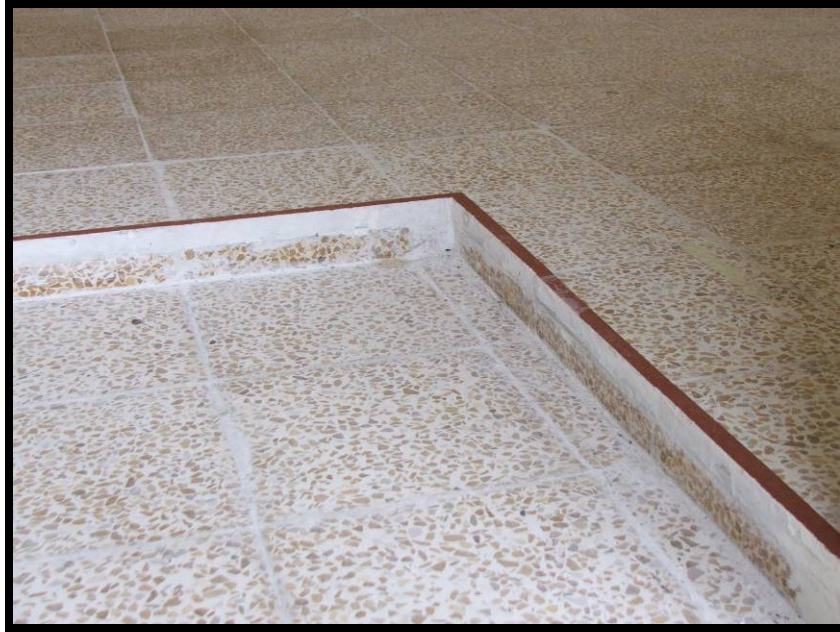
While not all tile floors were yet installed in those areas that required Terrazzo tile, SIGIR observed that work completed to date was satisfactory. Individual Terrazzo tiles were reasonably level and joints were evenly spaced and parallel between adjoining rows of tile. Site Photo 13 shows an example of a Terrazzo tile floor following initial installation.

Site Photo 13. New Terrazzo floor included lowered entry area.

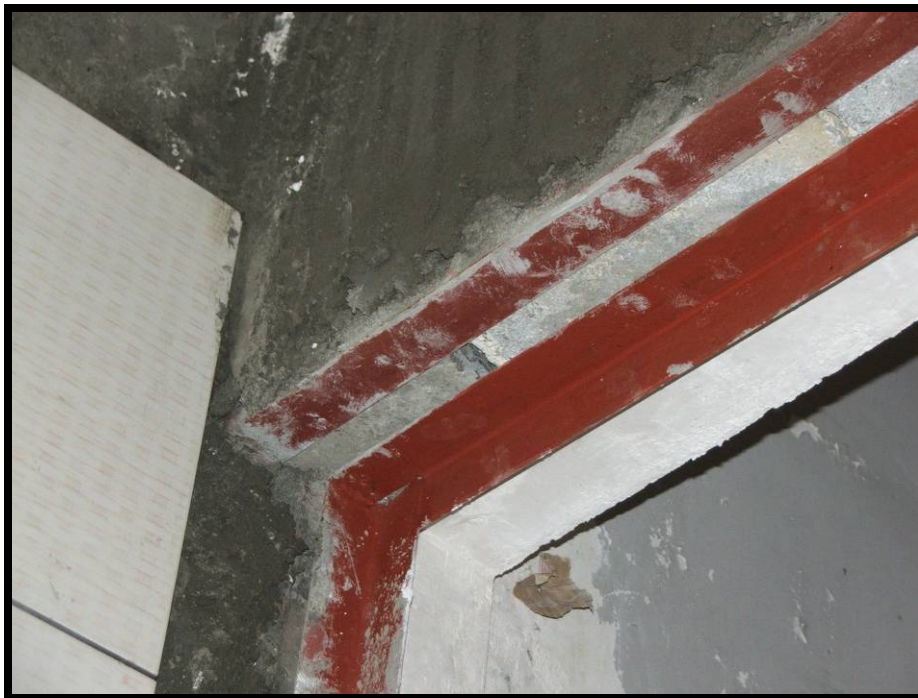
Window frames were renovated and steel door frames were installed. Site Photo 14 shows a steel door frame installed in a food handling area. All door frames appeared to be properly installed. Specifically, the frames were tight, square, and grouted flush with the wall. Therefore, once the doors are installed they should swing level. In addition, SIGIR observed a number of exterior doors with new latch hardware that was compliant with SORS requirements. The hardware was cast of a heavy and hard metal alloy. In addition, the lock assembly was a keyed dead bolt independent of the latch mechanism. Such a design offers durability not generally found in locksets where the latch assembly also functions as the lock.

Site Photo 14. Typical steel door frame installation.

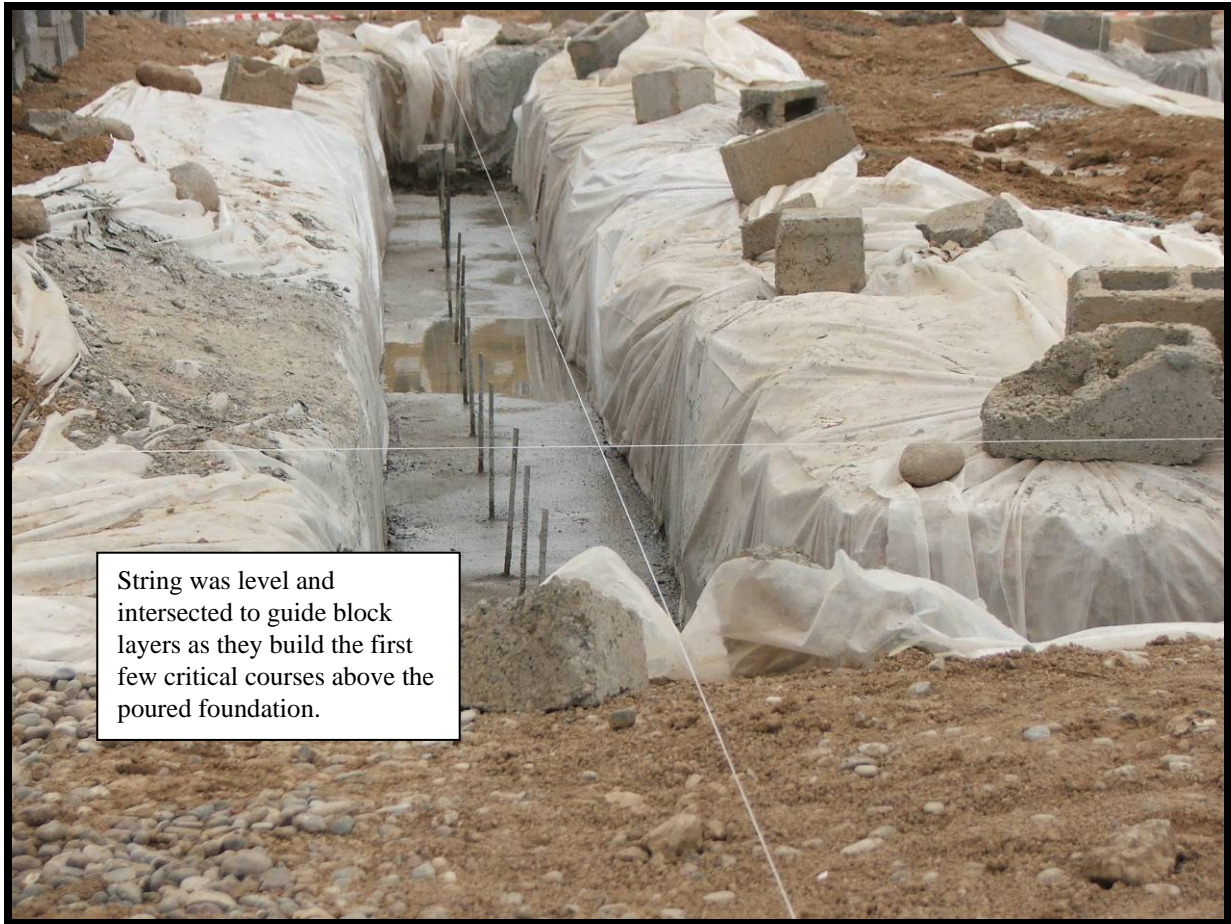
At the Debecha site, the subcontractor laid the first course of concrete blocks to ensure a square cornered building with level blocks placed at correct elevations. Specifically, string was used to show the line that block layers will use to guide the placement of concrete blocks. Using the string as a guide ensures corners are square, blocks are placed level and at the correct elevation (height), and blocks are placed in a straight line. Site Photo 15 shows the layout and string for the hand washing area outside the dining facility while Site Photo 16 shows a transit used to ensure correct elevations.

Site Photo 15. String at proper height with square corners will guide block layers.

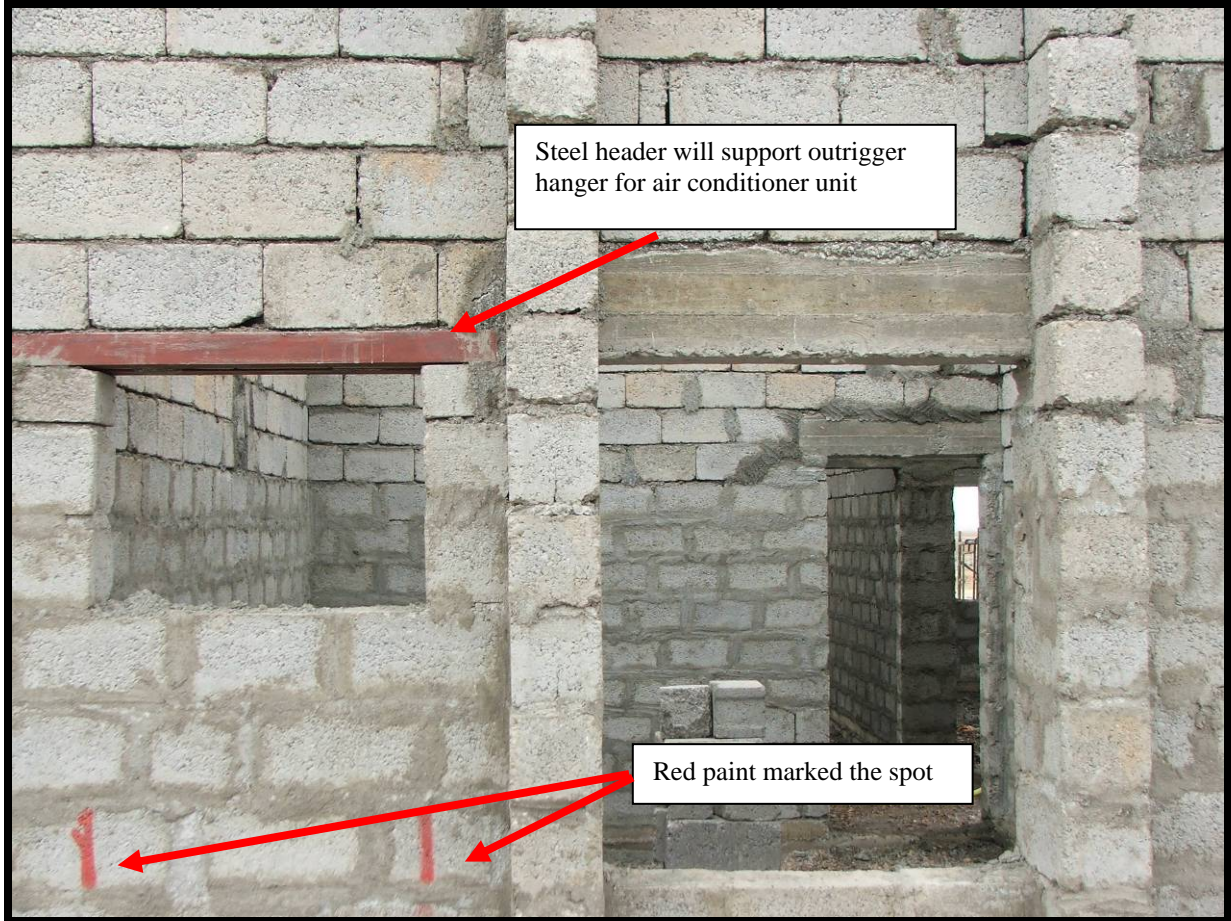
Red paint was used to mark specific measurements necessary for correct placement of window openings, air conditioning units, and elevations. For example, Site Photo 2 included earlier in this report shows that red paint was used to mark the final compacted grade or elevation height of the compacted backfill in the new dining facility. Similarly, Site Photo 17 shows that red marks were used to correctly place the opening for an air conditioning unit. This technique is a practical and effective way for the contractor's managers to observe completed work while lessening the likelihood of future mistakes.

Site Photo 17. Air conditioner location was marked by a supervisor.

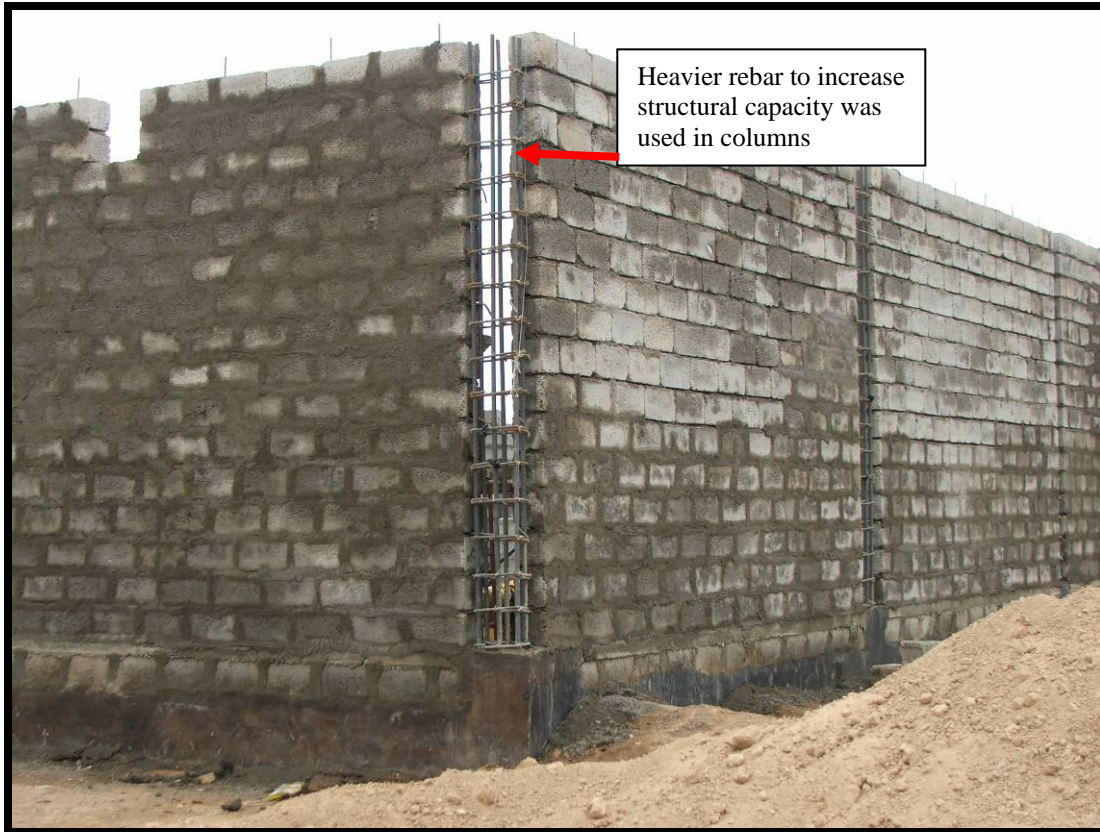
During the site visit to Debecha, SIGIR observed that several buildings were nearing the stage of construction where corner and wall columns would be cast following form work. Site Photo 18 shows the heavier reinforcement bars used in columns. After the columns are cast and sufficiently cured, workers will construct form work, install reinforcement bars and cast each building's roof flatwork and horizontal beams to complete the structural aspects of the roof system.

Site Photo 18. Typical wall construction before forming and casting columns.

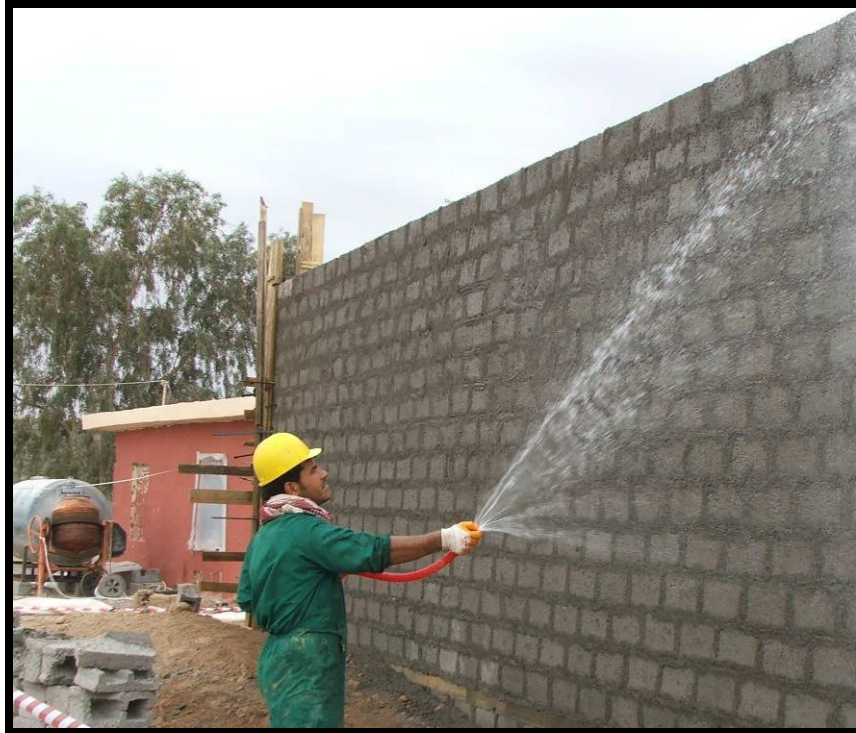
In Site Photo 19, a worker sprays water on the surface of a block wall to ensure that mortar used to fill cracks and spaces between blocks does not dry too fast and shrink. As a result, the walls will be a good surface upon which to apply finish exterior plaster/stucco.

SIGIR Photo 19. Walls were sprayed to prevent excessive shrink in joint mortar.

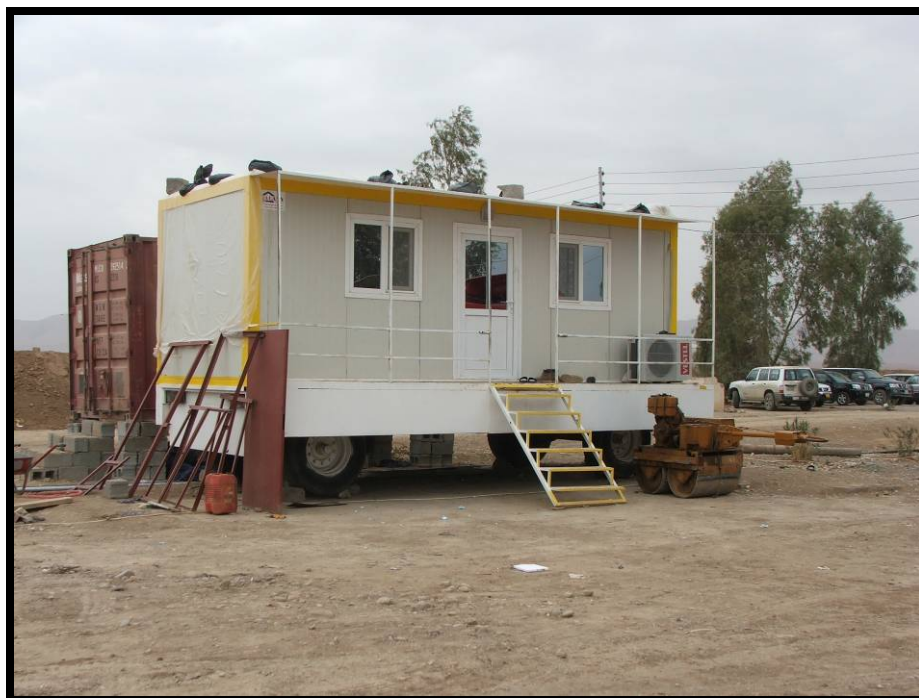
Site Photo 20 shows the construction office placed on site by the subcontractor for engineers and project supervisors. This will help the subcontractor fulfill its administrative and supervisory responsibilities.

Site Photo 20. Subcontractor construction office.
