**REPAIR OF THE AL GHAZALIYAH
G-7 SEWAGE LIFT STATION**

UNDER THE COMMANDER'S EMERGENCY RESPONSE PROGRAM

BAGHDAD, IRAQ

**SIGIR PA-07-118
JANUARY 25, 2008**

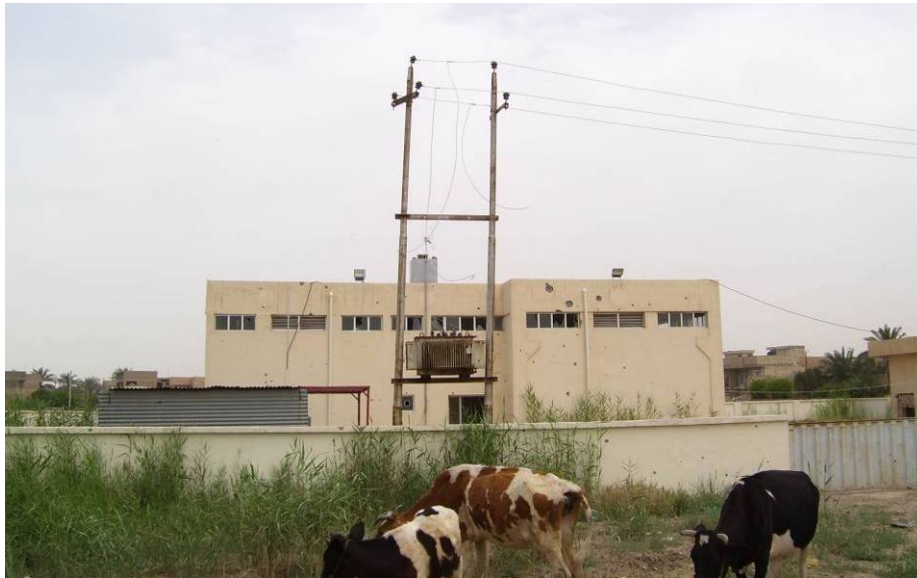
Site Photo 1. Exterior view of the Al Ghazaliyah G-7 Sewage Lift Station

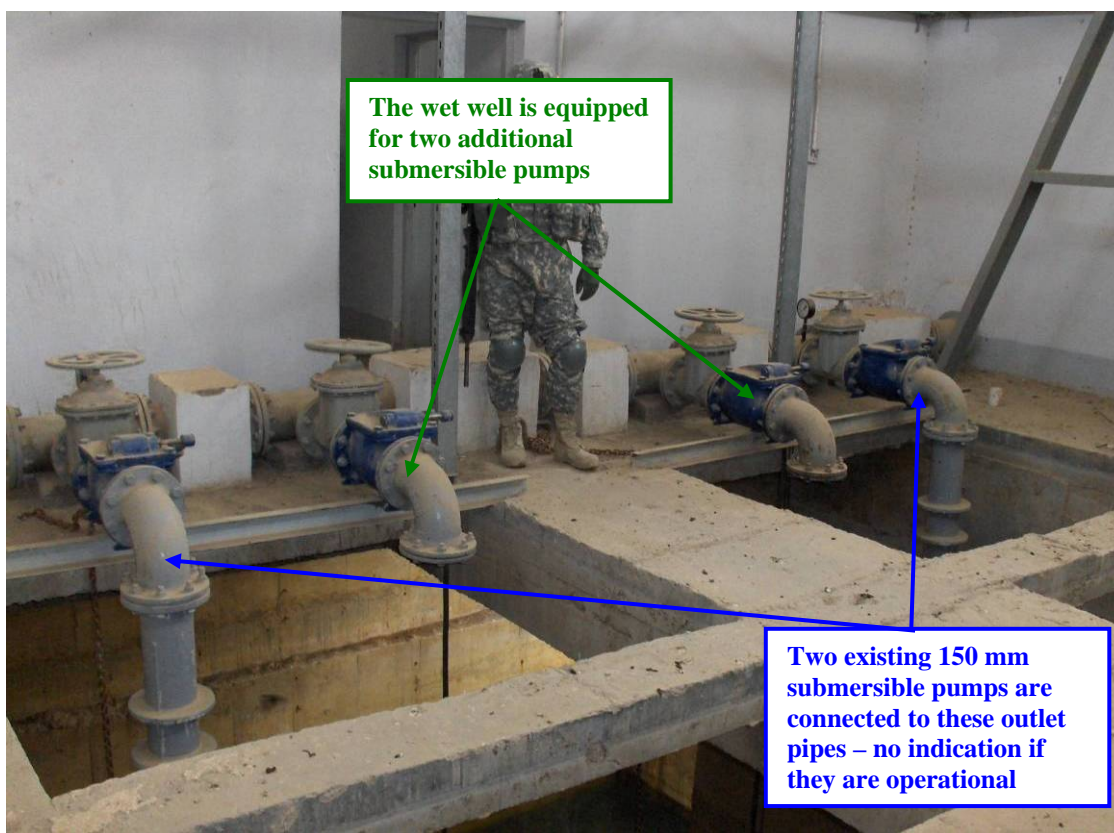
Site Photo 2. Interior view of Al Ghazaliyah G-7 Sewage Lift Station building

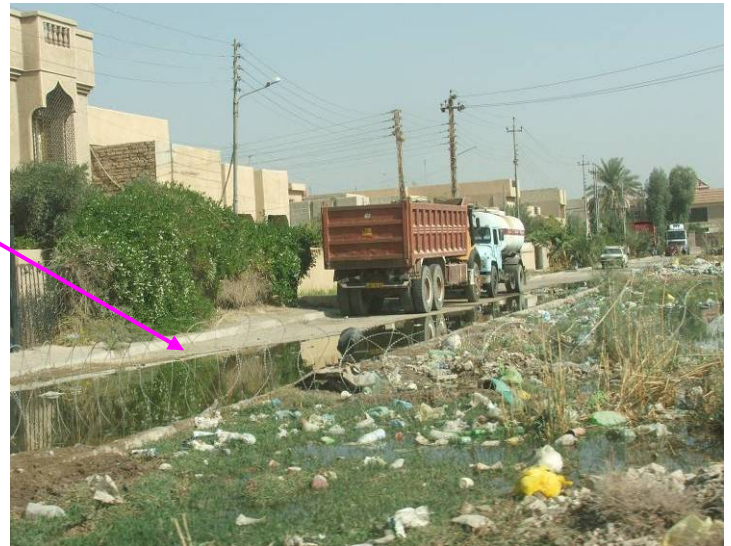
Site Photo 3. Backed-up sewer water

The degree of the streets' backed-up sewer water varied from several inches deep near the gutters to the entire width of the street.

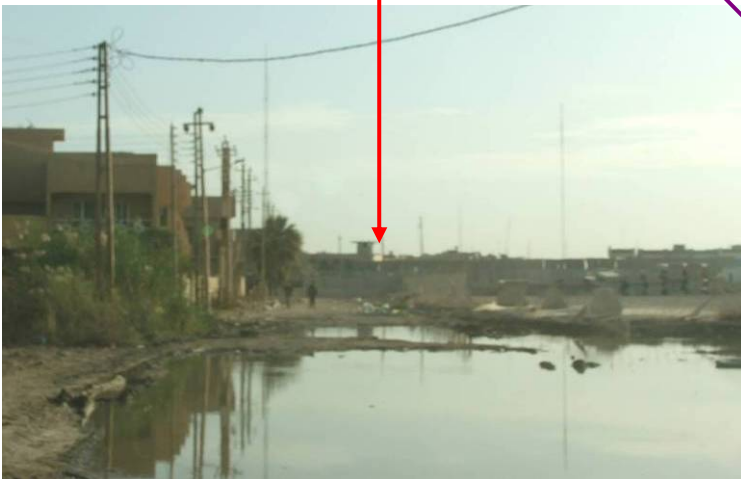
Site Photos 4 and 5. Backed-up sewer water in the Al Ghazaliyah area of Baghdad

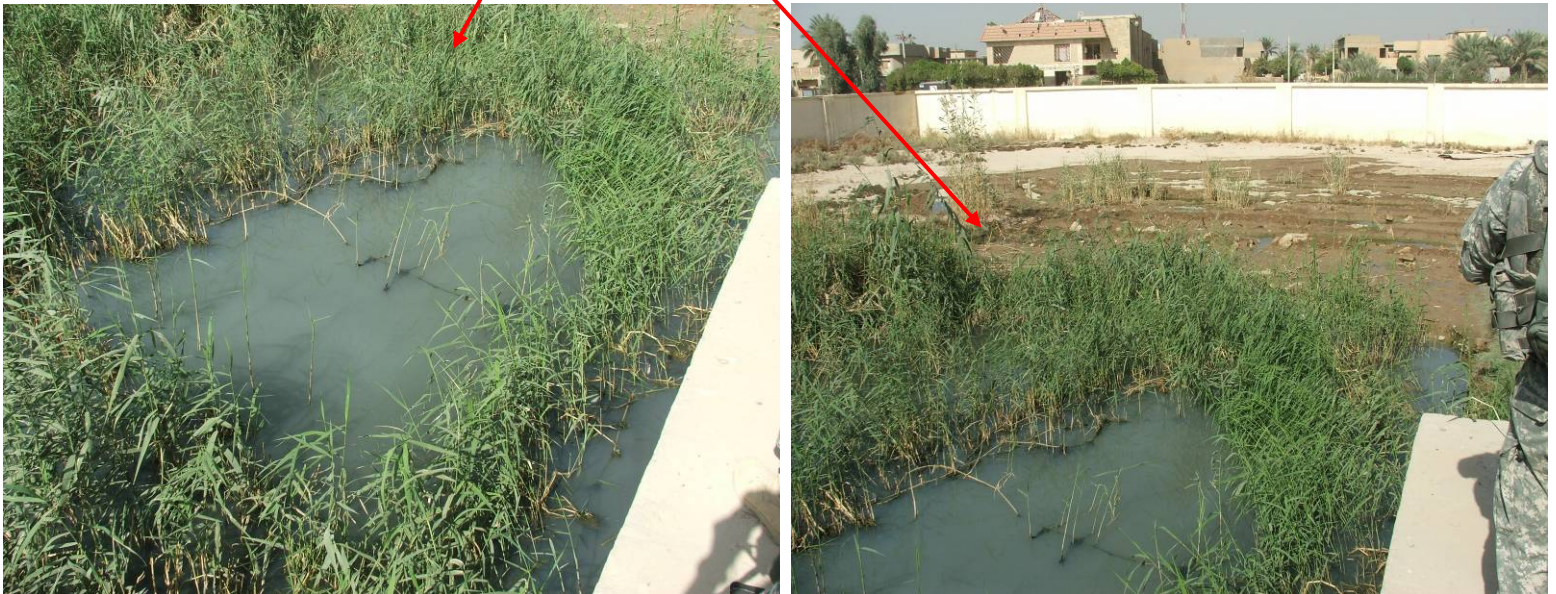
Inspectors also viewed a large pool of collected sewer water outside the sewage lift station building (Aerial Image 4 and Site Photos 6 and 7). During our site visit, maneuver unit personnel stated that the sewer pipes leading into the facility were old and broken. Considering the depth of the sewer water pool and the growth of weeds around it, the sewer line was broken for an extended period. However, the SOW did not address the problems with the broken sewer pipes. Without addressing this problem, the completion of this project will not lead to a "complete and useable facility" because the sewer water will not enter the lift station's wet well (to be pumped out to the next manhole).

Site Photos 6 and 7. View of pool of accumulated sewage water outside the G-7 lift station

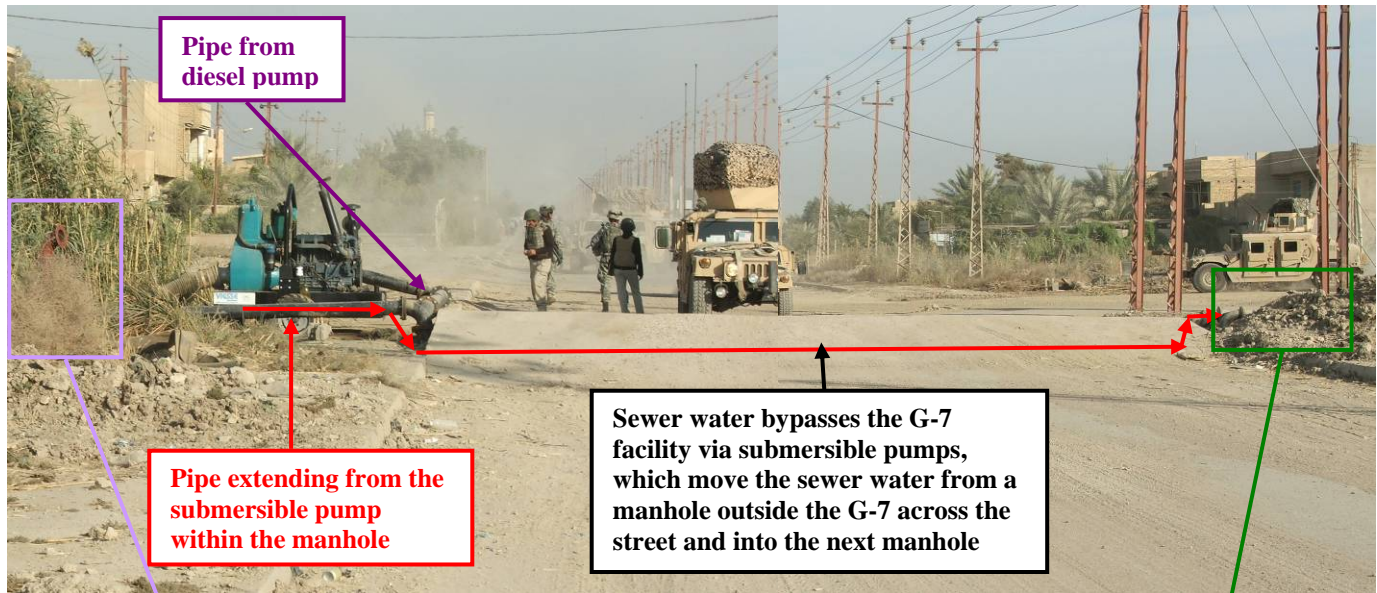
During our site visit, inspectors noticed two pipes exiting a manhole outside the lift station (Site Photo 8). One pipe was attached to an above ground diesel pump; while the other pipe was attached to a submersible pump. The two out-flow pipes rose out of an existing manhole and passed under a concrete hump to cross the street in order to use a higher elevation manhole as an outlet point (Site Photos 9 and 10).

Site Photo 8. View of bypass system employed to allow sewer water to flow to the next available manhole

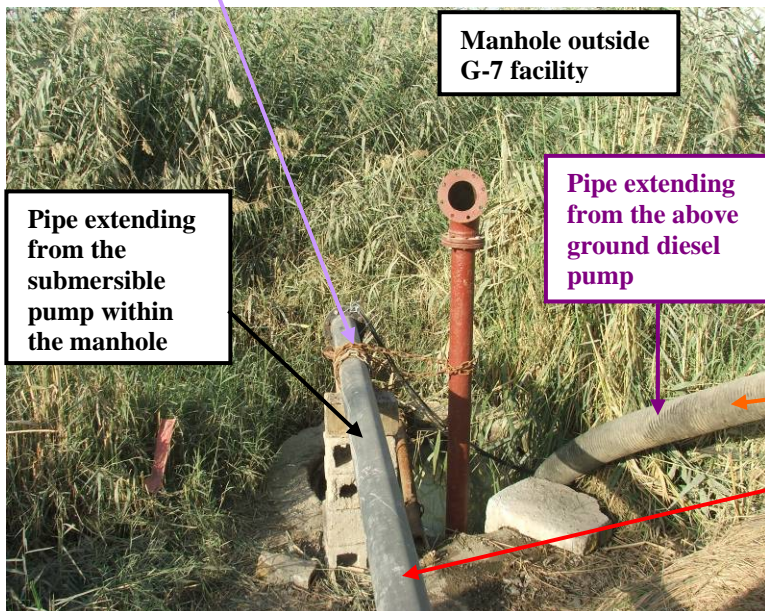
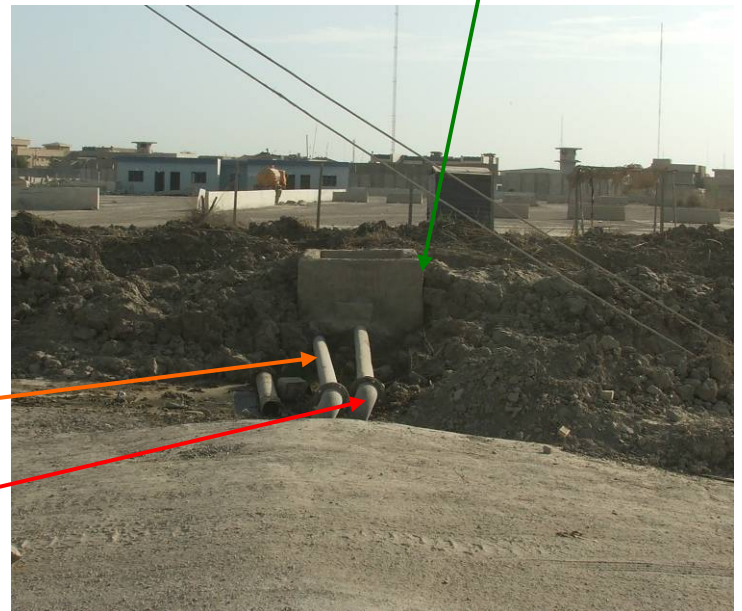
Site Photos 9 and 10. Enlarged views of Site Photo 8.

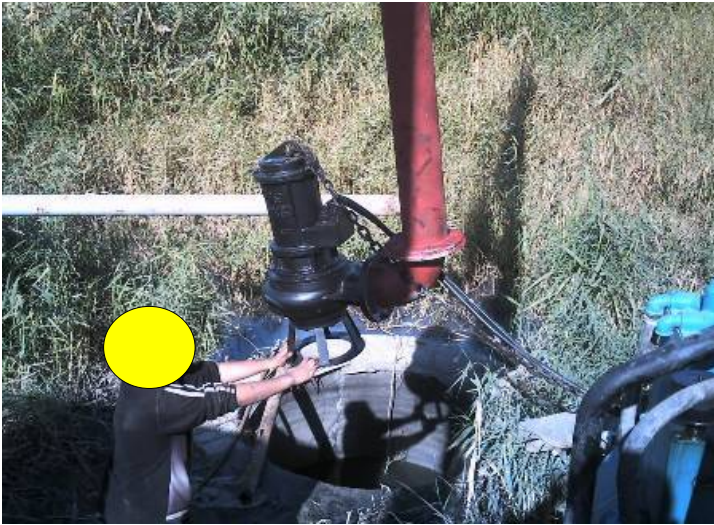
On 4 December 2006, the daily contractor's quality control (QC) report documented the delivery and installation of the single 150 mm submersible pump (Site Photo 11); while

Site Photo 11. Installation of 150 mm submersible pump into manhole outside G-7 lift station (Photo courtesy of USACE)

The contract file lacked documentation to explain the need for the submersible pump outside the lift station facility. As previously mentioned in the Project Design and Specifications section, the contractor did not provide design drawings to identify the use of the equipment required by the SOW. However, it appeared the original intent was to use the two submersible pumps either to replace or compliment the two existing submersible pumps inside the facility.

The use of the submersible pump inside the manhole appears to be a short term solution to deal with the large pool of sewer water outside the lift station building. Since the broken sewer pipe does not allow sewer water into the facility, the accumulation of sewer water grew each day. Installing the submersible pump into the wet well of the lift station would not help to alleviate the growing pool of sewer water outside.

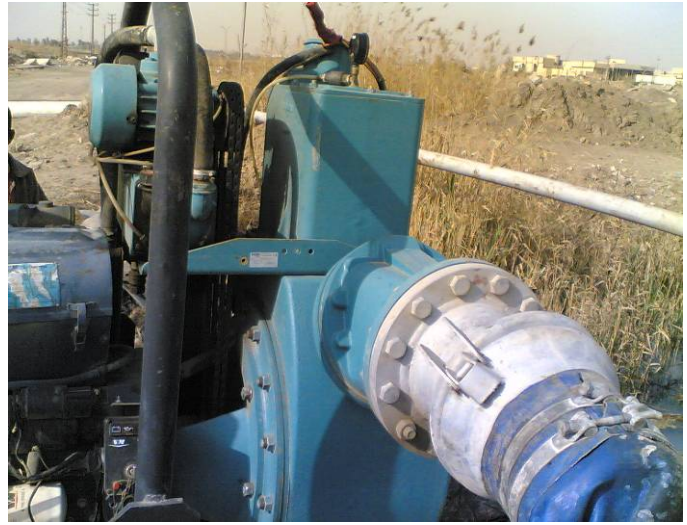
the 5 February 2007 daily government quality assurance (QA) report documented the arrival of the diesel pump at the facility (Site Photo 12).

Site Photo 12. Diesel pump used at the manhole outside the G-7 lift station (Photo courtesy of USACE)

Inspectors could not evaluate the installation of the submersible pump because, at the time of our site visit, neither the submersible pump nor the diesel pump was operational.

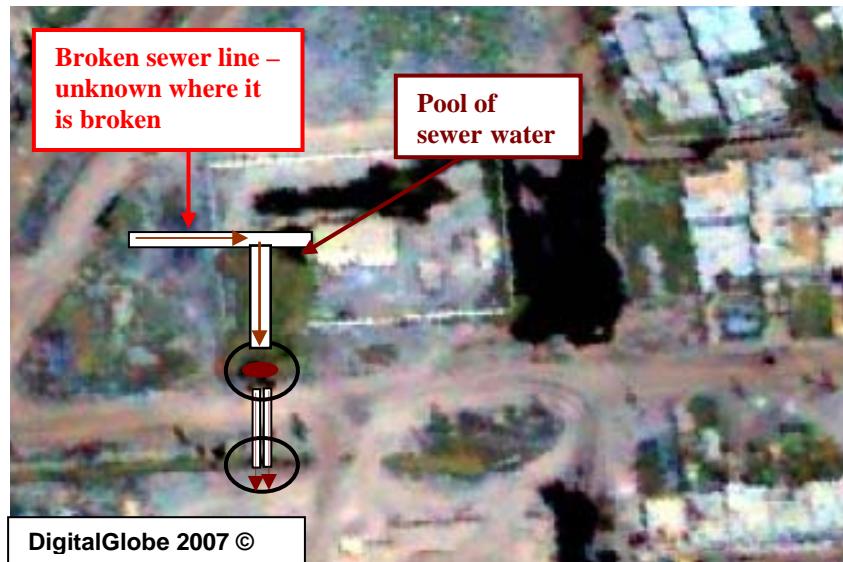
It is not clear if the submersible pump will remain in the manhole or whether it will eventually be moved into the lift station facility. The use of the submersible pump and the diesel pump to alleviate the sewer water pool has had little effect because inspectors noticed a significant accumulation near the side of the lift station facility.

Aerial Image 5. Aerial view of the flow of sewer water from the manhole outside the G-7 lift station to the next available manhole across the street

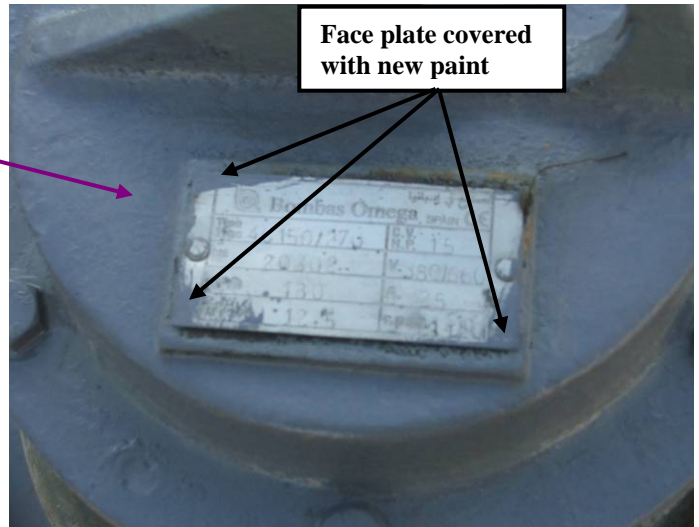
Site Photo 14. Close up view of a submersible pump (appears old pumps were just painted)

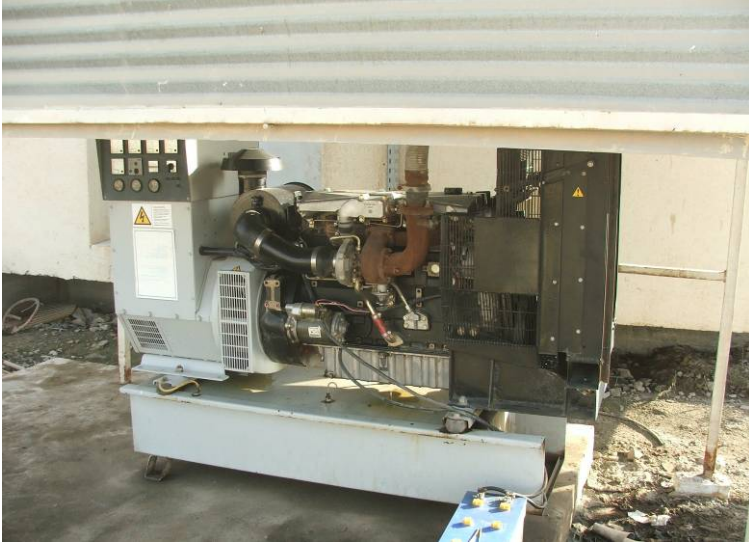
During our site visits, SIGIR identified two generators at the lift station site – one in front of the lift station and one in the rear. According to GRC documentation, the contractor supplied the generator in the rear of the facility (Site Photo 15). GRC personnel verified the contractor provided the contract required size generator (Site Photo 16). The generator was installed on a reinforced concrete pad, as required by the SOW.

Site Photo 15. Contractor provided 100 kVA generator

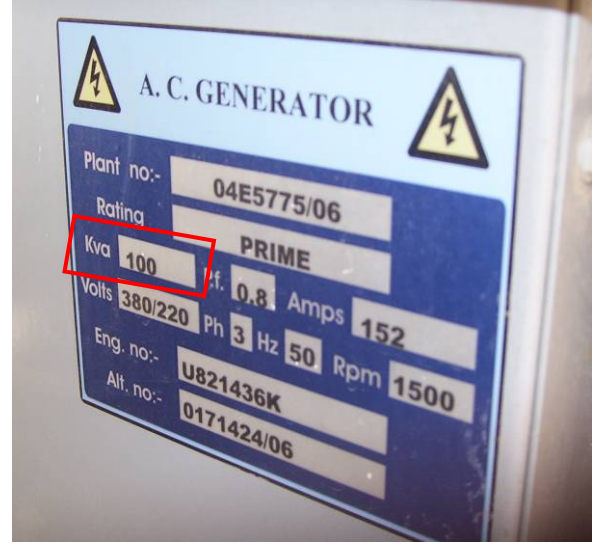
Site Photo 16. 100 kVA generator face plate

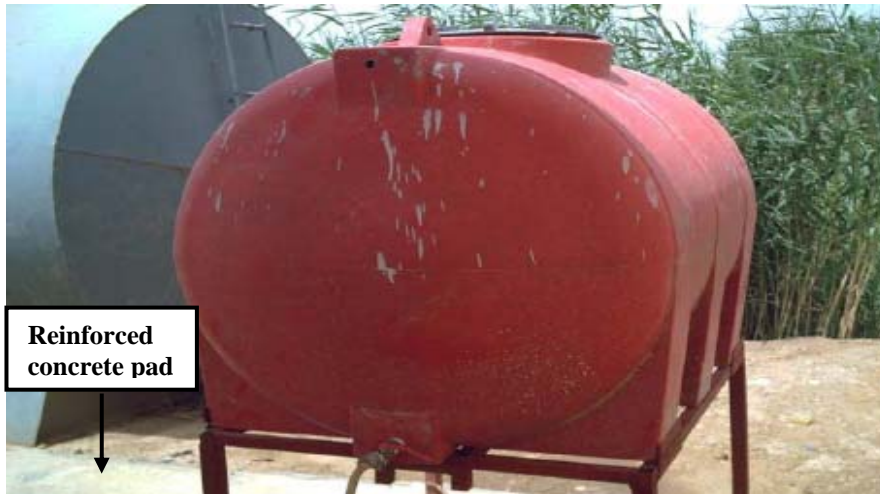
SIGIR identified two fuel tanks at the lift station. According to the daily QC reports, the smaller tank was the SOW required 1,000 liter fuel tank. The contract file lacked documentation to confirm this fuel tank is the required size. The fuel tank was installed on a reinforced concrete pad, as required by the SOW (Site Photo 17).

Site Photo 17. 1,000 liter generator fuel tank

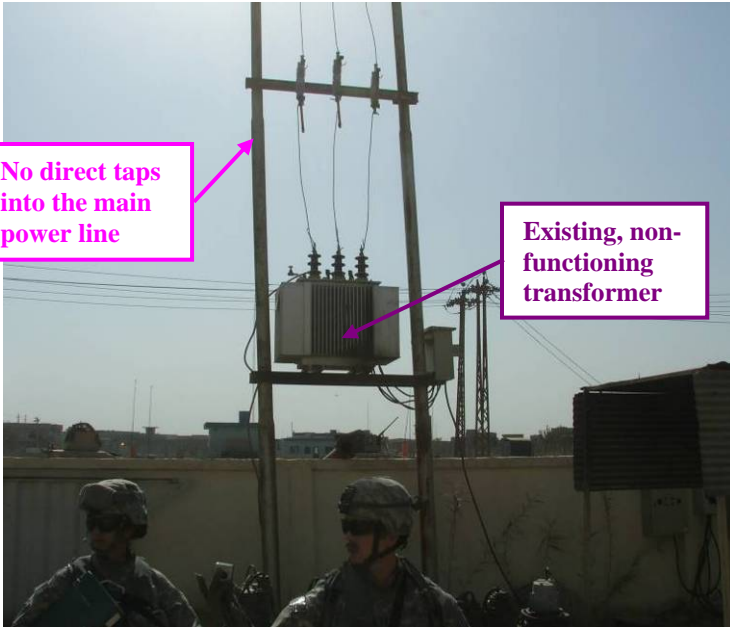
During our first site visit, SIGIR identified the old, non-operational transformer (Site Photo 18). The transformer was subsequently removed and the facility was directly tapped into the main power line by jury-rigging the electrical wires (Site Photo 19). This is an extremely dangerous practice and likely will damage and/or destroy the facility's electrical equipment and controls as well as endanger the safety of the operator. Iraqi main power lines normally carry 400 volts. Without a step-down transformer, turning on the control panel could potentially short circuit the equipment and potentially electrocute

Site Photo 18. Existing transformer

The lift station requires a new transformer to take advantage of the electrical grid and also the two on site generators.

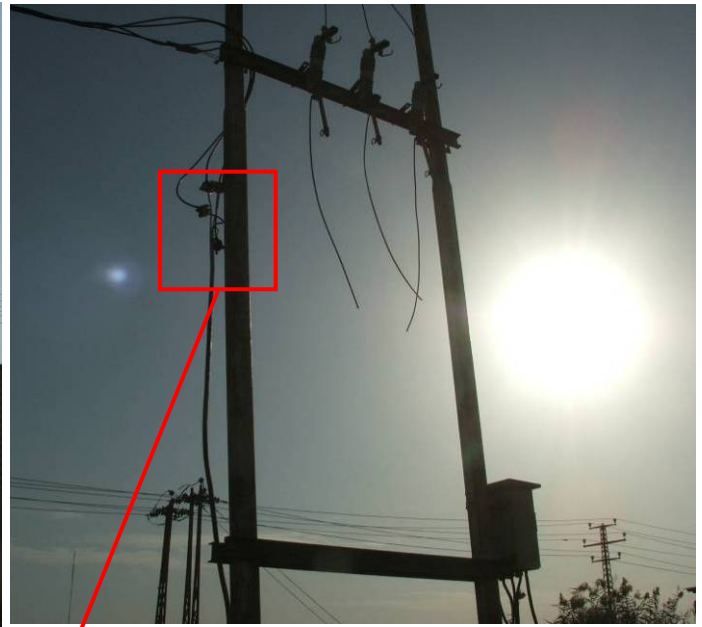
Site Photo 19. Missing transformer and direct tapping into the main power line

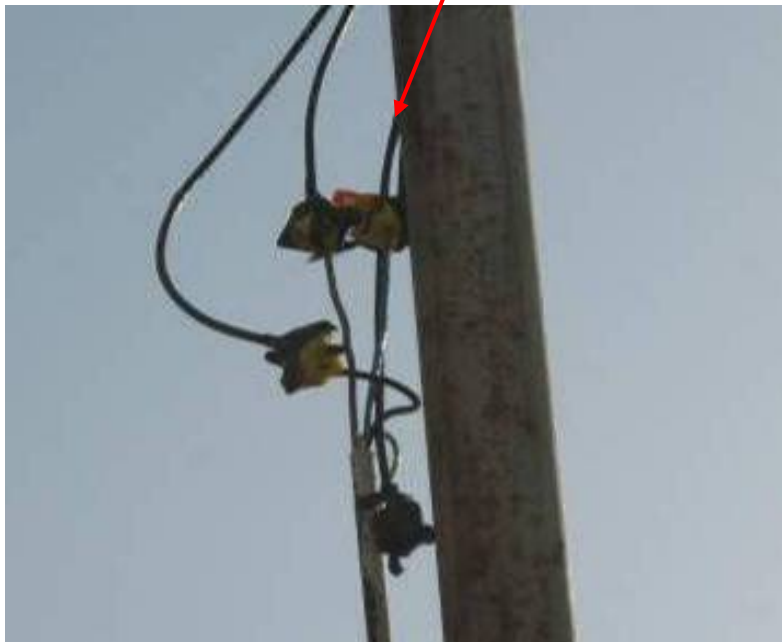
the operator. It is extremely unsafe to have unregulated splices in power cables carrying relatively high voltage since the splices are unsupported and unprotected (Site Photo 20). As a result, it is possible that a loose wire could come free and potentially electrocute someone in the vicinity of the lift station.

Site Photo 20. Unsafe splices directly into the main power line

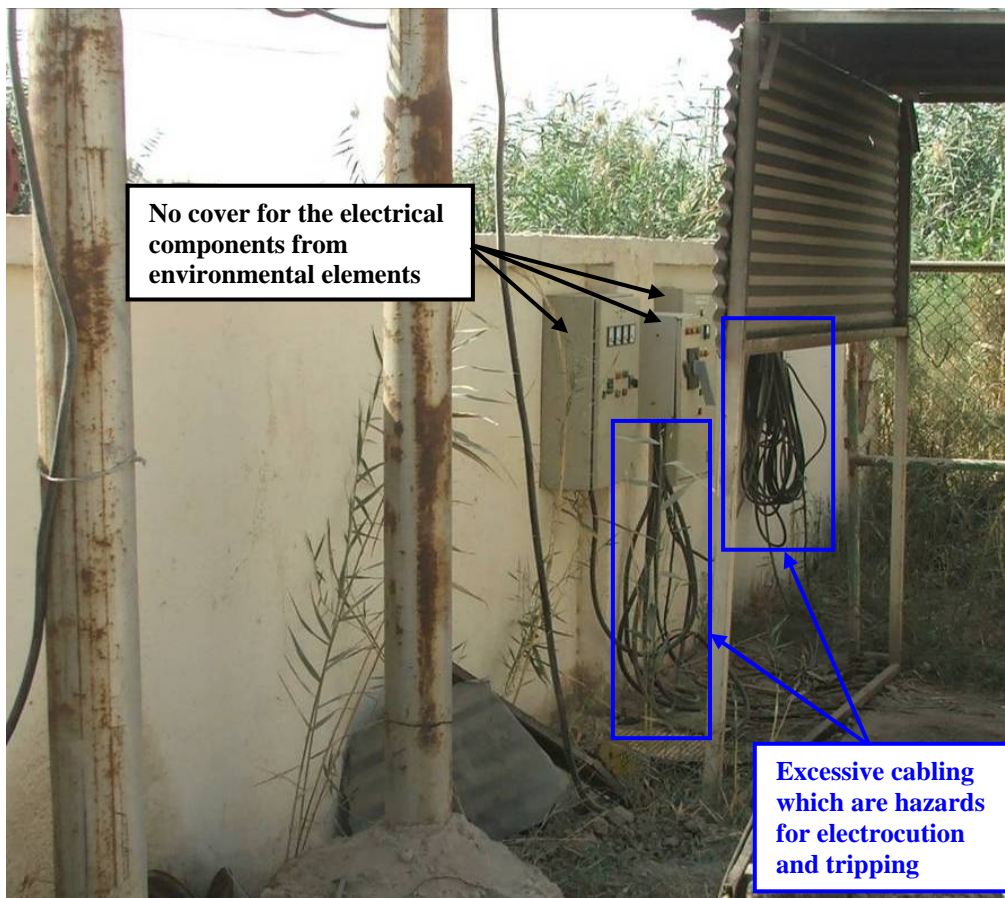
SIGIR identified the Main Distribution Panel and the cabling supplied and installed by the contractor to connect the facility to the main distribution grid (Site Photo 21). The installation technique used by the contractor was not adequate. For example, the contractor situated the control panel outside the facility without any method to protect the electrical components from the environmental elements, such as rain, excessive heat, sand, and dirt, which over time, will reduce the lifespan and usefulness of the control panel. In addition, an excessive amount of cabling was used, which resulted in electrical cable dangling down on the ground. The dangling cabling poses not only a tripping hazard, but could become damaged and also lead to electrocution.

In view of the previously noted fact that the electrical control panels were improperly directly tapped from the main distribution grid and without use of a step-down transformer, inspectors did not feel it was safe to touch the electrical control panels. As a result, we could not assess the quality of the contractor's performance.

Site Photo 21. Main Distribution Panel for the G-7 lift station
