SARWARAN PRIMARY SCHOOL
UNDER THE COMMANDER'S EMERGENCY RESPONSE PROGRAM
ERBIL, IRAQ

SIGIR PA-08-120
APRIL 21, 2008

SUBJECT: Report on Project Assessment of the Sarwaran Primary School, Erbil, Iraq (Report Number SIGIR PA-08-120)

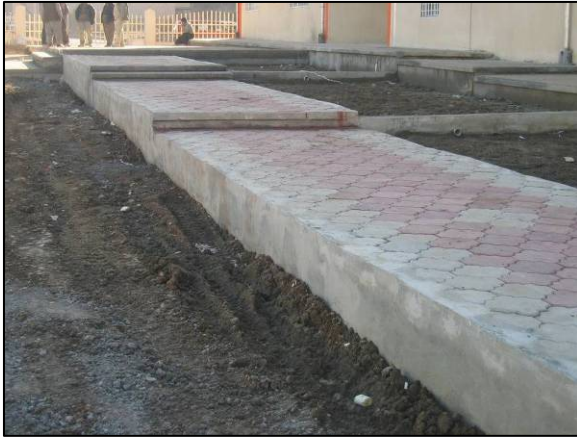
Although the contractor indicated that the current grading was complete, SIGIR recommended that it be expanded to ensure the grounds were sloped so that water would drain away from the buildings. SIGIR also recommended that the grading be made level with the walkways. The grading at the time of the site visit posed a

safety hazard because it was about one meter lower than the sidewalk. Site Photo 1 shows the drop from the sidewalk to the ground. Site Photo 2 shows the corrective action taken as a result of SIGIR's recommendation.

Site Photo 1. Safety hazard at the time of the site visit presented by grading one meter lower than sidewalk

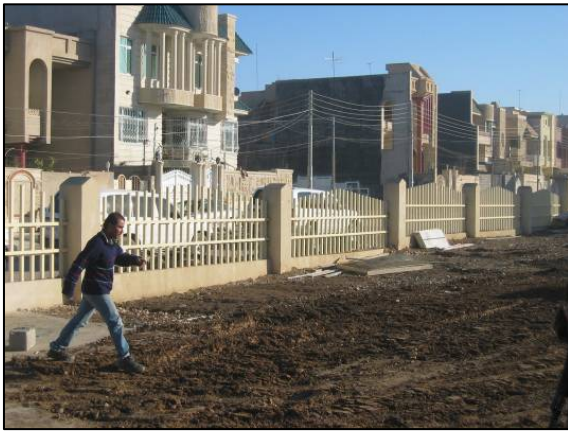
Site Photo 3. Perimeter fence

The perimeter fence is made from a concrete block foundation and has pillars spaced approximately five meters apart and filled with vertical steel pipe fencing. The outside of the two-story building was being finished at the time of the visit. The entrance doors were made of tempered glass and were installed properly. Materials and workmanship for these items were adequate. Site Photos 3 through 5 show the perimeter fence, external finishing, and glass doors.

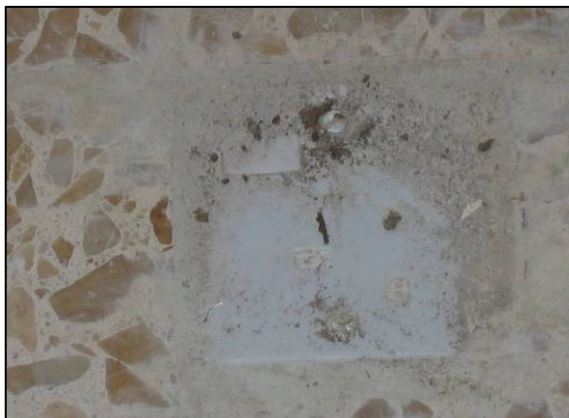
Electrical receptacles installed in the computer room floor were not covered, making them susceptible to being filled with dirt and stepped on. The MND-NE project engineer said that they were contracting for a five centimeter (cm) false floor to cover the receptacles. Site Photo 8 shows an uncovered receptacle at Sarwaran filled with dirt at the time of the site visit.

Site Photo 8. Computer room uncovered receptacle filled with dirt.

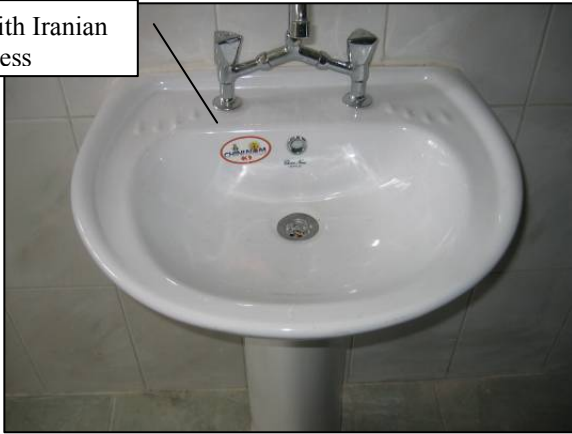
Each of the four bathrooms contained three eastern toilets, one western toilet, and three sinks. The quality and workmanship appeared adequate. The contract required the wash basins and water closet fixtures be Iranian-made products. Although we could not conclusively verify that the products were made in Iran,

we noted that a web site for the sink brand (www.chiniam.ir) was an Iranian site. Site Photos 10 through 13 show the bathroom fixtures and ceiling.

Site Photo 10. Bathroom sink

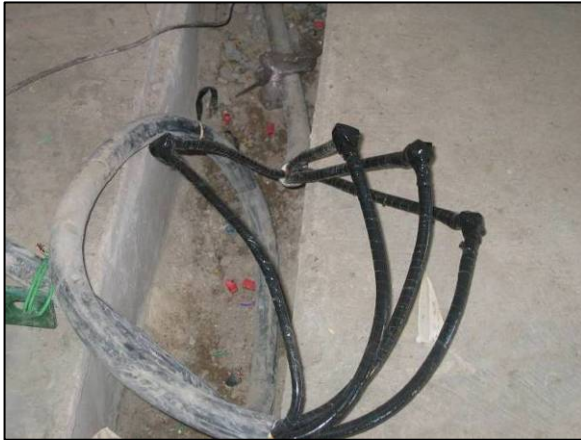
The generator building and fuel tank installations were finished and the workmanship and materials were adequate. The generator was functioning and provided adequate electrical power to the school. The connections to the school's main lines were temporary—connecting the cable terminals through loose wires covered with black tape. SIGIR commented that the connections should be made through an insulated power supply box. SIGIR did not observe an automatic turnover box that would supply continuous power from the generator when the city electrical grid shuts down. Site Photo 15 shows the backup generator connection at the time of the site visit. Site Photo 16 shows the corrective action subsequent to SIGIR's site visit to install the automatic turnover box and properly connect to the school's main lines.

Site Photo 15. Backup generator connection to the school

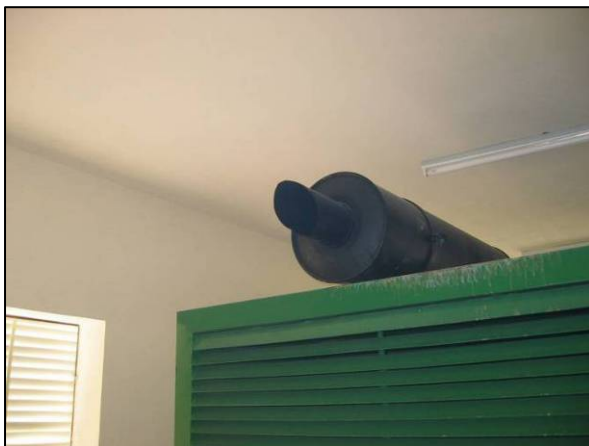
The generator exhaust was not routed outside the generator building and created a significant fire and health hazard to anyone inside while the generator was operating. Site Photo 17 shows the exhaust inside the generator building at the time of the site visit. Site Photo 18 show the corrective action taken subsequent to the site visit to vent the exhaust out of the generator building.

Site Photo 17. Generator exhaust inside the school

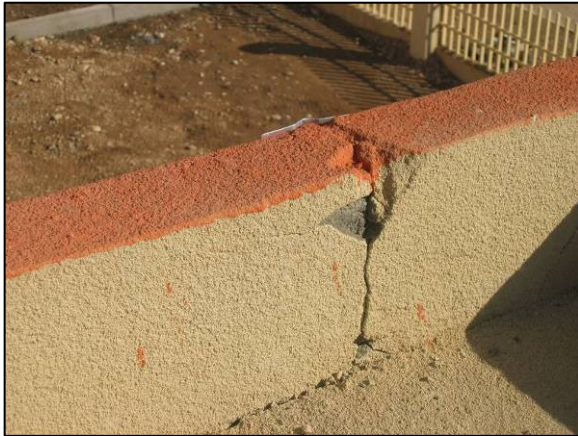
Expansion joints were installed to prevent stress cracks in the structural walls as the concrete expands and contracts during temperature changes. One expansion

joint on the roof was covered with concrete and experienced a stress crack about 8 cm long. SIGIR recommended that the parapet and the expansion joint be reconstructed. Site Photo 19 shows the stress crack along the roof. Site Photo 20 shows the corrective action taken subsequent to the site visit.

Site Photo 19. Stress crack in concrete covering an expansion joint.

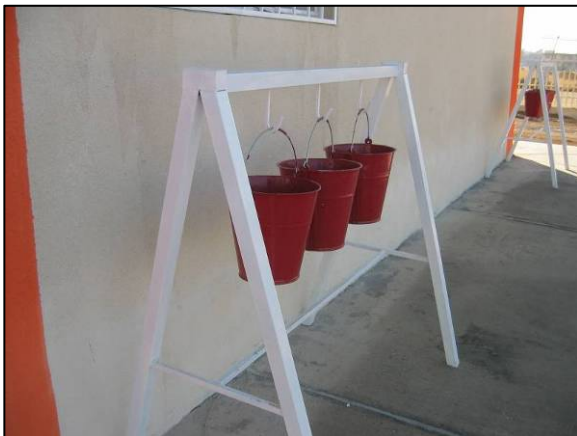
There were no fire sensors, alarms, or extinguishers in the building and we could find no requirement in the contract for these systems. The only fire safety equipment on site were bucket racks at the rear of the building shown in Site Photo 21. Site Photo 22 shows corrective action subsequent to the site visit.

Site Photo 21. Fire bucket racks, the only fire safety equipment observed at the time of the site visit.

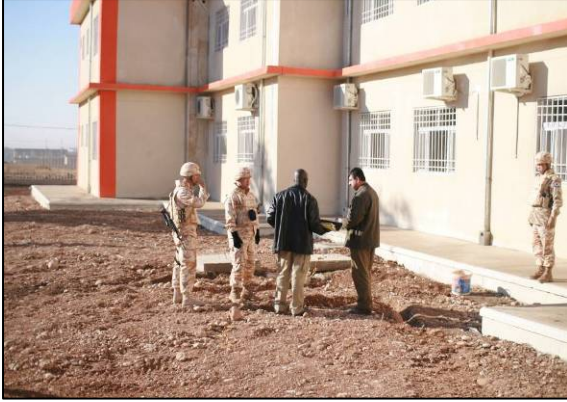
The septic tank and cesspool access covers were made of cast concrete approximately three feet square and four inches thick. The work appeared adequate; however the grading in the area was rough and uneven. Additionally, the area was not secured to prevent children from accessing it. Site Photo 23 shows the condition of the grading in the unsecured area. Site Photo 24 shows the corrective action subsequent to the SIGIR site visit to properly grade the area.

Site Photo 23. Unsecured septic tank and cesspool area with rough and uneven grading.

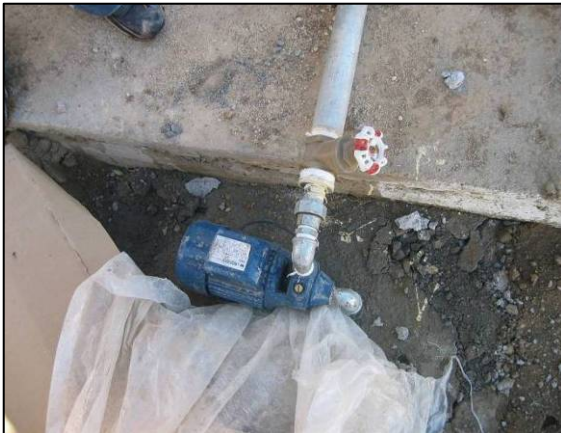
The water tank, mounted on a stand approximately five meters high, connects to the city water main and to the building. The tank was filled by a pump connected to the city main line. The pump was inadequately protected from the elements by a sheet of plastic and a cardboard box as shown in Site Photo 25. Site Photo 26 shows the corrective action subsequent to the SIGIR site visit to provide a cover for the pump.

Site Photo 25. Exposed water pump used to fill the main water tower from the city water supply.

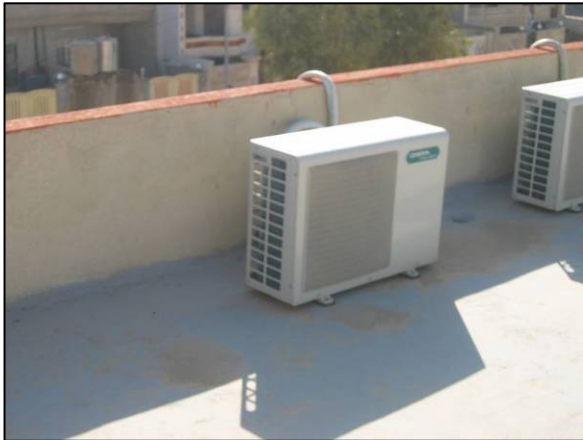
The split heating/air conditioning units on the roof were not yet anchored to the roof. Site Photo 27 shows unanchored heating/air conditioning units on the roof. Site Photo 28 shows the corrective action subsequent to the SIGIR site visit to anchor the heating/air conditioning units to the roof.

Site Photo 27. Split heating/air conditioning units not anchored.
