**RAMADI 132-KILOVOLT SUBSTATION
RAMADI, IRAQ**

**SIGIR PA-08-153
JANUARY 27, 2009**

SUBJECT: Report on Ramadi 132-Kilovolt Substation in Ramadi, Iraq
(SIGIR Report Number PA-08-153)

Ramadi 132-Kilovolt Substation Ramadi, Iraq

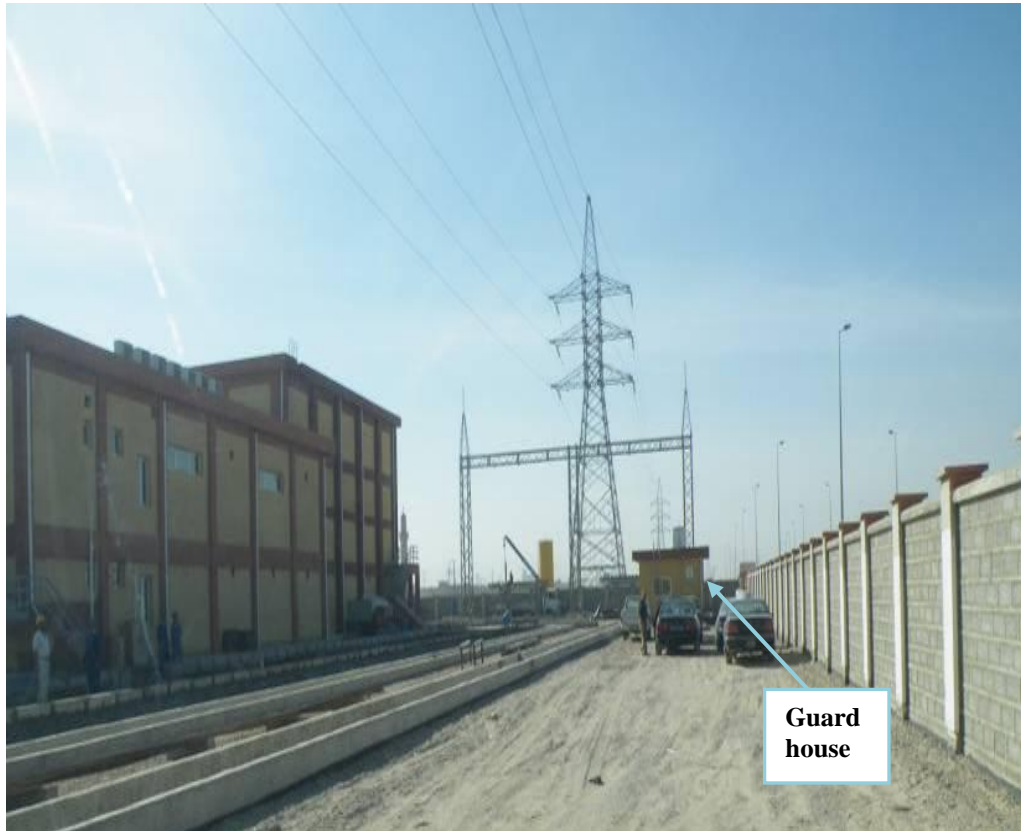
Site Photo 1. Guard house

The design required a guardhouse at the site entrance gate from the main public road (Figure 2). The site assessment team walked around the guardhouse (Site Photo 1); however, due to time limitations, did not enter. The wall design required a 2.0 meter high wall along the perimeter of the Ramadi 132-kV Substation (Site Photo 2), using thick reinforced concrete block (Site Photo 3) with a continuous reinforced concrete footer. The perimeter wall, surrounding the Ramadi 132-kV Substation, appeared well constructed with adequate brick alignment and quality mortar.

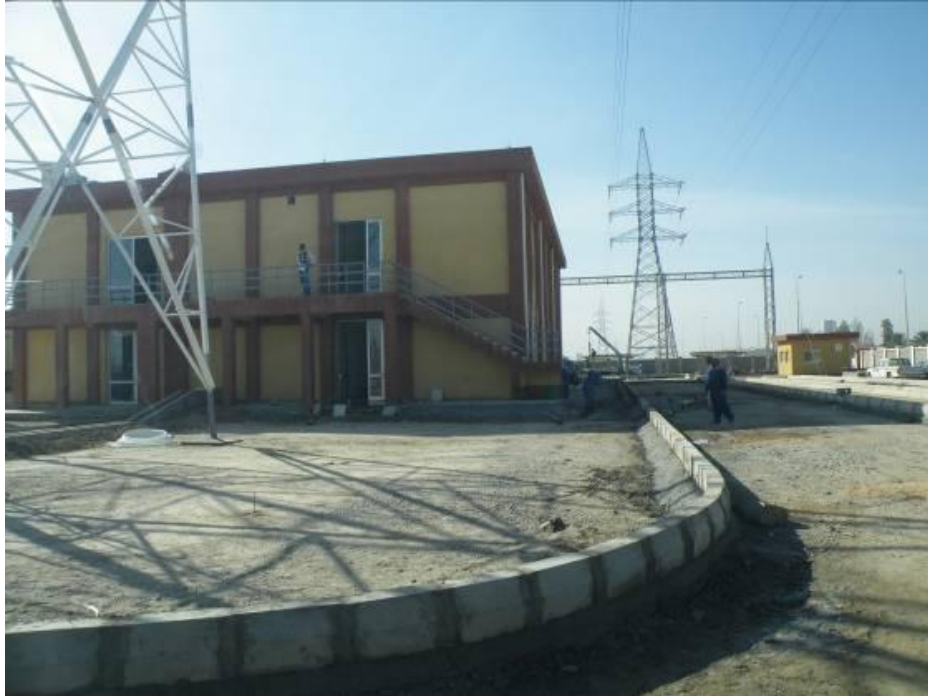
Site Photo 4. Exterior substation building

The design required that the substation building consist of a ground floor and a first floor. The building was to have through-wall ducts and trenches on all four sides for the appropriate transformer and feeder cables. The exterior of the 132-kV Substation building appeared to be well constructed (Site Photo 4). There were exterior stairs located at either end of the building.

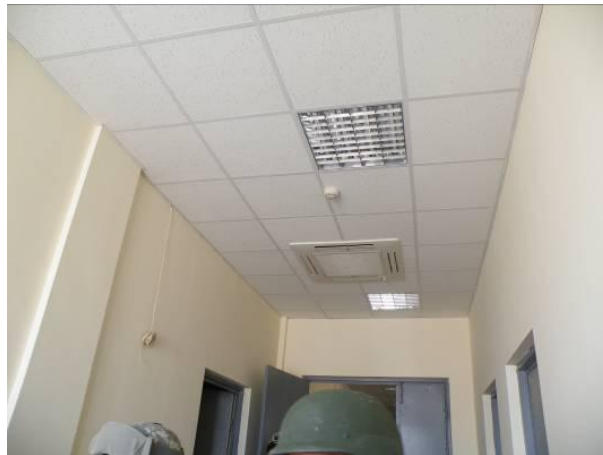
Site Photo 5. Interior finish

In addition, the interior of the substation building appeared to be well constructed (Site Photo 5). The ground floor design shows the columns required to support the heavy loads from the first floor's electrical equipment (Figure 3). During the site assessment, the inspectors observed that the ground floor columns were painted and there did not appear to be any patches. There were no obvious signs of cold joints, honeycombing, or steel exposure. The contractor had properly aligned and connected the elevated cable trays to the substation structure (Site Photo 6).

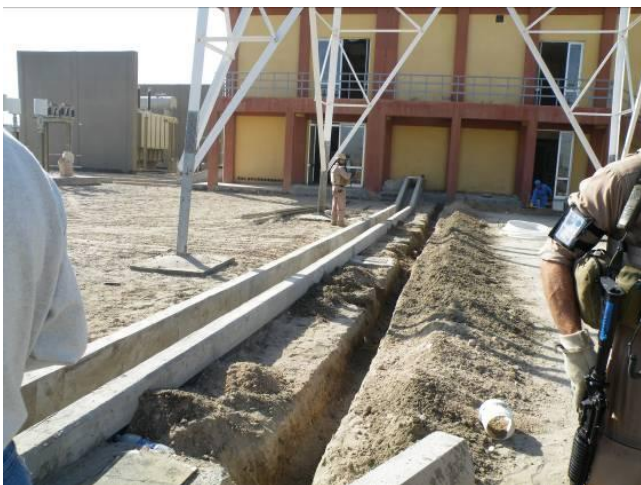
Site Photo 9. Cable trench entering building

The design required through-wall ducts and trenches for 132-kV feeder cables, 132/33/11 transformer cables, 33-kV feeder cables, and 11-kV feeder cables (Figure 4). The concrete cable trenches appeared to be well constructed and monolithic (Site Photo 7). For the wet season, the interior of the cable trenches has French drains (Site Photo 8). The cable trench proceeds up to the building (Site Photo 9), and the exterior wall of the substation has conduit installed to allow for the passage of cables from the transformer cables to enter the interior of the substation and for the feeder cables to exit the building (Site Photo 10).

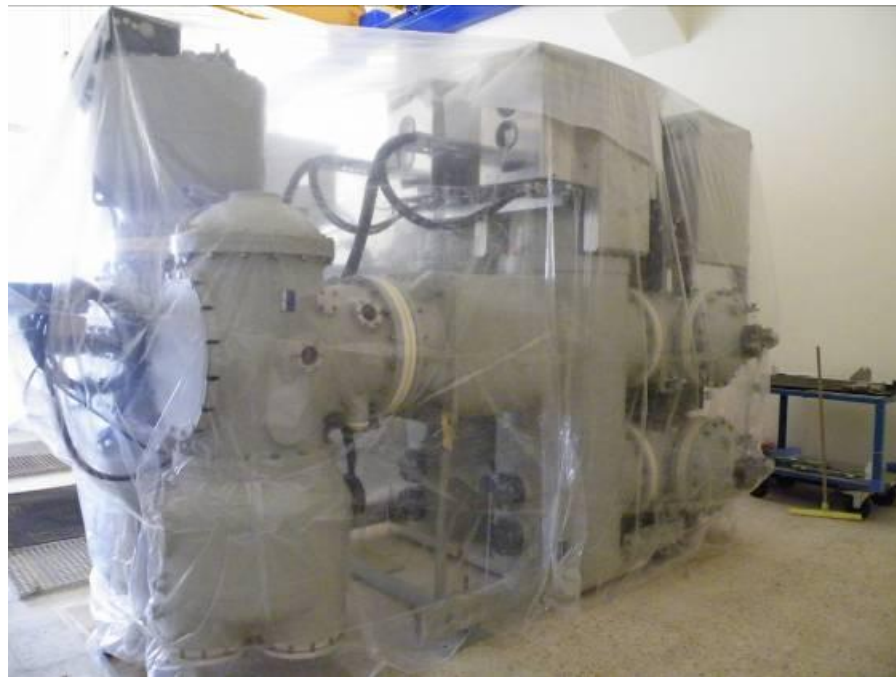
Site Photo 11. Gas insulated switch

The design required the first floor of the substation building to have five main areas. Main areas of the first floor include the 132-kV switchgear room, 33-kV switchgear room, control/relay room, communication and battery room, and 11-kV switchgear room (Figure 5). During the site assessment, a majority of the switching equipment was not completely installed, and the GIS was still in the original plastic wrapping (Site Photo 11). The site assessment team observed that the Gantry crane was installed, but not operational (Site Photo 12). The contractor stated that the electrical equipment required complete assembly before Site Acceptance testing could be performed. Until repaired or a work around solution is found, the damaged GIS units are preventing complete installation and testing.

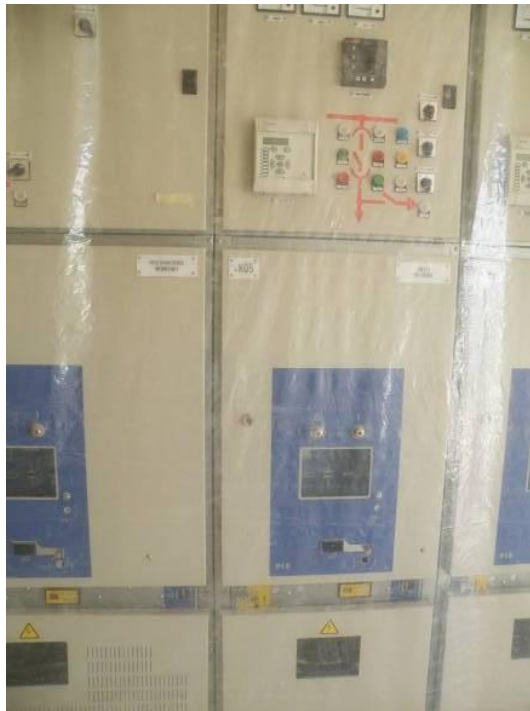
Site Photo 13. Electric metering equipment

The contract and design required the purchase of a 33-kV and 11-kV switchgear and installation of the switchgear into the newly constructed substation building. The site assessment verified the installation of the 33-kV and 11-kV bay of electric metering equipment (Site Photo 13). Details from the associated factory nameplate were not obtained during the site assessment; however, the equipment and installation appeared to be consistent with the contract, design, and specifications.

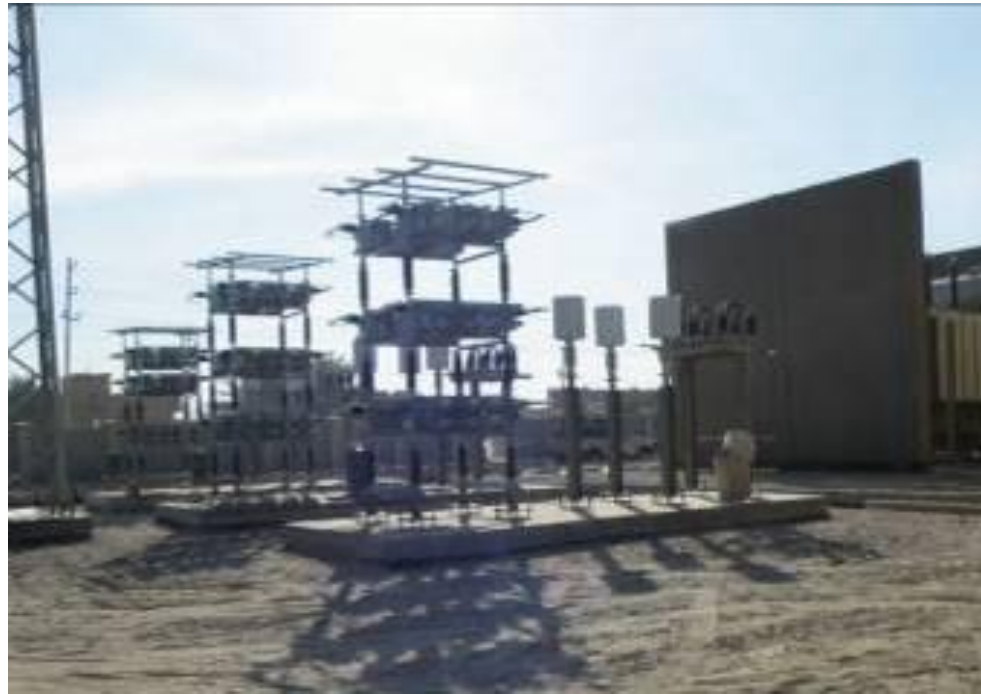
Site Photo 14. Capacitor banks

The capacitor banks looked new in appearance (Site Photo 14). The capacitors should provide greater reliability for the substation since the capacitors hold a charge on the system. This will provide a lag in the power drop when power is lost and will

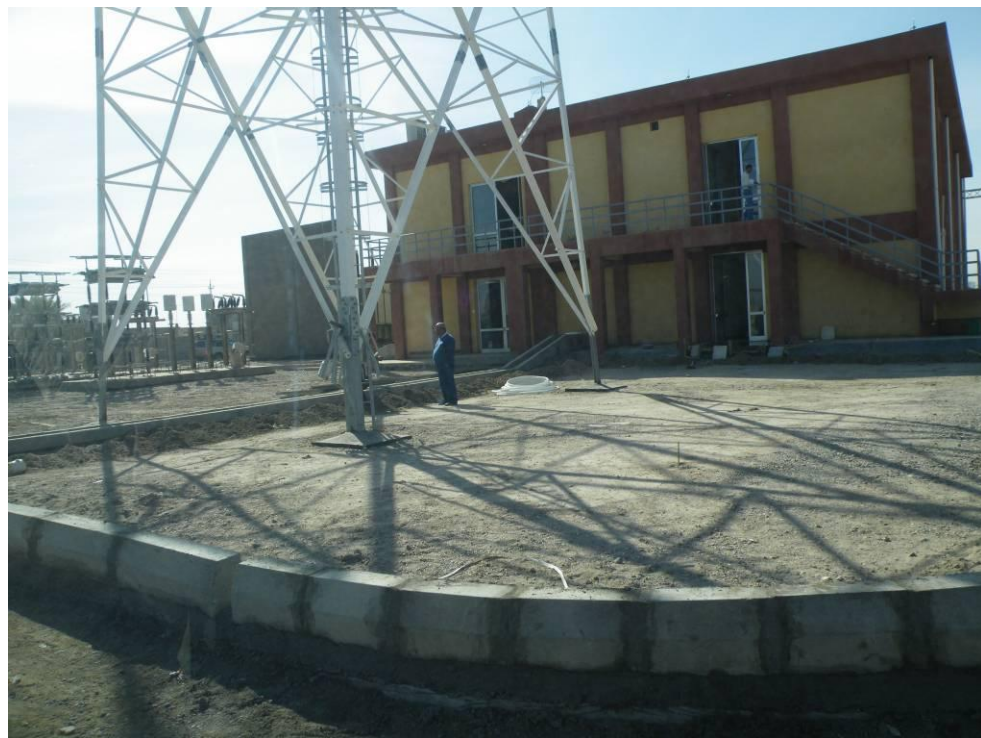
Site Photo 15. Communications tower

maintain power in the system until power is restored. SIGIR verified the installation of a communications tower (Site Photo 15).

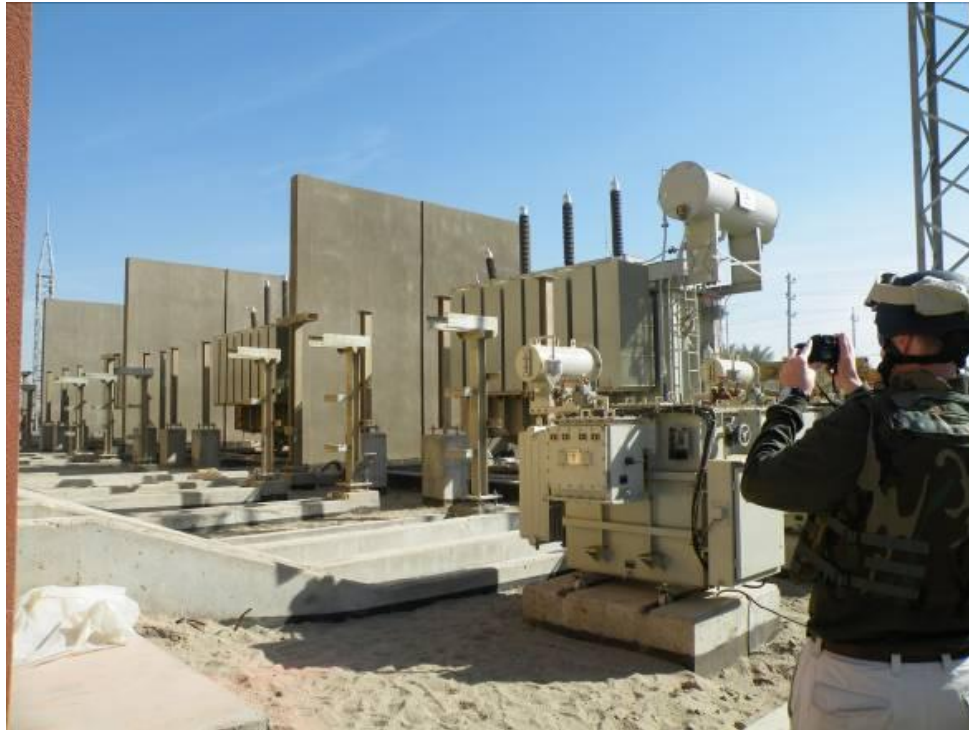
Site Photo 16. Transformer bays

The transformers, located behind the substation building, had a filter apparatus connected to filter the dielectric fluid. The USACE representative stated that the dielectric fluid should be free from any air or particulates. The transformer bays had gravel grid that was clean and well sorted; the gravel absorbs any oil that leaks from the transformers. In addition, large walls separate the transformers to contain the spread of a potential fire (Site Photo 16).

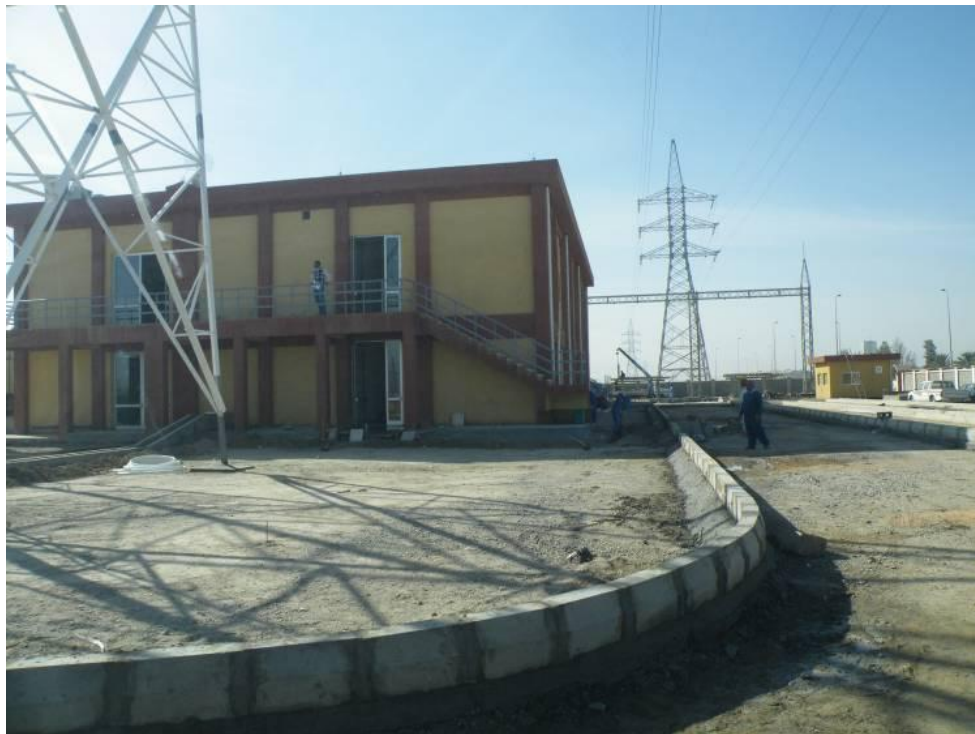
Since the project was reportedly 88% complete, the substation is still under construction in various areas. The contract required the vehicular and pedestrian entrance gates to be made of steel construction. Currently the contractor has not completed the vehicular entrance or pedestrian gates (Site Photo 17). In addition, the contract stated that the contractor would provide external access roads. When the site assessment team toured the Ramadi 132-kV Substation, the roads were still a work in progress (Site Photo 18).

Site Photo 18. Non-compacted road

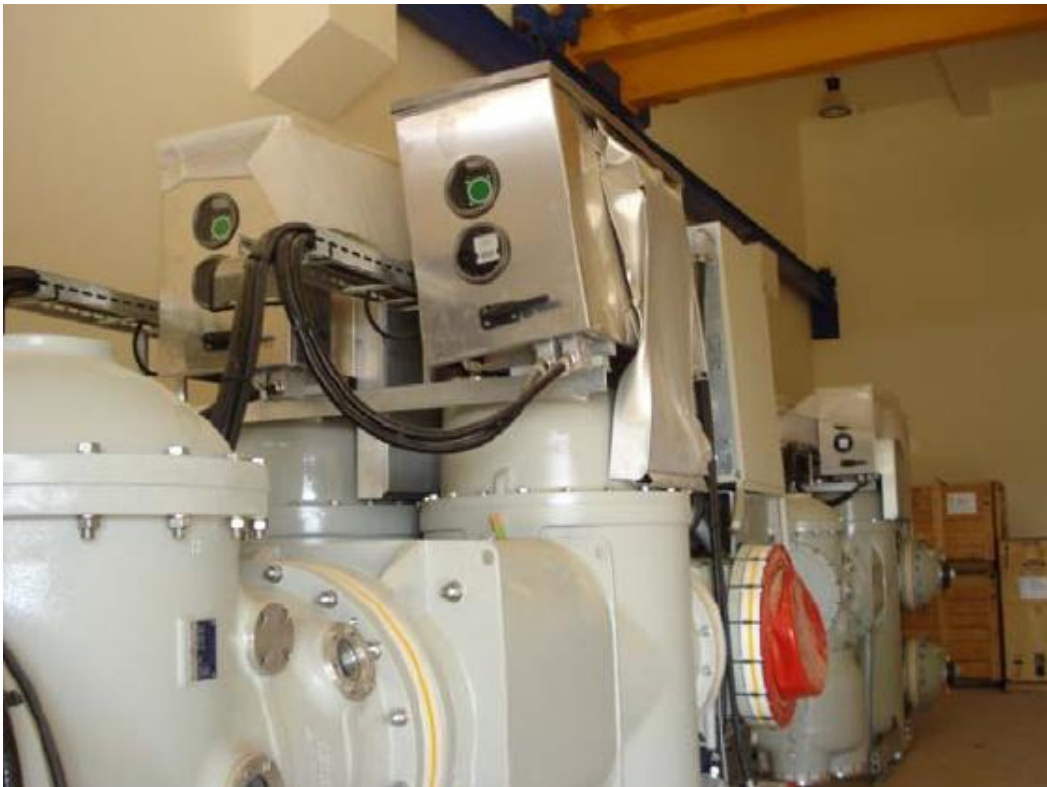
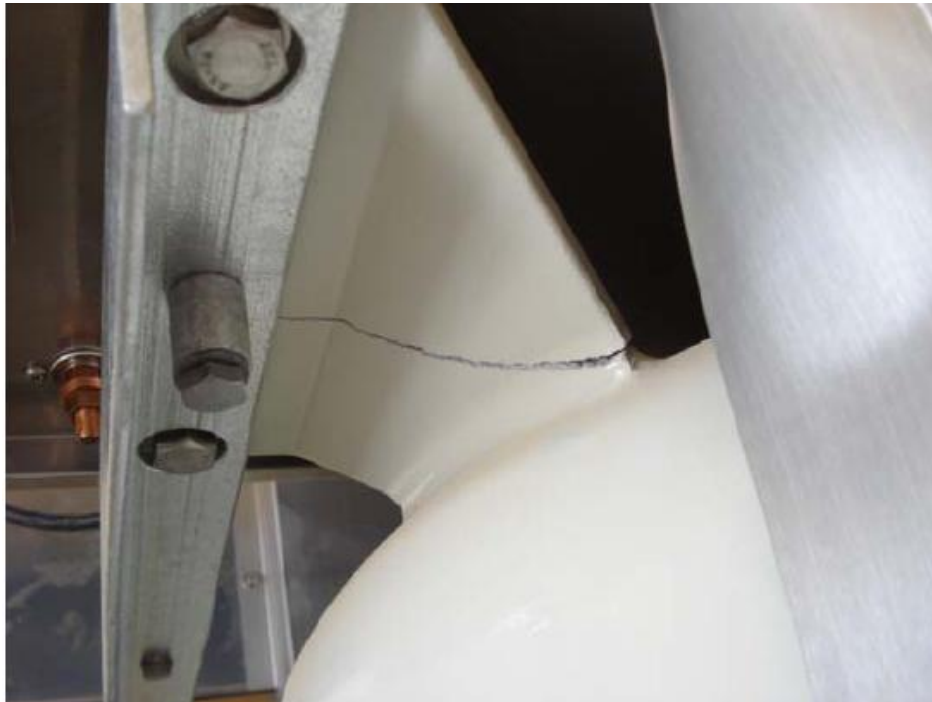
According to USACE, during the installation of the electrical equipment, the contractor noticed that one GIS had a crack in the housing that rendered the equipment unusable. The damaged 132-kV GIS bays E05 and E06 (Site Photo 19) have broken mountings, which are for the circuit breaker operating mechanism boxes, and damaged flanges for the busbar compartments. The mountings, located on the top of the circuit breaker head cover, cannot be repaired on site (Site Photo 20). A visual inspection of the damaged 132-kV GIS mountings indicates that professional welding is required. If welded in the field, the application of heat could damage the GIS. In addition, the impact that caused the break could have damaged internal GIS components. A factory examination can verify whether the internal moving parts were disturbed. Until the E05 and E06 are repaired and installed, one transformer (E05) and one line bay (E06) will not be commissioned.

On 30 November 2008, the USACE received an email from Areva, the vendor, that stated that the GIS casings were not opened. Areva's worst-case scenario was that rebuilding the units would take approximately twelve months. If the vendors have the critical parts available, then the time can be reduced. USACE indicated that different options were being discussed to circumvent waiting for the estimated period for returning the GIS equipment. USACE may take advantage of the design redundancies in the system and run the substation with the other GIS. However, USACE indicated that if this is done, the commissioning of the system would need to be reviewed and the warranty time with Areva may be increased.

Site Photo 20. Cracked GIS E05 and E06 (Courtesy of USACE)

In addition, the contractor should inspect and verify items as soon as received on site. According to USACE, during the installation of the electric equipment, the contractor noticed that one GIS had a crack in the housing that rendered the equipment unusable. Through a visual inspection of the 132-kV GIS, the contractor could have identified the problem earlier in the project.

1. Continue efforts to expedite repair of the gas-insulated switchgear.
2. Require the contractor to provide the 90% design submittals.

Command Comment. Concur. The switch manufacturer will replace the gas-insulated switchgear units. The contractor is expeditiously working to obtain replacements for the three defective GIS units from the manufacturer.
