**MISSAN SURGICAL HOSPITAL**  
**UNDER THE ECONOMIC SUPPORT FUND**  
**AL AMARAH, IRAQ**

**SIGIR PA-08-165**  
**SIGIR PA-08-167**

**JULY 16, 2009**

## Missan Surgical Hospital

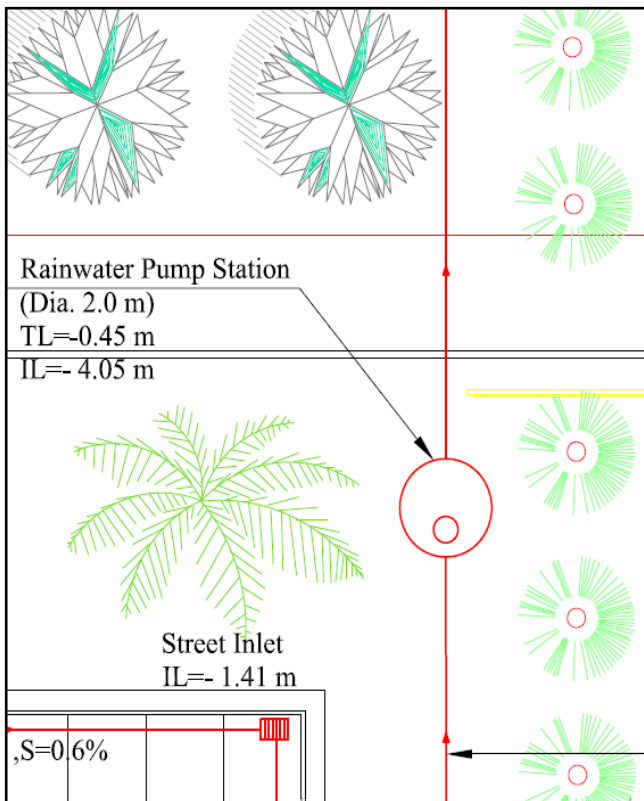
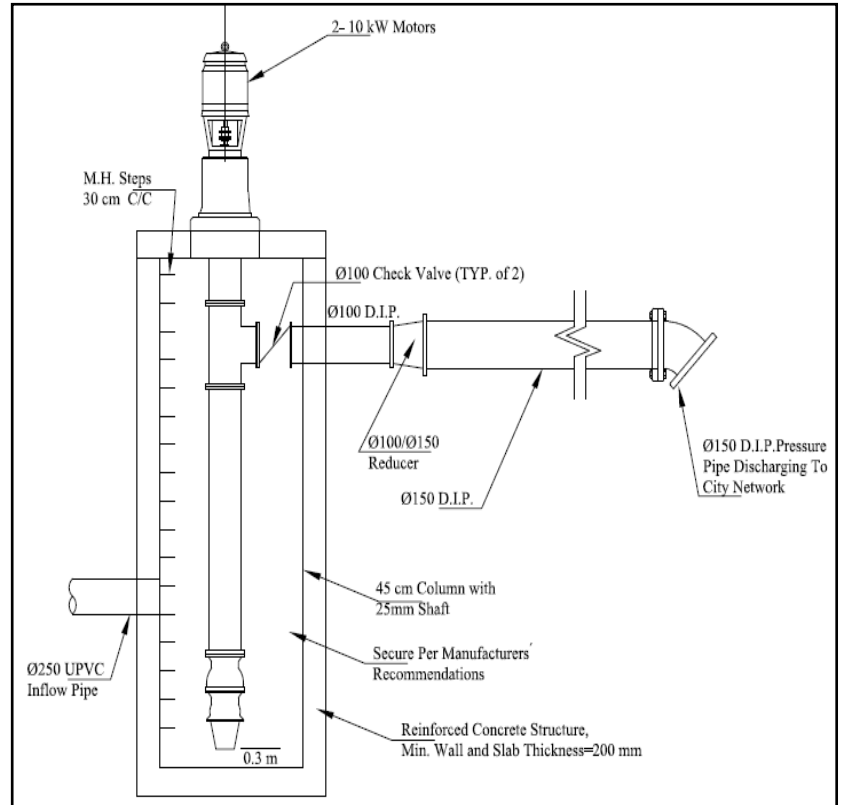
The storm water collection and conveyance system appeared to provide positive drainage for the project site. The drainage system relies on a storm water pump station at the low end of the system to convey water from the project site to the municipal system (Figures 6 and 7). The plans specify the pump station with two-2000 liters per minute shaft driven pumps placed in a 2 meter (m) diameter reinforced concrete structure.

The contractor's plans lacked adequate information for SIGIR to determine how the pumps are controlled or how they will address low-flow conditions. SIGIR is concerned that the high capacity of the pumps combined with the small size of the wet well may result in a rapid cycling of the pumps leading to overheating and premature pump failure.

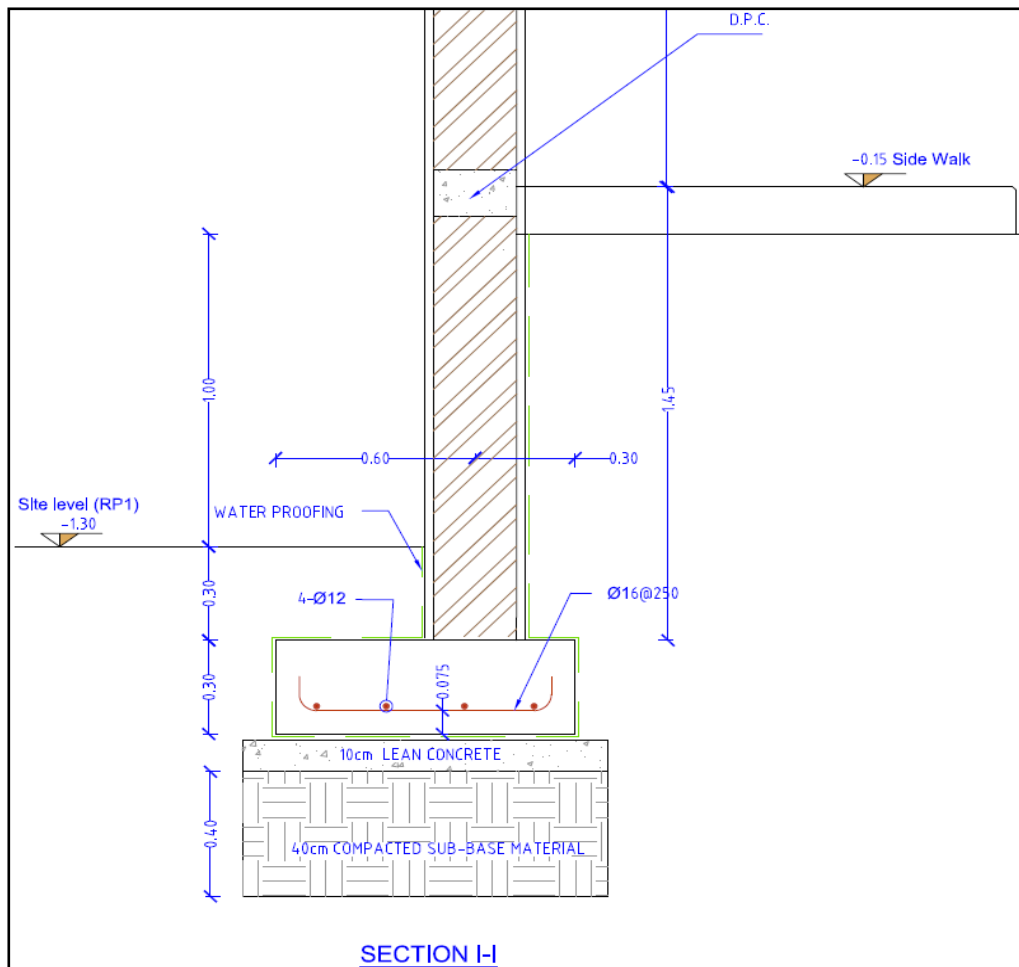
**Figure 8. Perimeter retaining wall section**

The contractor's design plan detailed the perimeter fence along the north edge of the project site. The plan indicated the application of waterproofing to the portion of the wall below grade (Figure 8). However, the application of waterproofing without the integration of subsurface drainage behind the wall may allow for the buildup of hydrostatic pressure against the wall and possible localized failure of the brick infill.

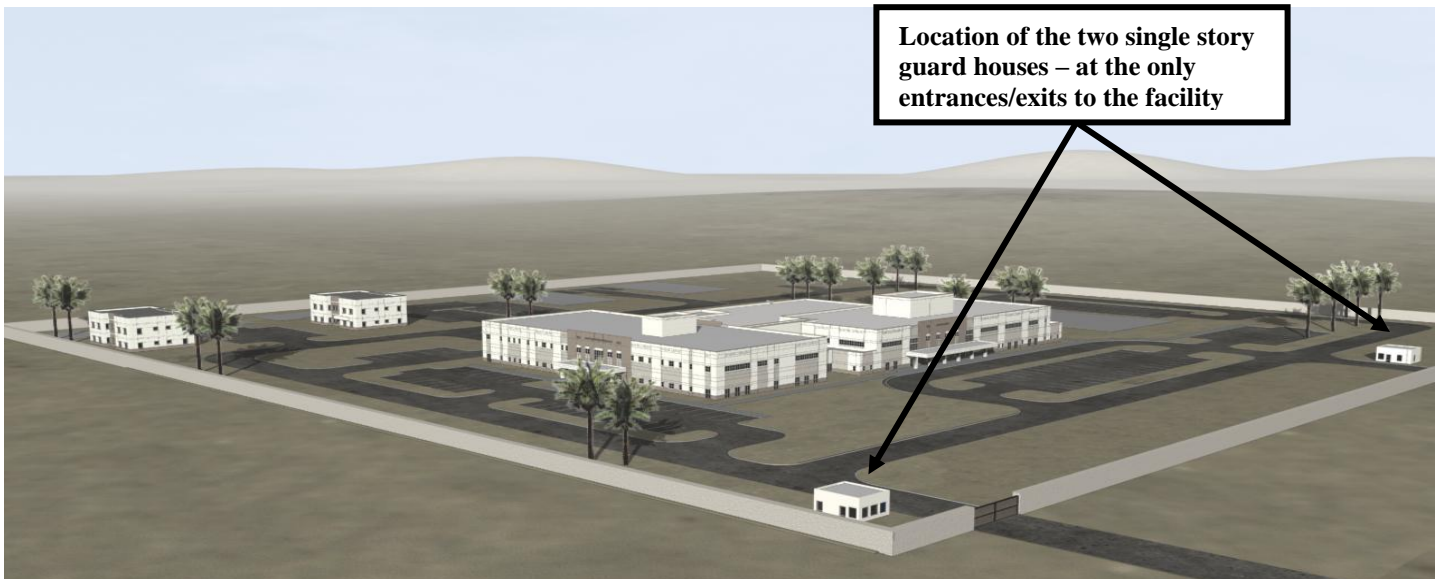
from the guard house, additional guard houses and elevated guard towers are necessary to provide adequate security.

**Figure 9. Location of the two guard houses for the MSH (Courtesy of GRS)**

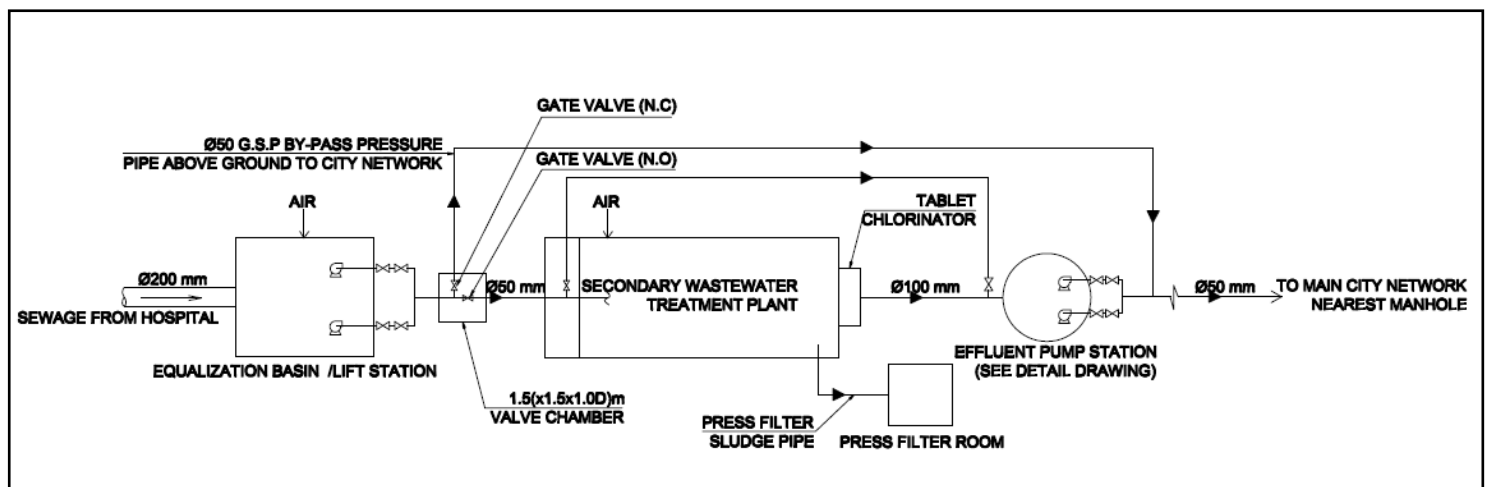
Similar to the water supply system, the wastewater system design lacked significant details, such as the alignment and outfall of the sewage leaving the hospital site. Figure 14 shows the overall wastewater treatment plant schematic drawing, which indicates that the sewage leaving the hospital will be deposited directly into the “main city network nearest manhole” without identifying the exact location and distance to the nearest manhole, the size, elevation, and condition of the main city network sewer pipe, and whether or not an analysis has been performed to determine if the existing city network system can accommodate the significant additional flow the hospital will provide. To ensure that sewage does not back up into the hospital or in nearby neighborhoods, it is important that the network have the capacity to handle the additional flow.

Figure 14. Contractor’s overall wastewater treatment plant schematic drawing (Courtesy of GRS)

1. Resolve the design deficiencies, omissions, and areas of concern with the contractor to guarantee that the project is adequately designed.
2. Follow-up with the contractor to ensure that the complete design drawings include water distribution lines from the river intake to the hospital site and wastewater distribution lines from the hospital site to the appropriate sewer line connection.

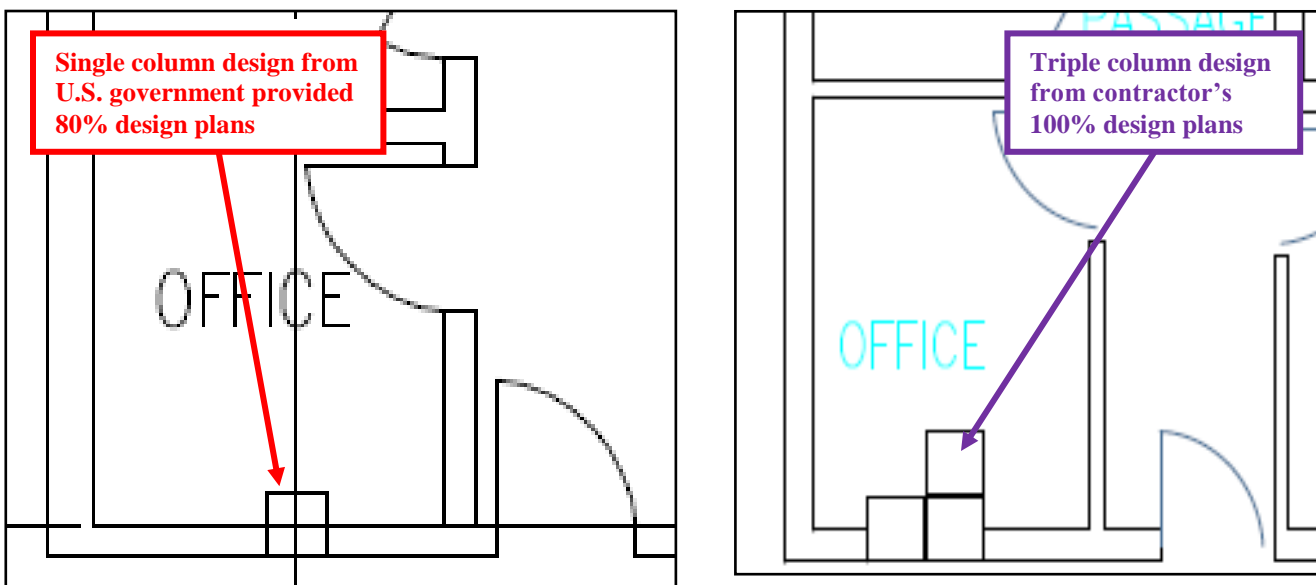
The design drawings include a structure layout with additional columns to accommodate expansion joints in the building. While the floor plans were adjusted to accommodate the additional columns, there appeared to be spatial conflicts in several of the rooms. For example, Figure 15 is the original floor plan (80% design), which allocated a 0.5 m x 0.5 m column in this office; while Figure 16 is the contractor's re-design, which added the expansion joint and two additional 0.5 m x 0.5 m columns for the same office. Although the contractor made the office larger to compensate for the undesirable use of space, the additional columns render the office less efficient and aesthetic than if the floor plan was modified to place the columns in less obtrusive locations. SIGIR observed this in several locations.

Figures 15 and 16. The contrast between the 80% design single column configuration (left) and the contractor's triple column configuration (right). The triple column configuration is less efficient space wise and less aesthetically pleasing. (Courtesy of GRS)

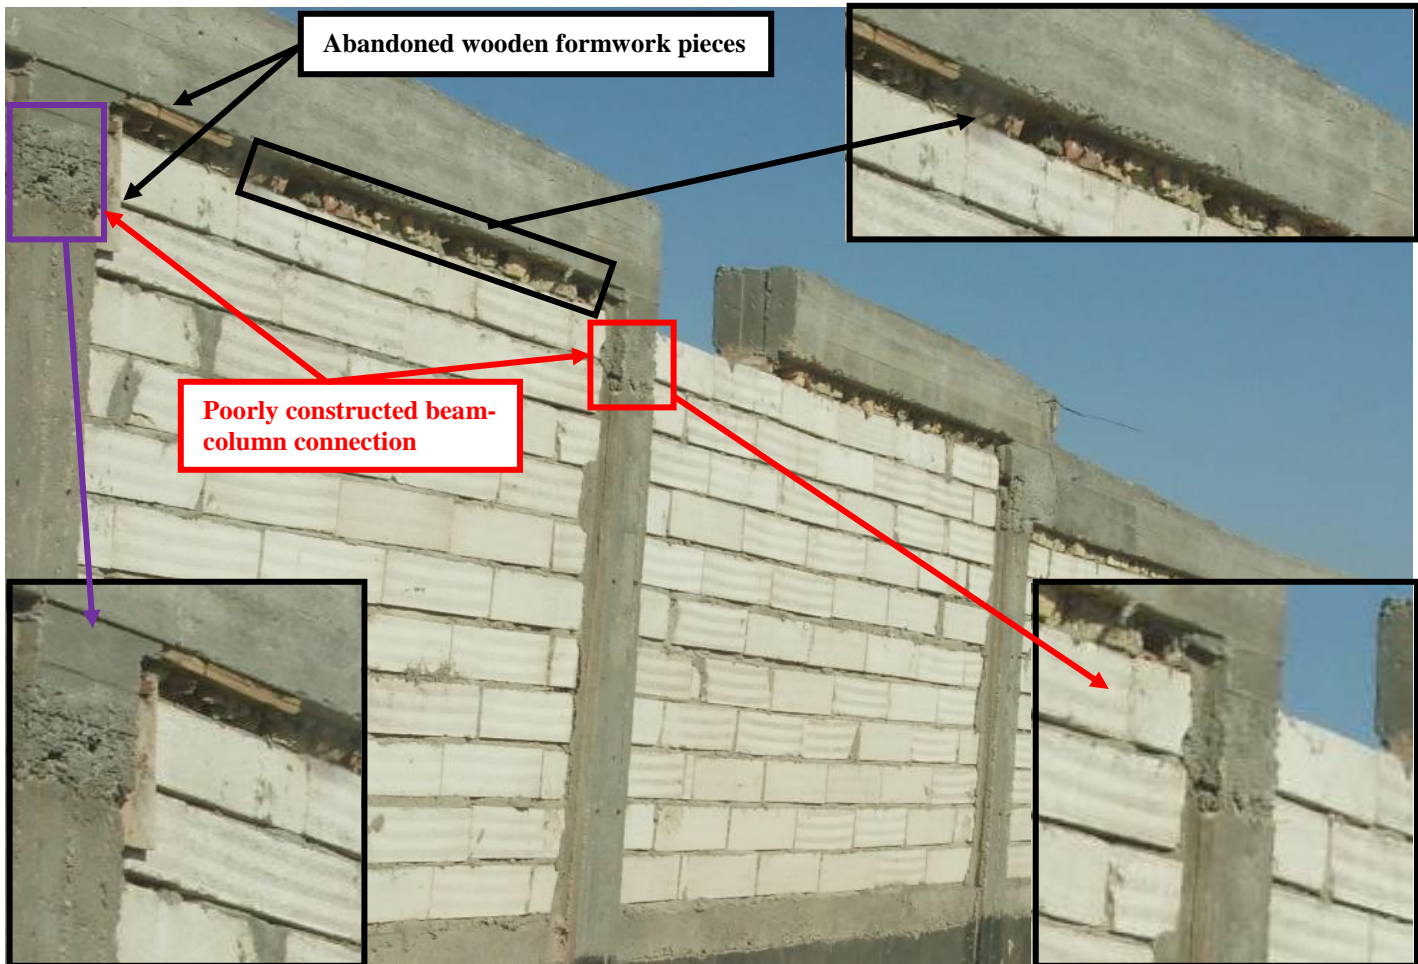
At the time of the site visit, the perimeter wall appeared adequate as a deterrent to anyone attempting to unlawfully enter the compound; however, the concerns identified by SIGIR regarding the wall's construction will ultimately affect the wall's long term sustainability.

Site Photo 3. Perimeter security wall construction

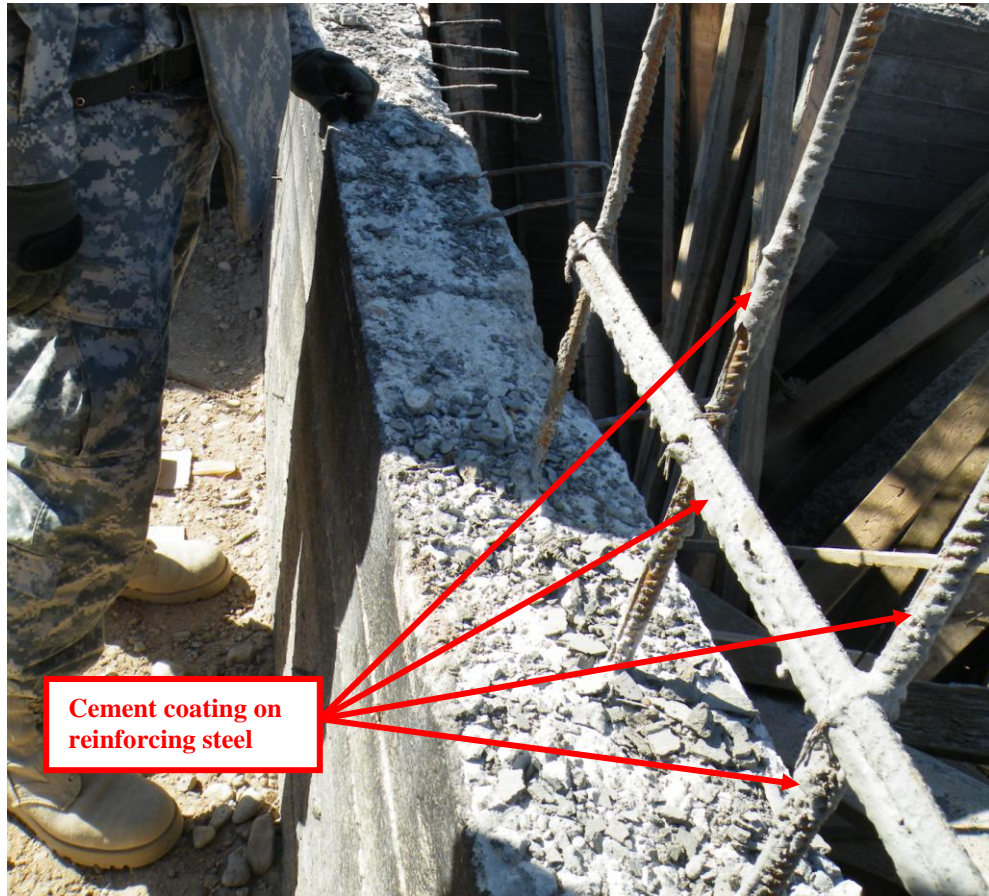
Due to time limitations on site, SIGIR did not have the opportunity to analyze the reinforcing steel inside the formwork to determine if this issue was being rectified prior to concrete pouring operations.

**Site Photo 4. Cement coating on reinforcing steel**

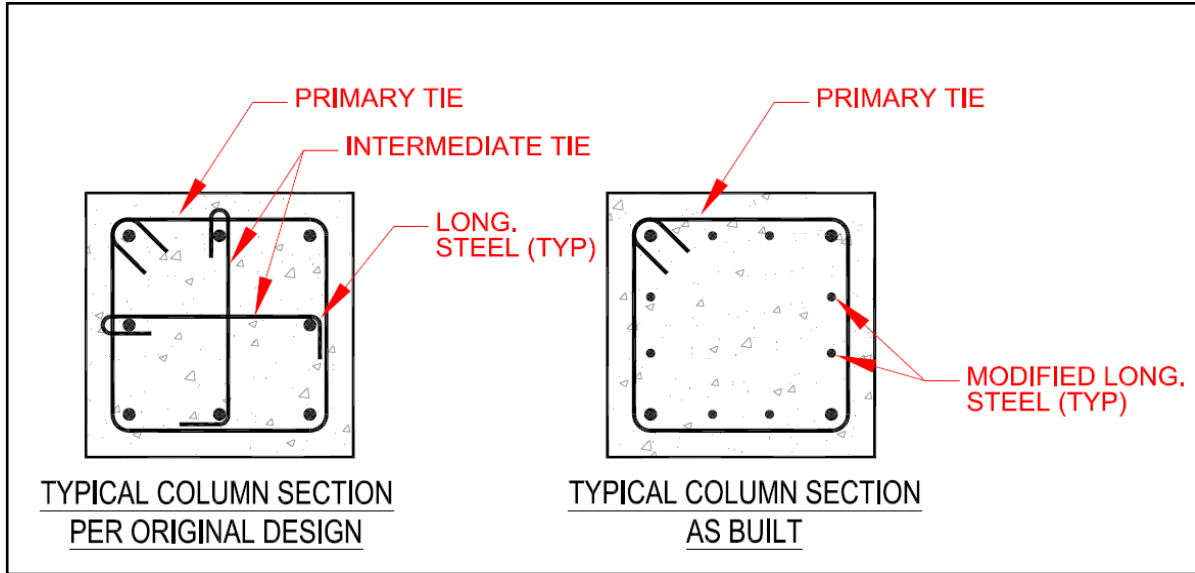
In addition, SIGIR noted that the reinforcing configuration used in the construction of the reinforced concrete columns varied from the configuration specified in the design drawings. Figure 17 clearly illustrates the difference between the design drawing and actual construction of the reinforcing configuration. The design drawing required three separate pieces of reinforcement bar along with two ties (primary and intermediate). The primary ties a steel bar around the perimeter of the vertical reinforcement bars; while the intermediate ties a steel bar from the middle reinforcement bar of one side to the other. However, the contractor opted to use four vertical pieces of reinforcement bar along with a primary tie around the perimeter.

In order to more clearly illustrate the difference in the design versus actual construction, Figure 17 is the reinforcement configuration from the design drawings; while Figure 17 and Site Photo 5 document the actual construction performed by the contractor.

**Figure 17. Comparison of typical design column section versus column as constructed**

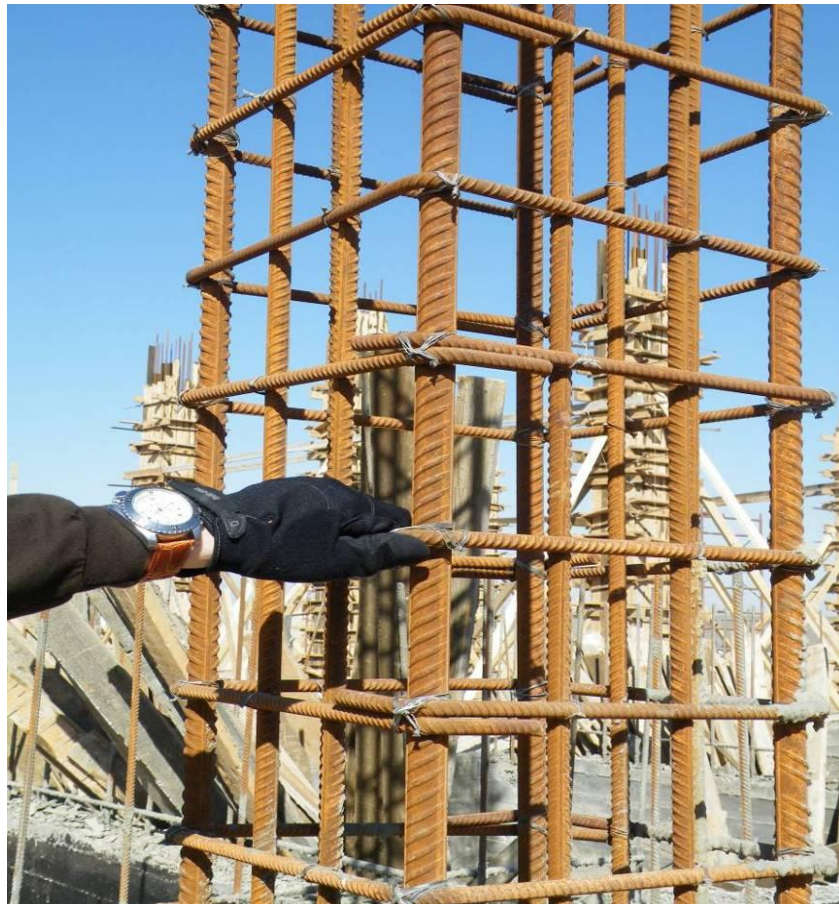
**Site Photo 5. Example of constructed column section**

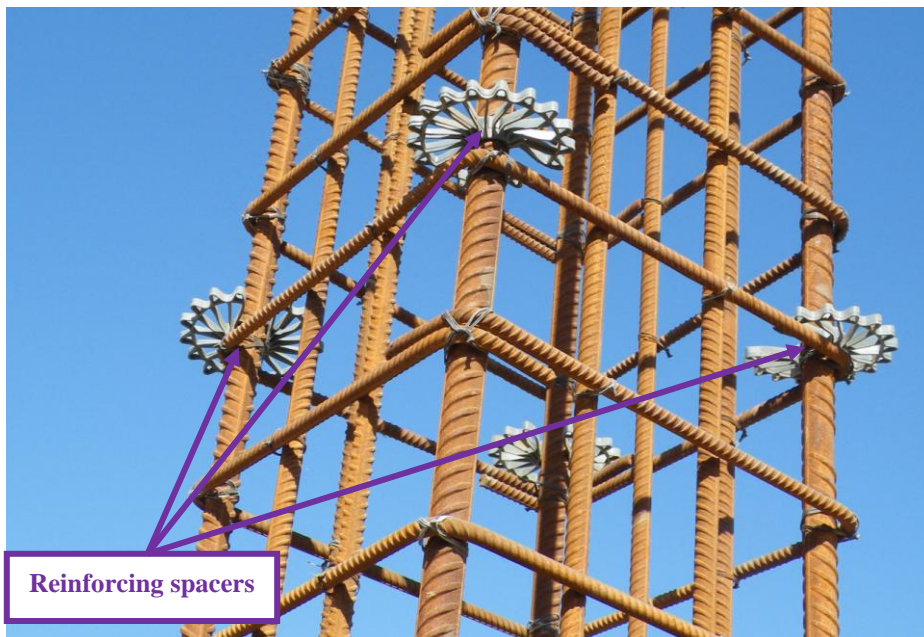
Upon review of the reinforcing steel for the columns, SIGIR noted a wheel type of spacer used in the construction of the reinforcing cage (Site Photo 6). In general, the use of spacers to maintain adequate concrete cover over the reinforcing steel is a good construction practice. However, the configuration of the spacers SIGIR observed may prove to be problematic. Specifically, the contractor utilized spacer with radial spokes between the reinforcing bars and the outer edge of the spacer. The distance between the radial spokes appeared to be smaller than the maximum possible dimension of the aggregate in the concrete mix. During pouring operations, the spokes may become clogged, preventing concrete from completely filling the corners of the column below the spacer, which would result in voids and/or honeycombing at the corners of the columns.

**Site Photo 6. Column reinforcing cage and form spacers**

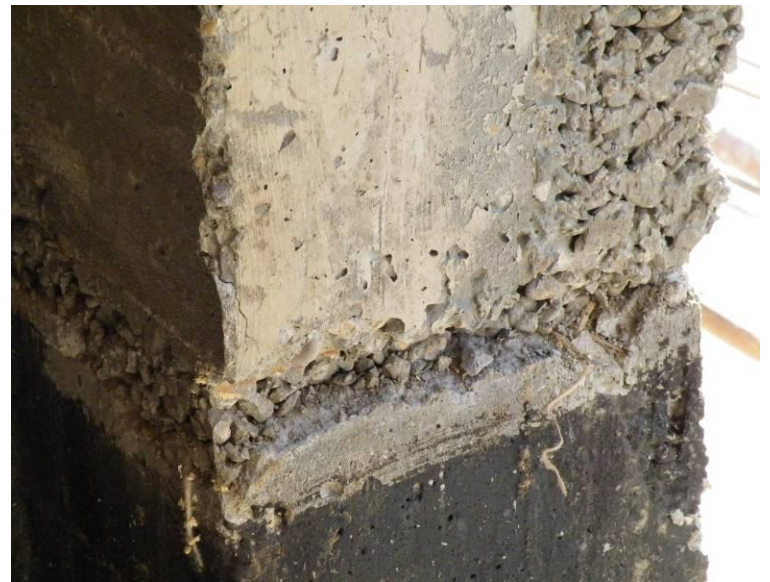
SIGIR identified several examples, from slight to moderate to severe, of honeycombing of the reinforced concrete members (Site Photos 7 and 8). This construction deficiency appeared to be most prevalent at construction joints between successive pours and along the corners of the reinforced concrete members.

**Site Photos 7 and 8. Typical examples of slight to moderate concrete honeycombing in columns**

Due to time limitations on site, SIGIR could not assess the extent and severity of the honeycombing, which may require limited destructive testing to ascertain. However, SIGIR did observe, in at least one location, exposed primary reinforcing steel (Site Photo 9). The full extent of the honeycombing should be assessed and appropriate remedial measures taken based upon the impact to each member.

3. Require the contractor to remove all defective concrete and replace it with a suitable repair material.
4. Require the local national on-site quality assurance representatives to closely monitor and ensure that the contractor removes and replaces deficient concrete.

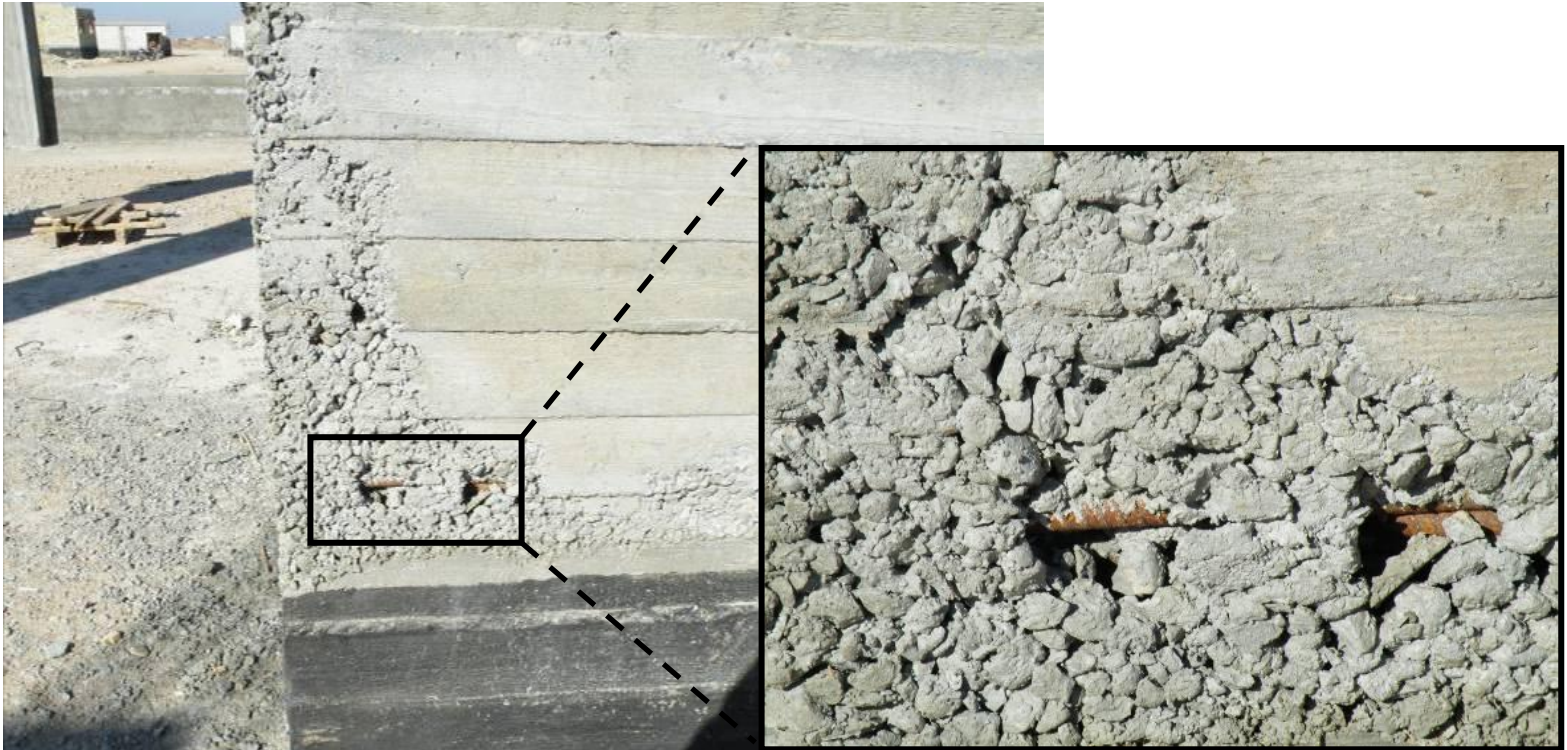
**Site Photo 9. Example of severe concrete honeycombing (including exposed reinforcement bar)**

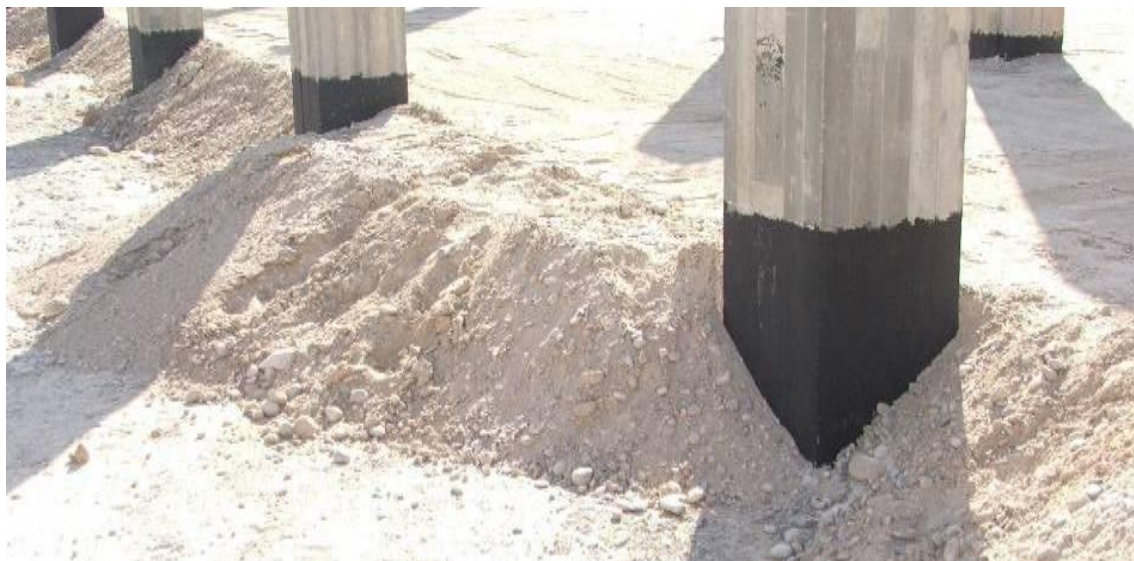
At the time of the site visit, backfilling operations were not taking place. SIGIR noted a lack of visible compaction layers at the edge of fill, which indicates the potential for inadequately compacted backfill (Site Photo 12).

**Site Photo 12. Edge of backfill over foundation**

SIGIR did not observe any watering equipment available on site, nor did it appear that the contractor was wetting the soil prior to compaction in order to obtain the optimum moisture content. Failure to obtain proper compaction could potentially result in cracking and/or settlement of the ground floor concrete slab.

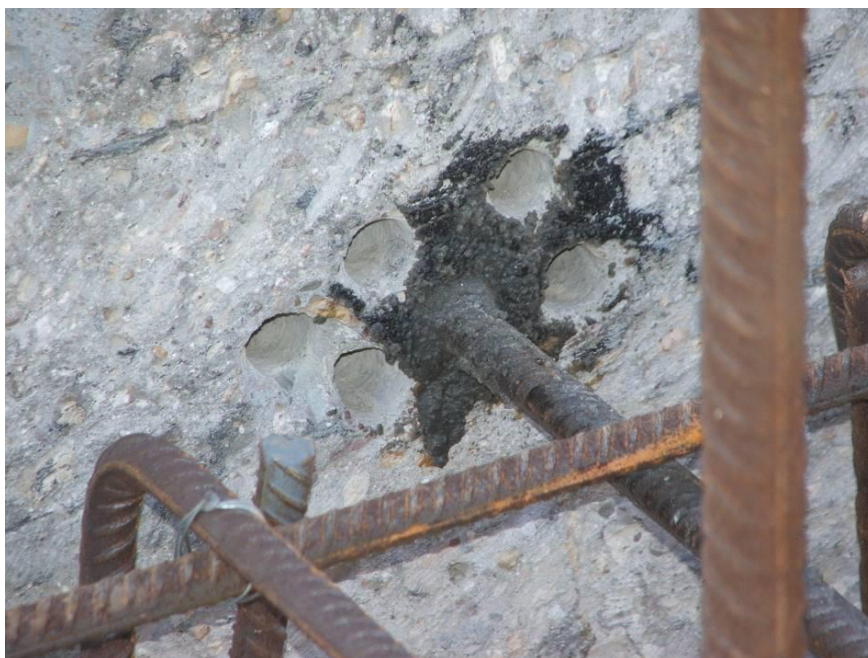
SIGIR examined the footings and identified a series of miss-drilled dowel holes surrounding an epoxy anchored dowel pin (Site Photo 13). The close proximity of the holes to the anchored dowel has resulted in reduced strength at this connection. However, since this dowel is one in a series of several dowels along the face of the footing, the impact of the weakened connection to the strength of the overall structure appeared to be minimal.

**Site Photo 13. Multiple holes surrounding epoxy anchored dowel**

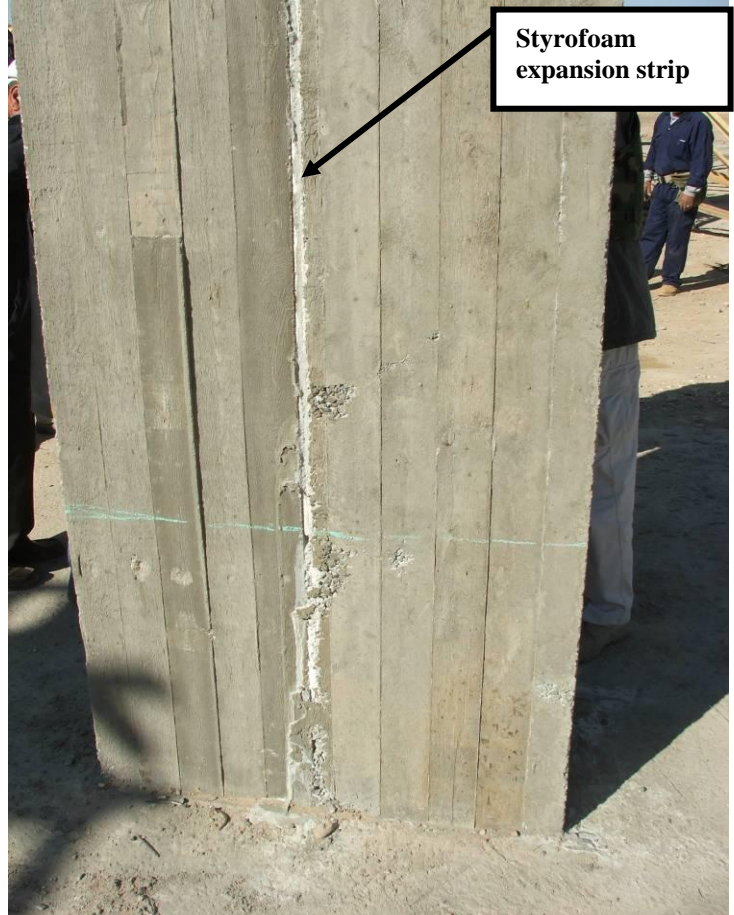
The columns appeared to be constructed from independent concrete pours with Styrofoam expansion strip placed between the columns (Site Photo 15). While not the ideal material to use, Styrofoam will effectively isolate the columns along their length.

Site Photo 15. Example of Styrofoam expansion strip

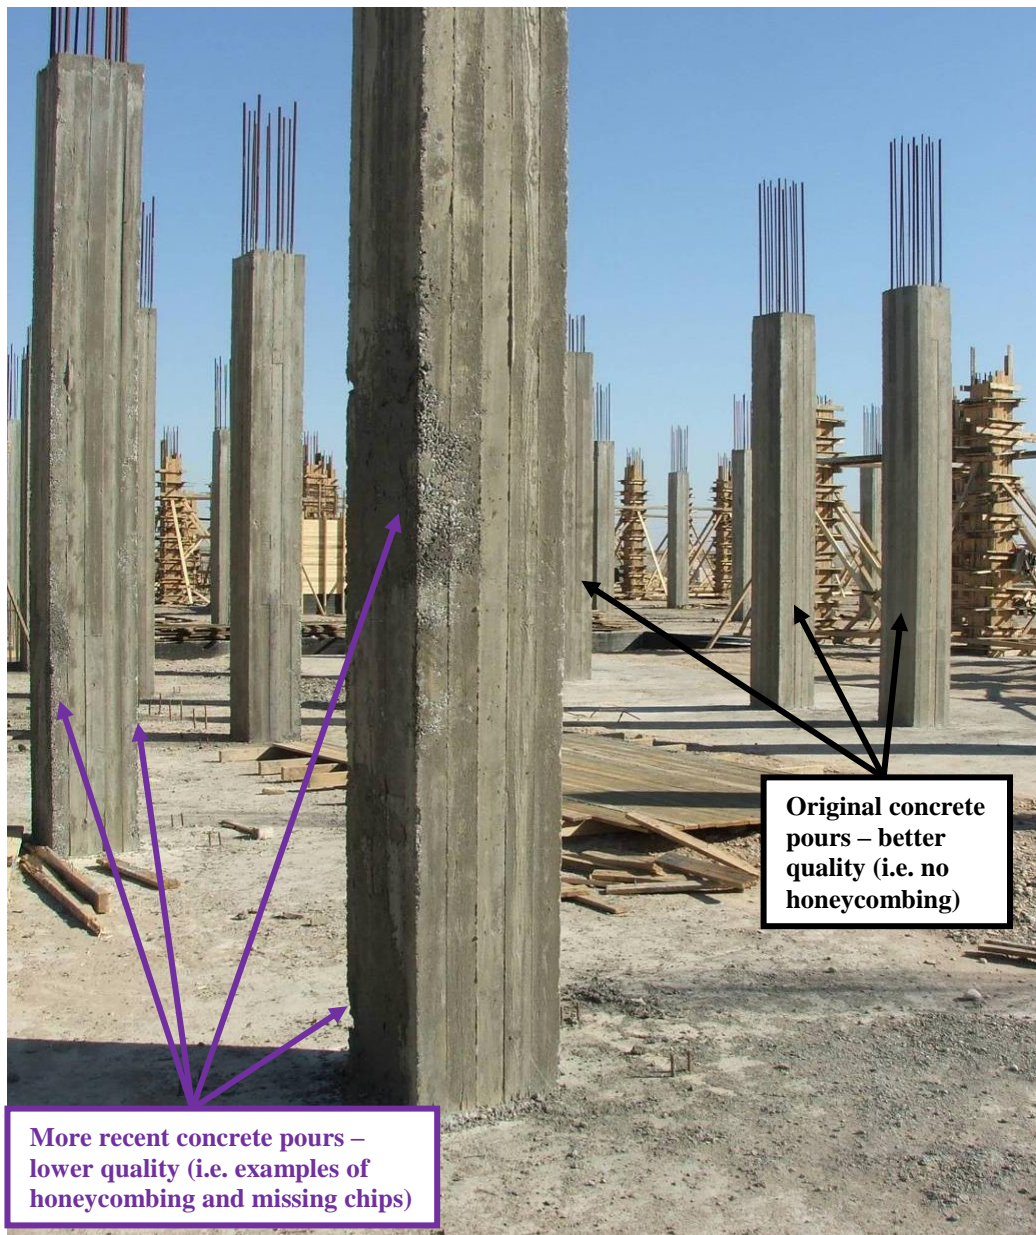
SIGIR noticed that the quality of the more recently constructed structural concrete columns was considerably less than some of the original columns (Site Photo 16). There is the possibility that contractor efforts to expedite the project may have led directly to concrete quality issues. For example, in an effort to increase productivity, the contractor probably pulled the column formwork too quickly and failed to adequately clean it prior to the pouring of the next column. Pulling the formwork before it is completely dry and not adequately cleaning it will significantly affect the quality of the next formwork concrete pours. SIGIR mentioned this to the GRS AAO representatives, who agreed that the more recent concrete quality issues could be due to the contractor being asked to follow a more expedited construction schedule.

Site Photo 16. Example of difference in concrete quality from more recent concrete pours

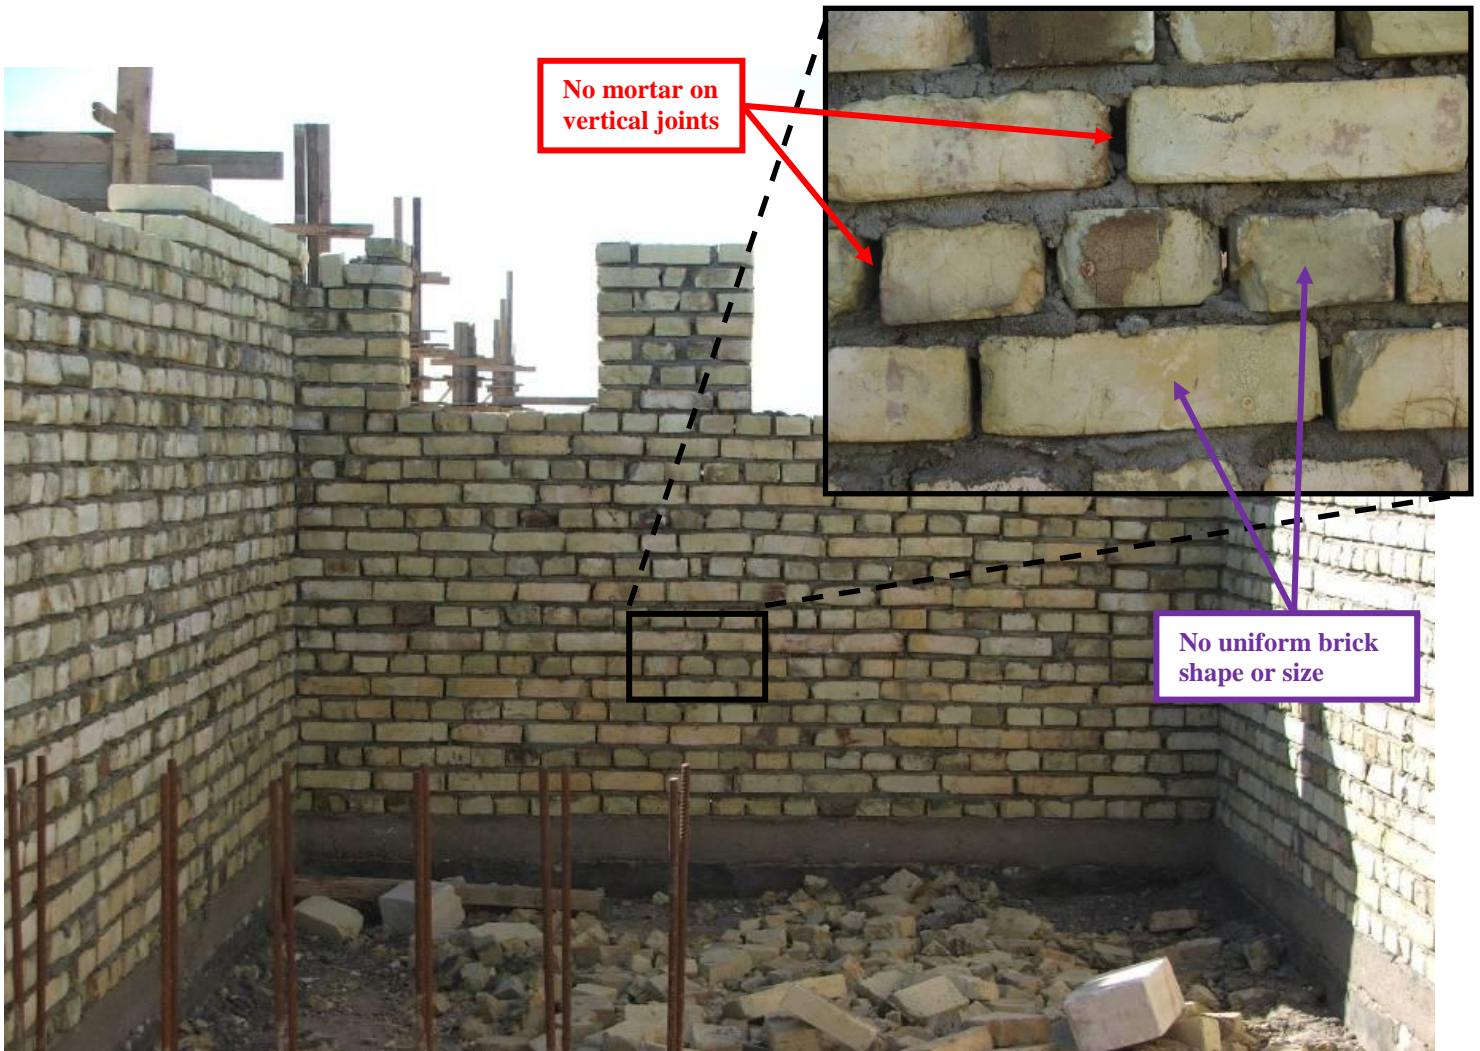
The construction of the brick walls followed local construction techniques and is a two "Wythe English" bond configuration. The bricks are not mortared on perpendicular (vertical sides) nor are they uniform in shape or size (Site Photo 18). While the methods and quality of construction is not comparable to typical European brick masonry, the small size and limited number of stories of this structure should result in relatively low stresses in the brick.

Site Photo 18. Physicians' residence (typical example of brick construction)

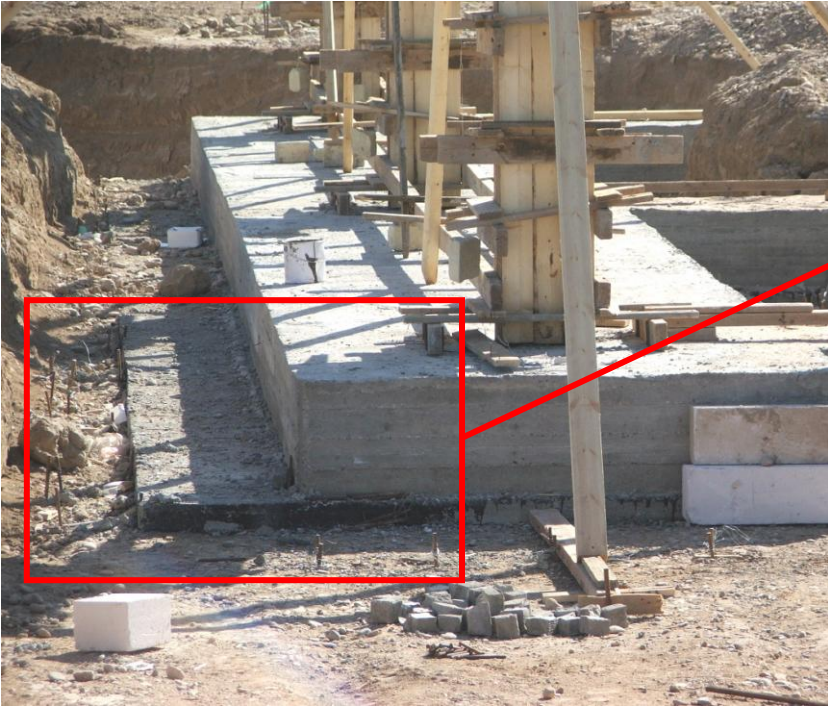
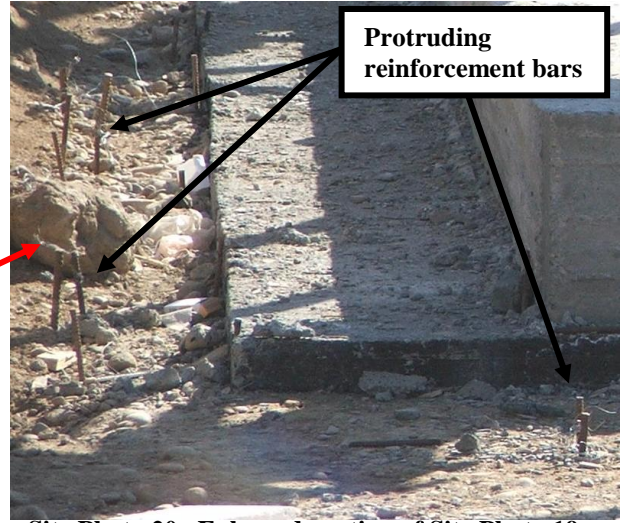
Site Photo 19. Examples of protruding reinforcement bar

Site Photo 20. Enlarged portion of Site Photo 19

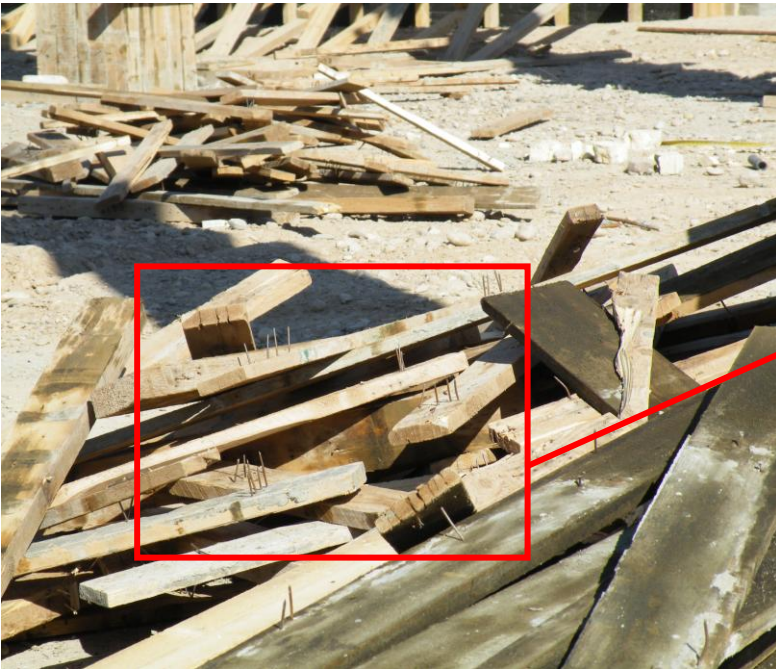
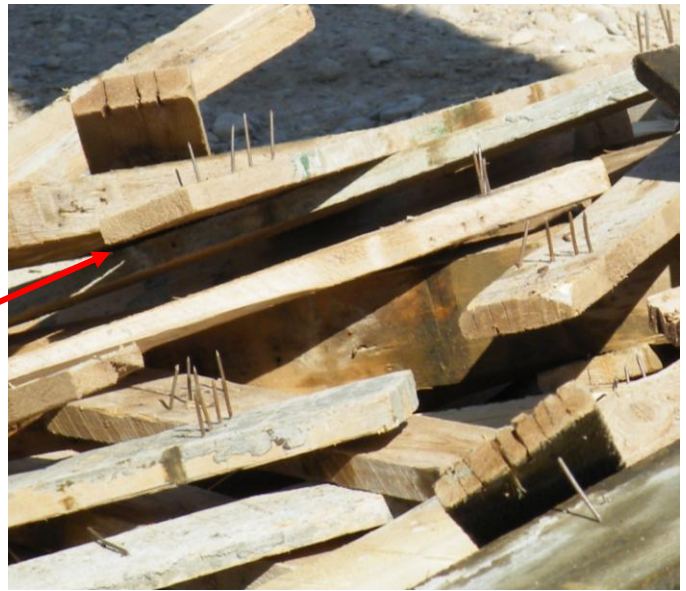
Site Photo 21. Example of protruding nails

Site Photo 22. Enlarged portion of Site Photo 21
