OFFICE OF THE SPECIAL INSPECTOR GENERAL FOR IRAQ RECONSTRUCTION

**SECURE DOCUMENT STORAGE FACILITY  
BAGHDAD, IRAQ**

**SUSTAINMENT ASSESSMENT**

**SIGIR PA-08-166  
OCTOBER 20, 2009**

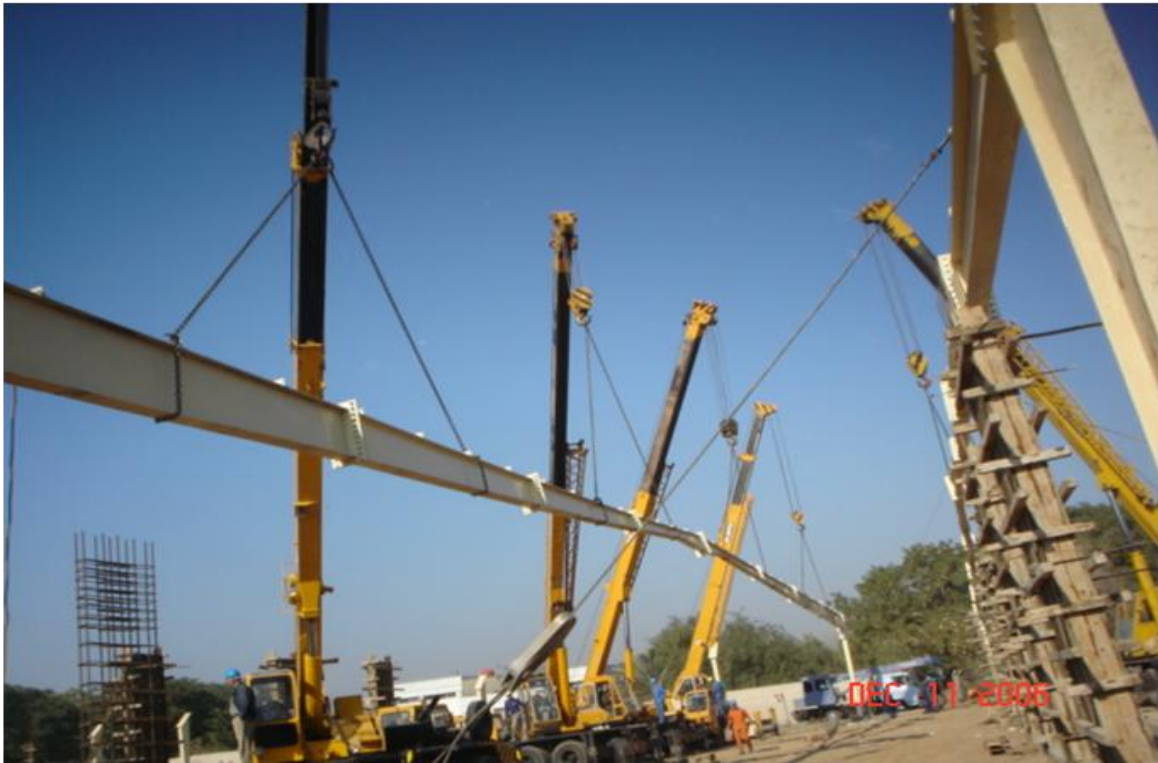
Site Photo 1. Initial construction of the steel columns prior to the structural failure (Courtesy of GRC)

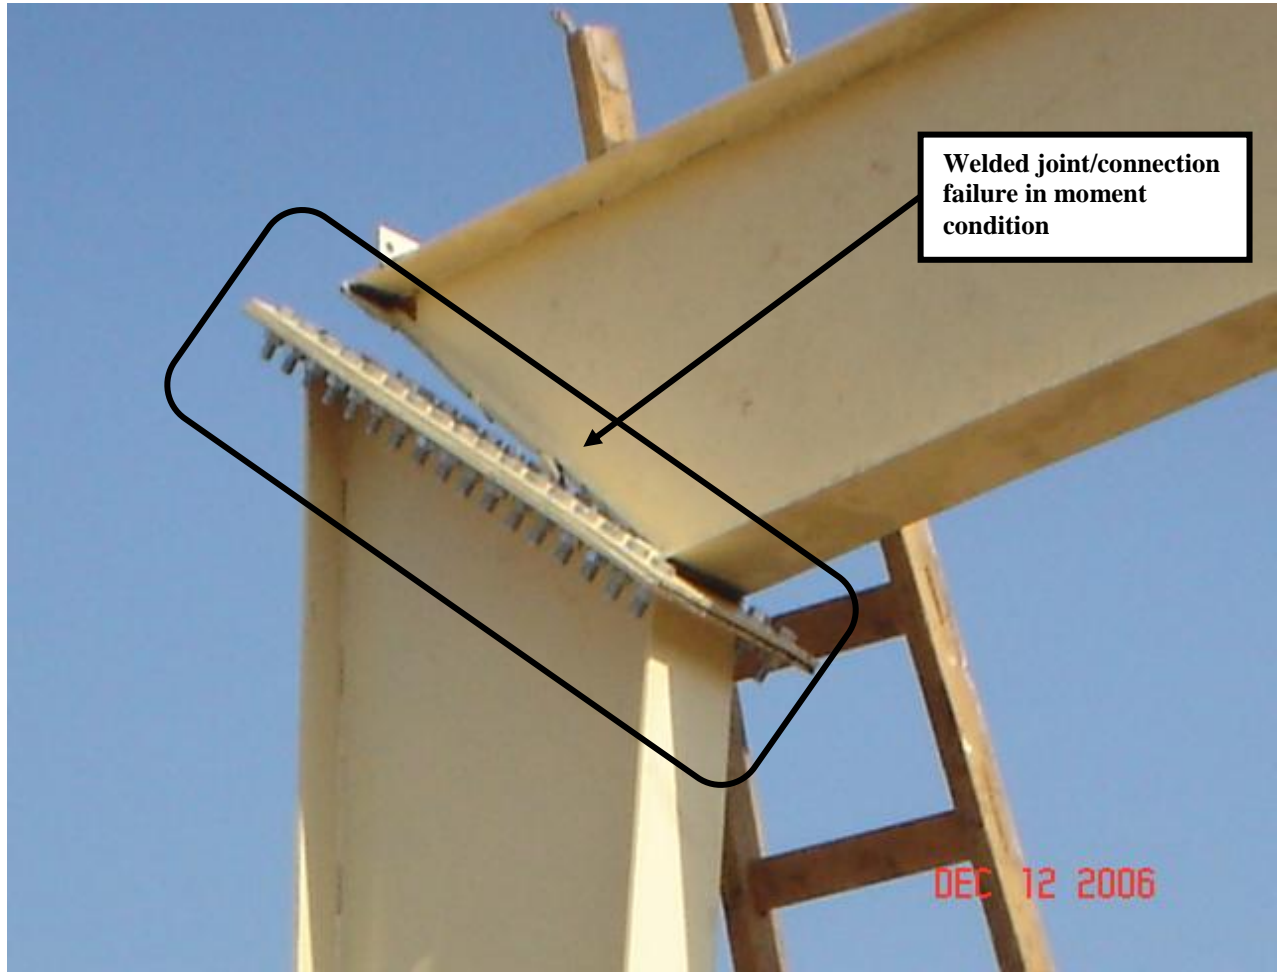
According to project file documentation, the contractor started work on 10 August 2006. At the beginning of the project, the contractor appeared to make steady progress. However, upon reviewing the project file photographs for the installation of steel columns, SIGIR immediately noticed that the contractor's beam span was far too long (Site Photo 1). SIGIR's concern was confirmed when the contractor initially placed the roof members and a structural failure occurred (Site Photo 2).

**Site Photo 2. Structural failure resulting from contractor's inadequate initial design (Courtesy of GRC)**

SIGIR reviewed the contractor's initial design. It appeared that the contractor failed to coordinate the design information with the drawings released for construction, which resulted in at least two significant omissions contributing to the initial failure of the structure and the subsequent need for reinforcing:

restraint of the column bases must be provided. The foundation details do not provide any method for lateral restraint.

After the December 2006 structural failure, the contractor performed an evaluation and proposed a revised design in January 2007. Specifically, the contractor proposed reinforcing the structure to accommodate the design deficiencies. The proposed solution consisted of the following:

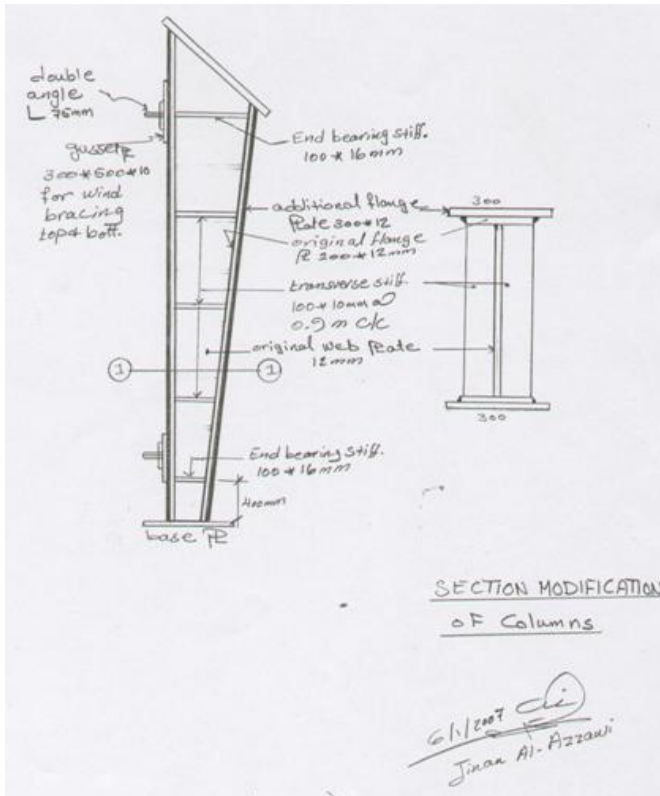
Figure 1. Strengthening columns

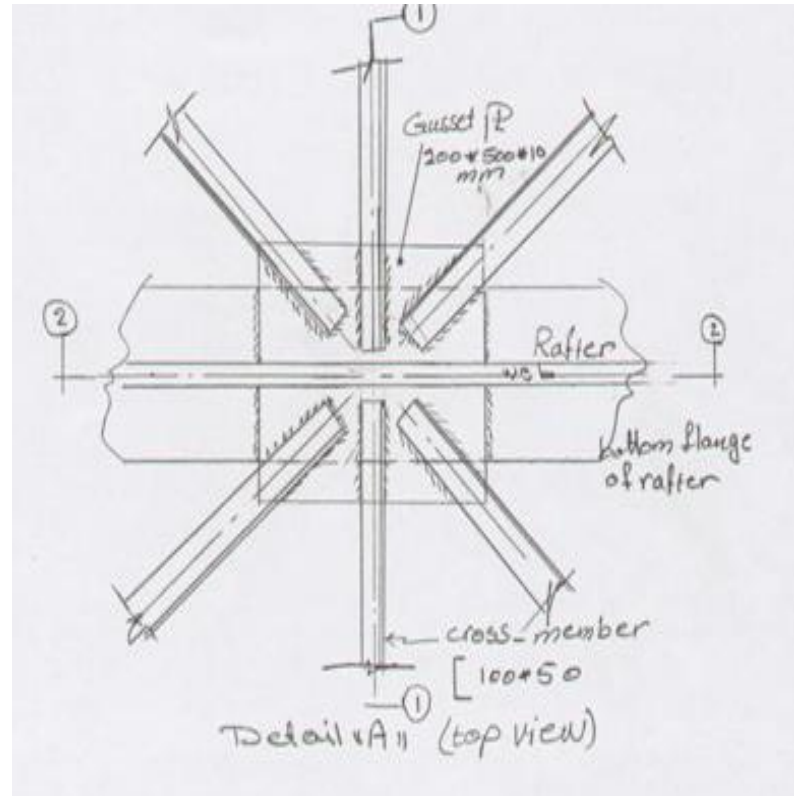
Figure 2. Additional bracing

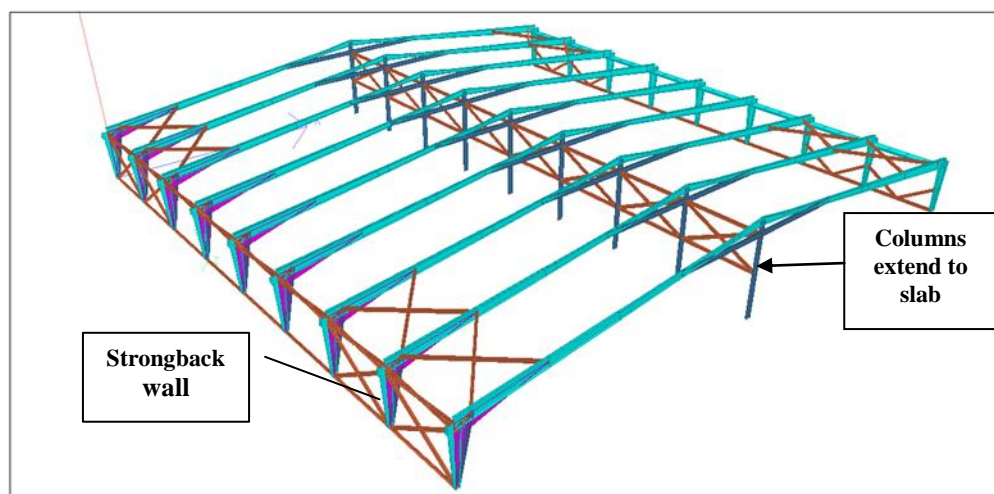
**Figure 3. Three-dimensional model of contractor-proposed improvements (Courtesy of GRC)**

Figure 3 illustrates the proposed new steel columns along the centerline, extending to the floor. However, by this time, the interior vault rooms had already been constructed, including a reinforced-concrete beam and partition wall running the length of the building, beneath the centerline of the steel frames. Based upon review of the October 2007 QA reports, it appeared that the contractor performed a modified approach to placing the columns. A base plate was placed on the top of the reinforced-concrete beam, and the columns were welded to the base plate (Site Photo 3). Consequently, this model and corresponding structural analysis do not account for the additional load to the reinforced-concrete beam, supporting columns, and foundation.

of the beam indicates that the original designer did not anticipate the wall to be a structural element.

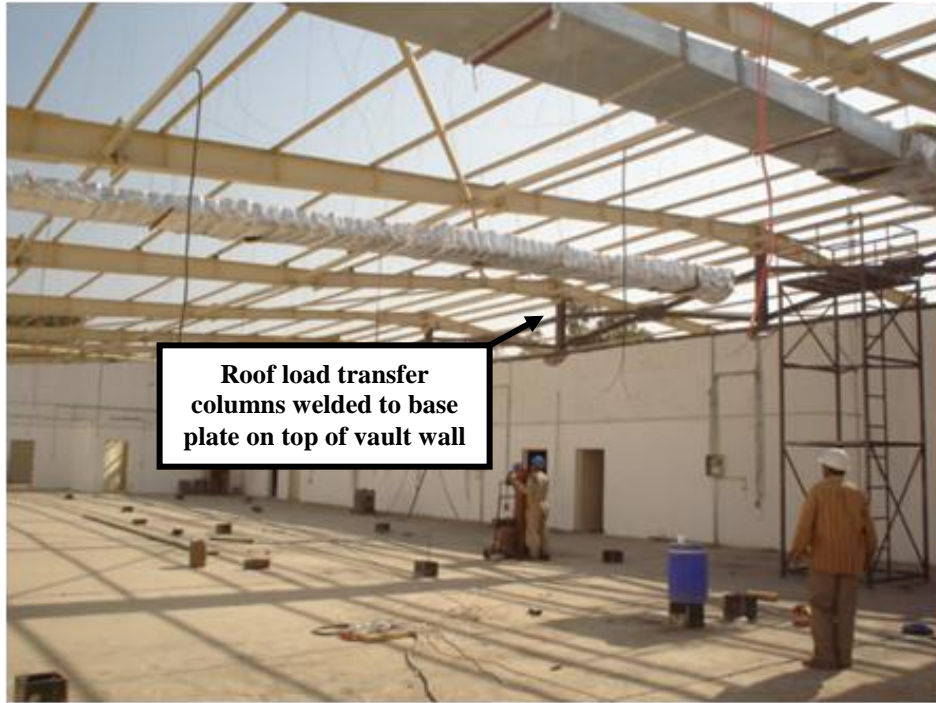
Site Photo 3. Base plate and columns (Courtesy of GRC)

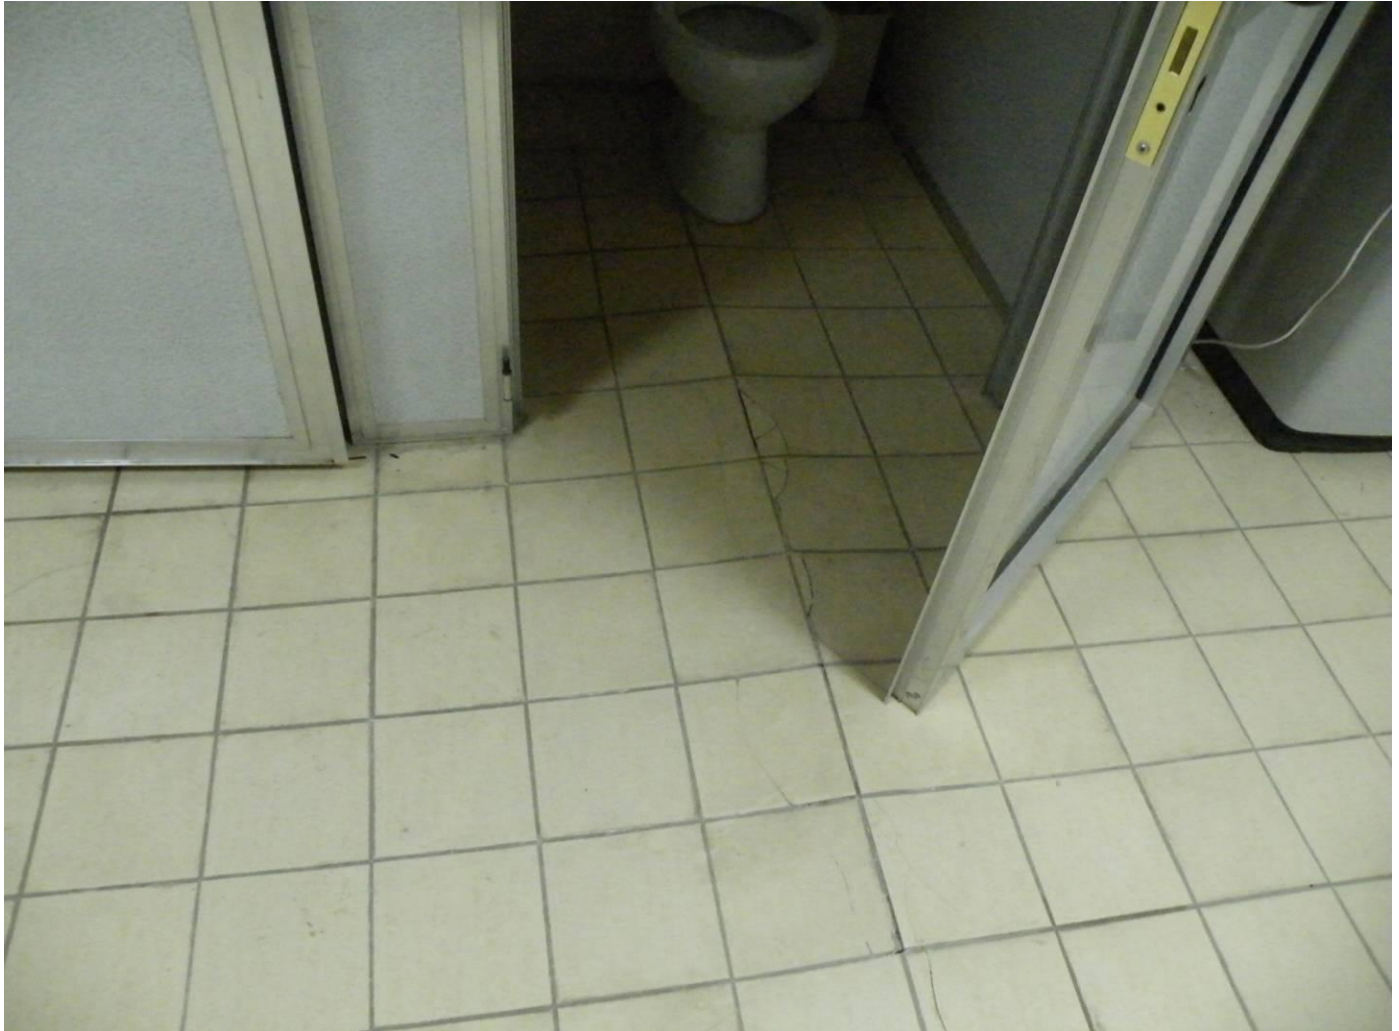
The SOW required the construction of four masonry wall 4.6m x 4.6m latrines—two male and two female (one eastern-style and one western-style toilet in each latrine). SIGIR visited all four latrines. SIGIR identified low-quality (not durable) sink fixtures leaking in two of the latrines. In addition, SIGIR noticed that the tile floors were either cracked or buckled due to poor installation (Site Photo 8). The SDSF facility manager stated that the hot water heater in one of the male latrines consistently burned out, even after the IHT replaced it. SIGIR inspected the hot water heater but could not determine if the problem was inferior hot water heaters or a more serious wiring issue.

**Site Photo 8. Example of tile cracking and buckling inside SDSF latrine**

1. Repair the floor in all four bathrooms.
2. Repair the HVAC duct insulation and reconnect the flex duct to the registers.

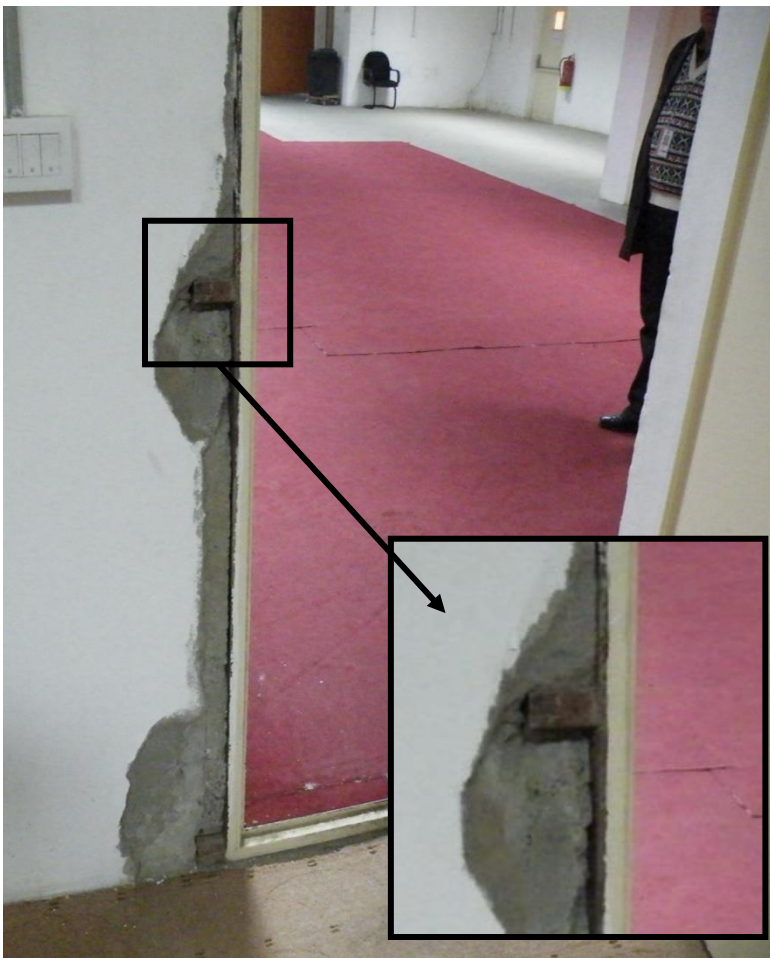
Throughout the SDSF, SIGIR observed significant damage to the interior and exterior door frames (Site Photo 9). According to the SDSF facility manager, the original doors used were too heavy and the door assembly fell out of the wall, which caused damage to the surrounding walls. The SDSF facility manager stated that IHT maintenance personnel were able to reattach the door, but at the time of the site visit, the surrounding walls had not been repaired.

SIGIR did observe damage to both interior and exterior door frames. Site Photo 9 shows a poorly installed door frame. The frame anchor is not embedded into the concrete block wall securely; instead, it is outside the block wall, which left the door frame being secured by the plaster covering the block wall. The door frame is too heavy for the plaster and eventually cracked the plaster and fell off. The SDSF facility manager stated that IHT maintenance personnel had reattached several door frames throughout the facility; therefore, SIGIR could not assess the quality of the contractor’s door frame installation. (The door frames that did not fall off were still covered with plaster; the door frames that did fall off had been reattached by IHT maintenance personnel.)

Site Photo 9. Interior door damage

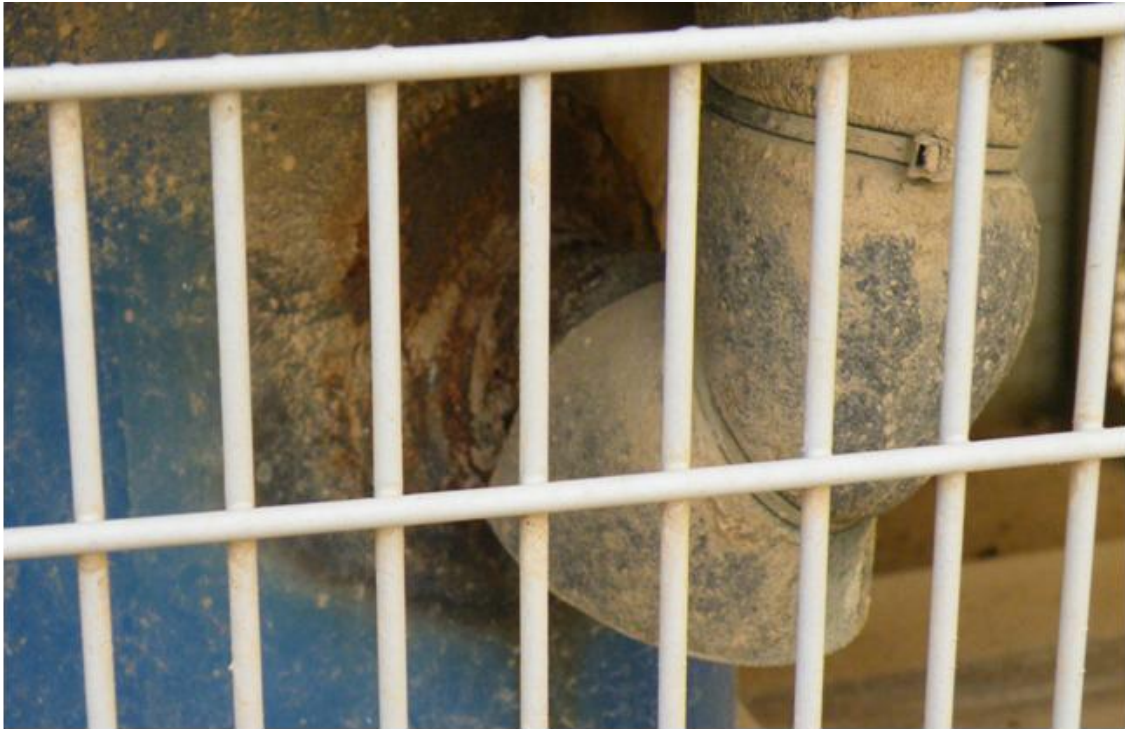
**Site Photo 13. Welding done on HVAC unit**

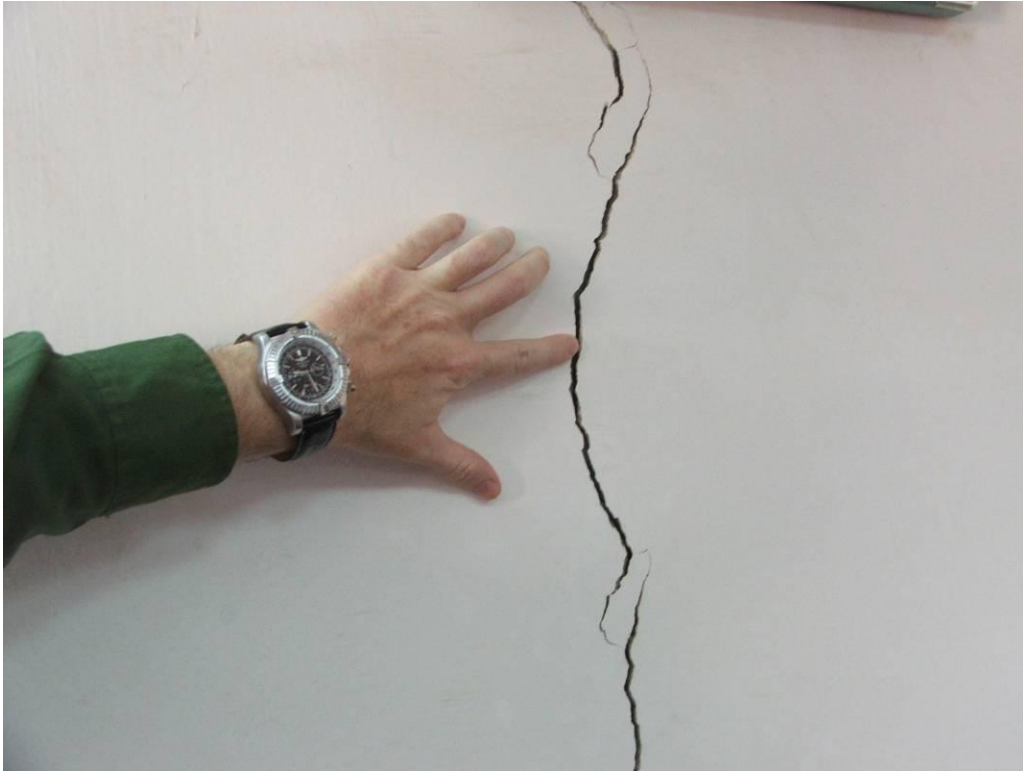
SIGIR observed numerous large cracks to the interior and exterior walls throughout the facility (Site Photo 14). GRC inspected the interior walls and stated that the "cracks in the plaster are caused by expansion and contraction of the plaster. The cracks extend only through the plaster not into the structure." Therefore, GRC did not view the wall cracks as warranty items. However, the cracks are an indication of poor-quality construction; considering that the wall cracks occurred before the facility was even one year old, SIGIR is concerned that these cracks will continue to spread and new cracks will emerge. SIGIR believes that the wall cracks should be addressed under the warranty.

**Site Photo 14. Example of cracking of interior wall**

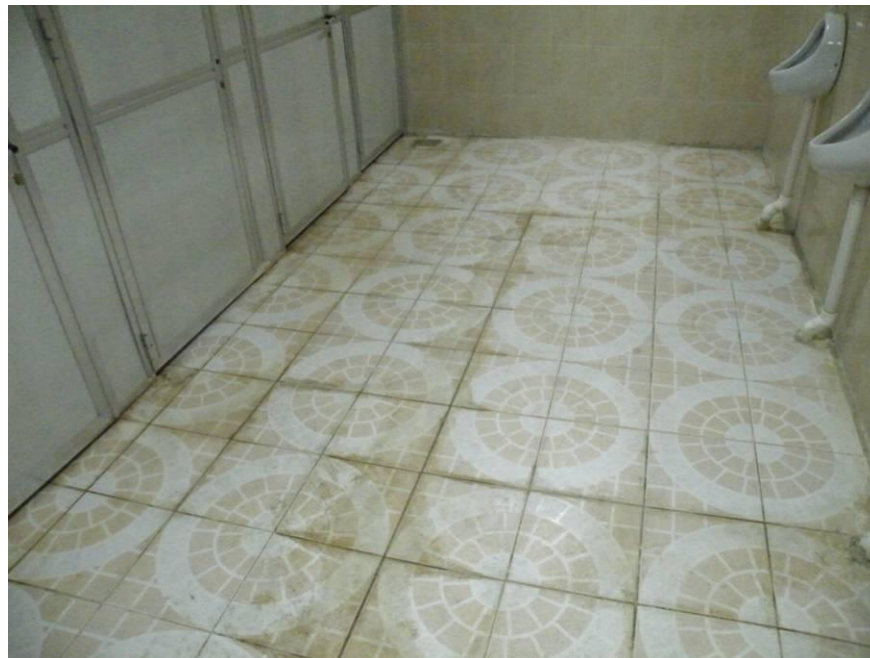
**Site Photo 15. Contractor replaced previously cracked and buckling floor tiles (See Site Photo 8 for original condition of bathroom floor.)**

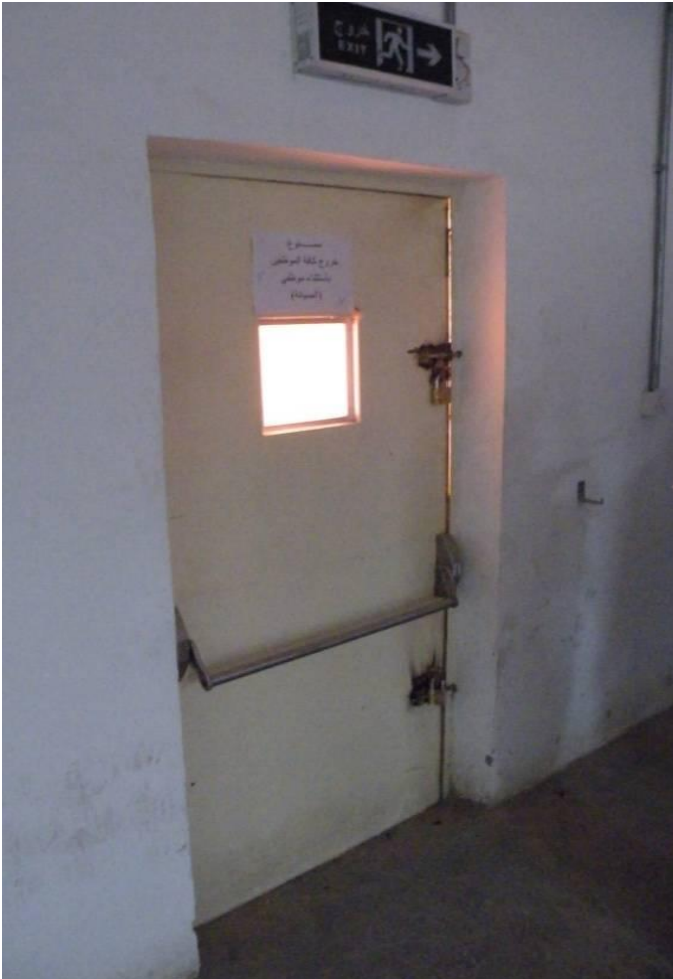
Site Photo 16. Newly installed security door funded by the IHT

In addition, the IHT used its own funding to correct some of the other issues not covered by the warranty, such as the HVAC units and interior/exterior doors. The IHT purchased several condensers, which remedied the HVAC unit problems; purchased a small air-conditioning unit for the room without air vents; and purchased and installed quality security doors and frames (Site Photo 16). SIGIR noted several wall cracks; however, the SDSF facility manager stated that the IHT maintenance personnel will continue to patch the wall cracks as they appear (Site Photo 17).

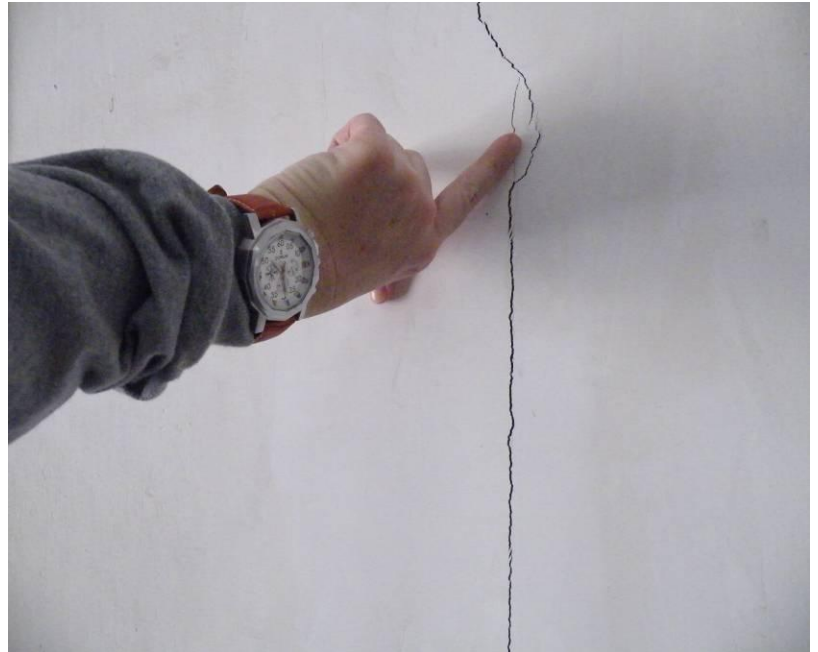
Site Photo 17. Wall crack again appearing even after IHT patched it (see Site Photo 14 for original wall crack)
