**MUJARRAH CANAL BRIDGE  
RAMADI, IRAQ**

**SIGIR PA-09-170  
JULY 14, 2009**

## Mujarrah Canal Bridge

### Summary of Report: PA-09-170

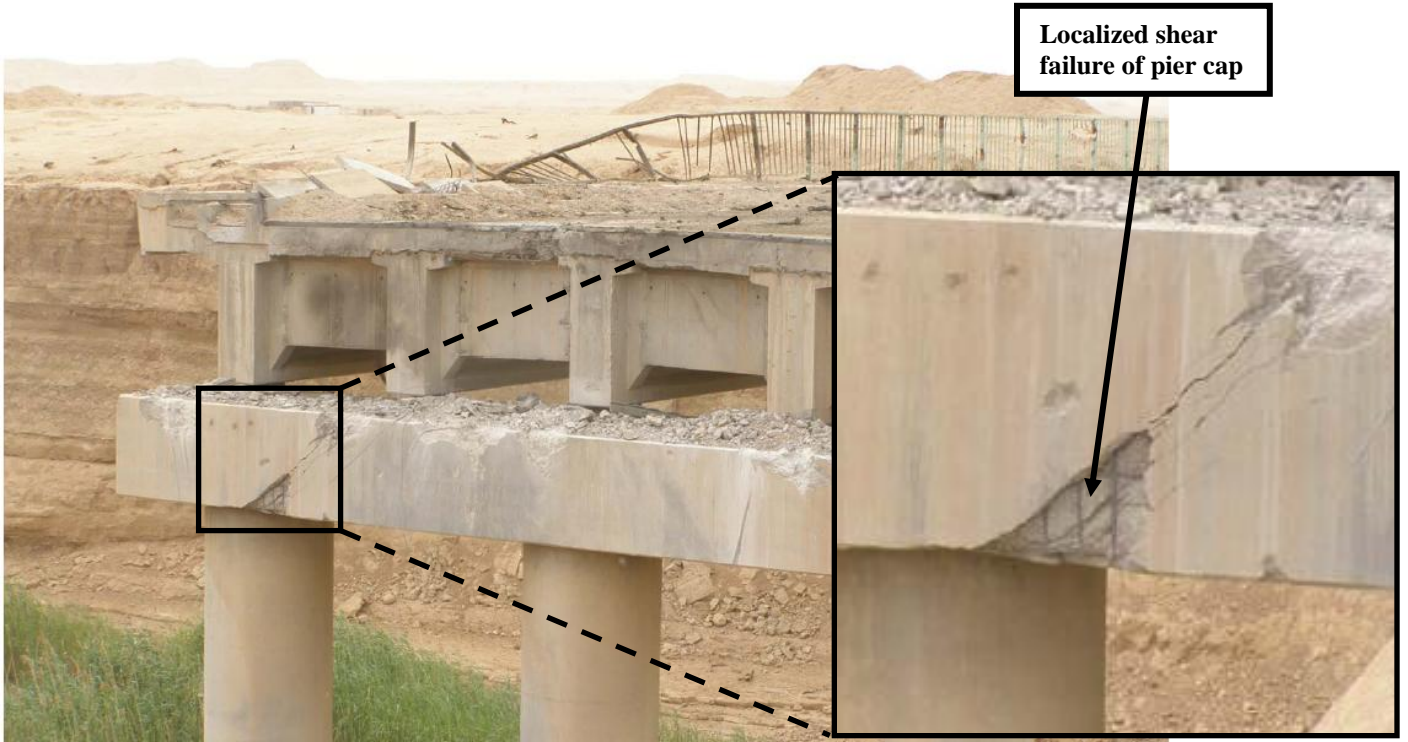
**Site Photo 3. VBIED damage to the Mugarrah Canal Bridge's pier cap at Bent No. 1 (Courtesy of GRC)**

Damage from the VBIED resulted in a shear failure<sup>3</sup> of the reinforced-concrete pier cap at Bent No. 1 and a collapse of Span No. 1. Abutment No. 1 was also damaged, most likely as secondary damage caused by the collapse of Span No. 1. The project file documentation also identified other damage:

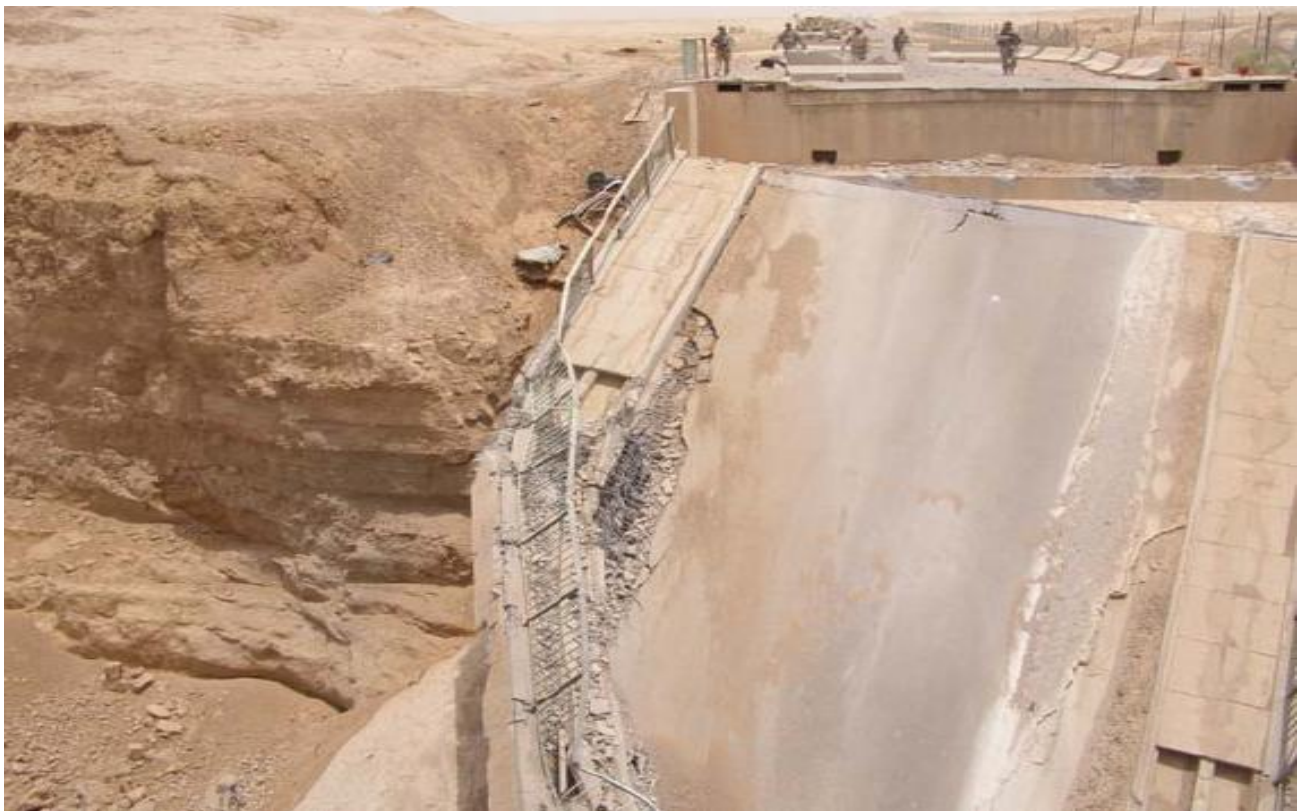
According to project file documentation, in May 2007, a VBIED was detonated on the eastern span (Span No. 1) of the structure. The detonation caused damage to the pier cap (the beam across the column top) of Bent No. 1 and post-tensioned concrete girders, resulting in the collapse of Span No. 1 (Site Photos 3 and 4).

**Site Photo 4. Mugarrah Canal Bridge with VBIED damage to Span No. 1 (Courtesy of GRC)**

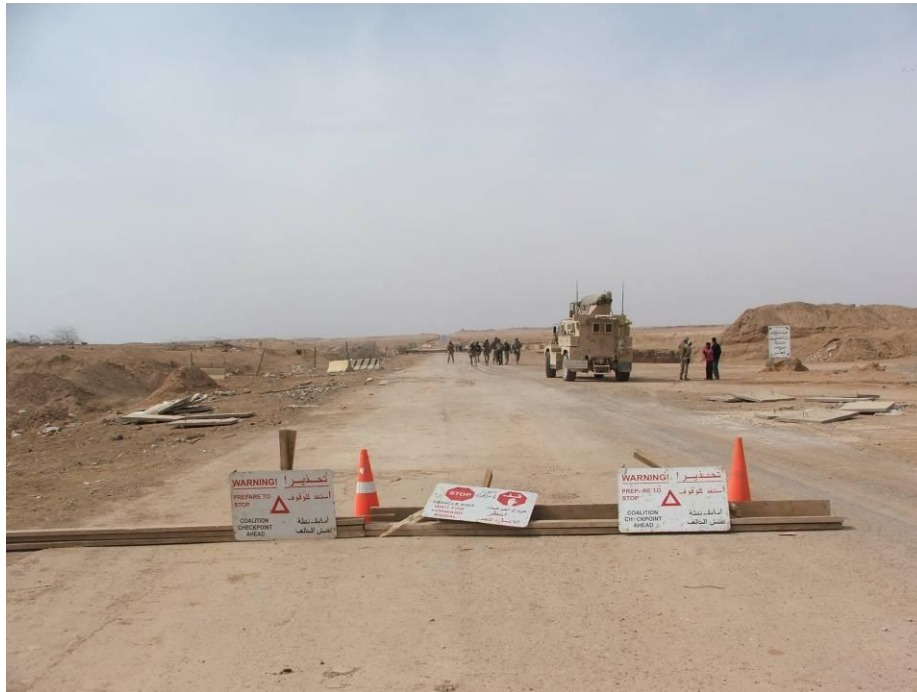
SIGIR observed warning signs near the project with concrete or timber barricades across the roadway at either end of the project site (Site Photo 6); however, it is questionable

whether the distance from the signage to the structure is adequate for vehicles to perform a controlled stop.

The methods employed at the site to protect traffic and pedestrians do not meet the contract specifications, and they expose the traveling public to danger. Also, any collision with the structure will damage the work in progress, resulting in a serious setback to the contractor's completion schedule, which has already been significantly delayed.

**Site Photo 6. Traffic control signs looking south across the bridge**

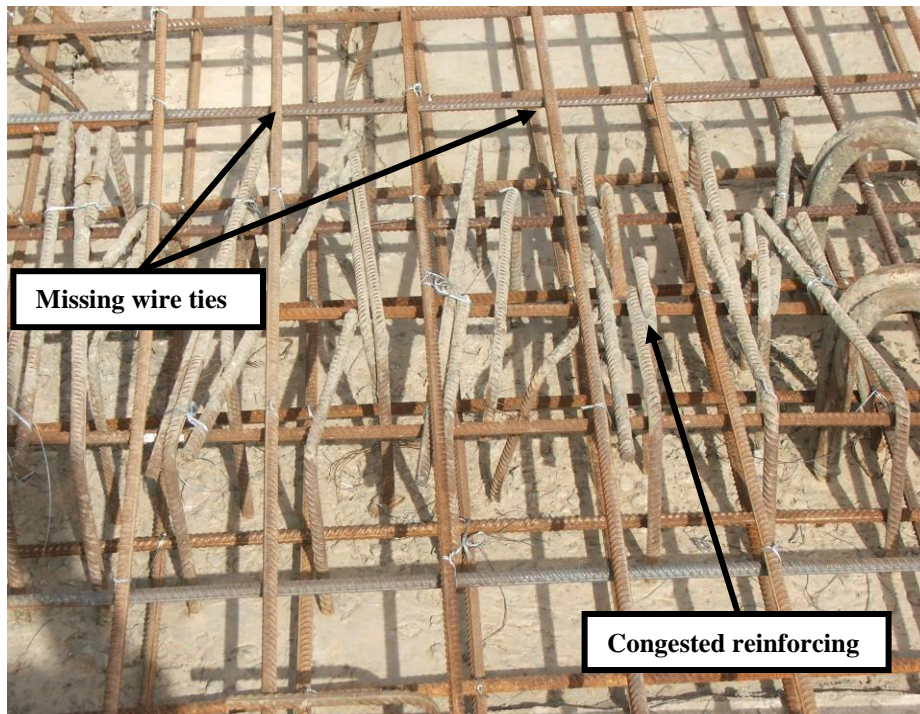
SIGIR noted several issues with the placement of the reinforcing for the concrete deck. For example, near the ends of the girders, SIGIR found areas of severe reinforcing steel congestion (Site Photo 9.) SIGIR is concerned that this configuration of reinforcing steel may prevent homogeneous concrete placement, which would result in voids in the deck. Since the purpose of the reinforcing steel in this area is to create composite action

between the deck and the girders, voids beneath the reinforcing could reduce the capacity of the structure.

**Site Photo 9. Reinforcing congestion and missing wire ties at girder ends**

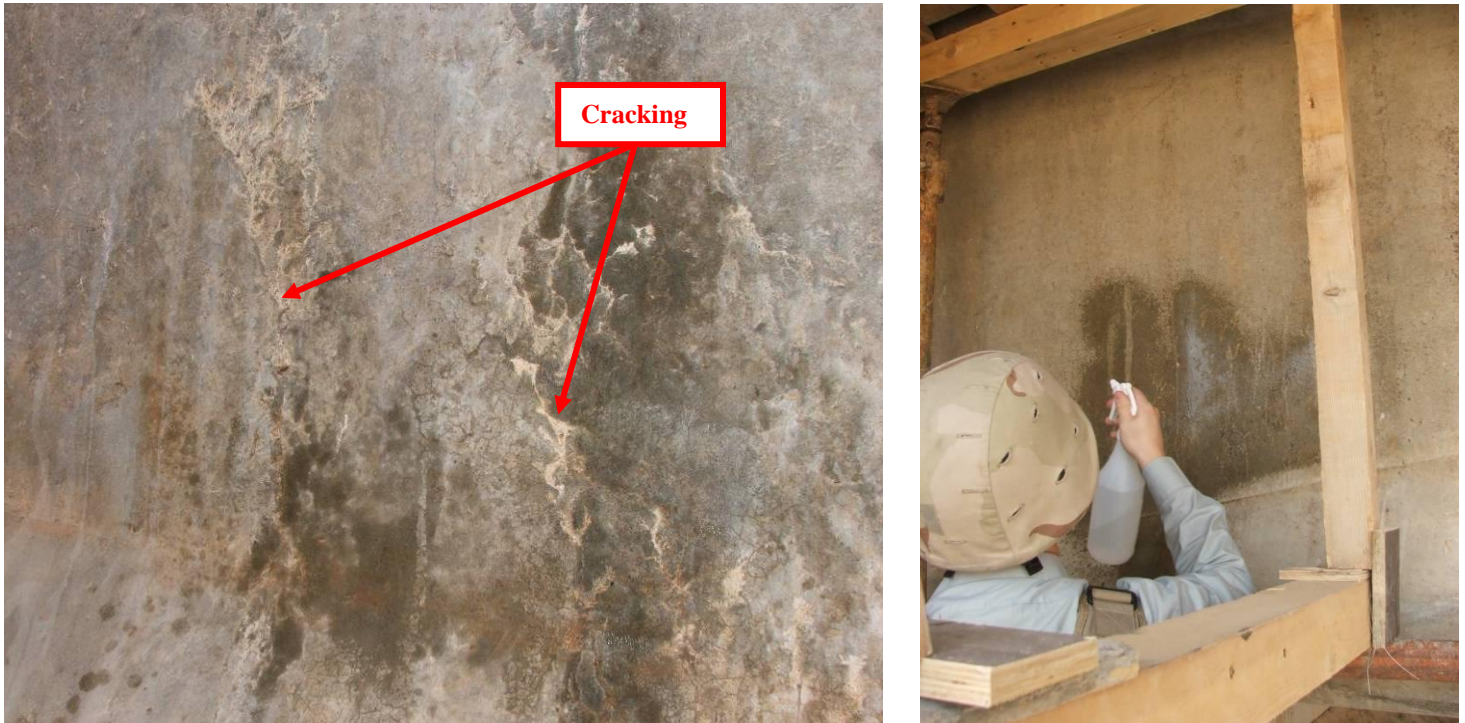
SIGIR observed no exposed honeycombing<sup>8</sup> but did identify hairline cracking on the girders. Using squirt bottles, SIGIR sprayed water onto the concrete girders to wash away dirt and make any existing cracks more visible (Photo 11 and 12). Due to time limitations, SIGIR could not map the cracking or determine if the quantity and depth of the cracks are indicators of significant issues with the beams. Any visible cracking, specifically vertical and diagonal, are indicators of potentially serious issues with either post-tensioning or shear reinforcement.<sup>9</sup> In a draft of this report, SIGIR recommended that the GRC Fallujah Resident Office further investigate and determine the seriousness

of the cracks. A Fallujah Resident Office team conducted an on-site inspection on 20 May 2009. Their inspection revealed no structural cracking, only minor surface shrinkage cracks and cracks caused by form irregularities.

**Site Photos 11 and 12. Cracking at girder ends**

SIGIR recommends that the Gulf Region Division of the U.S. Army Corps of Engineers investigate the hairline cracks on the girders and determine if the quantity and depth of the cracks are indicators of significant issues with the beams and take necessary corrective actions.

GRD concurred with the recommendation and provided the results of an investigation by the Fallujah Resident Office team conducted on-site on 20 May 2009. Their investigation revealed no structural cracking, only minor surface shrinkage cracks and cracks caused by form irregularities.

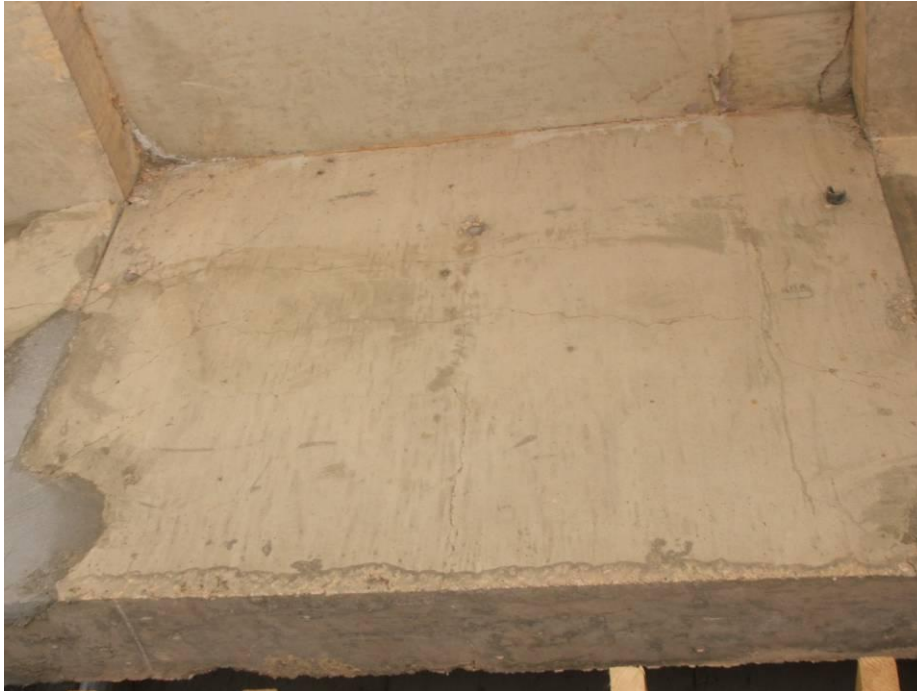
SIGIR examined some of the existing bridge structure near Pier Cap No. 1. Several of the end diaphragms for Span No. 2 had been damaged in the VBIED detonation, and the panels show varying degrees of attempted repair.

The existing end-diaphragm panel near the center of the pier appeared to have been shattered (Site Photo 14). The horizontal and vertical cracking through the center of the panel indicated that the panel has completely failed and offered limited resistance as a diaphragm. An attempt appeared to have been made to patch some of the damaged areas of the panel; however, due to its complete failure, a more comprehensive repair or complete replacement of this panel should have been considered.

**Site Photo 14. Existing damaged diaphragm at Bent No. 1**
