AMMANA MARKET RENOVATION
MAJJASIM, IRAQ

SUSTAINMENT ASSESSMENT

SIGIR PA-09-171
JULY 30, 2009

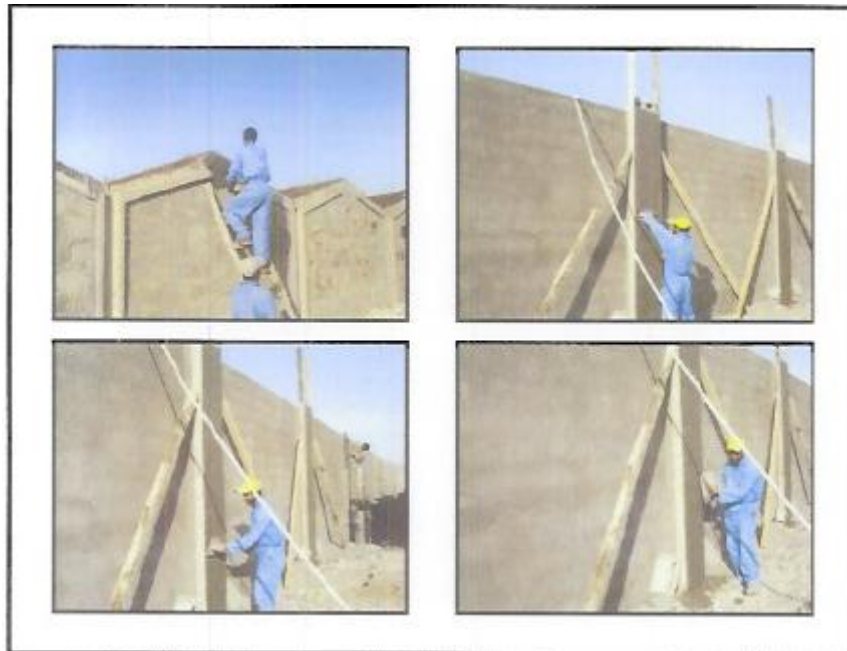
Site Photo 1. Construction of perimeter security wall (Courtesy of MNC-I)

According to the available project file documentation, the contractor provided at least three progress reports during the course of the project. However, the project file contained only the last progress report, which included pictures to verify progress and completion of work. The photos document the construction of the perimeter wall (Site Photo 1), the construction of the market buildings, and the painting of the interior market shops.

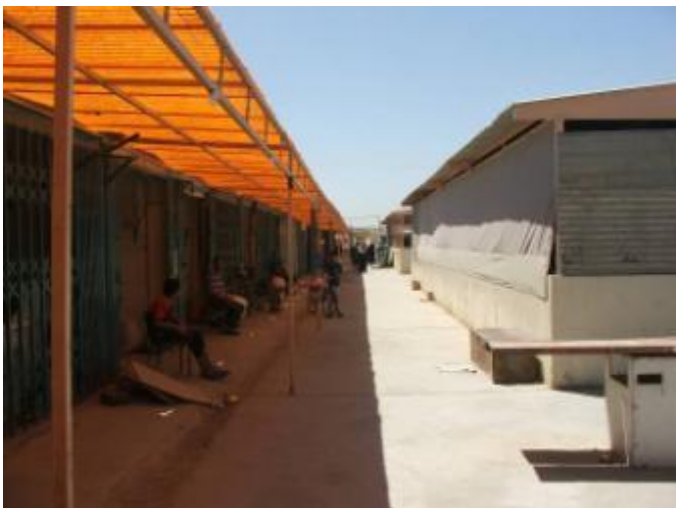
Site Photo 2. Slab along existing shops

The concrete pad was constructed with expansion joints along the edges of the existing shops (Site Photo 2) and in the parking area (Site Photo 3); however, it was not apparent whether expansion joints were constructed in the slab beneath the steel truss roofs of the market stalls. Also, the contractor did not maintain the site: a bicycle had been ridden through the wet concrete.

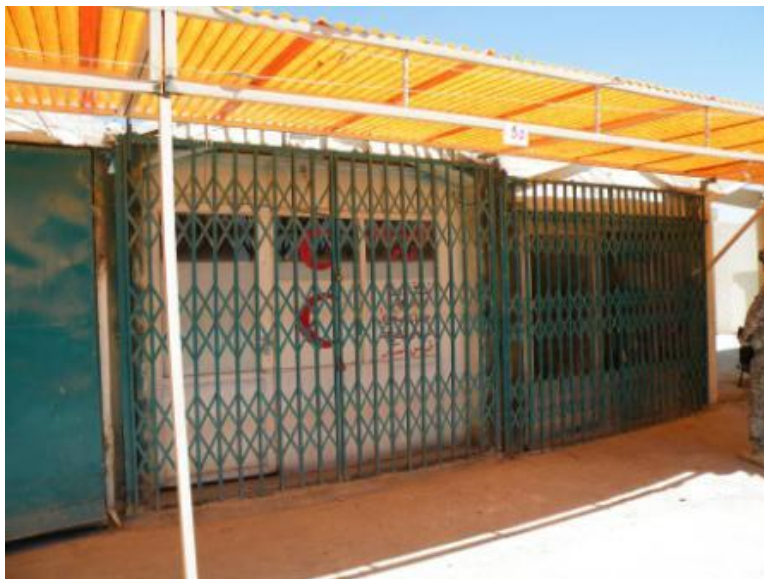
Site Photo 12. Security doors and grills

The individual market shops had either solid steel doors or folding metal grills for security (Site Photo 12). The quality of the doors appeared to be typical of locally available materials. Several doors inspected had padlocks as required in the SOW.

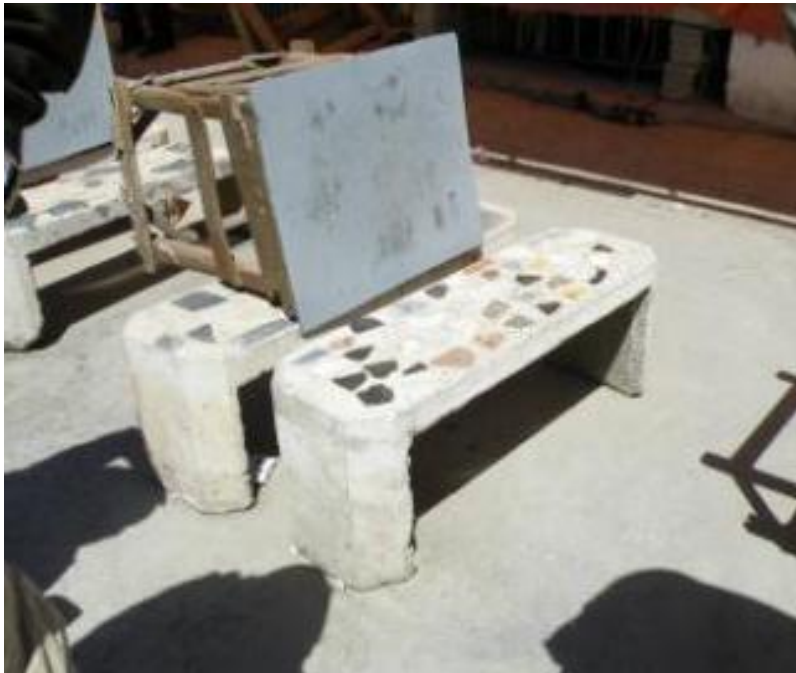
Site Photo 13. Pre-cast concrete benches

The SOW required the contractor to provide six pre-cast concrete benches for the project; however, the project file documentation lacked design information. SIGIR verified the presence of six pre-cast concrete benches on the project (Site Photo 13), which appeared to be of poor quality.

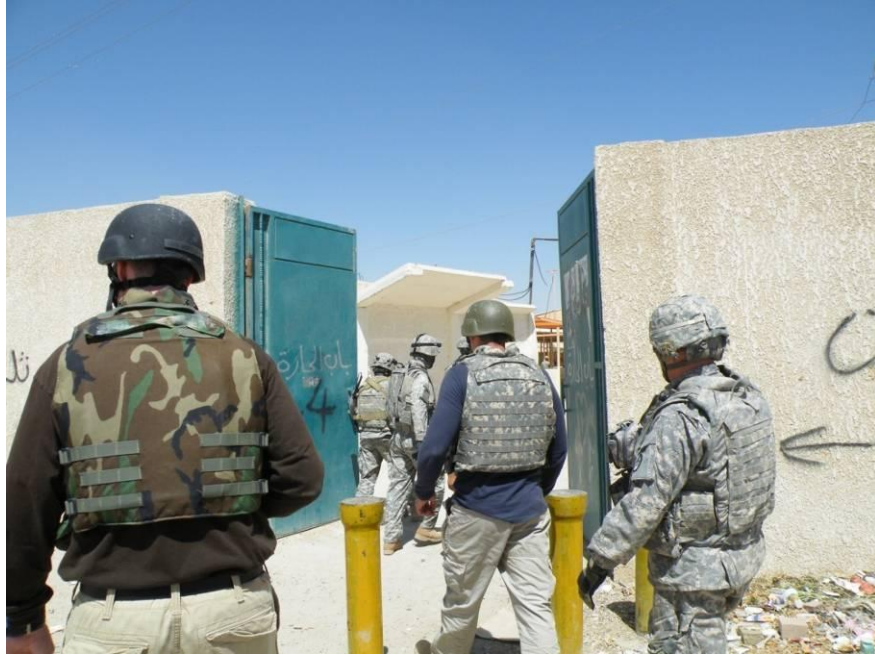
Site Photo 14. Bollards and pedestrian gate

The security wall appeared to be constructed to the general overall dimensions indicated on the plans and in the SOW. The security wall had pillars installed at regular intervals. The construction appeared to be of decent quality, with no apparent cracking or settling of the wall (Site Photo 14).

The SOW required the contractor to install brackets and four strands of barbed wire along the top of the security wall. SIGIR observed that the security wall did not have brackets or barbed wire.

The contractor installed the pedestrian and vehicle gates in the perimeter security fence. The pedestrian entrances required bollards (safety guards) on their exterior to prevent vehicles from being driven directly into the market area. SIGIR noted that the bollards were constructed in the same general configuration as indicated on the plans (Site Photo 14).

The pedestrian and vehicular gates were constructed with a locking mechanism as required in the SOW, and the gates were generally the same height as the security fence. The SOW required the vehicular and pedestrian gates to be topped with four strands of barbed wire, similar to the specifications for the security wall. SIGIR noted that the pedestrian and vehicular gates were not topped with any barbed wire.

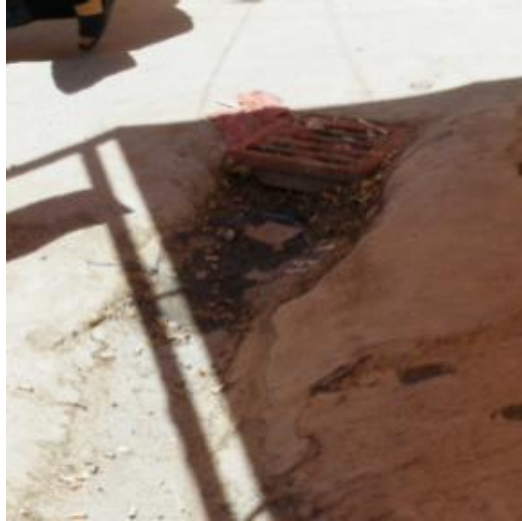
Site Photo 17. Gutter inlet

During the site visit, SIGIR identified drainage gutters in the concrete slab around the perimeter of the market courtyard. The drainage gutters consisted of a V-channel slope and allowed drainage to flow to the cast iron inlet grate (Site Photo 17). Because of time constraints, SIGIR was unable to determine whether the inlets were connected to a larger drainage system.

The drainage gutters were not covered with a perforated cover as required in the SOW. However, the use of perforated covers could be problematic. Perforated covers on the drainage channels would likely become clogged with debris, reduce their effectiveness, and require continual maintenance.
