ABU GHRAIB DAIRY
ABU GHRAIB, IRAQ

SIGIR PA-09-172
JANUARY 14, 2010

Abu Ghraib Dairy

Summary of Report: PA-09-172

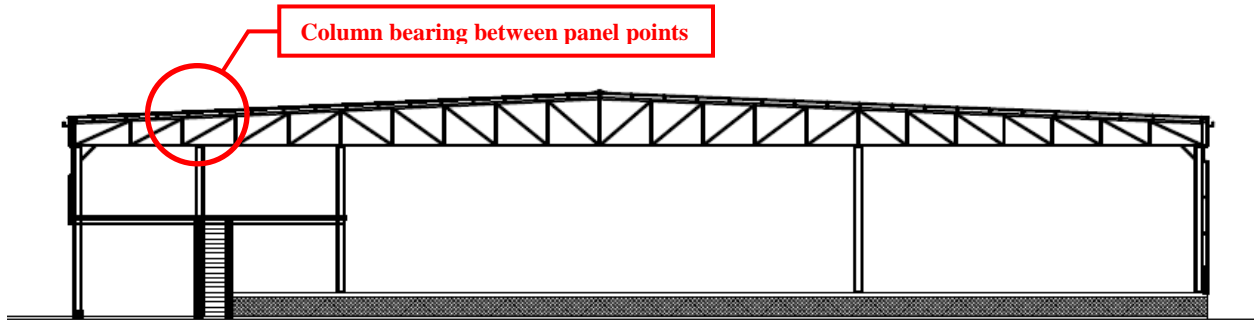
In the area of the mezzanine, the plans show additional columns (Figure 3), which extend through the mezzanine to the underside of the truss. The additional bearing locations provided by these columns are not at a truss panel point. The resulting reactions from these columns will introduce bending into the lower chord of the truss. SIGIR is

concerned that the members used in the lower chord of the truss are relatively light and do not appear to have the capacity to resist a significant amount of bending stress in addition to the compressive load that will result from the intermediate support.

Figure 3. Truss configuration at mezzanine level

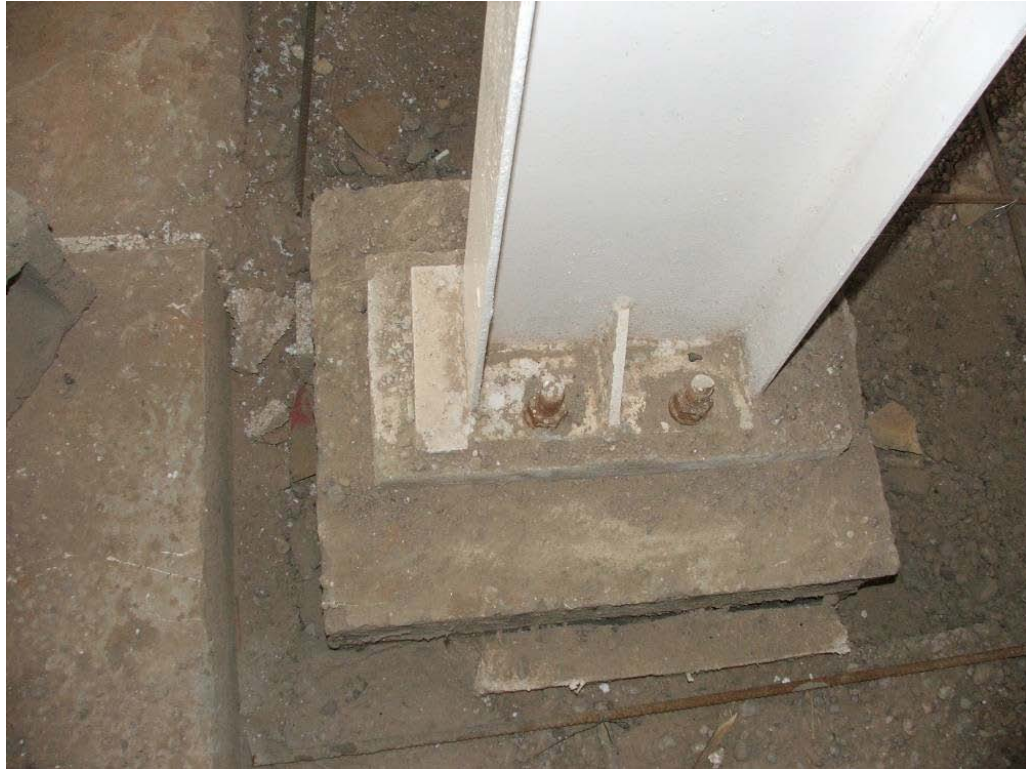
At the time of the site visit, the foundations for the facility were installed. The foundation system appeared to be concrete pedestals with steel anchor bolts attached to the base plates of the steel columns (Site Photo 1). The foundation system also included spread footings to support the concrete pedestals and columns. Since the foundation was in the later stages of construction, only the upper portion of the foundation was exposed for inspection; consequently, SIGIR could not verify the construction of the foundation.

Site Photo 1. Typical foundation pedestal and anchor bolts

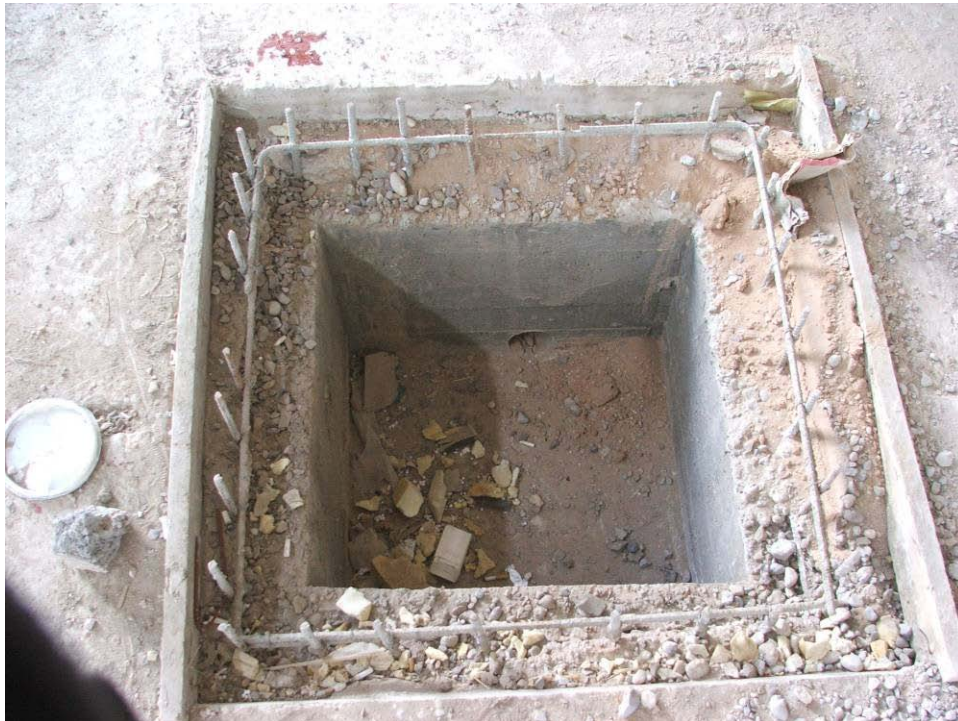
SIGIR observed sanitary sewer manholes in several locations in the floor (Site Photo 12). The sanitary manholes were constructed as cast-in-place reinforced concrete with polyvinyl chloride sewer piping cast directly into the manhole walls. The contractor failed to install a manhole on the interior of the building; instead the contractor installed a polyvinyl chloride elbow. This will result in future problems because the sewer line is not accessible for cleaning.

Site Photo 12. Cast-in-place sanitary sewer manhole

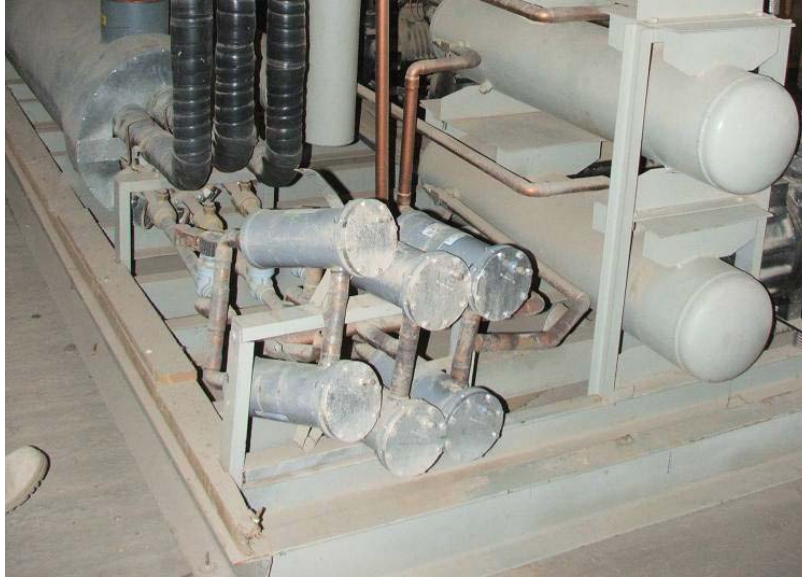
With the exception of one large piece of equipment already located inside the newly constructed facility, the milk processing and packaging equipment is stored inside a leaking warehouse²³ near the Abu Ghraib Dairy (on the Ministry of Industry and Minerals compound). SIGIR toured the warehouse and found most of the equipment in its original packaging and appeared to be in good condition. One of the pieces of equipment sustained some damage due to either improper storage or handling (Site Photo 16). SIGIR was able to identify several pieces of equipment with visible nameplates (Site Photo 17), and the remainder of the equipment was labeled with shipping labels.

Site Photo 16. Damaged dairy production equipment

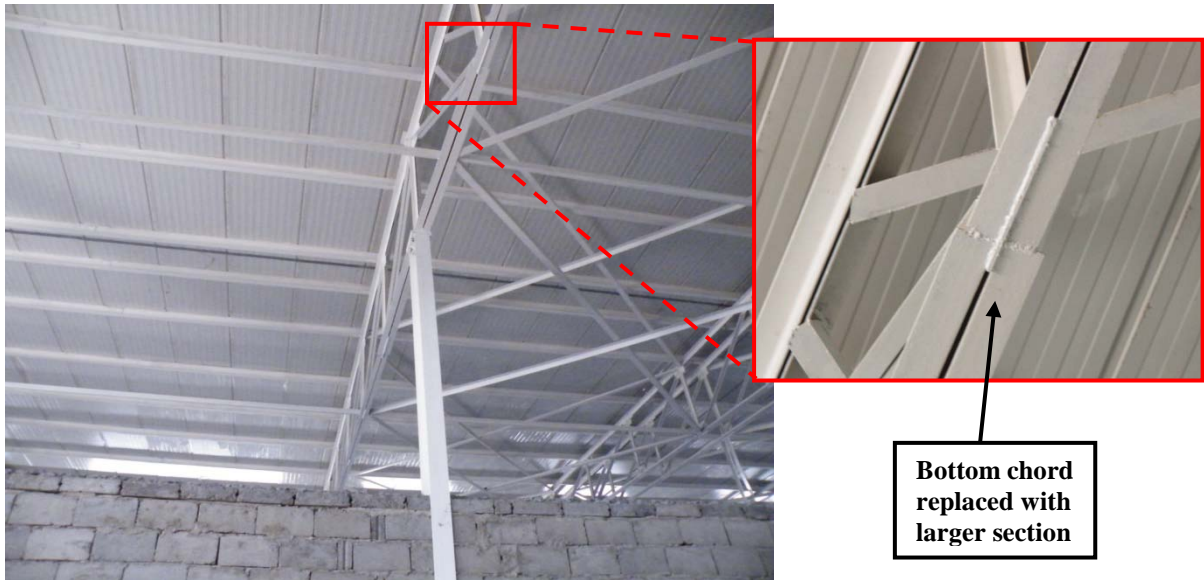
Site Photo 18. Contractor's truss modification

it was inadequate and replaced it with a larger section. Aerial lift capabilities were not available at the time of the site visit; therefore, a hands-on inspection of the repair could not be made. However, SIGIR was able to verify that the trusses had a larger bottom chord section in the areas previously noted as deficient (Site Photo 18).

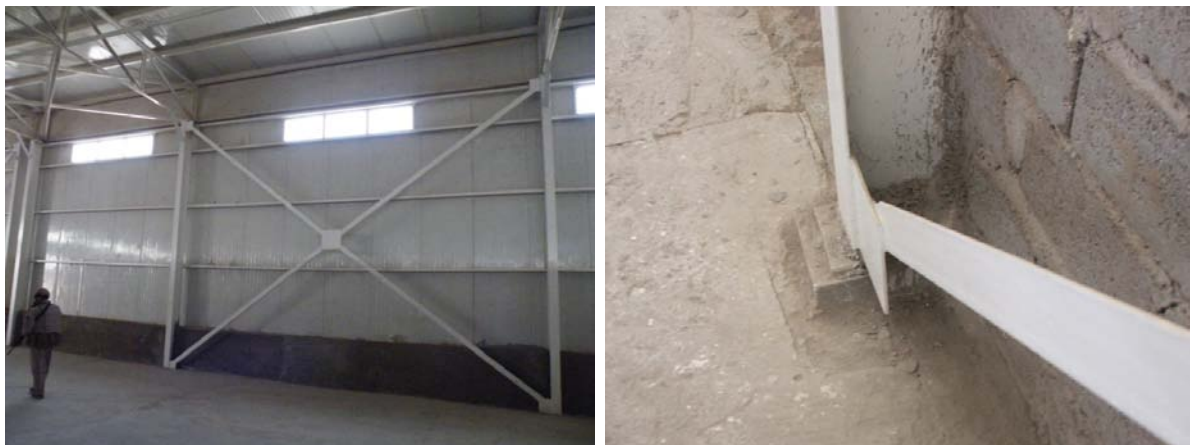
Site Photos 19 and 20. Cross bracing located to perimeter CMU wall interior

Previously, SIGIR noted that due to the contractor's deviation from the design drawings, the steel cross bracing for the structure conflicted with the CMU perimeter wall. To correct this, the contractor removed the CMU wall, relocated the steel cross bracing to the interior of the wall, and reconstructed the wall (Site Photos 19 and 20).

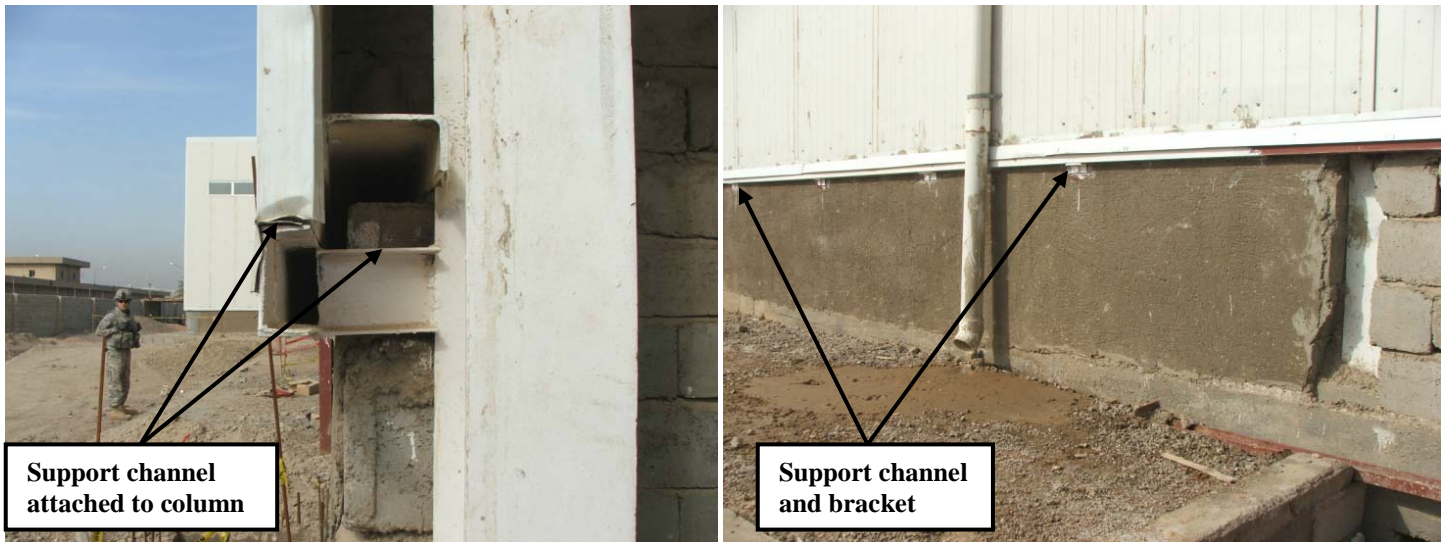
Another previously noted deficiency was the lack of support for the sandwich panels used as cladding for the building exterior. This lack of support was due to the contractor's deviation from the original design, which located the perimeter CMU wall to the interior of the steel framing. To remedy this situation, the contractor installed steel channels

Site Photos 21 and 22. Support channel for sandwich panel

around the perimeter of the building attached to the columns and supporting the panels (Site Photos 21 and 22).

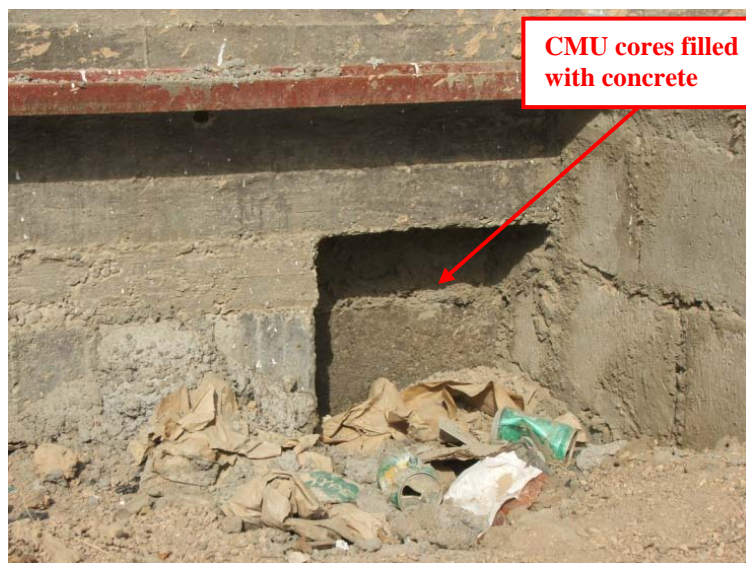
Site Photo 23. CMU cores filled with concrete

Initially, the contractor incorrectly placed CMUs with their sides' horizontal along the foundation wall. This orientation significantly weakened the CMUs. The contractor corrected this deficiency by using concrete to fill the cores of the CMUs, which provides increased strength to the wall (Site Photo 23).
