NATIONAL TRANSPORTATION SAFETY BOARD

HIGHWAY ACCIDENT REPORT

**TRANSPORT COMPANY OF TEXAS,
TRACTOR-SEMITRAILER (TANK) COLLISION
WITH BRIDGE COLUMN AND SUDDEN
DISPERSAL OF ANHYDROUS AMMONIA CARGO,
I-610 AT SOUTHWEST FREEWAY,**

REPORT NUMBER: NTSB - HAR - 77 - 1

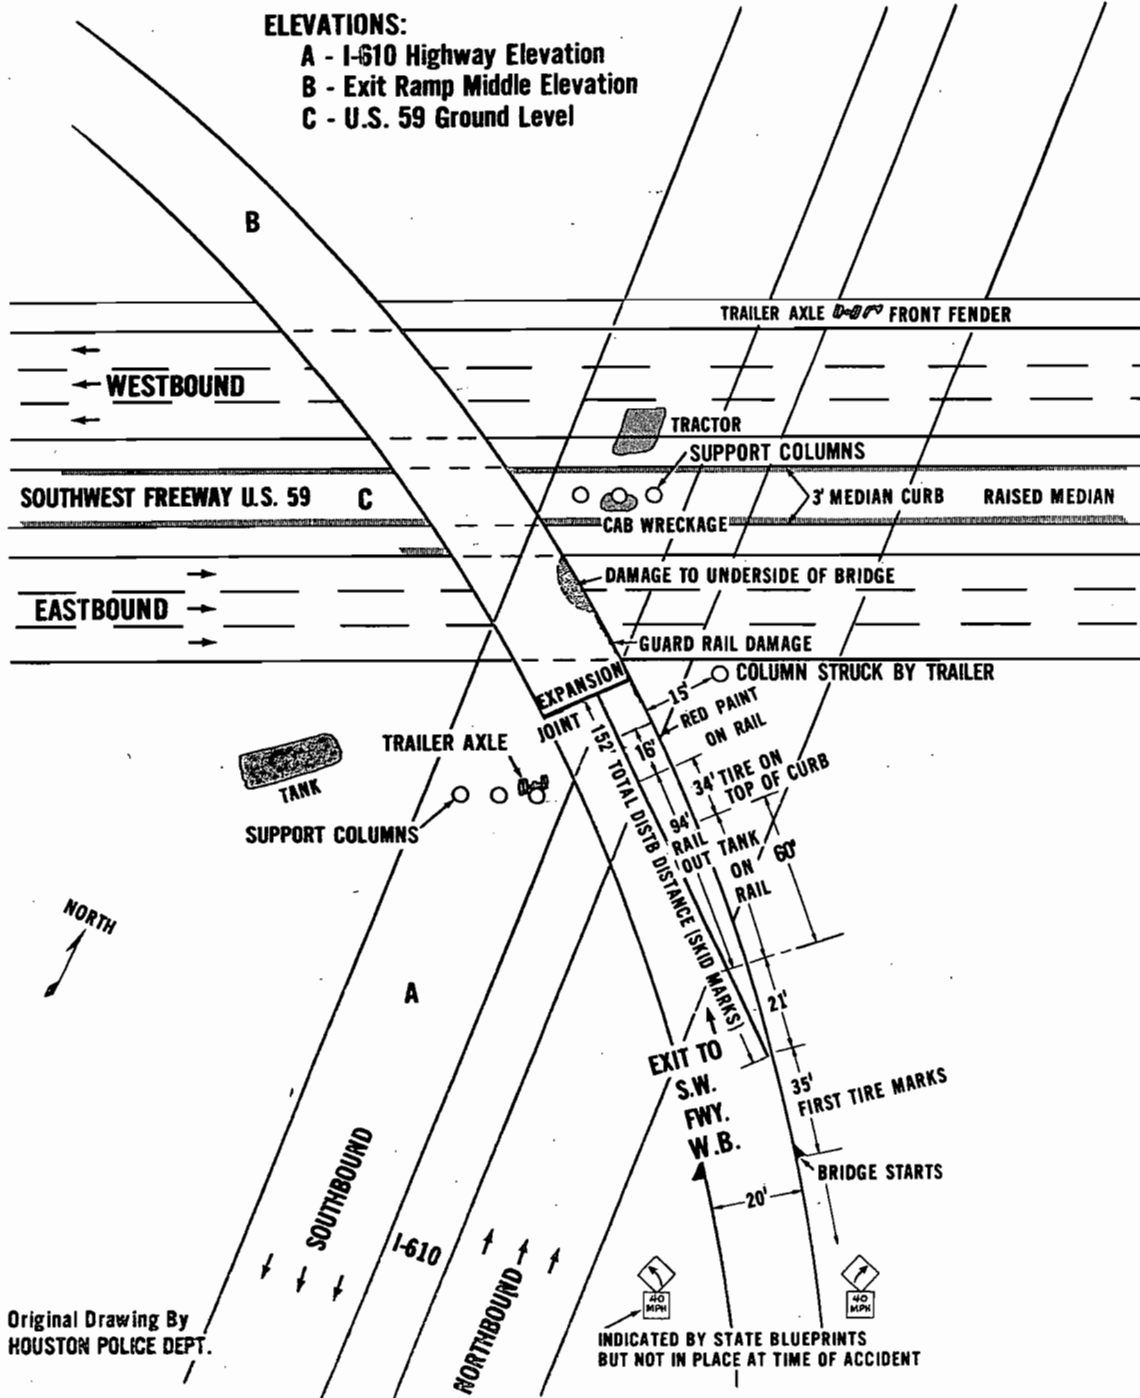
Figure 1. Plan view of accident site.

Shortly after entering the curved ramp, the tractor-semitrailer entered onto a bridge. (See figure 1.) The truck and the trailer began to roll to the right, its wheels struck the curb, and the combination vehicle began to leave the ramp. The upsetting tank crushed and penetrated the bridge rail, and the vehicle fell onto the Southwest Freeway, approximately 15 feet below. As it fell, the tank struck a support column of an overpass that crossed over the ramp on which the truck was traveling.

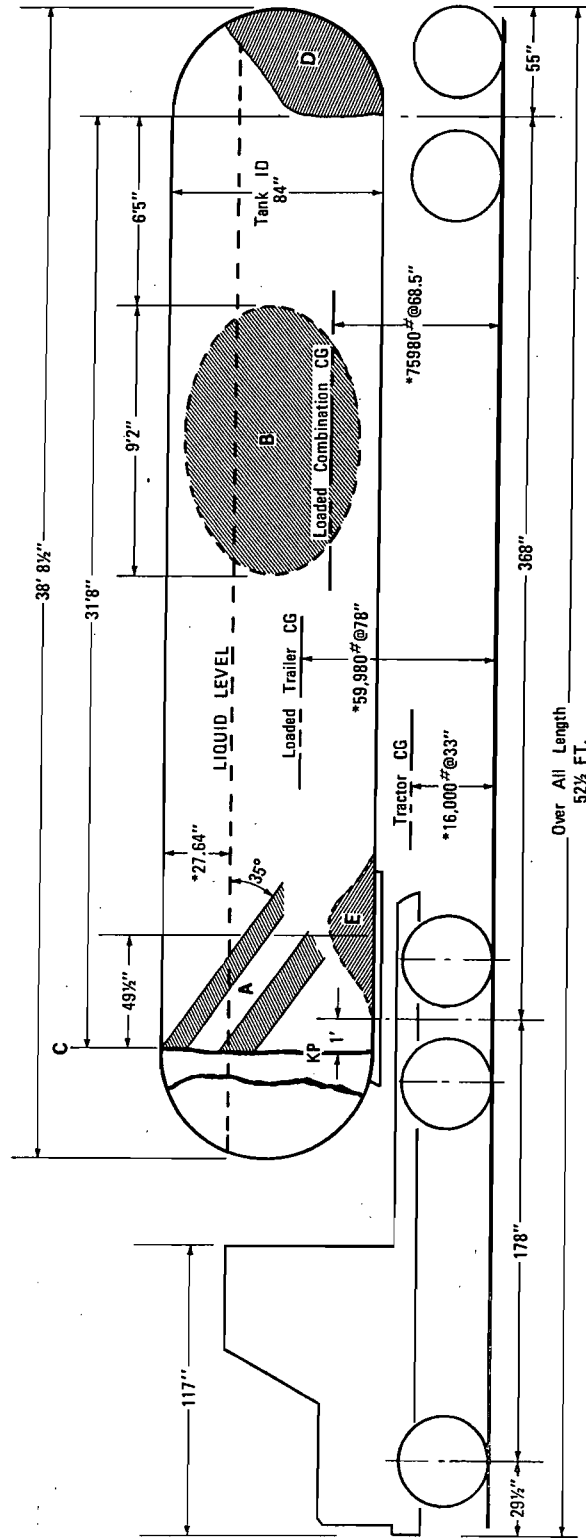
The semitrailer was a MC 331, 2-axle, 10,500-gallon cargo tank, manufactured in 1969 by the Dal-Worth Tank Company. At the time of the accident, the tank was 71.8 percent full. (See figure 3.)

- A - Scrape marks on right (or curb) side
 - B - Indentation on left (or road) side
 - C - Two front head parts
 - D - Approximate hole size at rear head
 - E - Transverse inward dent across bottom
- * CALCULATED FIGURES

Figure 3. Physical dimensions of tractor-semitrailer. Letters indicate damage to semitrailer explained in appendix A.

Assuming that the truck was entering the curve at 53.6 mph, the calculated centrifugal force on the vehicle was 29,458 pounds. The loaded vehicle's center of gravity (CG) height was calculated to be 68.5 inches above the road. (See figure 3.) At this CG height the lateral force necessary to overturn the vehicle at 53.6 mph is 49,918 pounds. Therefore, the truck should not have overturned at a speed of only 53.6 mph. At a CG height of 68.5 inches and with a solid, non-fluid cargo, this vehicle should have been able to negotiate the 493-foot-radius curve ^{3/} at a speed up to 69.6 mph without overturning. The fact that the vehicle did overturn and that the cargo was a liquid that was loaded to only 71.8 percent of the tank's capacity suggests that transverse loadings resulting from lateral liquid surge contributed significantly to the overturn of the vehicle.

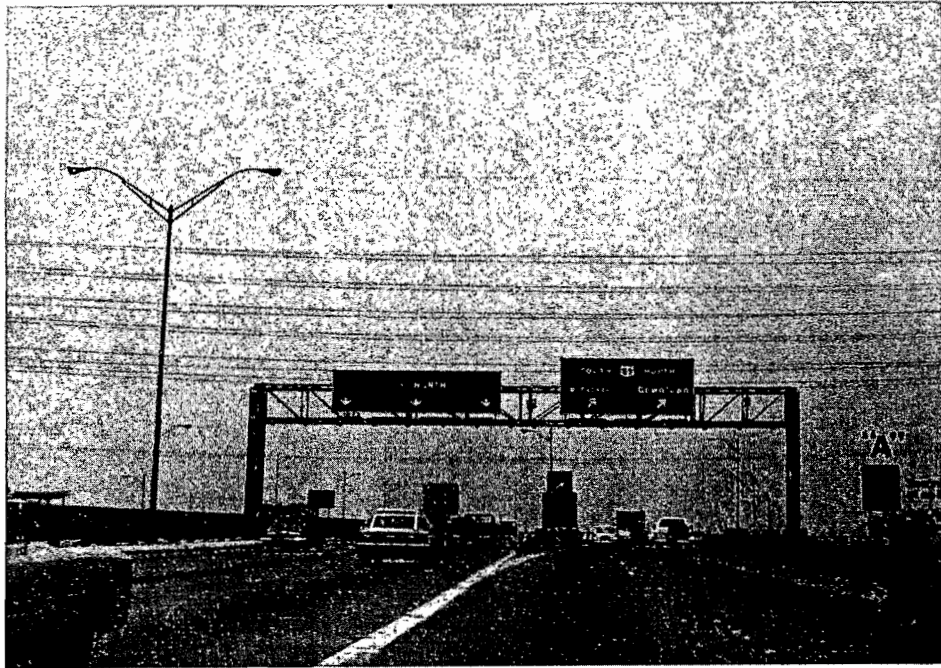
Figure 4. Next-to-last overhead sign before connector ramp. Letter "A" indicates speed limit sign located 800 feet from connector ramp.

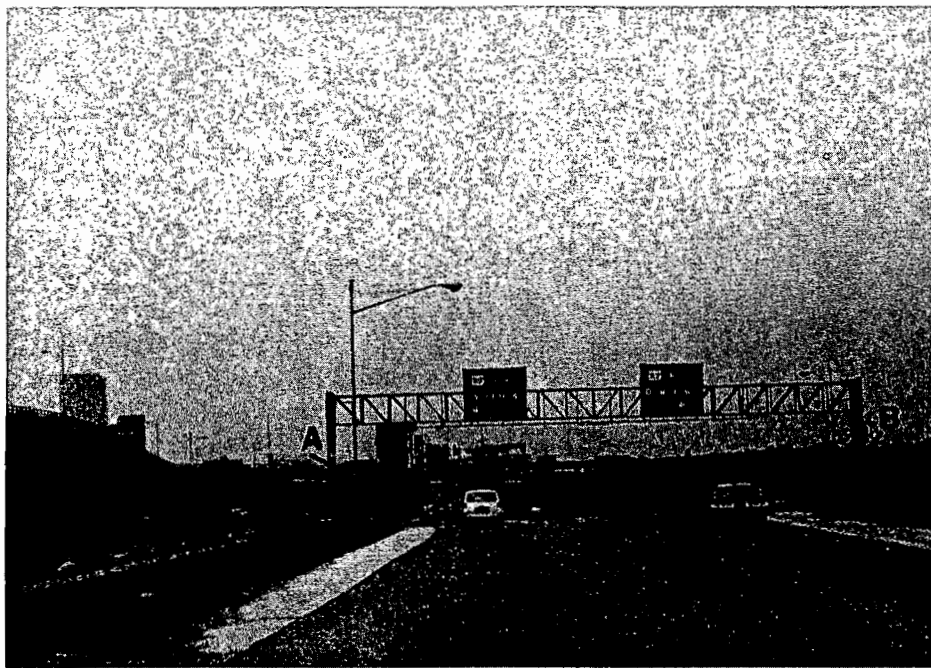
The posted speed limit is 55 mph for the main section of I-610. Signs indicating an upcoming Southwest Freeway exit are located at several points along the 2 1/2 miles before the exit. Adjacent to the overhead exit sign was the last advisory speed limit sign (40 mph) that the driver could have observed. (See figure 4.) This sign was about 800 feet from the connector ramps. The last overhead sign the driver could have observed indicates the south and north connector ramps to the freeway. An advisory speed limit sign (40 mph) was in place on the connector ramp to the right. An advisory speed limit sign was not in place on the connector ramp to the left at the time of the accident according to testimony taken at the Safety Board's public hearing. (See figure 5.)

Figure 5. Overhead signs at entrance to connector ramps and 40 mph advisory signs on ramps. Sign indicated by letter "A" was not in place at the time of the accident. Sign indicated by letter "B" was in place.

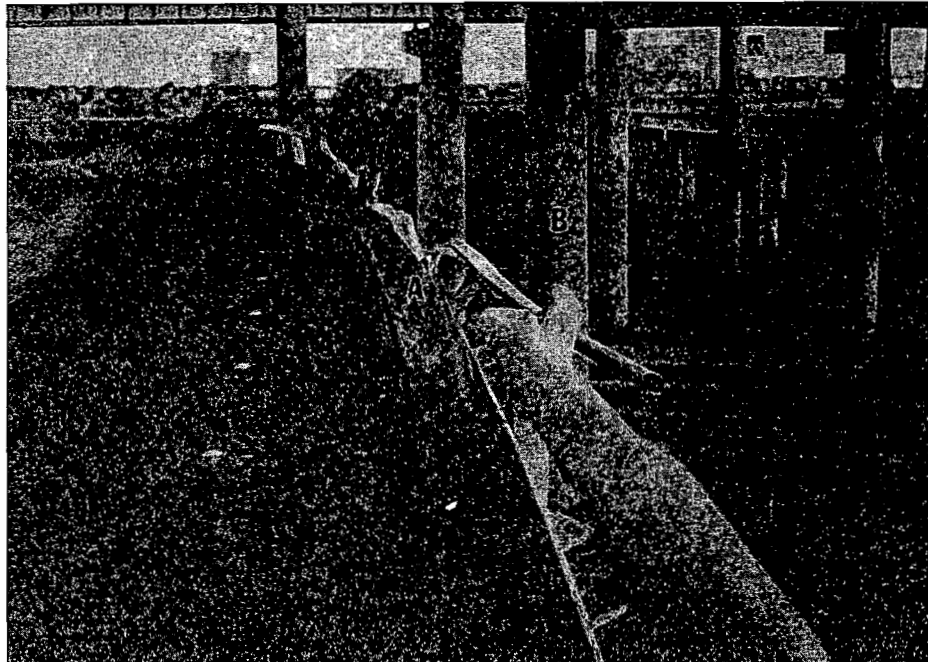
Figure 7. Connector ramp. Letters indicate conditions pertinent to investigation: (A) trailer tire marks on top of curb (B) column struck by trailer (C) damage to bridge deck.
