Highway Accident Report - Multiple-Vehicle
Collision and Fire, U.S. Route 101, Los Angeles,
California, March 3, 1980

(U.S.) National Transportation Safety Board
Washington, DC

HIGHWAY ACCIDENT REPORT

MULTIPLE-VEHICLE COLLISION AND FIRE
U.S. ROUTE 101,
LOS ANGELES, CALIFORNIA
MARCH 3, 1980

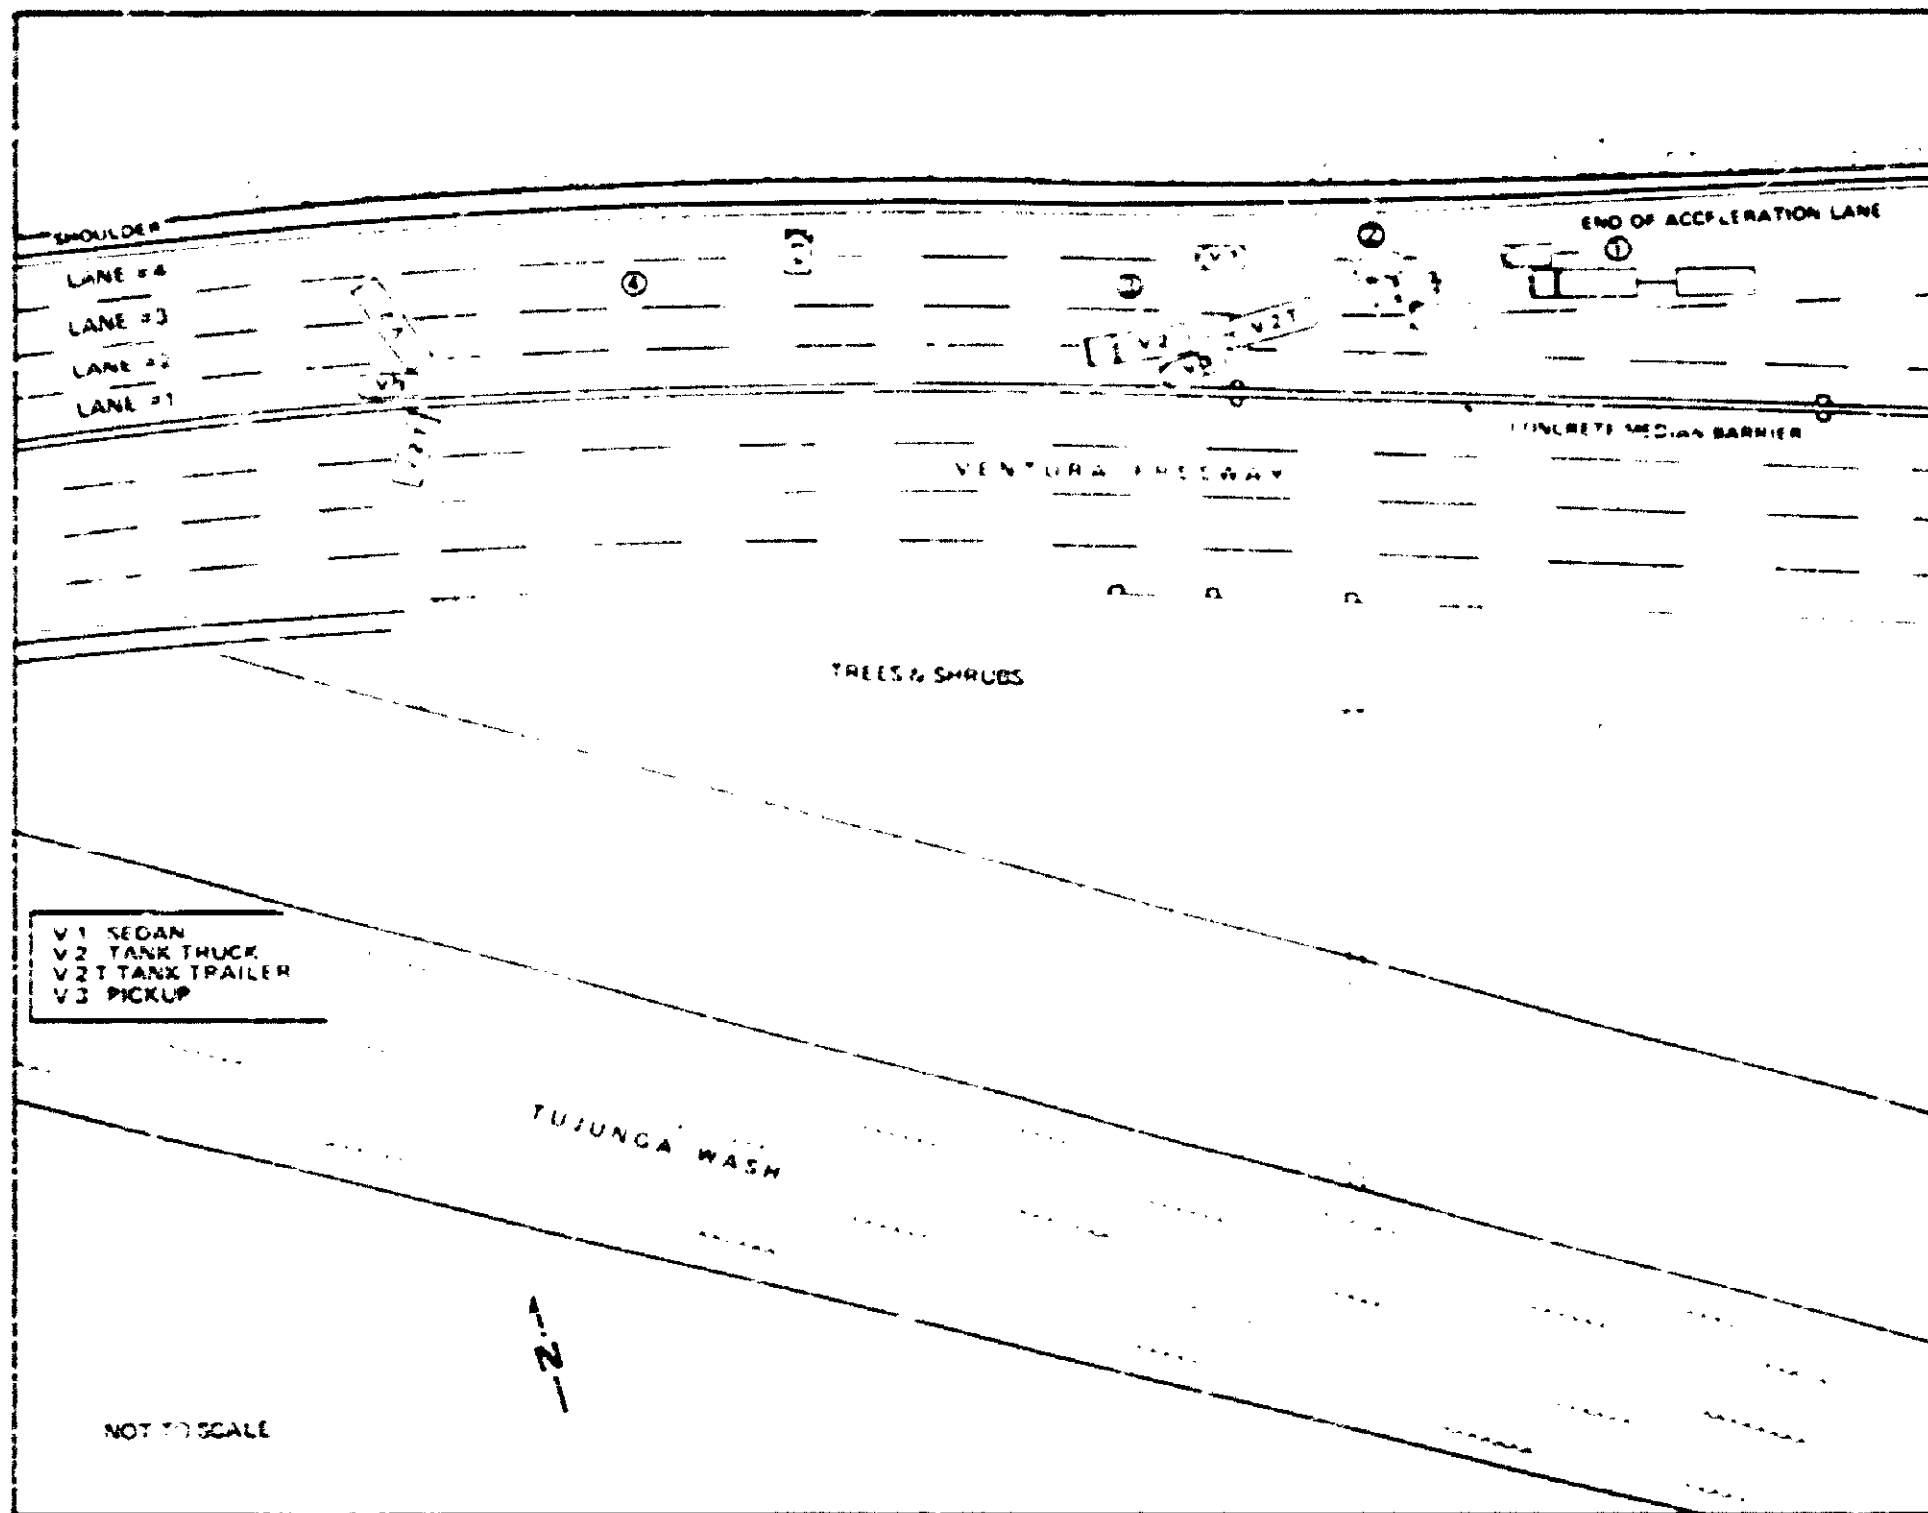
Figure 1.--Sequence of events.

The sedan and the tank truck both moved to the left after the left side of the sedan collided with the right front of the tank truck. The hub of the truck's right front wheel tore into the sedan body from a point behind the left rear wheel forward to a point just forward of the rear of the left door. Black rubber tire transfer marks were visible along the left side continuing forward of the gouged metal area.

The sedan and the tank truck moved to the left into lane No. 2 where the tank truck sideswiped the right side of a pickup truck with a small camper shell installed in the truck bed. The pickup was also traveling about 55 mph.

As the three vehicles moved to the left across lane No. 1, the sedan separated from the tank truck, spun clockwise 100°, and came to rest straddling the lane-dividing line between lanes No. 3 and No. 4.

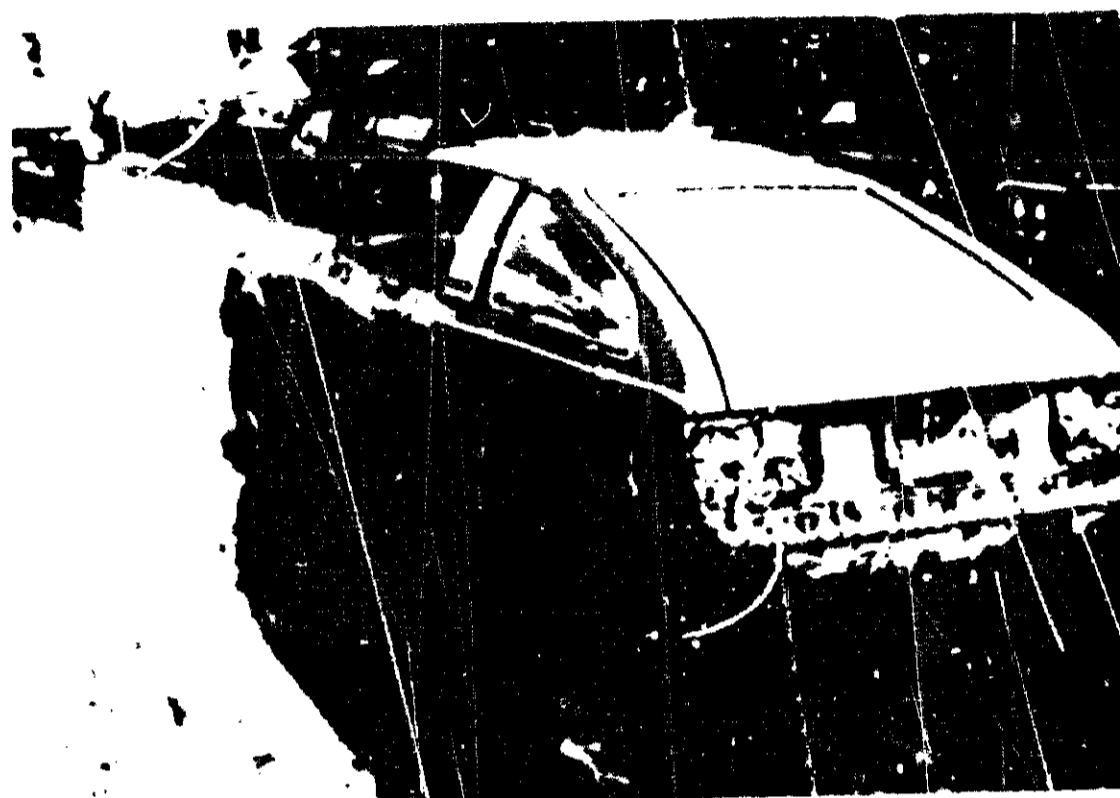
The left door and quarter panel had been penetrated along a line 16 to 22 inches above the ground from the rear to a point forward of the rear of the left door. Circumferential tire marks also extended over this area for about 50 inches. A 6-inch circular dent, forward of the rear of the door, had compressed the door panel inward 3 inches. The left window was broken and missing. (See figures 2.) All plastic and paint areas at the rear were scorched or melted by the fire. The brakes were found to be operational, and the tires were in good condition and properly inflated. The right front tire head was reported to have been displaced near a rim abrasion and deflated, but when it was remounted it was found to retain air. The undercarriage, suspension, and steering were not damaged.

Figure 2.--Left side and rear damage to the sedan.

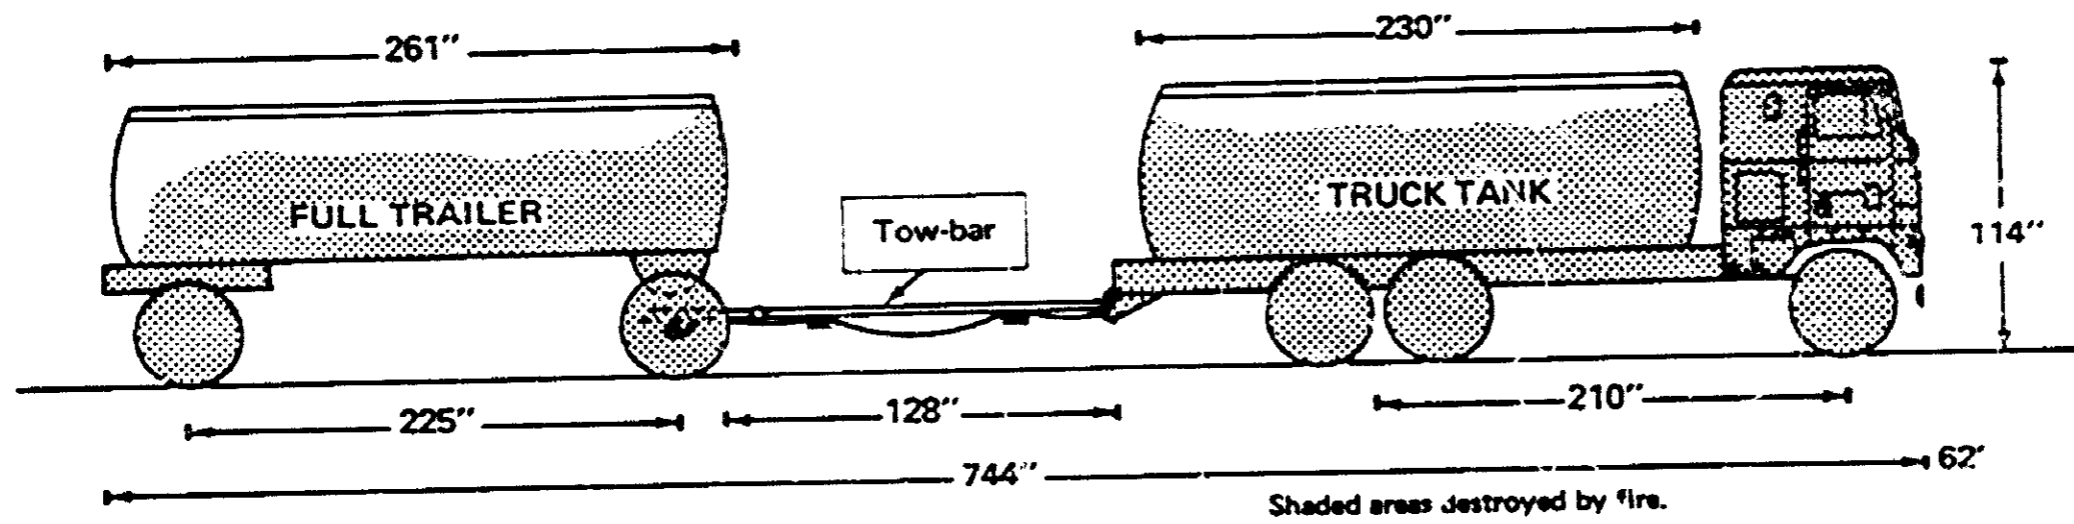
The trailer had similar damage with about 65-percent of the tank melted; portions of the suspension members were damaged. (See figures 5 and 6.) The drawbar was still attached at the truck and the trailer. It was not twisted, because it was fitted with a rotating ring. The tank's rear bulkhead was intact but had heavy abrasions on the lower left portion. The trailer tank's front manhole cover dome cap and a portion of the cover plate were missing. Any hazardous material placards that may have been on the two vehicles were destroyed in the fire.

Figure 6.--Diagram of damaged areas of tank truck and tank trailer. Lined area destroyed by fire.

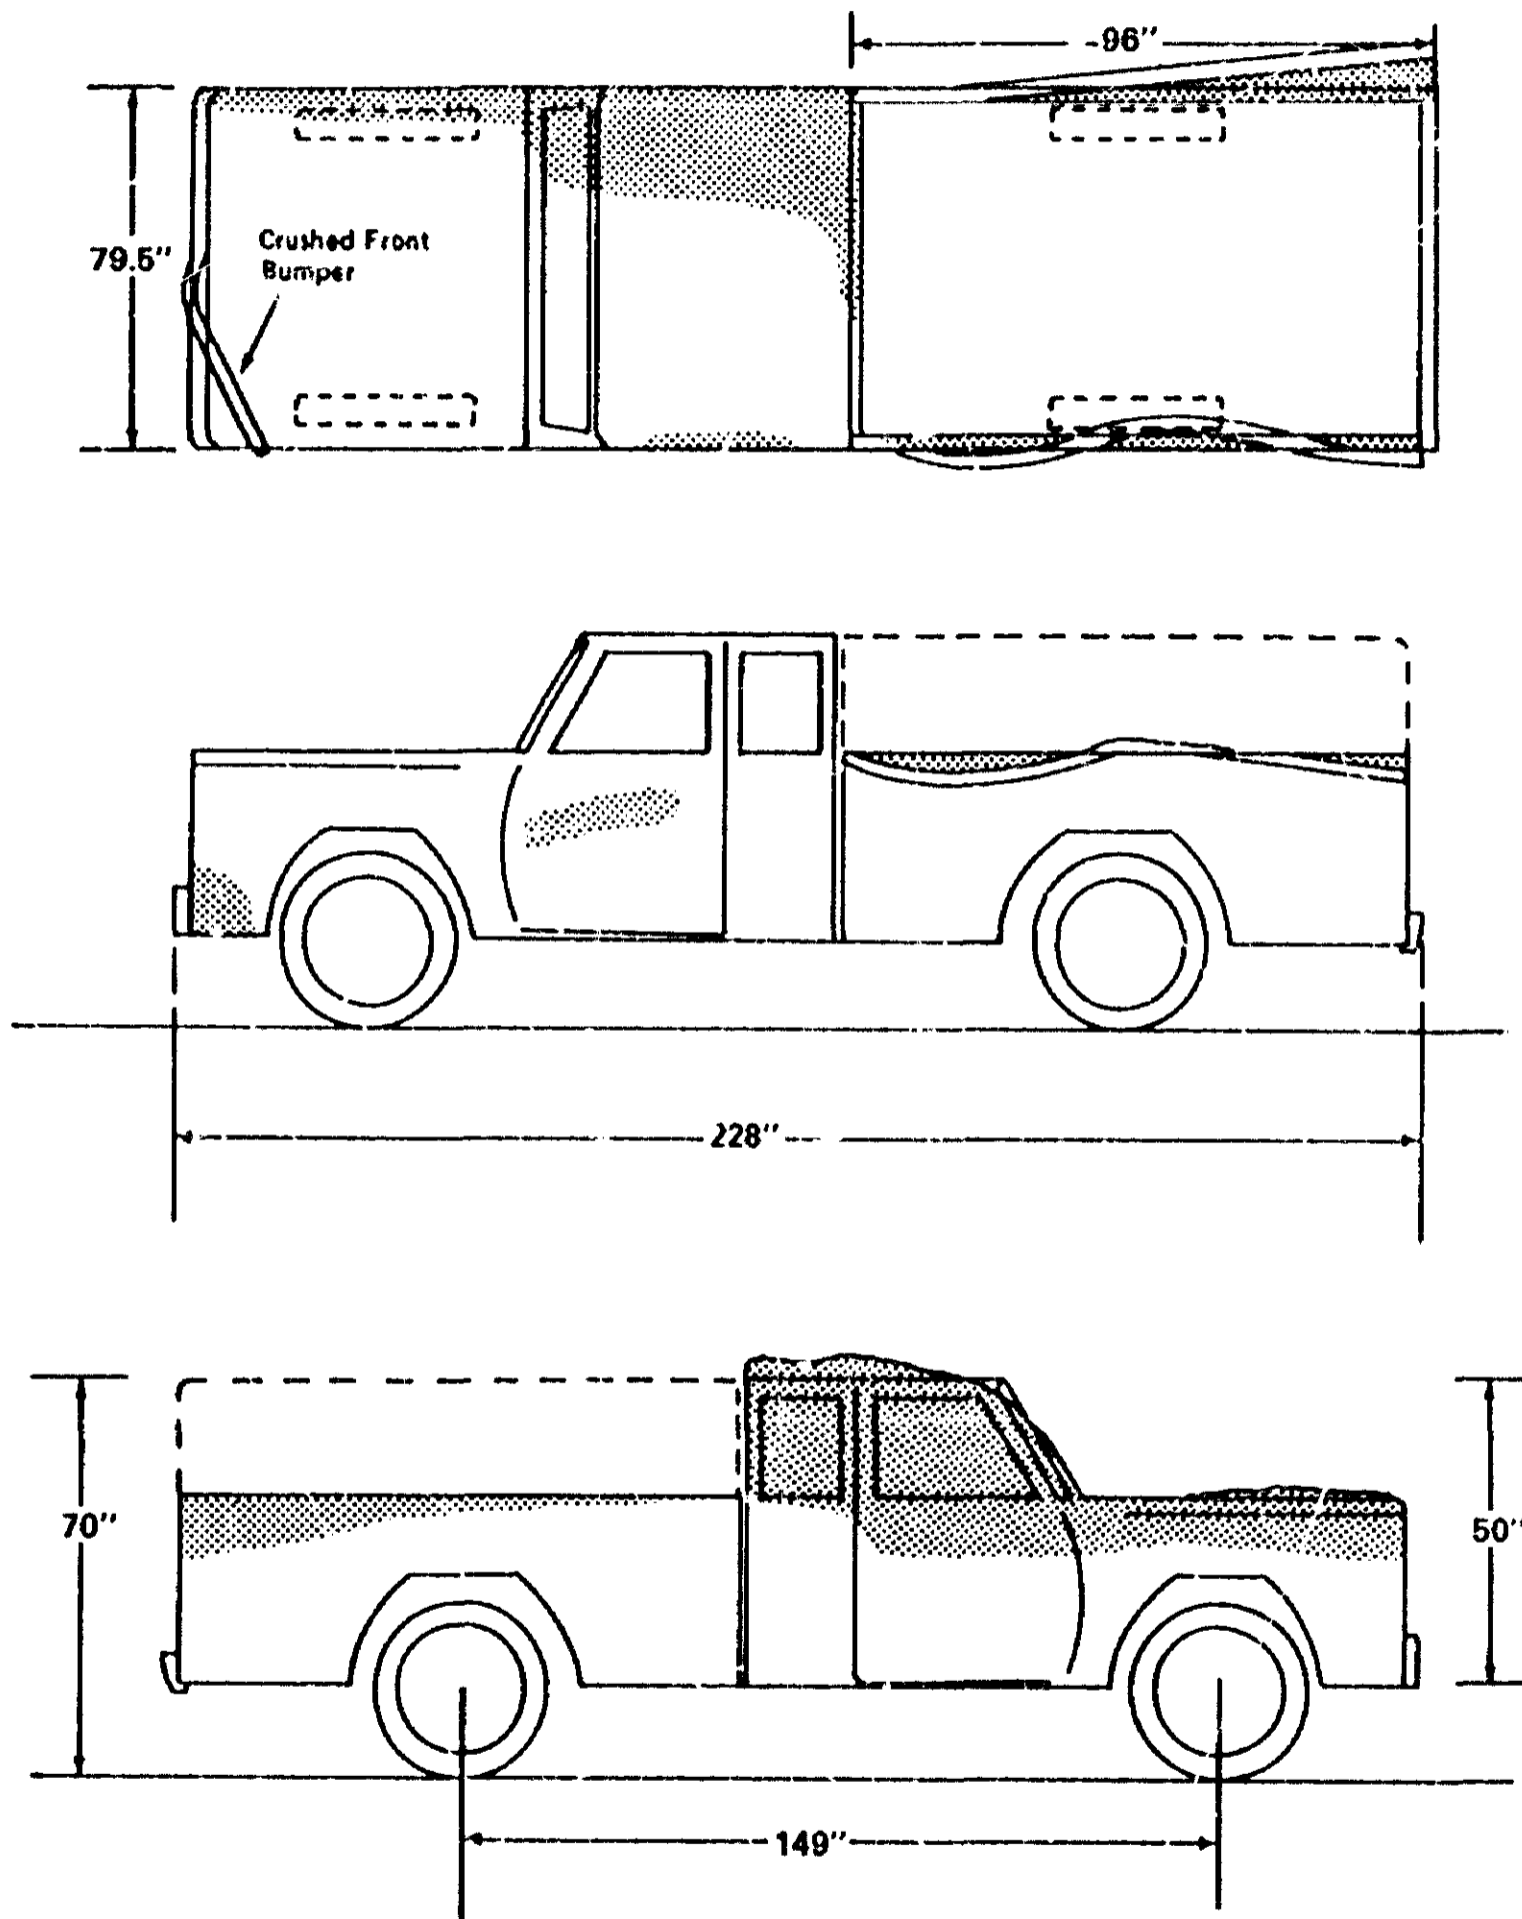
All flammable components on the pickup, including the camper, were consumed by fire and all soft metals were melted. The engine and drive train components only sustained fire damage. (See figure 7.)

Figure 7.--Diagram of impact damage to pickup truck.

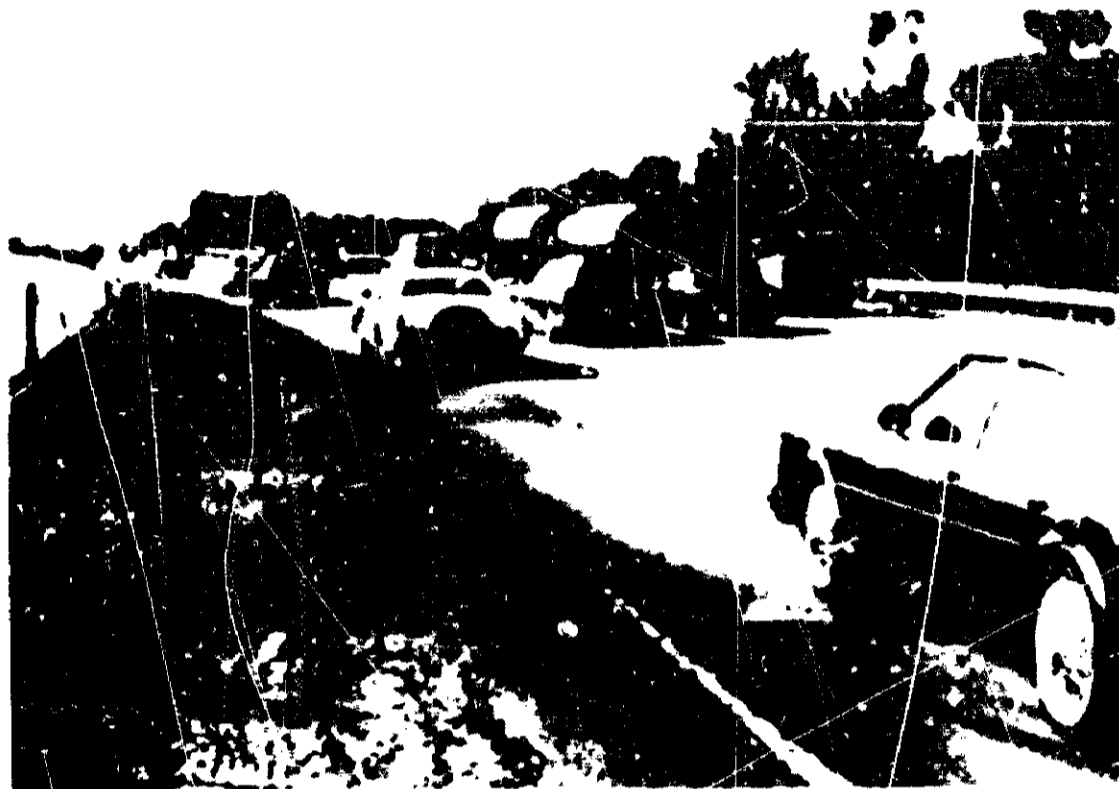
The road surface was spalled and chipped by heat all along the median in this area. The road surface on both sides of the median was heat damaged. Burn stains were found along drainage routes to the catch basins and also where underground pipes surfaced to carry fluid to the flood channel, where the gasoline was dispersed in the water. (See figures 10, 11, and 12.)

Figure 10.-- Westbound fire damage area and tank trailer skid marks at right.

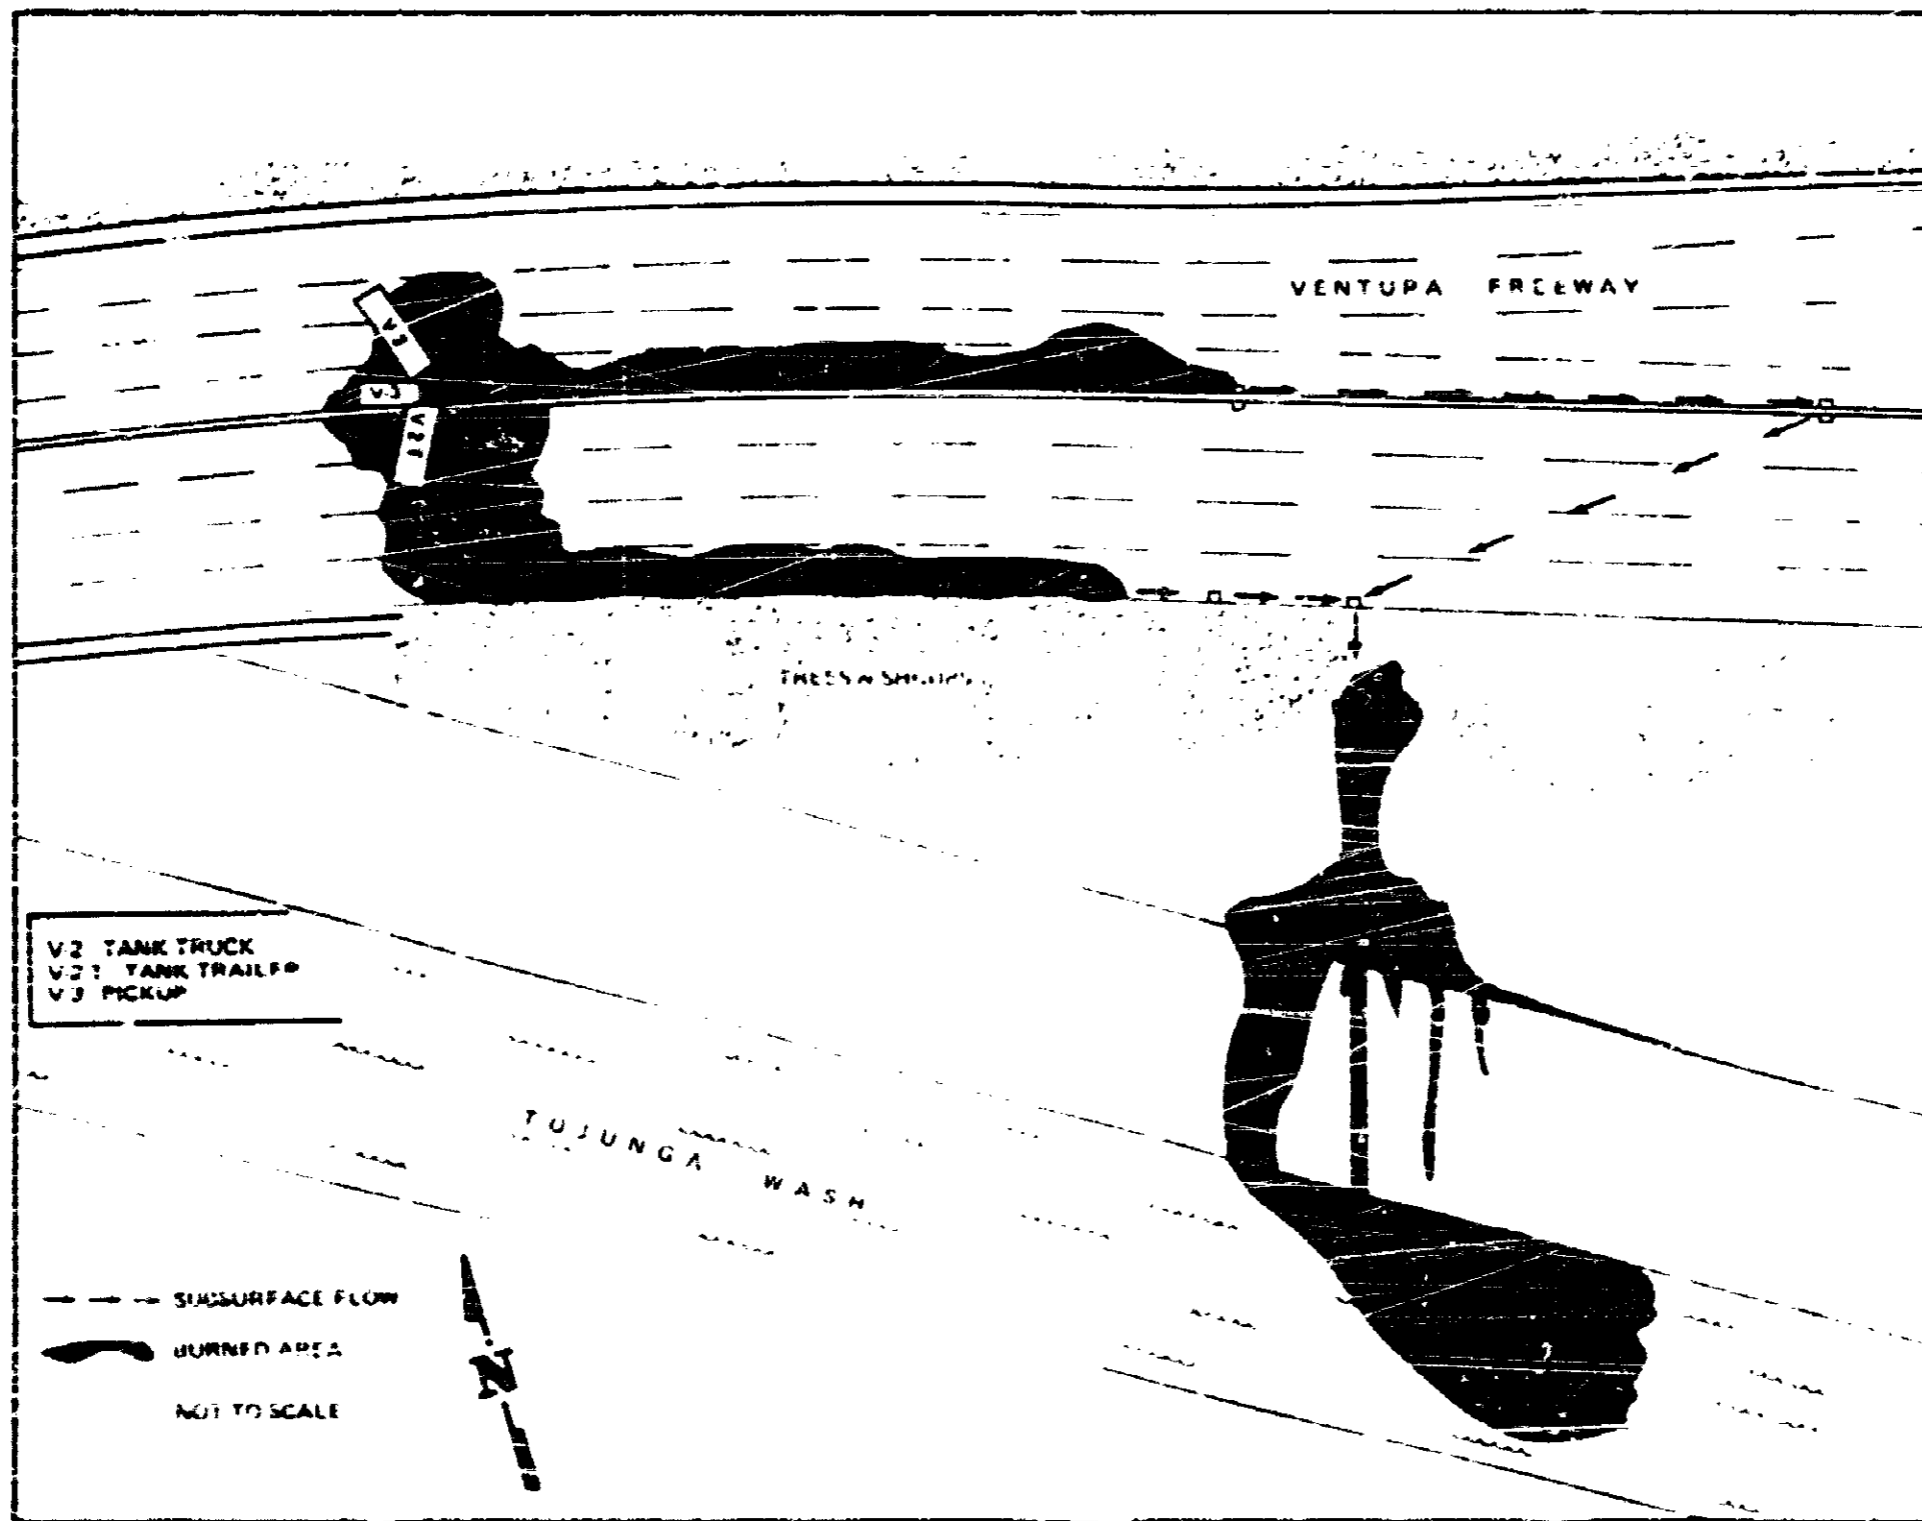
Witnesses stated that, almost immediately after the trailer tank rolled over the median barrier, they saw fuel flowing down both sides of the barrier and onto the highway. The fuel was on fire and flowing south across both the eastbound and westbound lanes. The fuel on the westbound side flowed to the median barrier then east to catch basins. The fuel on the eastbound side flowed to a gutter at the shoulder and then eastward to catch basins. The catch basins discharged into an open concrete ditch south of the freeway that carried the burning fuel across an open area into the Tujunga Wash flood control channel. (See figure 13.)

Figure 13.--Gasoline dispersal.
