A Summary of Aging Effects and Their Management in Reactor Spent Fuel Pools, Refueling Cavities, Tori, and Safety-Related Concrete Structures

The Oak Ridge National Laboratory conducted an independent review of operating experience at U.S. commercial nuclear power plants regarding spent fuel pool and reactor cavity leakage, boiling-water reactor Mark I containment torus corrosion and cracking, and aging degradation of safety-related concrete structures. The review was restricted to information in publicly available sources, including license renewal applications submitted by the licensees and safety evaluation reports prepared by the staff. Information compiled for spent fuel pool and reactor refueling cavity leakage focused on the cause and extent of leakage, the effects of borated water on materials, the effects on concrete and steel degradation, corrective actions, and the effects of material degradation on load-carrying capacity. The review of boiling-water reactor Mark I containment information involved identification of the causes of torus corrosion and cracking, the locations of corrosion and cracking, and engineering evaluations and acceptance criteria. The review of opera

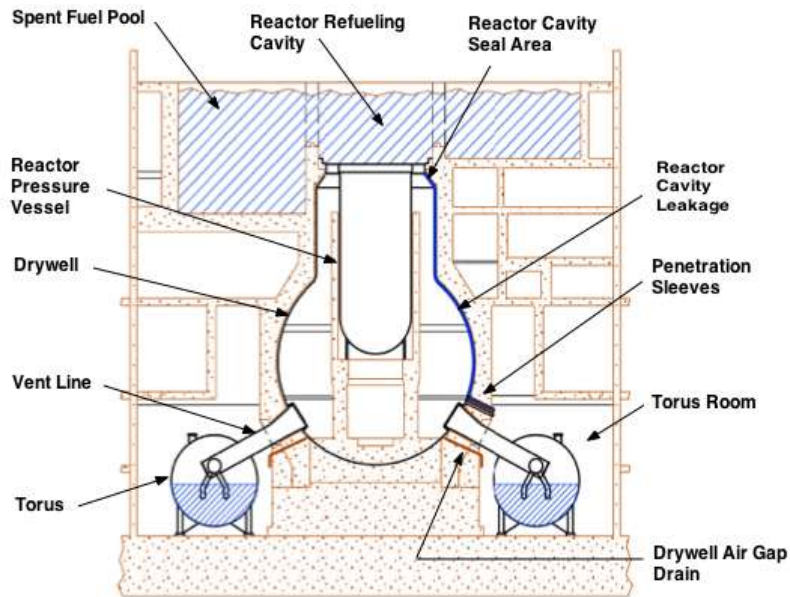
Figure 6-1 Cross section of BWR MK I showing location of reactor refueling cavity, spent fuel pool, and torus as well as one leakage path that has been observed

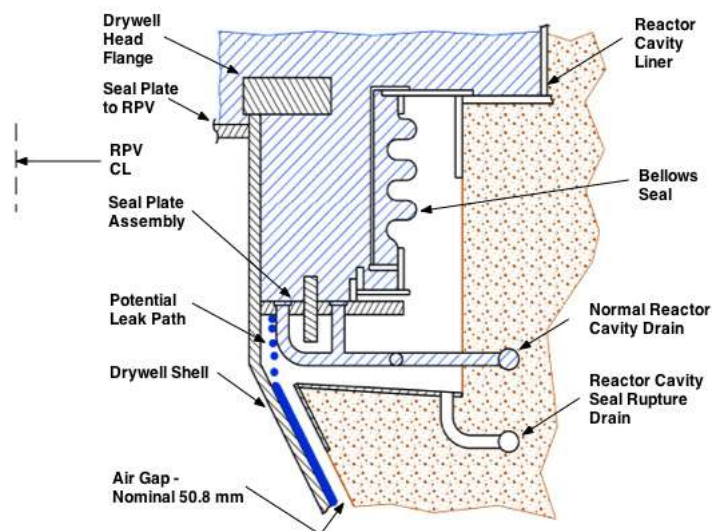
Figure 6-2 Detail of drywell—reactor cavity seal area and identification of potential leakage path

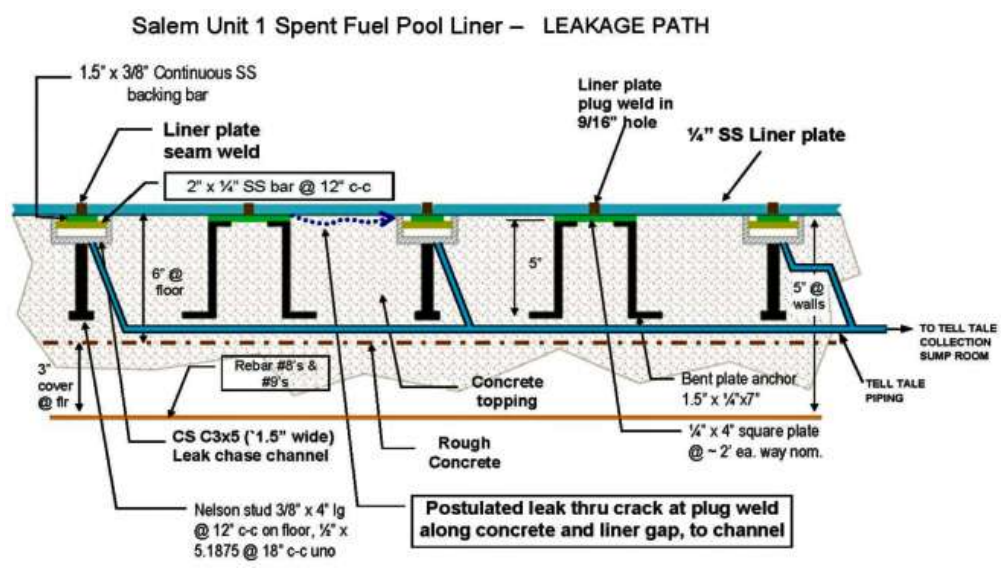
Figure 6-4 Cross section of a leak chase system for a PWR plant and a postulated path for leakage occurrence

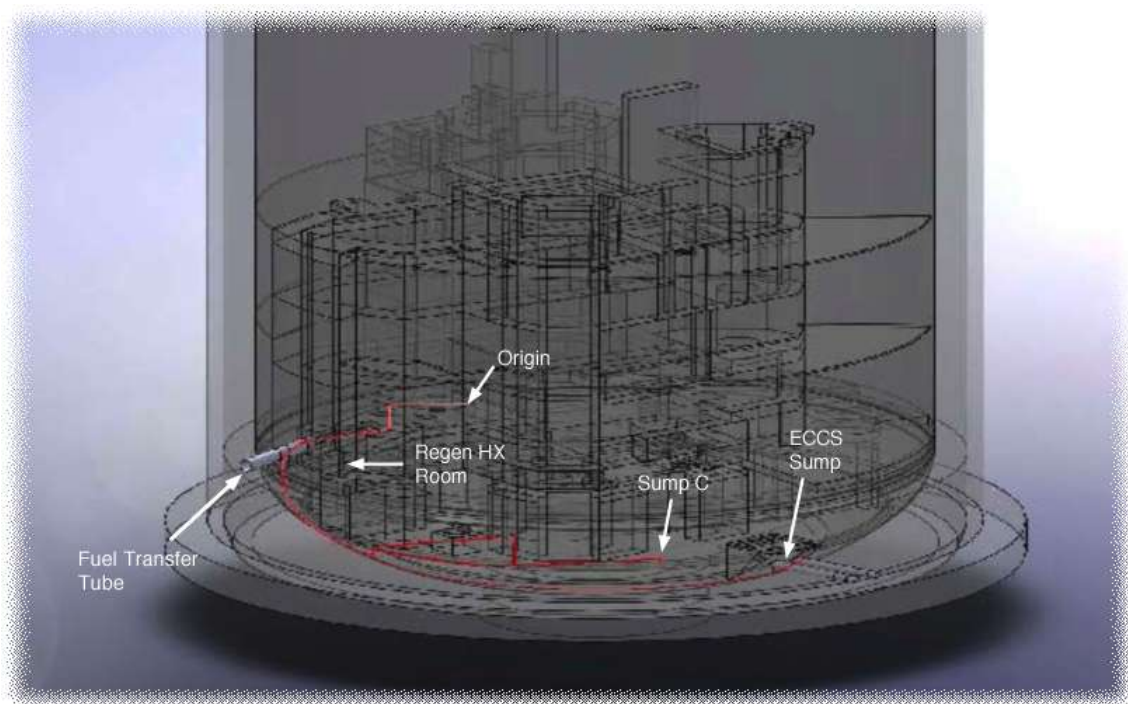
Figure A.6-1 Potential leakage paths for refueling cavity water

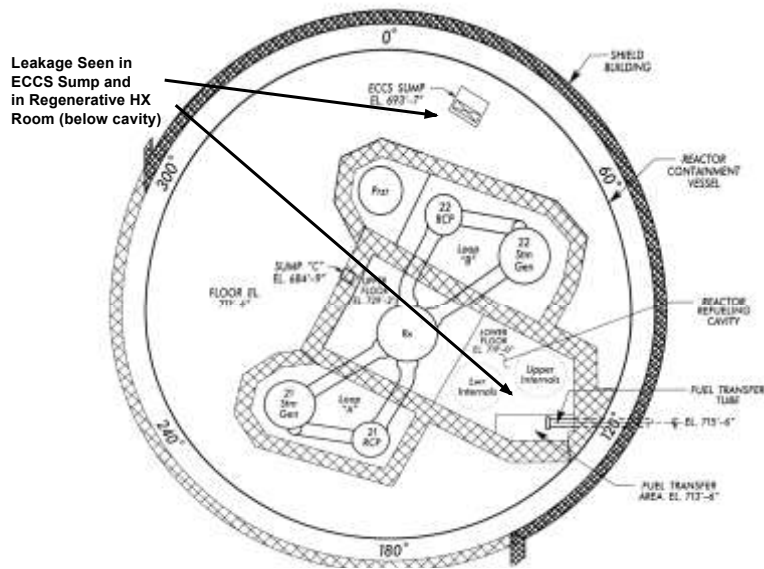
Figure A.6-2 Locations of observed leakage of refueling cavity water

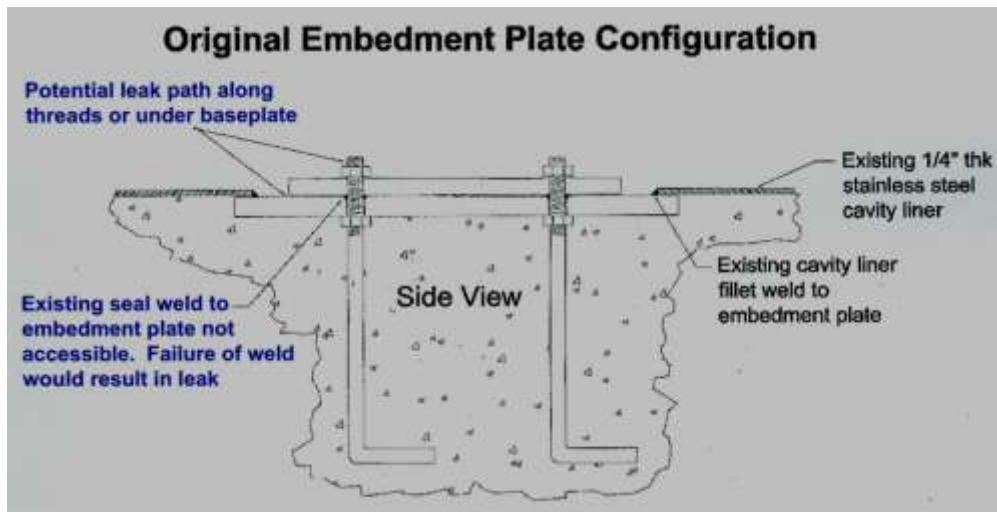
Figure A.6-3 Cross section of original embedment plate configuration showing potential leakage paths

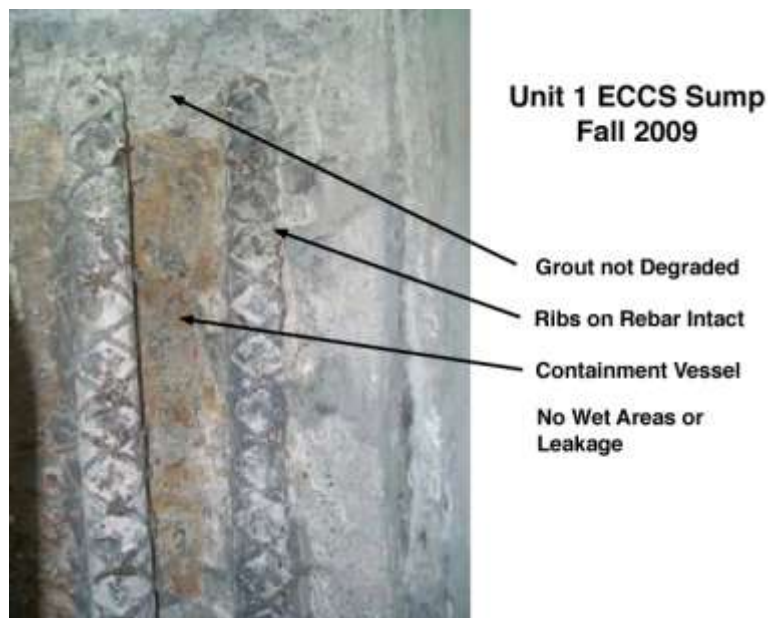
Figure A.6-5 Condition of containment shell, grout, and concrete steel reinforcement in Unit 1 ECCS after grout removal

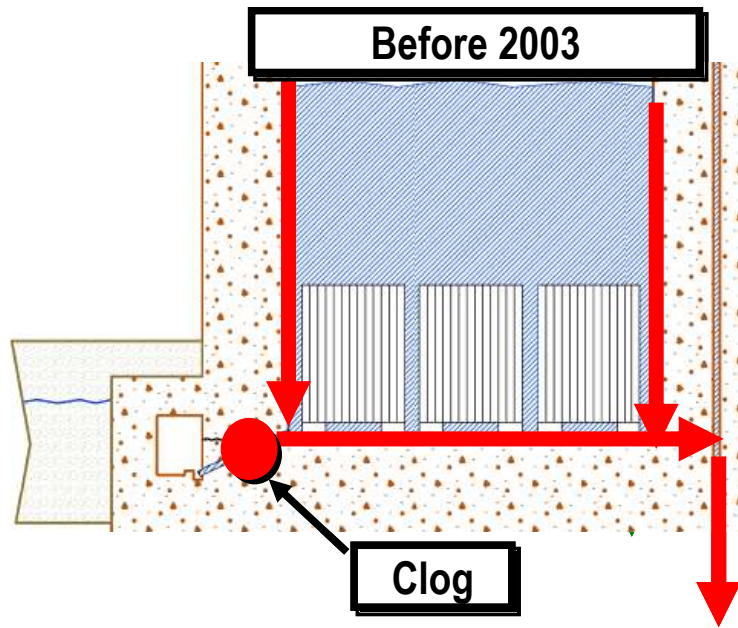
Figure B.9-1 Spent fuel pool leakage path for Salem Unit 1 before 2003

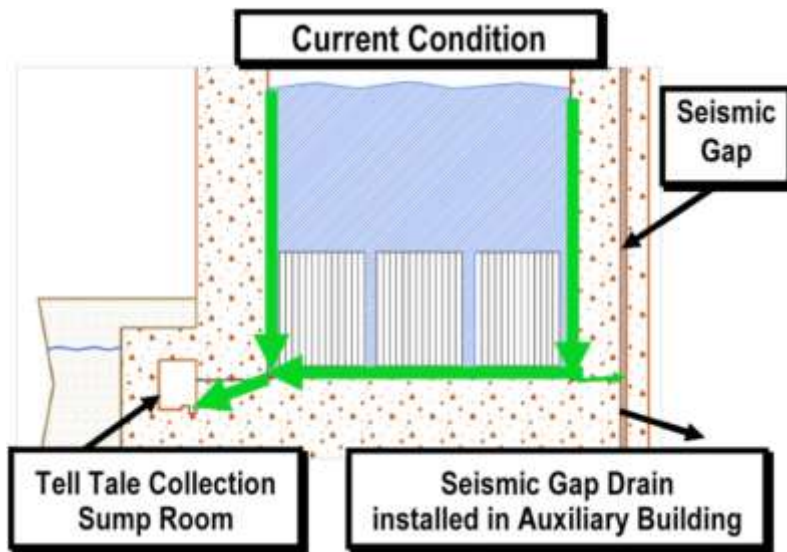
Figure B.9-2 Current spent fuel pool leakage path for Salem Unit 1

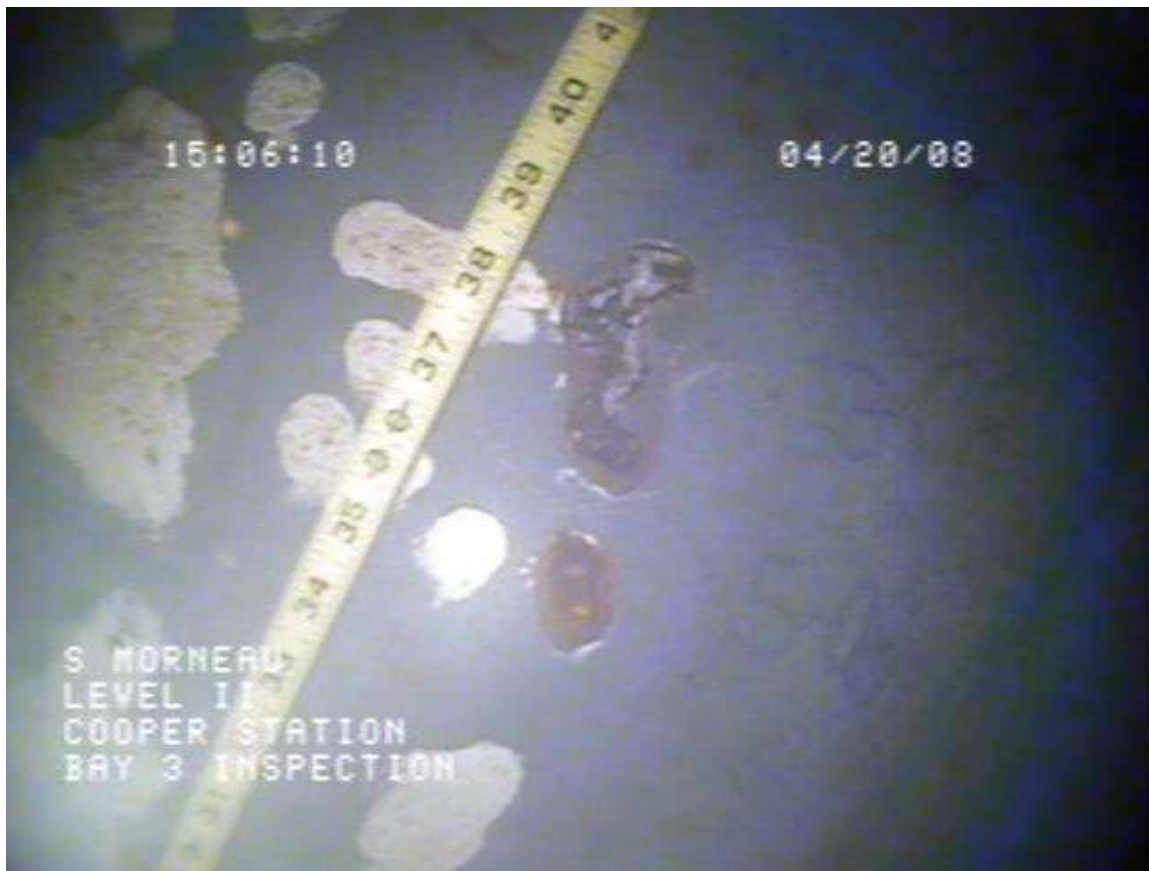
Figure C.1-1 Example of pitting corrosion in torus

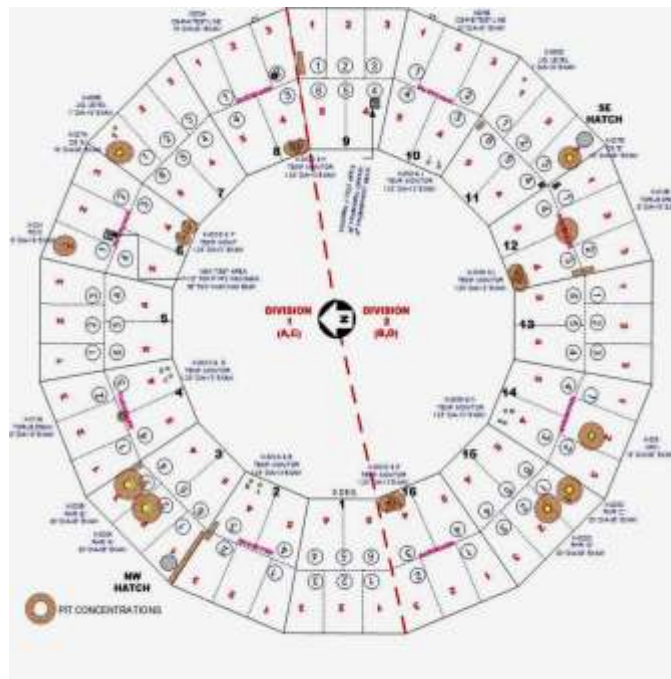
Figure C.1-3 Example of pitting corrosion concentrations in torus
