**TECHNICAL MEMORANDUM
BROWNFIELDS SUSTAINABILITY PILOT
LANGDALE MILL, VALLEY, ALABAMA**

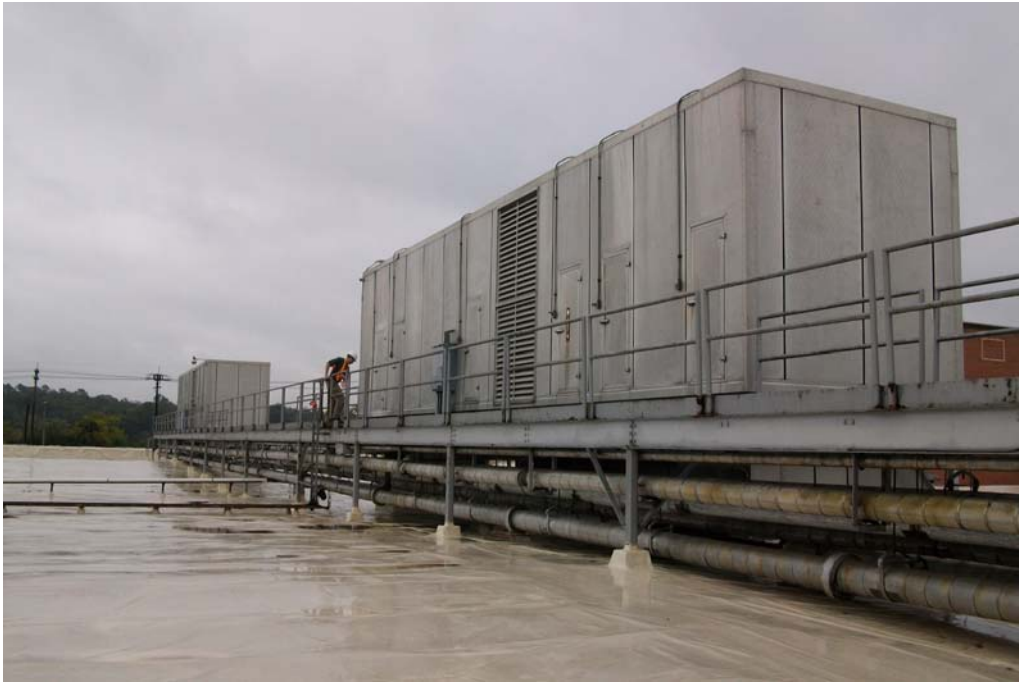
Photograph No. 1: Rooftop air handling units and associated steel support structure above Weave Room No. 2.

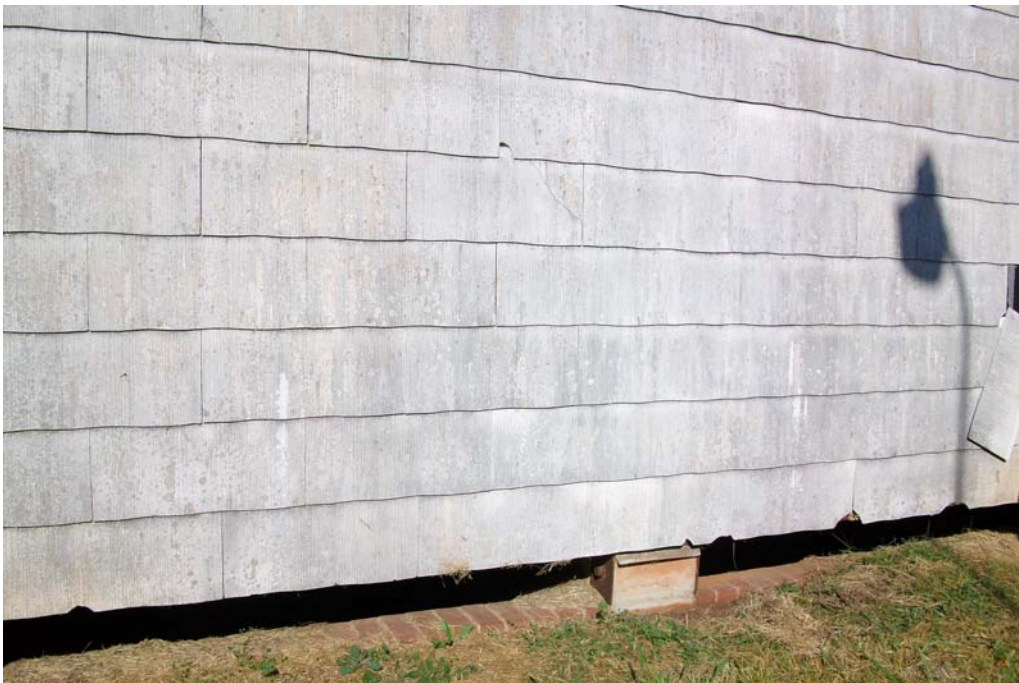
- **Asbestos and Hazardous Materials:** According to field measurements, approximately 4,200 sf of exterior siding that appeared to be asbestos-containing material (ACM) is present on Warehouses No. 1 and 2 (see Photo No. 2); ACM may also be present in the roof coating materials. ACM material should be properly tested and managed accordingly; associated ACM management and disposal costs should be added to the cost of deconstruction. In addition, more than 400 fluorescent light fixtures were also present; light fixtures may be salvaged for scrap metal value, but the associated fluorescent lamps should be removed and disposed of as “universal waste” according to the applicable regulations found in Alabama Department of Environmental management (ADEM) Administrative Code Chapter 335-14-11.

Photograph No. 2: Possible asbestos containing material (ACM) shingles on exterior of Warehouse No. 1.

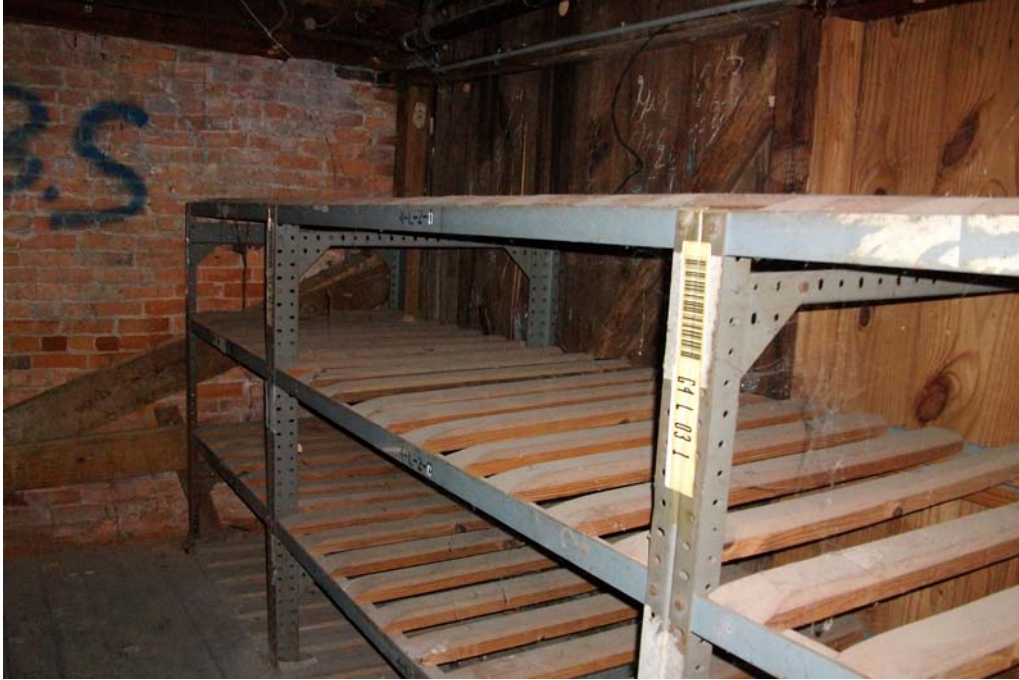
Photograph No. 3: Typical metal shelving unit in Warehouse No. 4.

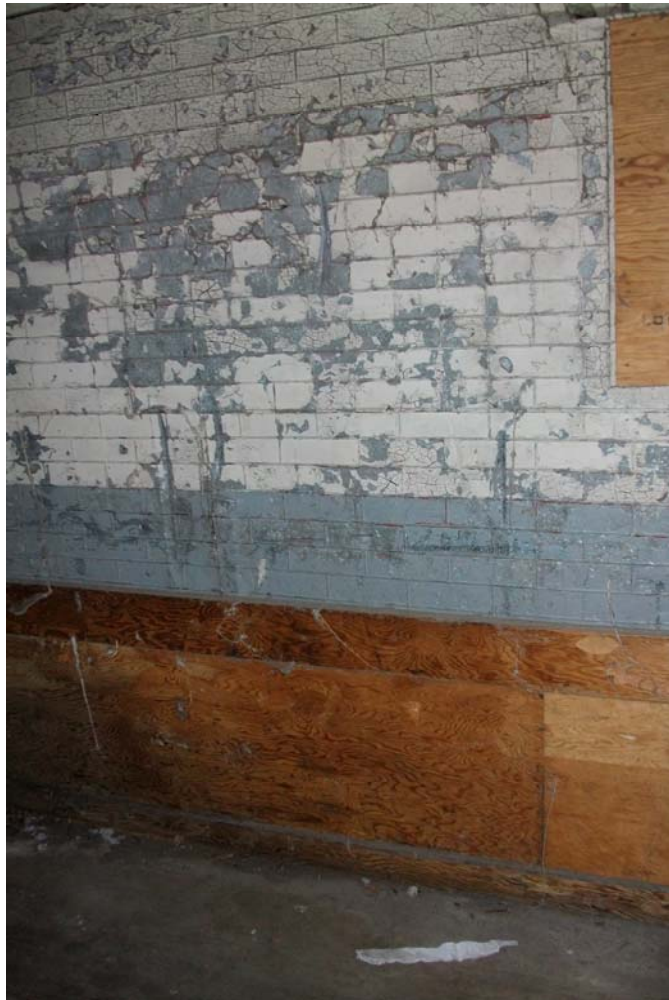
- **Pressed Metal Fascia:** Approximately 2,700 sf of pressed metal (likely tin), faux brick fascia was noted on site (see Photograph 4). This material could be refinished and reused on walls or ceilings of the redevelopment to highlight the historical architecture of the mill and promote the sustainability aspects of the project.

Photograph No. 4: Pressed metal, faux brick fascia on wall of Warehouse No. 4.

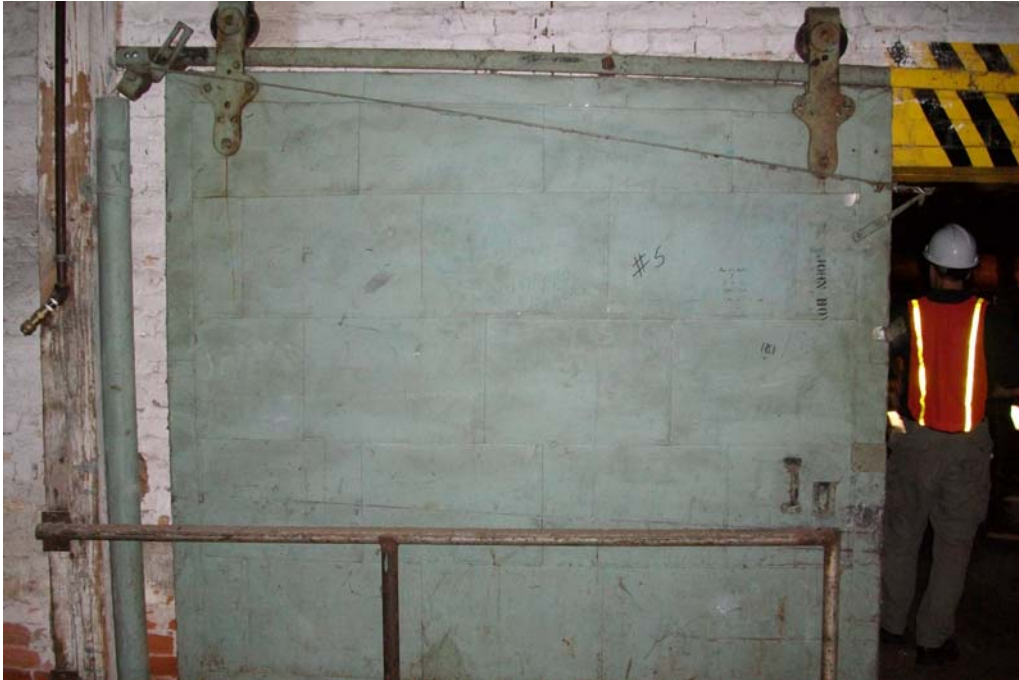
Photograph No. 5: Typical sliding track, wooden doors with pressed metal finish in Warehouse No. 5.

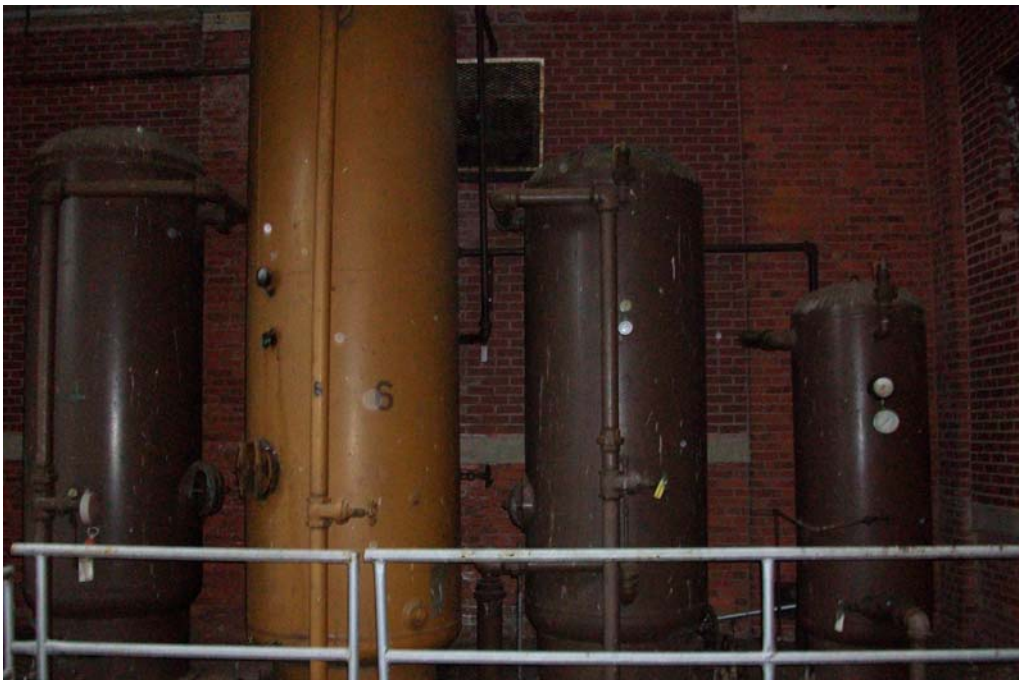
Photograph No. 6: Compressor tanks.

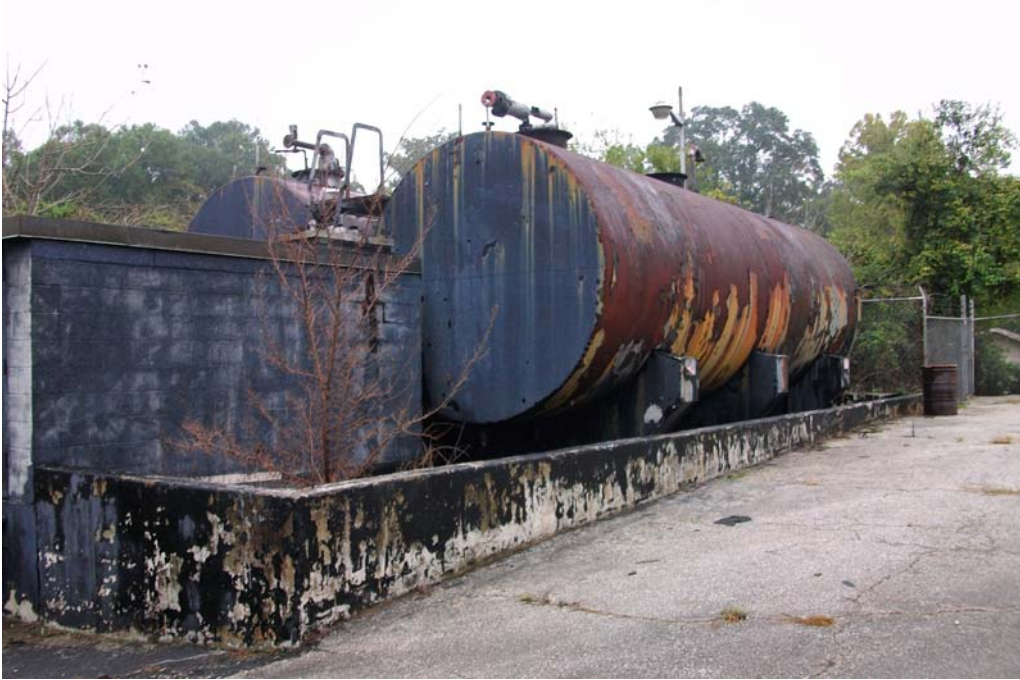
Photograph No. 7: Fuel oil storage tanks.

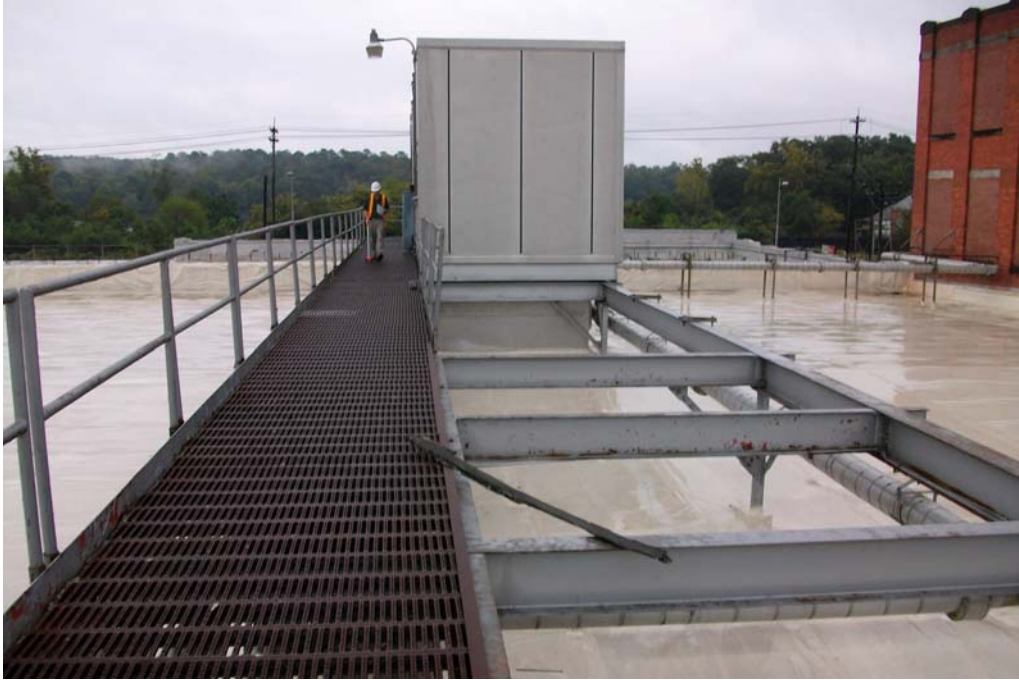
Photograph No. 9: Metal walkway grating and associated handrails of the rooftop air handling unit above Weave Room No. 2.

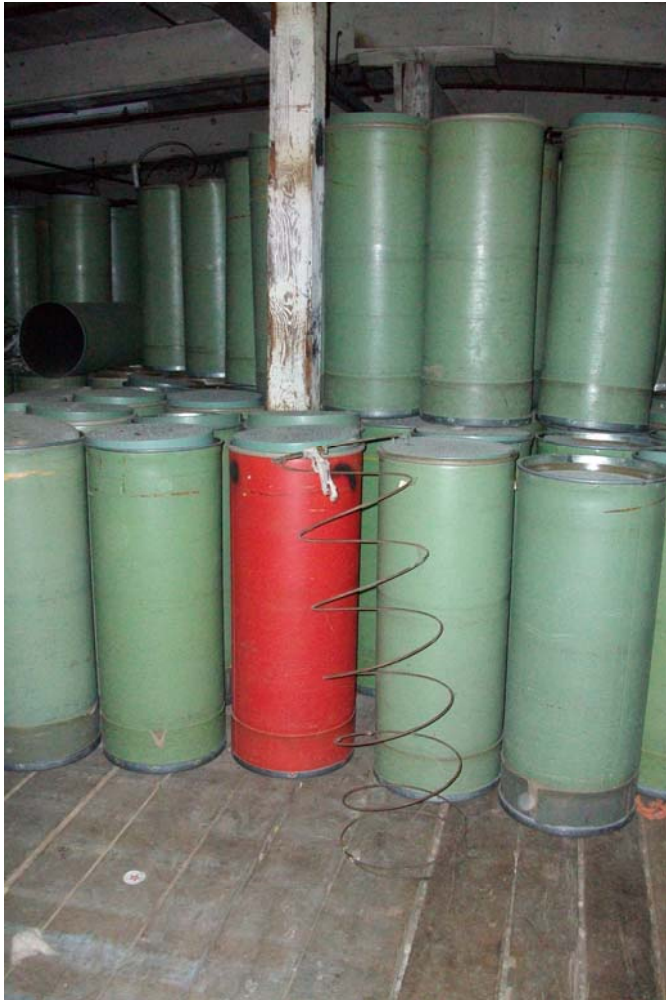
- **Storage Containers:** Approximately 2,900, 16-inch-diameter by 36-inch tall fiberglass/fiberboard storage containers with metal coils to spring-load the bottoms were observed in Warehouses No. 2 and 5 (see Photograph No. 10). These containers could be sold for reuse or recycled. The approximately 7,400 pounds of steel coils could also be salvaged as scrap metal for an approximate value of \$370.

Photograph No. 10: Fiberglass/fiberboard storage containers with metal coils in Warehouse No. 5.
