Air Midwest Flight 5481, Charlotte, NC Board Meeting

Robert L. Swaim

National Resource Specialist Aircraft Systems Engineering

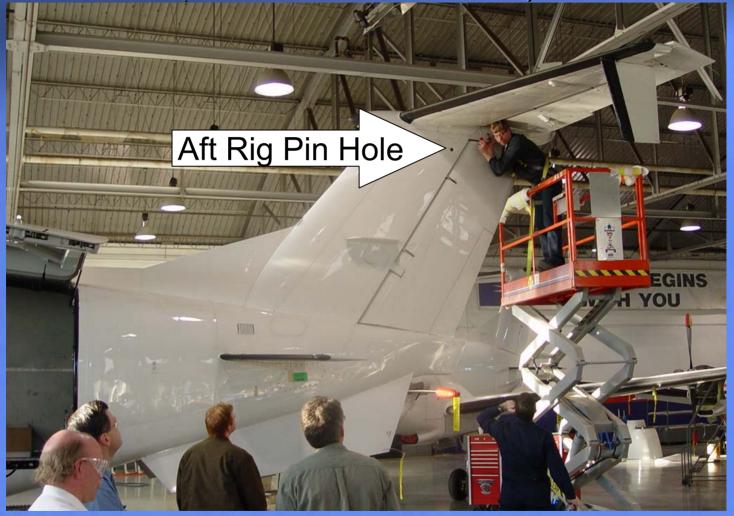
Aft Rig Pin Installed in Ground Tests

(First AMM Deviation)

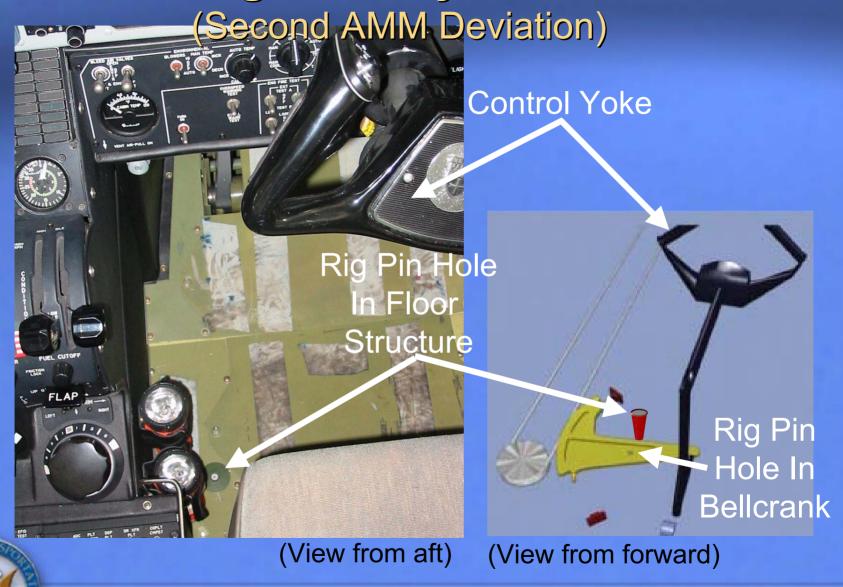
Forward Rig Pin May Miss Bellcrank

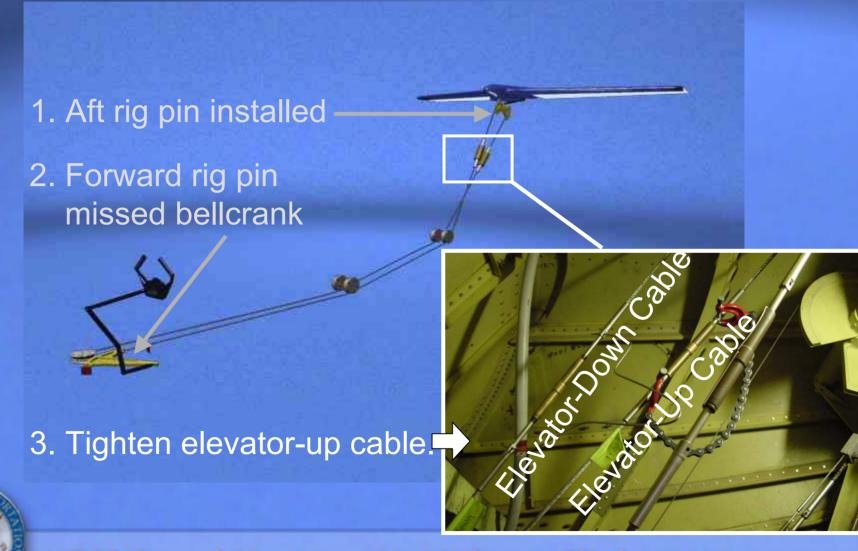
Tighten Control Cables

(Third AMM Deviation)

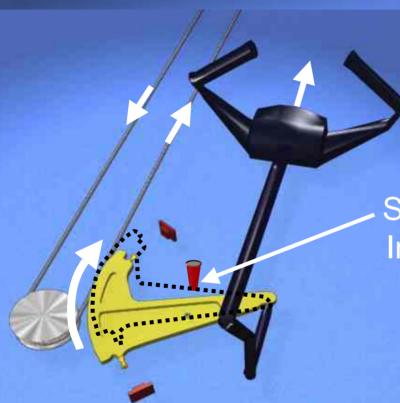
Tightening Elevator-Down Cable Moved Forward Bellcrank Aft

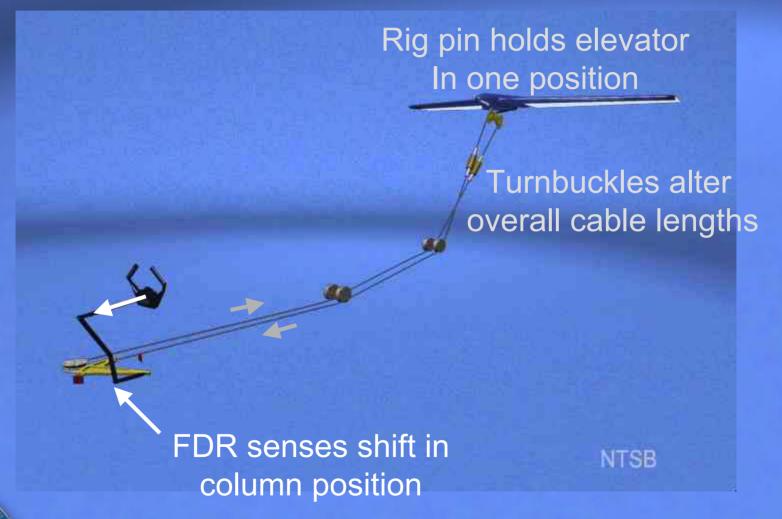
Side of Bellcrank Stopped At Improperly Installed Rig Pin.

(Pin should be inserted in bellcrank hole.)

Cable Misrig Altered Relation Between FDR Sensor and Elevator

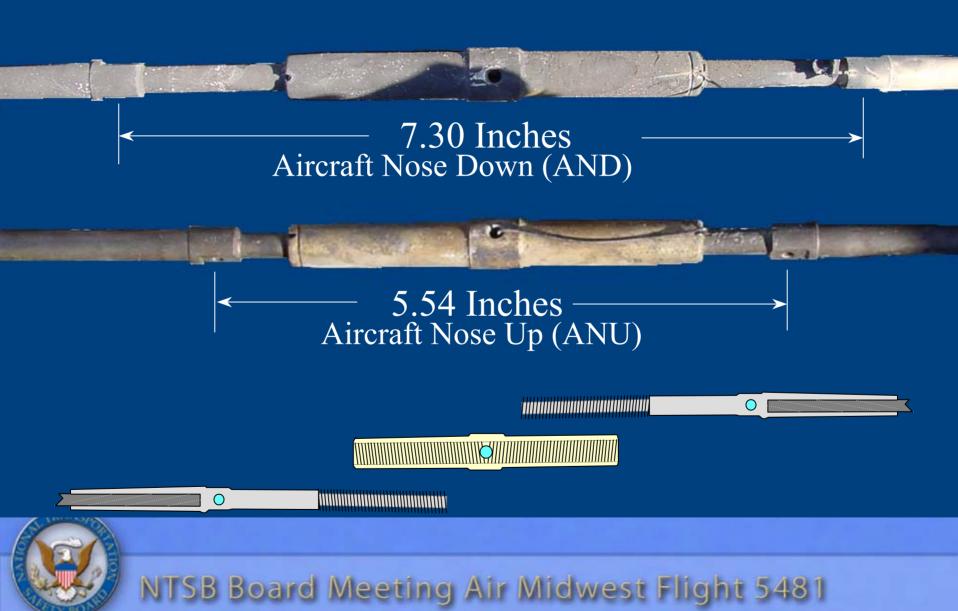
Pitch Control Turnbuckles Found In Wreckage
