HANFORD BX-FARM LEAK ASSESSMENTS REPORT

February 2011

Prepared for the U.S. Department of Energy
Office of River Protection

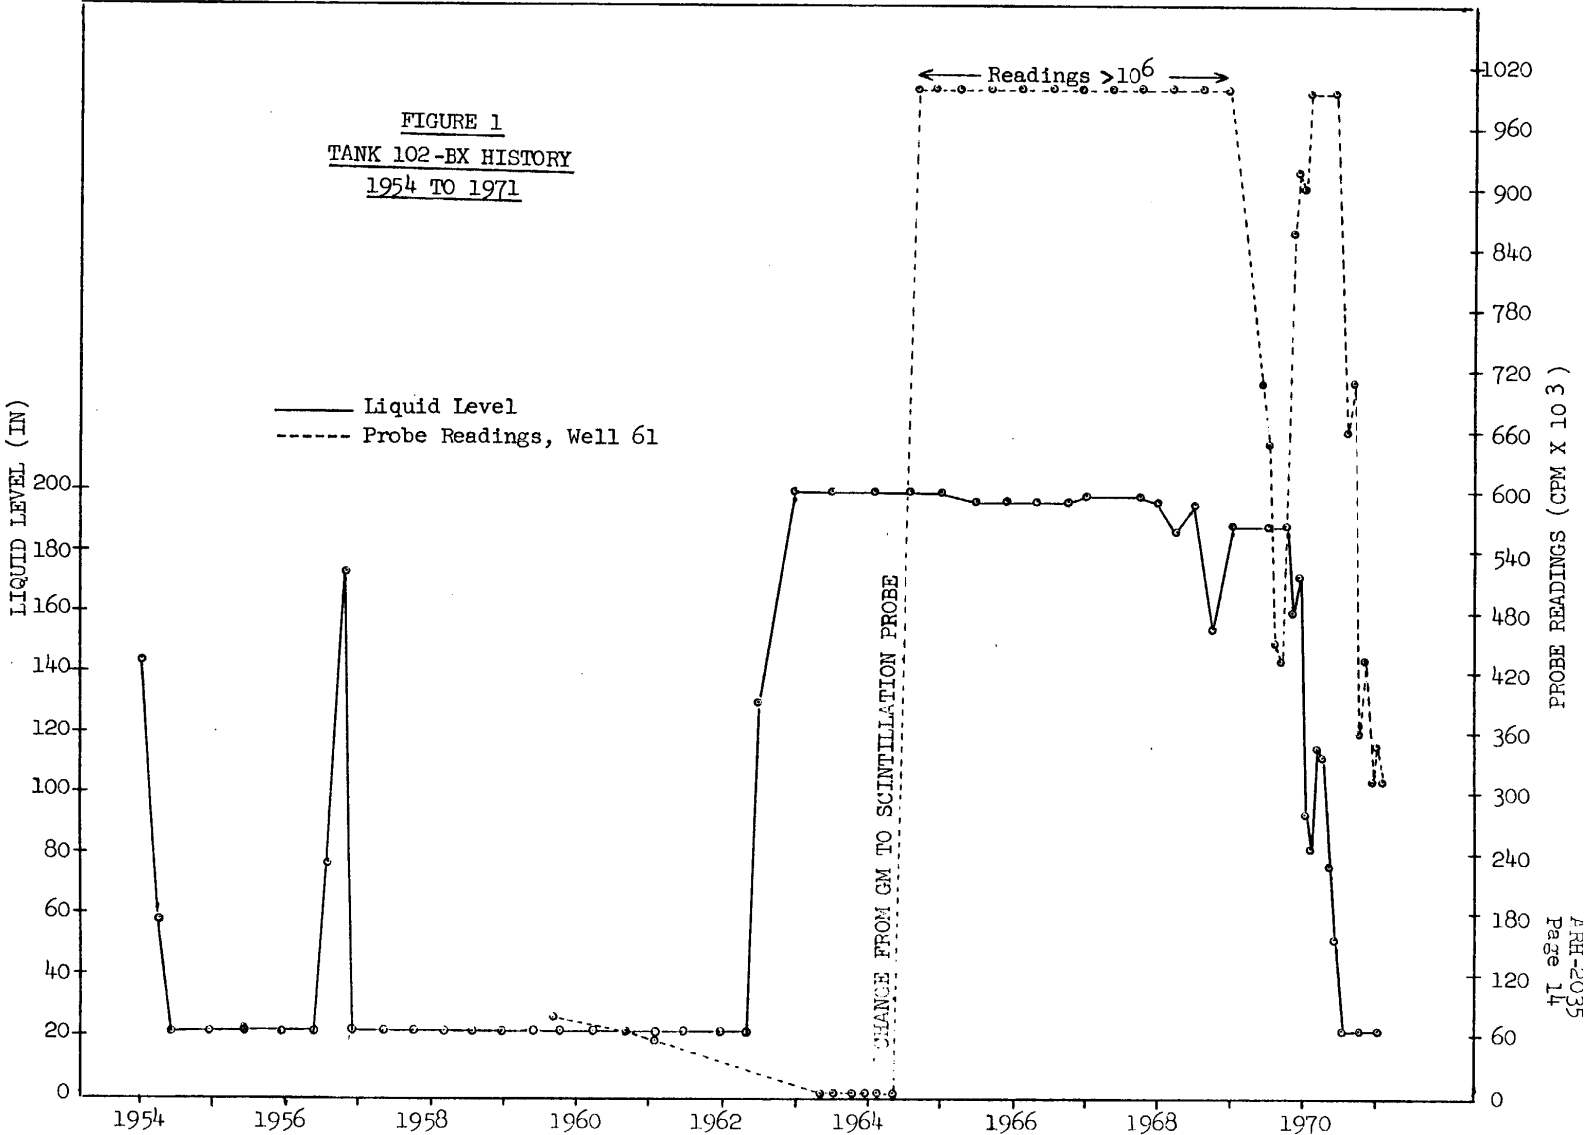
Figure B2-23. Drywell 61 (21-27-01) Gamma and Tank 241-BX-102 Liquid Levels

observed in drywell 27 (now 21-02-04) at 1E8 pCi/g at 40 to 50 ft. This well is near tank BX-102, and like drywell 61 activity increases were attributed to leaks from the tank. Figure B2-7 shows 2000 SGLS logging results for drywells near tank BX-102 (GJ-HAN-19, *Vadose Zone Characterization Project at the Hanford Tank Farms Tank Summary Data Report for Tank BY-102*). Drywell 21-02-03, 21-02-04, 21-02-06, 21-27-01 and other 21-27 series drywells are discussed in the following sections.
