# National Transportation Safety Board

## Safety Recommendation

**In reply refer to:** A-00-120

On March 24, 1999, at 1300 central standard time, an Extra Flugzeugbau GmbH EA-300S, N9K, operated by Above & Beyond Aviation, Inc., experienced a separation of the upper left longeron<sup>1</sup> and a diagonal brace tube member at the attach point of the horizontal stabilizer.<sup>2</sup> The separation occurred when the airline transport-rated pilot entered a roll maneuver while practicing for an airshow in Dow, Illinois. The pilot was able to land the airplane without further incident. The pilot was not injured, but the airplane was substantially damaged. The flight was operating under Title 14 *Code of Federal Regulations* (14 CFR) Part 91, in visual meteorological conditions, and without a flight plan.

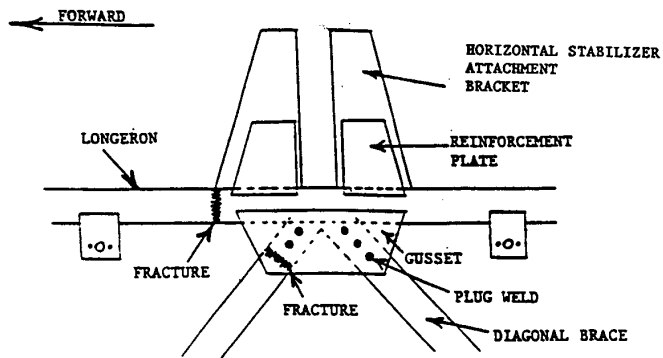
Figure 1. The attachment assembly for the horizontal stabilizer on the N9K accident airplane.

The fuselage construction in the area of the attachment assembly for the horizontal stabilizer on the accident airplane is illustrated in figure 1 (enclosed). The fuselage assembly of airplanes in the Extra 300 series is manufactured from steel tubing. The ends of the tubing are cut at angles then welded to each other to form a frame structure. Four longerons (0.7-inch outside diameter tubing) run the length of the fuselage. An attachment assembly for the horizontal stabilizer is welded to the two upper longerons. This attachment assembly contains one forward and one aft fitting (bracket). On the upper left side of the airplane, two diagonal braces intersect the upper longeron in the vicinity of the attachment brackets for the horizontal stabilizer. The diagonal brace running forward and down from the horizontal stabilizer is called the forward diagonal brace in this letter, and the diagonal brace running aft and down from the attachment assembly for the horizontal stabilizer is called the aft diagonal brace. The brackets and braces on the right side of the airplane are a mirror image to those on the left side.

Metallurgical examination of the separated pieces from N9K was conducted at the Safety Board's materials laboratory. This examination disclosed a fracture through the upper left longeron that intersected a fillet weld located at the forward end of the base of the forward attachment bracket. This fracture contained a fatigue crack that emanated from the toe of the fillet weld. The length of this fatigue crack measured about 0.35 inch circumferentially. A thumbnail-shaped portion of the fatigue crack region contained a blue tint. This blue tint

measured 0.25 inch circumferentially at the surface of the weld and extended from the surface to a depth of 0.02 inch. The blue tint indicates the size of a crack that existed at the time of heat exposure, such as a welding operation, probably during the weld repair of a crack or installation of gussets and reinforcement plates after the operator's February 1998 annual inspection.<sup>3</sup> Visual examination of the fuselage at the materials laboratory disclosed the presence of a repair reinforcement plate (see figure 1) that had been welded between the upper left longeron and the forward bracket of the attachment assembly for the horizontal stabilizer. A similar repair reinforcement plate had been welded between the longeron and the aft bracket of the attachment assembly for the horizontal stabilizer.

Another fracture was through the forward diagonal brace and was located about 1 inch below and slightly forward of the attachment assembly for the horizontal stabilizer. The metallurgical examination determined that in the area below the attachment assembly for the horizontal stabilizer, a repair gusset had been attached by welds to the diagonal braces and the longeron; however, this gusset had been removed from the airplane before the fractured pieces were sent to the Safety Board's materials laboratory. The operator of the accident airplane indicated that the gusset was removed from the fuselage after the accident in an attempt to repair the fractured tubes, and that the Safety Board's requests to have the fuselage pieces shipped to the laboratory were made after the gusset had been removed.<sup>4</sup> The operator indicated that the gusset was manufactured from a flat steel plate, and that three separate plug welds<sup>5</sup> attached each diagonal brace to the gusset. Reinforcement plates and a gusset also had been installed on the corresponding area on the right side of the fuselage.

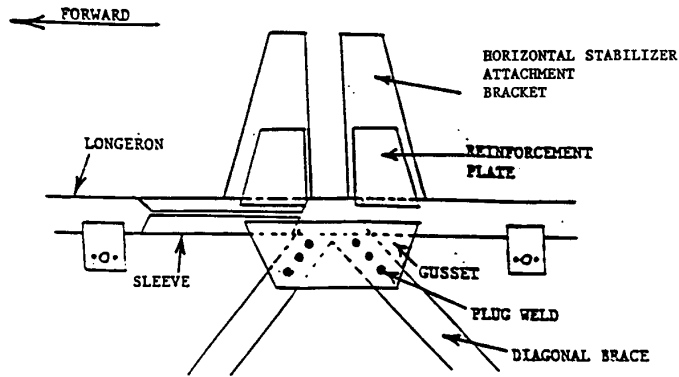
Figure 2. The retrofit parts according to Issue B of Extra Flugzeugbau Service Bulletin SB 300-2-95.

Issue B part II provided repair instructions that would terminate action for the recurring 50-hour inspection specified in Issue A. According to these instructions, the type of repair is determined by the location of cracking. If cracking is found on the forward end of the bracket for the attachment assembly for the horizontal stabilizer, the crack should be covered by a sleeve,<sup>7</sup> and reinforcement plates and a gusset also should be installed in the area of the attachment assembly for the horizontal stabilizer. Alternatively, if cracking is found in the general vicinity between the brackets for the attachment assembly, reinforcement plates and a gusset should be installed in the area of the bracket assembly. Figure 2 illustrates the retrofit parts that should be installed on the fuselage according to Issue B of the SB.

Issue B part II also indicates that the terminating action (installation of reinforcement plates and a gusset) is mandatory on any airplane in which cracks are found, and on all EA-300S airplanes even when cracks are not found. The terminating action is optional for EA-300 and EA-300L airplanes on which cracking has not been detected. Issue B states that no further inspection<sup>8</sup> for cracking needs to be performed on an airplane after the terminating action is accomplished. The Safety Board materials laboratory determined that the reinforcement plates found in the N9K airplane were manufactured from 4340 steel and were installed on the left and right sides of the airplane in the positions indicated in Issue B.

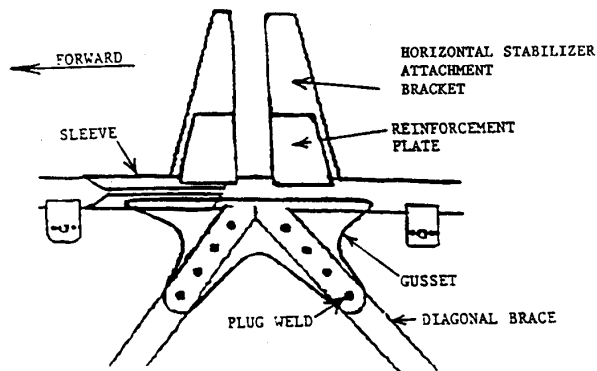
Figure 3. The retrofit parts according to Issue C of Extra Flugzeugbau Service Bulletin SB 300-2-95.

Issue C of SB 300-2-95, released on July 15, 1998, contained several changes regarding the retrofit parts that should be installed on the fuselage (see figure 3). The gusset described in Issue C is made from a plate that contains two legs with rounded edges, whereas the gusset described in Issues A and B is made from a plate with straight edges. The Issue C gusset is also slightly larger than the Issue B gusset, and it has four plug welds<sup>9</sup> on each diagonal brace instead of the three plug welds for the Issue B gusset. A representative from Extra Flugzeugbau indicated that the Issue C gusset allows for better distribution of stiffness in the reinforcement area.

The gusset in Issue B is slightly smaller than the gusset in Issue C, and it contains fewer plug welds than the gusset in Issue C. Issue B gussets may have been installed in the fuselage of EA 300 series airplanes, and this gusset may not have been replaced with an Issue C gusset. The Safety Board believes that the round edges and larger size of the Issue C gusset will provide better stress distribution at the attachment area of the horizontal stabilizer. The Safety Board is concerned that the Issue B gusset may not adequately reinforce the attachment area and, as indicated earlier in this letter, believes the FAA should mandate the installation of Issue C gusset on EA-300 series airplanes.

Issue an airworthiness directive to make compliance with Extra Flugzeugbau Service Bulletin 300-2-95 Issue C mandatory with the exception that the visual inspections be replaced with dye penetrant inspection and that the inspection areas be expanded to include the welds associated with the aft end of the aft brackets for the attachment assembly of the horizontal stabilizer. For any crack detected in the upper longeron area, require operators to weld repair the crack before installing the sleeve described in Issues B and C of the service bulletin. Compliance with this service bulletin should be accomplished on an expedited basis, but no later than the next inspection required by Issue C or annual inspection, whichever is sooner. (A-00-120)
