National Transportation Safety Board

Safety Recommendation

In reply refer to: A-00-1 through -3

(DCA981A020, Air Force 1, 1/28/98)

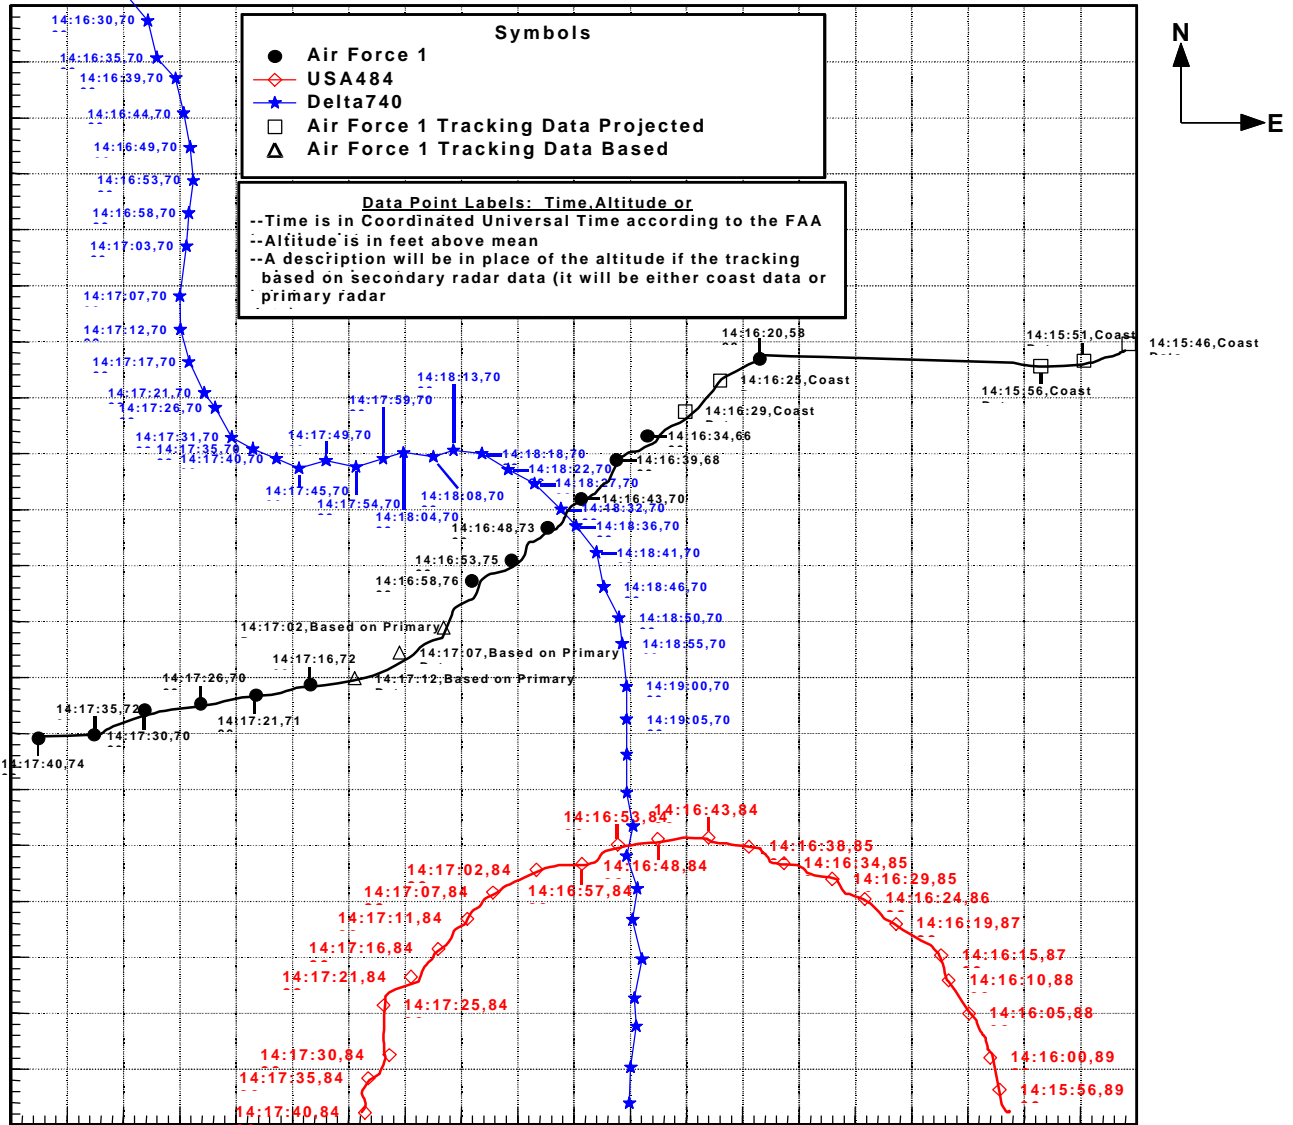
Figure 1

On January 28, 1998, at 0916:58 eastern standard time, an operational error¹ involving Air Force 1 (A1)², a Boeing 707, and US Airways flight 484 (USA484), a Boeing 737, occurred approximately 6 miles west of Ronald Reagan Washington National Airport (DCA). Recorded radar data indicate that the two aircraft were separated by 2.7 miles horizontally and 800 feet vertically. Approximately 30 seconds later, recorded radar data indicate that A1 and Delta Air Lines flight 740 (DAL740), an MD-80, were at 7,000 feet³ and 2.56 miles apart. The DCA Air Traffic Control Tower (ATCT) was providing ATC separation. (Figure 1 shows the positions of the three aircraft during this time period.) The departure radar controller, a developmental⁴ controller, was responsible for A1, and an approach controller was responsible for the other two aircraft.
