National Transportation Safety Board

Safety Recommendation

In reply refer to: A-00-22

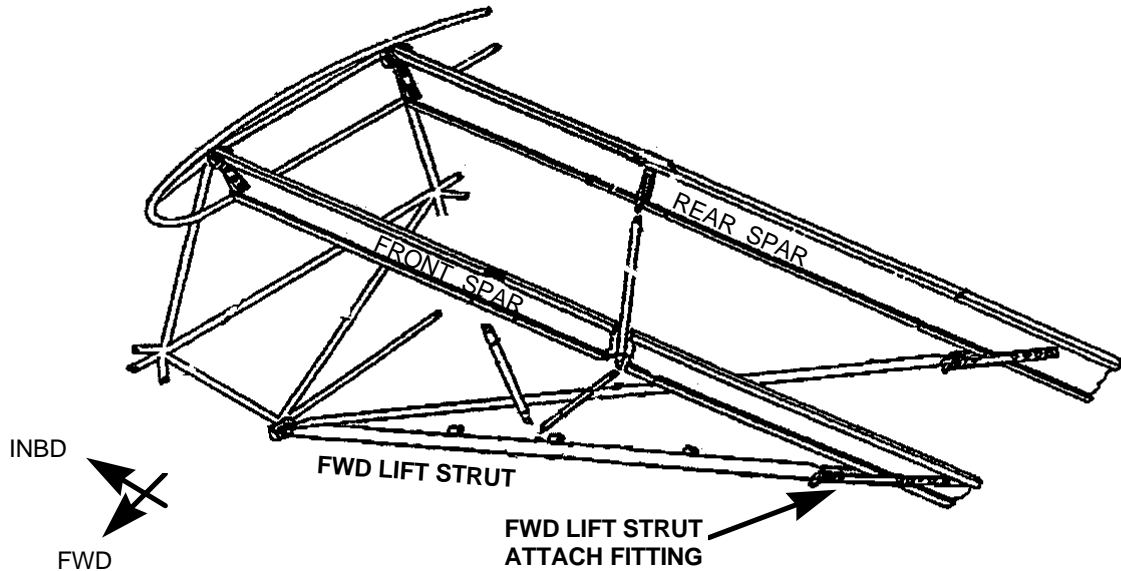
Figure 1. Typical Wing Structure of a High-Wing Piper Airplane

The National Transportation Safety Board's investigation revealed that the left-wing forward lift strut² had separated from the wing in flight. Metallurgical analysis revealed that the separation was precipitated by corrosion of the lift strut's forward attach fitting (see figure 1).³ The corrosion originated on the front face of the fitting, near its connection to the forward lift strut, in an area concealed by the leading edge of the wing. A cross-section of the fitting revealed that corrosion had completely penetrated it.

The Safety Board also examined the forward attach fitting from the right (intact) wing's forward lift strut and found evidence of moderate corrosion damage in the same area as in the left wing fitting. Minor corrosion was found on the aft attach fittings. The airplane's maintenance records indicated that the accident airplane was covered with Ceconite⁴ on October 21, 1967, after 761 hours of operation, and it had not been re-covered since. The airplane had been operated 9,731 hours since it was manufactured in 1963 and had undergone a 100-hour inspection 10 days before the accident. No comments regarding corrosion were found in the maintenance records pertaining to the 100-hour inspection. The applicable Piper 100-hour inspection checklist does not specify an inspection for corrosion on the wing lift strut attachment fittings.

Require The New Piper Aircraft, Inc., to develop a recurrent inspection procedure adequate to detect corrosion of any portion of the lift strut attach fittings installed on high-wing Piper airplanes and require that owners of these airplanes implement those recurrent inspection procedures.
(A-00-22)

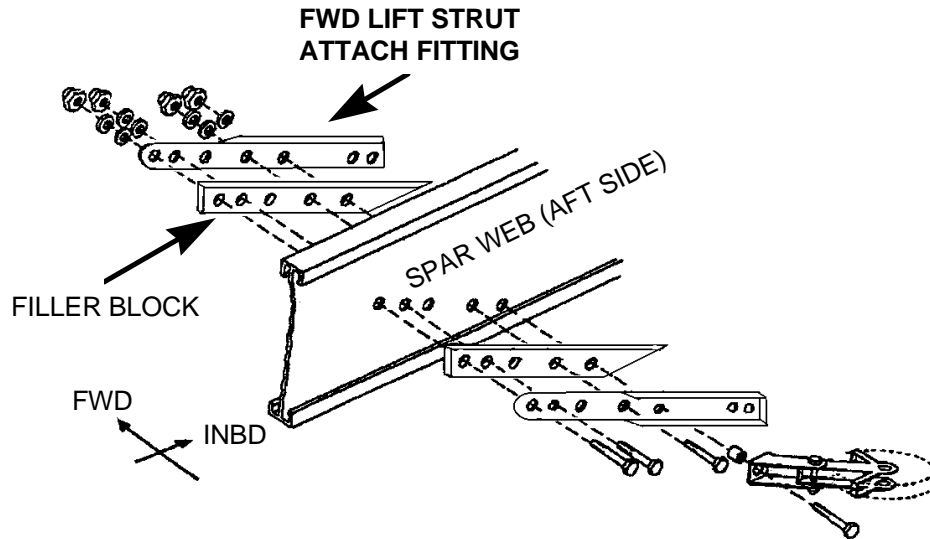
Figure 2. Close-up View of Forward Lift Strut Attach Fitting Assembly

The lift strut attach fittings connect the outboard end of the forward lift strut to the forward and aft faces of the wing spar (see figure 2). Each fitting is bolted to the spar through an aluminum filler block that is sandwiched between the fitting and the spar web. The lower (inboard) portions of both fittings protrude beneath the lower surface of the wing and can be easily inspected. The upper (outboard) portion of the aft fitting is installed behind the front spar and can be inspected via an access panel underneath the wing. However, there are no access panels forward of the front spar; therefore, it is not possible to inspect the upper portion of the forward fitting without removing a portion of the wing leading edge. The only opportunity to inspect the entire forward fitting typically occurs when the wing skin needs to be replaced.

Further, the Safety Board also notes that the SAIB does not specify how to inspect the forward attach fitting if corrosion is detected on the exposed surfaces that protrude beneath the wing and that the surface condition in the aft area of the fittings may not adequately represent the surface condition in the area of the forward portion of the fitting that protrudes into the bottom skin of the wing and is hidden from view. Therefore, a lack of corrosion in the aft area does not preclude the possibility of corrosion on the forward portion of the fitting. In most of the fittings that the Safety Board examined, minor corrosion was noted on the aft attach fittings and the exposed lower portions of the forward fittings, while severe corrosion was detected on the area of the forward portion of the fitting that protrudes into the bottom skin of the wing. This area is more susceptible to corrosion because the bottom surface of the leading edge mates with the forward face of the front spar web, which creates a confined space that traps moisture.

corrosion cannot be adequately inspected without removing a portion of the wing leading edge. Therefore, the Safety Board believes that the FAA should require The New Piper Aircraft, Inc., to develop a recurrent inspection procedure adequate to detect corrosion of any portion of the lift strut attach fittings installed on high-wing Piper airplanes and require that owners of these airplanes implement those recurrent inspection procedures.
