National Transportation Safety Board

Safety Recommendation

Date: April 24, 2000

In reply refer to: A-00-28 and -29

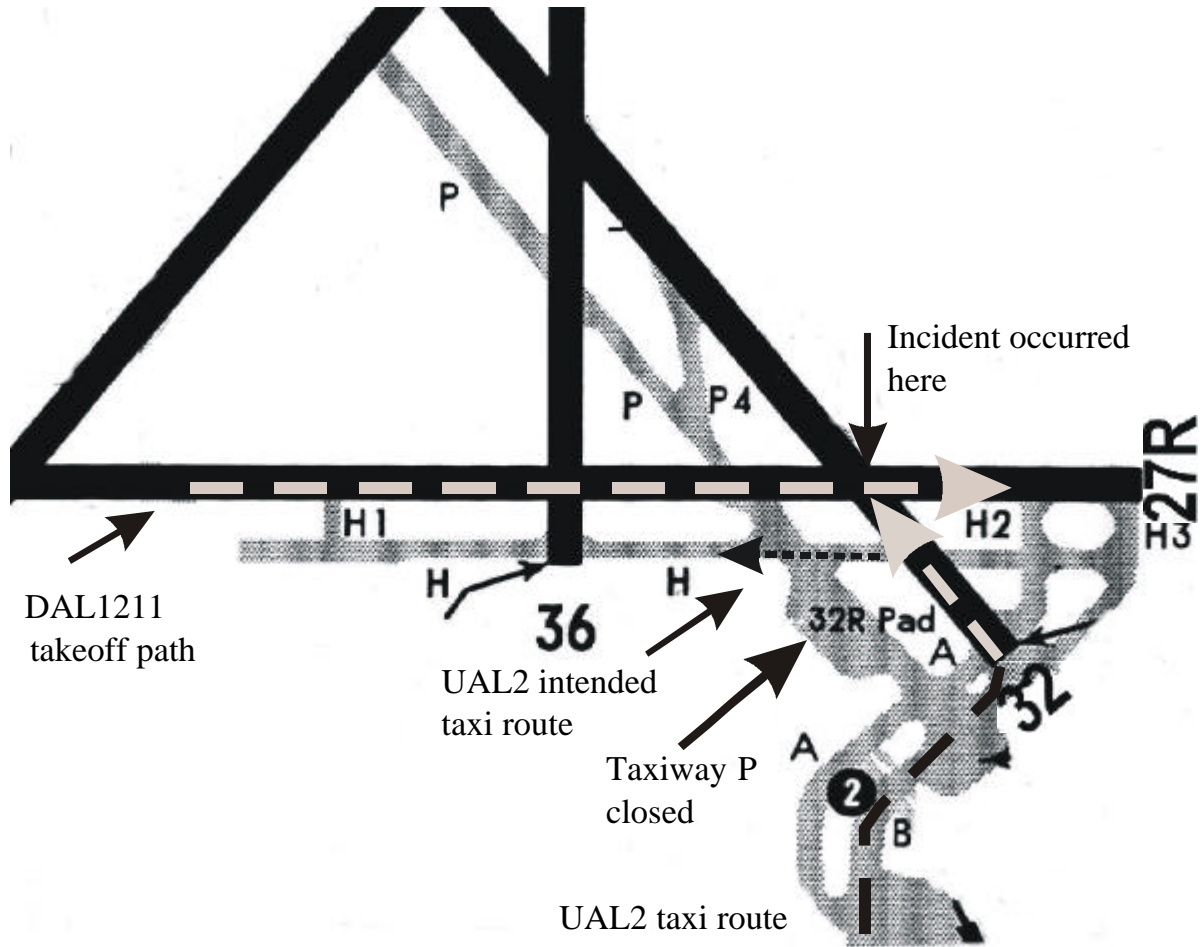
Figure 1. ORD Airport Diagram

The UAL2 maintenance crew was repositioning the airplane from ORD's International West terminal east to gate C11. The ORD ground controller instructed the UAL2 crew to taxi from the International West terminal to the "north port"¹ via taxiway B, the Bravo bridge, runway 32R, and taxiway H. (See figure 1.) The crew became uncertain of the airplane's position, missed the turn onto taxiway H, and continued along runway 32R toward its intersection with runway 9L. The UAL2 crew and the tower ground controller simultaneously detected the error. As the crew was applying the brakes, the ground controller instructed UAL2 to stop and hold its position on runway 32R. Both the tower local and ground controllers independently observed UAL2's position and decided that the airplane had stopped clear of runway 9L.

Safety Board investigators found that the taxi route assigned for use between taxiways B and H at the time of the incident was not the taxi route usually assigned. Aircraft taxiing between taxiways B and H would normally follow taxiway P; however, a section of taxiway P had been closed for several weeks for reconstruction. The tower controllers elected to use runway 32R as a taxiway to bypass the closed section of taxiway P. The UAL2 crew was not familiar with that part of the route, and no signage identified taxiway H at its intersection with runway 32R.

Investigation revealed that the ORD airport certification manual approved by the Federal Aviation Administration (FAA), pursuant to 14 Code of Federal Regulations Part 139, does not require a sign at the intersection of taxiway H and runway 32R because it is close to the threshold of runway 32R and aircraft do not normally turn off there. However, when the tower controllers elected to use runway 32R to bypass the unusable segment of taxiway P, the intersection of

The mechanic who was taxiing UAL2 stated that he was looking for a sign identifying taxiway H. Both crewmembers stated that the area was very dark and that they did not see any signs or lights identifying taxiway H. Thus, the absence of appropriate signage and markings at the runway 32R/taxiway H intersection apparently contributed to the loss of situational awareness experienced by the UAL2 crew, causing them to miss the turn onto taxiway H. This potential problem might have been detected and addressed if ORD's ATC managers had informed airport management about its alternate taxi plan and asked that the route be checked for adequate signage and markings. Detection and correction of such problems is important because, especially in unfamiliar situations, flight and ground crews depend on proper signs and surface markings to maintain situational awareness and avoid runway incursions. Therefore, the Safety Board believes that the FAA should amend FAA Order 7210.3, "Facility Operation and Administration," to require tower ATC managers to monitor planned airport construction projects or other activities that may require significant use of nonstandard taxi routes and coordinate with airport management to ensure that such routes are inspected for adequate signage and markings.

Amend Federal Aviation Administration Order 7210.3, "Facility Operation and Administration," to require tower air traffic control managers to monitor planned airport construction projects or other activities that may require significant use of nonstandard taxi routes and coordinate with airport management to ensure that such routes are inspected for adequate signage and markings. (A-00-28)
