National Transportation Safety Board

Safety Recommendation

Date: June 16, 2000

In reply refer to: A-00-32 through -40

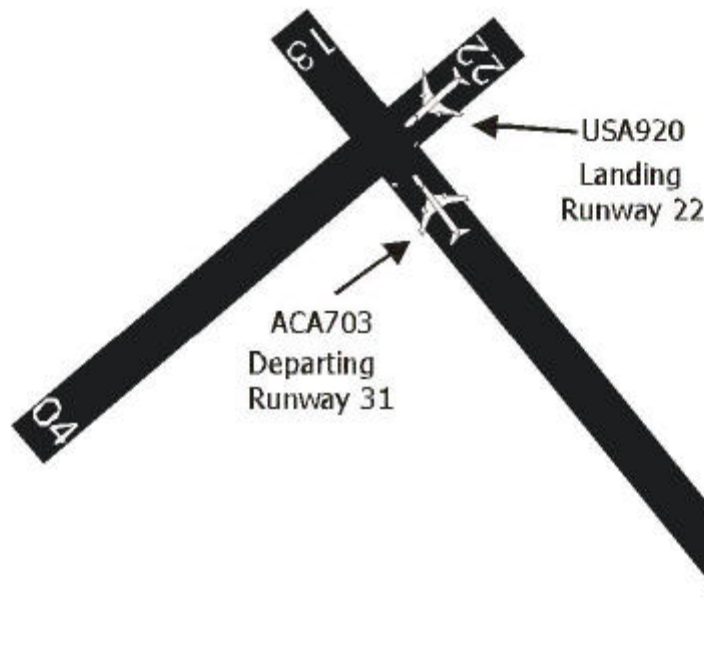
On April 3, 1998, about 0821 eastern standard time, US Airways flight 920 (USA920), a McDonnell-Douglas DC-9, and Air Canada flight 703 (ACA703), an Airbus Industries A-319, nearly collided above the intersection of runways 22 and 31 at LaGuardia Airport (LGA), Flushing, New York (see figure 1). Both aircraft were scheduled passenger flights; USA920, as a domestic carrier, was operating under 14 Code of Federal Regulations (CFR) Part 121, and ACA703, as a foreign air carrier, was operating under 14 CFR Part 129 while in U.S. airspace. The incident occurred in visual meteorological conditions, and no injuries were reported.

Figure 1. Approximate aircraft orientation for April 3, 1998, near midair collision (NMAC) at LGA

At the time of the incident, aircraft landing at LGA were using runway 22 and departing aircraft were using runway 31. Runway 22 intersects runway 31 approximately 5,300 feet from the threshold of runway 31. According to the LGA tower local controller, USA920 was executing a visual approach to runway 22 and had been cleared to land. The local controller then cleared ACA703 for takeoff from runway 31. Approximately 30 seconds later, he reassessed the traffic situation and decided that ACA703 would not clear the intersection before USA920 crossed the threshold of runway 22.¹ The local controller then instructed USA920 to go around.² ACA703 was airborne and climbing before it reached the intersection with runway 22; consequently, USA920 and ACA703 were in the air when their paths crossed. The captain of USA920 saw ACA703 on his left and alerted the first officer, who was flying the airplane. The first officer immediately took evasive action to avoid a collision. Radar data were not available because both airplanes were below radar coverage at the time of the incident; however, in the NMAC report he filed with the FAA, the captain of USA920 estimated that his aircraft passed 85 feet below ACA703 with horizontal separation of 75 feet. The local controller estimated the separation distance at 20 feet.

Amend LaGuardia tower procedures to extend the spacing standard used to separate converging arrivals and departures to a distance greater than 2 miles. (A-00-32)

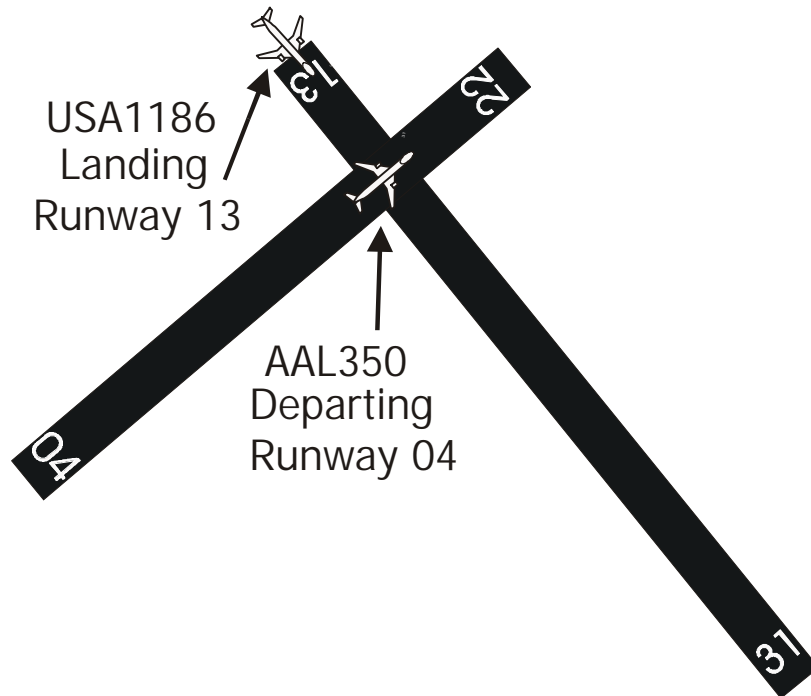
On January 23, 1998, about 1819 eastern standard time, US Airways flight 1186 (USA1186), a Boeing 737, and American Airlines flight 350 (AAL350), a McDonnell-Douglas MD-80, nearly collided at the intersection of LGA runways 4 and 13 (see figure 2). The reported weather was ceiling 600 feet and visibility 2 miles. According to an NMAC report filed by the captain of USA1186, his aircraft was on a 2.5 mile final for an instrument landing system approach to runway 13 when the local controller cleared AAL350 for takeoff from runway 4. The USA1186 captain reported that AAL350 did not pass through the intersection of runways 4 and 13 until after USA1186 had crossed the runway 13 threshold. The runway 13 threshold is 1,700 feet from the intersection with runway 4 or 7.5 seconds flying time at an estimated approach speed of 135 knots.

Figure 2. Approximate aircraft orientation for January 23, 1998, NMAC at LGA

The captain of AAL350 stated that he looked to his left as his aircraft passed through the runway 4/13 intersection and saw USA1186 approximately over the runway 13 threshold. Recorded air traffic control (ATC) communications indicate that after departure, one of the pilots of AAL350 said to the local controller, “that was close.”
